ACCIDENT

Aircraft Type and Registration:	Savannah Jabiru, G-CEED	
No & Type of Engines:	1 Jabiru Aircraft Pty 2200 piston engine	
Year of Manufacture:	August 2006	
Date & Time (UTC):	20 October 2007 at 1030 hrs	
Location:	Near Mergate Hall, Bracon, Norfolk	
Type of Flight:	Private	
Persons on Board:	Crew - 1	Passengers - 1
Injuries:	Crew - None	Passengers - None
Nature of Damage:	Nose landing gear bent backwards, slight indentation on the underside of the engine cowling and forward fuselage	
Commander's Licence:	Private Pilot's Licence	
Commander's Age:	51 years	
Commander's Flying Experience:	247 hours (of which 11 were on type) Last 90 days - 4 hours Last 28 days - 1 hour	
Information Source:	AAIB Field Investigation

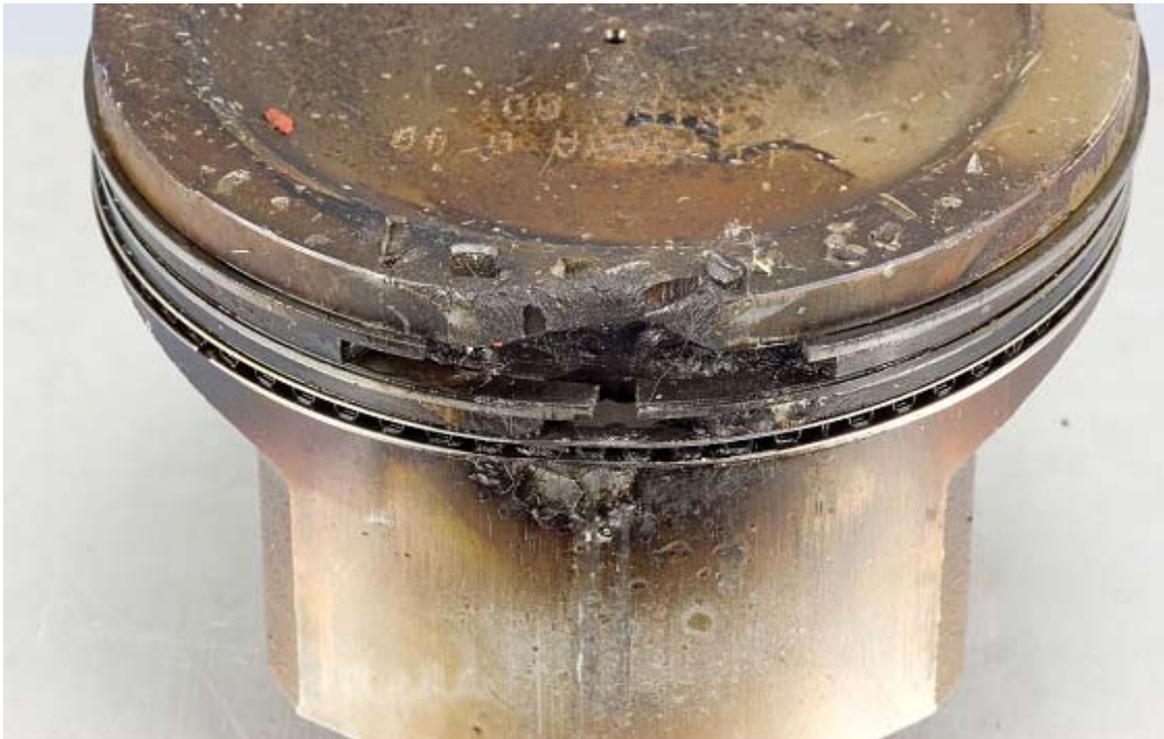
Figure 2

or exhaust manifold systems and no restriction within the engine oil supply system. There was, however, good evidence of the onset of piston seizure within the cylinders and burn-through of the No 3 piston (Figure 2).

Three cylinders and their associated pistons were taken to the Materials Department at QinetiQ for detailed metallurgical examination. Examination of the three cylinders showed that No 3 piston and cylinder exhibited characteristics similar to the No 3 piston and cylinder from G-CEED. The piston/cylinder head interface exhibited sooting on one side of the cylinder, with the corresponding edge of the piston exhibiting burn-through (Figure 2). The internal surface of the cylinder showed evidence of minor wear and material pick-up from the piston at the point of the piston burn-through. Skirt wear was observed on the piston similar to that observed in the examination of the engine from G-CEED. Minor wear was observed below the burn-through with the opposite skirt exhibiting more severe wear. The other two pistons both exhibited skirt wear similar to the No 3 piston. One of the pistons showed evidence of damage to the edge of the piston crown with reciprocating wear and material pick-up on the internal surface of the cylinder. The damage appeared to be purely mechanical, with no evidence of burn-through as seen in the No 3 piston.

Examination of the piston rings and oil scraper rings showed that the lower piston ring was seized in the closed position on one of the pistons and on another the upper ring was seized at the area of the damage, so that it was flush with the piston edge. The other end of the piston ring was free to move. On the No 3 piston both the lower piston ring and oil scraper ring were seized in the closed position.

No 3 piston from G-CEFY showing pre-ignition damage and burn-through

The visual examination of the three pistons and cylinders showed that an engine failure similar to that of G-CEED. In both cases the engines exhibited seized piston and oil scraper rings, piston skirt wear and burn-through.
