Rail Accident Investigation Branch

Rail Accident Report

Class investigation into rail breaks on the East Coast Main Line

Report 24/2014
November 2014

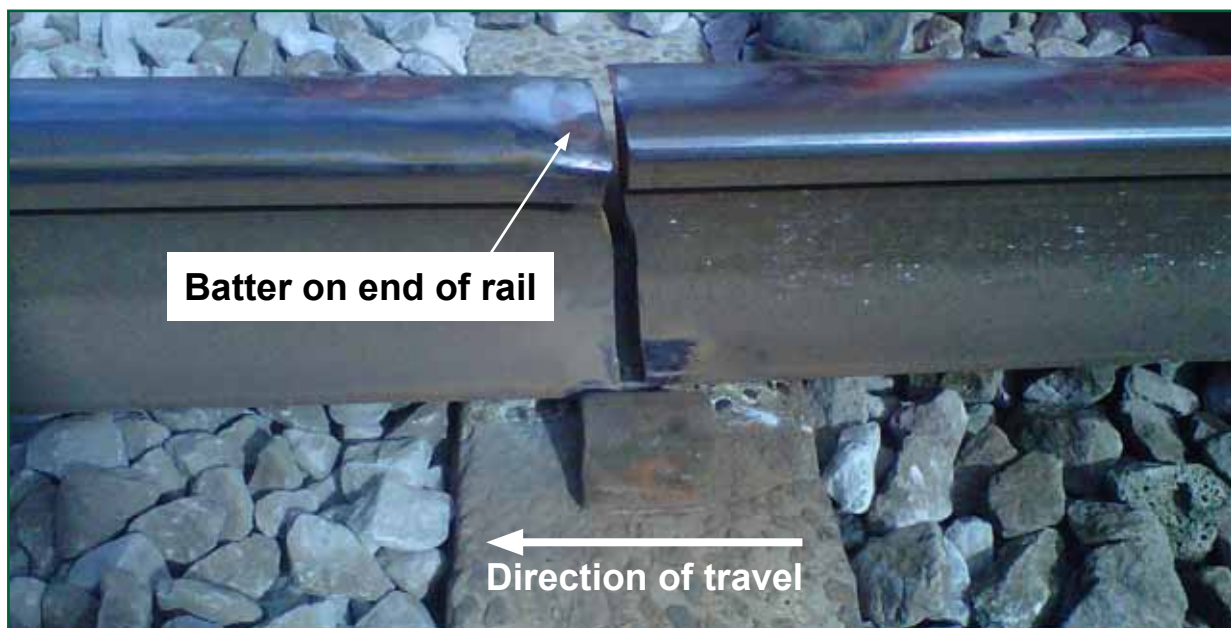
Figure 2: Corby Glen - Broken rail (image courtesy of Network Rail)

- 10 The break occurred at 97 miles 62 yards on the *down* main line of the ECML in an area of straight *continuous welded rail* with a maximum permitted train speed of 125 mph (200 km/h). The rail was of the *flat bottom* type designated BS113A and had been manufactured in 1985. It was clipped to concrete *sleepers* with a *pad* between the rail and each sleeper. Trains travelling in the normal direction of traffic passed over a weld joining two pieces of rail about 1.5 metres before the location of the break.
- 11 Tata Steel Rail Technologies examined the broken rail at Network Rail's request and concluded that the break developed because:
- pad wear immediately beneath the rail resulted in moisture collecting between the rail and the sleeper (figure 3);
 - the moisture caused corrosion which led to two small *corrosion pits* developing on the underside of the rail;

- stresses in the rail caused by train loads were concentrated into areas of rail very close to the corrosion pits and these initiated cracks, known as *fatigue cracks*, for reasons explained in paragraph 59;
- the fatigue cracks grew as a result of forces imposed by passing trains, merged together, and then continued to grow;
- as crack size increased, the stresses at the crack tip probably increased for reasons explained in paragraph 60;
- a sudden break (*brittle fracture*) occurred when the fatigue crack size meant that the remaining intact rail was unable to carry the stresses imposed by a train;
- the break allowed a gap of about 15 mm to open between the rail ends as they moved apart due to the tension in the continuous welded rails (paragraph 41); and
- train wheels striking the exposed rail end after passing over the gap caused batter damage to the rail (figure 2).

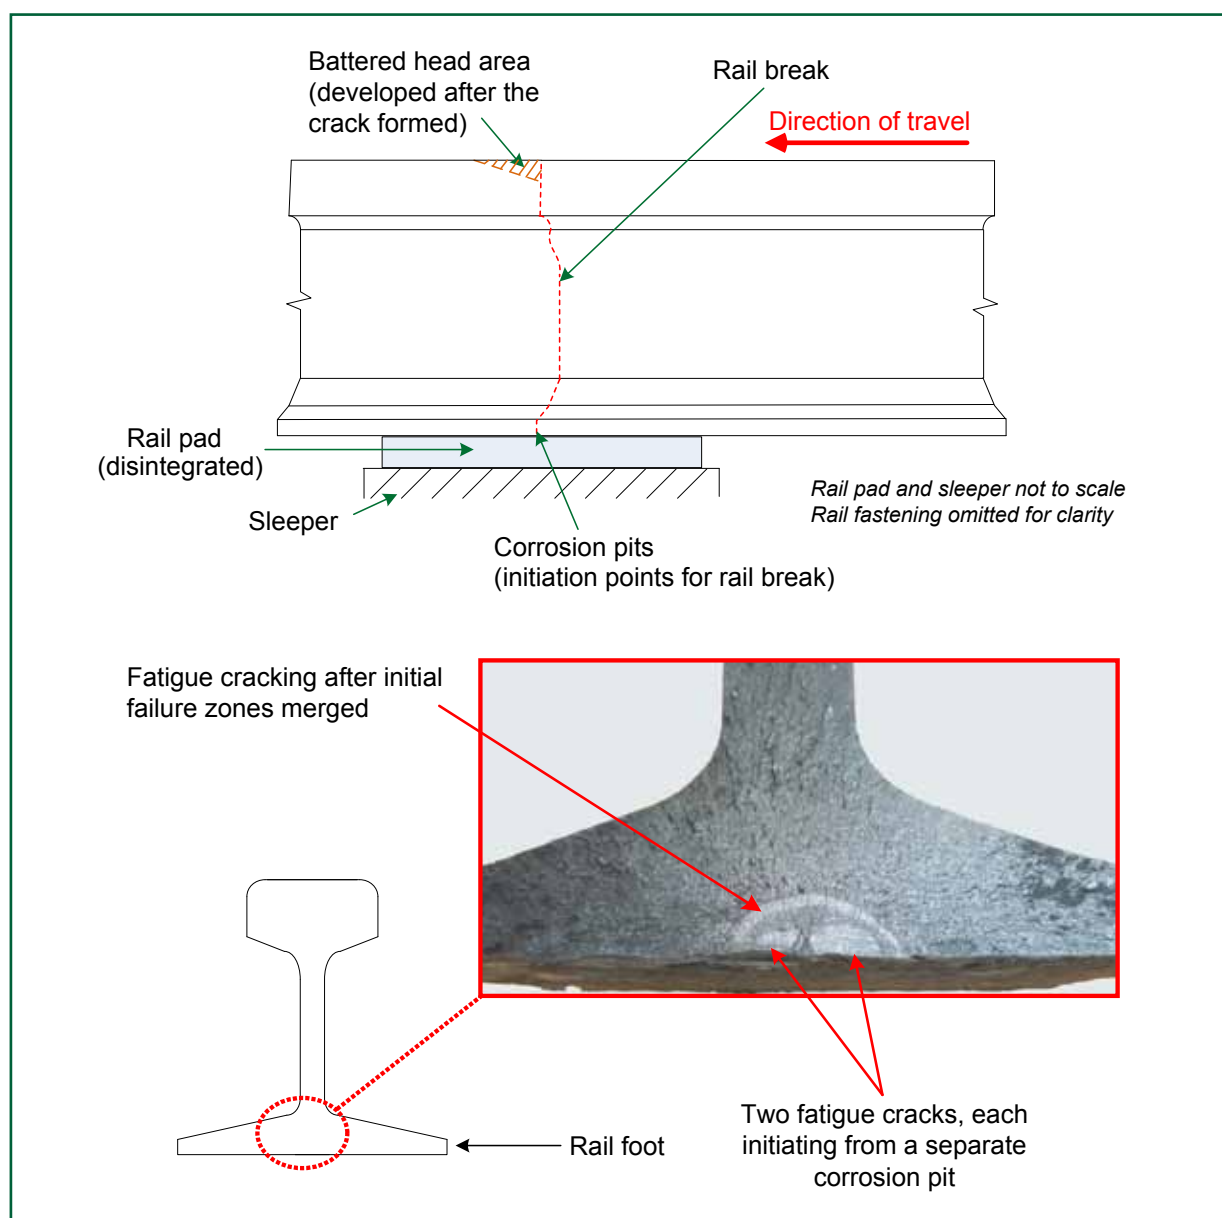
Figure 3: Corby Glen - Failure mode

- 12 Network Rail has expressed the view that one factor in this break was the small dip in the rail head caused by an old weld about 1.5 metres before the section of rail which broke.

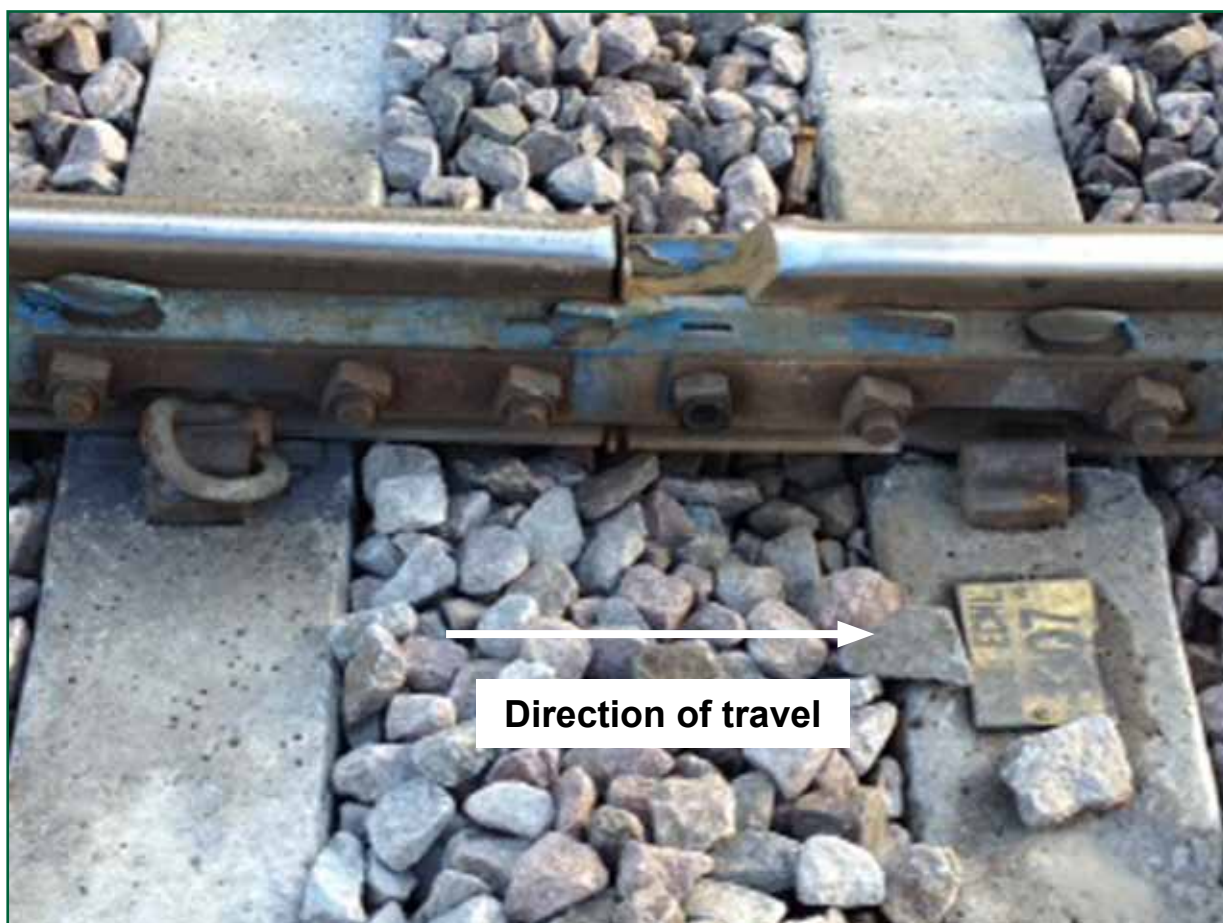
Figure 4: Copmanthorpe - Broken rail (image courtesy of Network Rail)

- 19 Serco Rail Technical Services (SERCO) examined the broken rail at the RAIB's request and, taking account of information provided by Network Rail about the condition of the ballast intended to support the sleepers, SERCO concluded that the break occurred because:

- inadequate support to sleepers from the underlying *ballast* meant that part of the train loads intended to be carried by these sleepers were actually carried through the rail to adjacent, better supported, sleepers in a manner which caused additional bending at the joint (figure 6);

- these relatively high loads caused wear (and/or overloading) of the plastic insulating material permitting movement of the fishplates relative to the rail, and thus misalignment of the rail ends on each side of the joint;

- the increased stresses caused fatigue cracks to propagate from corrosion pits on the underside of the rail head (the corrosion was not particularly severe but the pits provided a *stress concentration* feature (paragraph 60) which governed the precise location at which cracks initiated);

- the fatigue cracks gradually enlarged until they had penetrated approximately 2 mm into the rail;
 - the amount of rust found on the surface of these cracks after the rail broke indicated that the gradual growth probably occurred over a period of several months; and

- a 110 mm length of rail head broke off when the remaining intact rail was unable to carry the loads caused by trains (particularly the high stresses at the tips of the fatigue cracks).

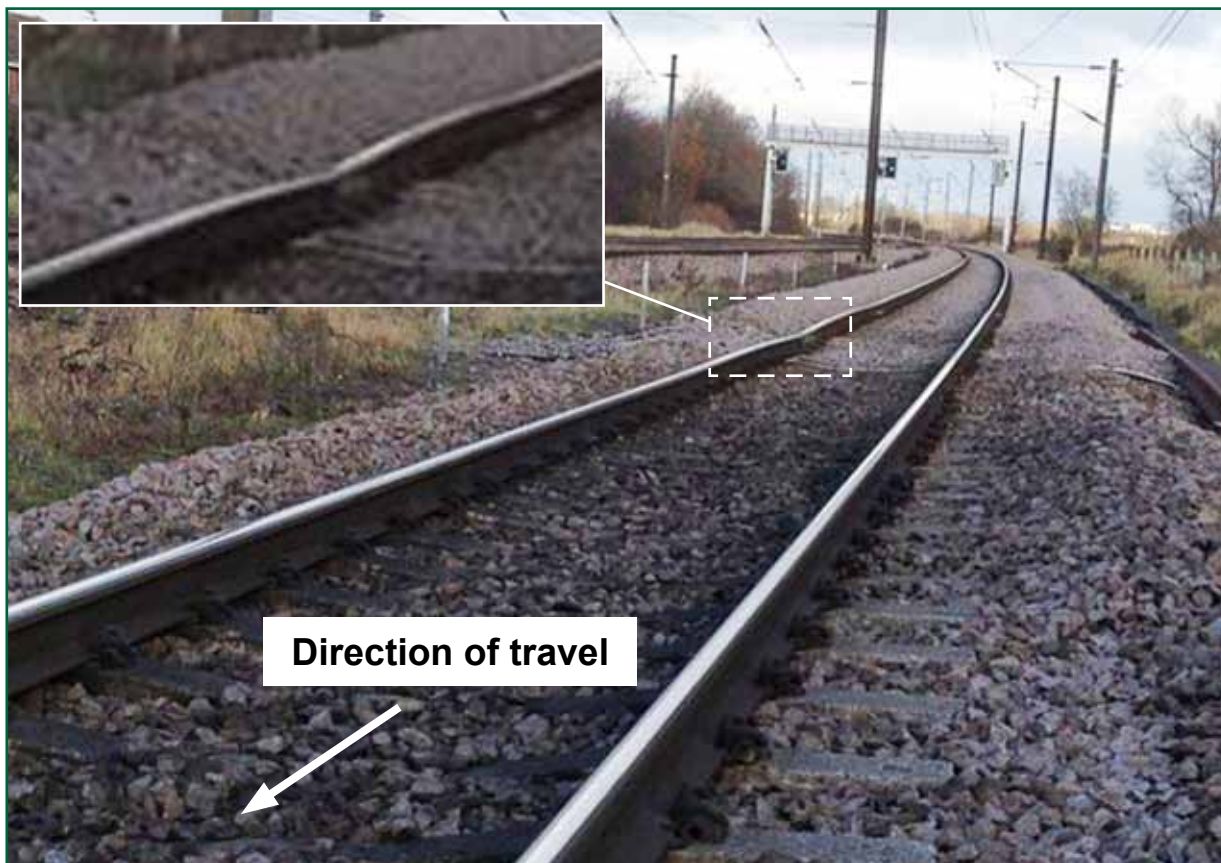
- rail misalignment caused wheel impact loads which were greater than the loadings on correctly aligned track and which caused increasing movements, and thus an increasing dip (figure 7);

Figure 7: Copmanthorpe - Dipped joint (image courtesy of Network Rail)

- 22 Although the cracks were not detected, the dipped joint had been reported since May 2012 and *wet beds*, a common cause of loss of support from ballast, had been reported since September 2012. These reports triggered maintenance work on five occasions in the ten weeks before the incident (Table 1). The reasons why this maintenance did not prevent the rail break are discussed in paragraph 72 onwards.
- 23 Contrary to reports in the media shortly after the break occurred, the crack had not been identified and marked with blue paint (as an indication that it needed repair or replacement) four days before the incident. The reports were based on a photograph taken on site which appeared to show areas of blue on the top of the rail and on parts of the fishplates (figure 9).

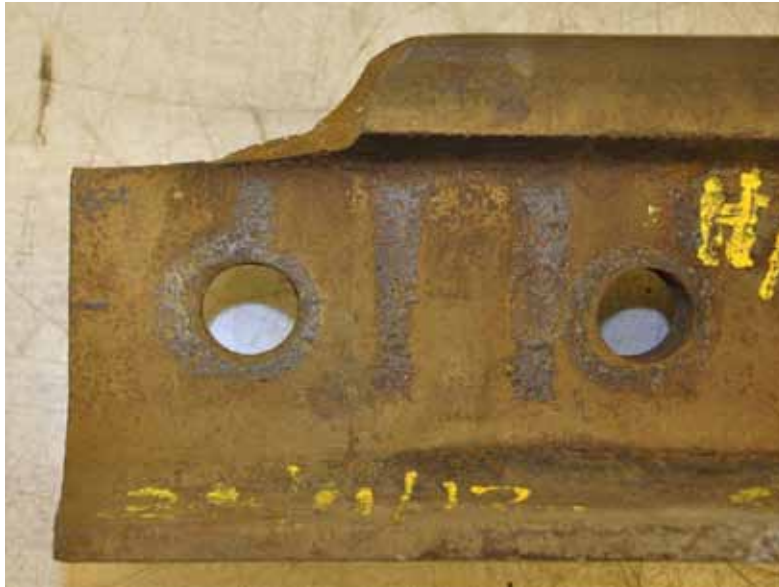
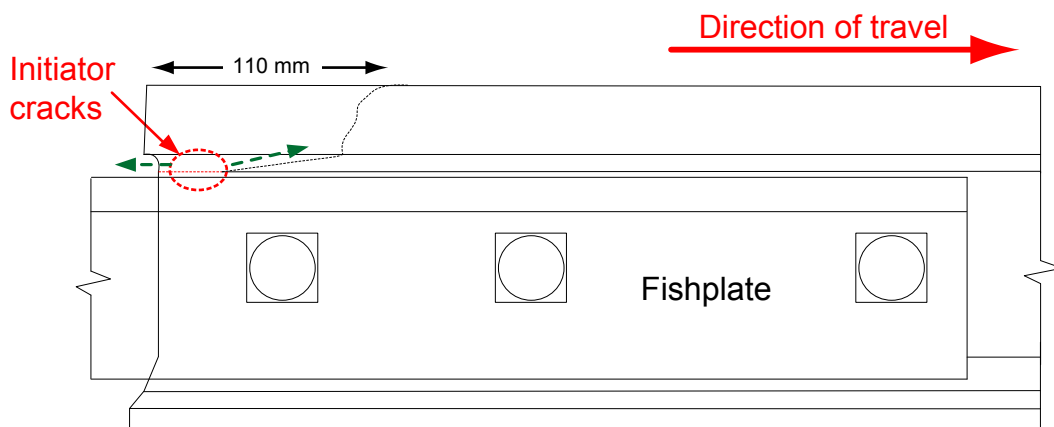
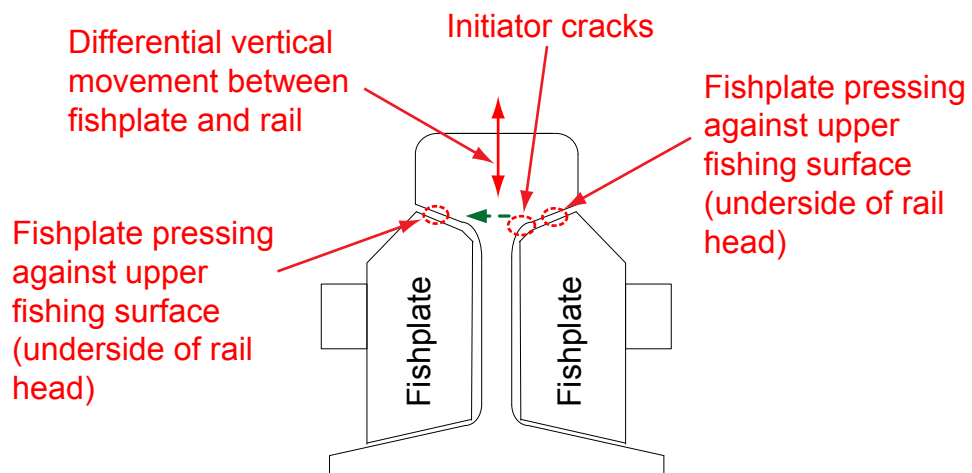
Rail with broken portion missing and fishplate removed

Green arrows show direction of crack propagation from initiation points

Figure 8: Copmanthorpe - Failure mode

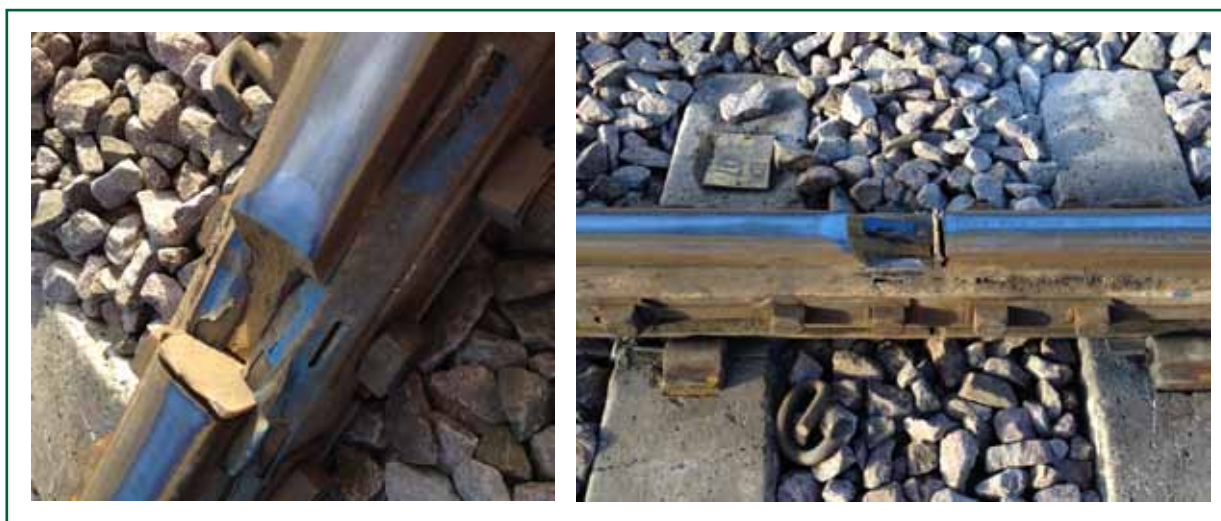
Figure 9: Copmanthorpe - Photographs showing 'blue' areas

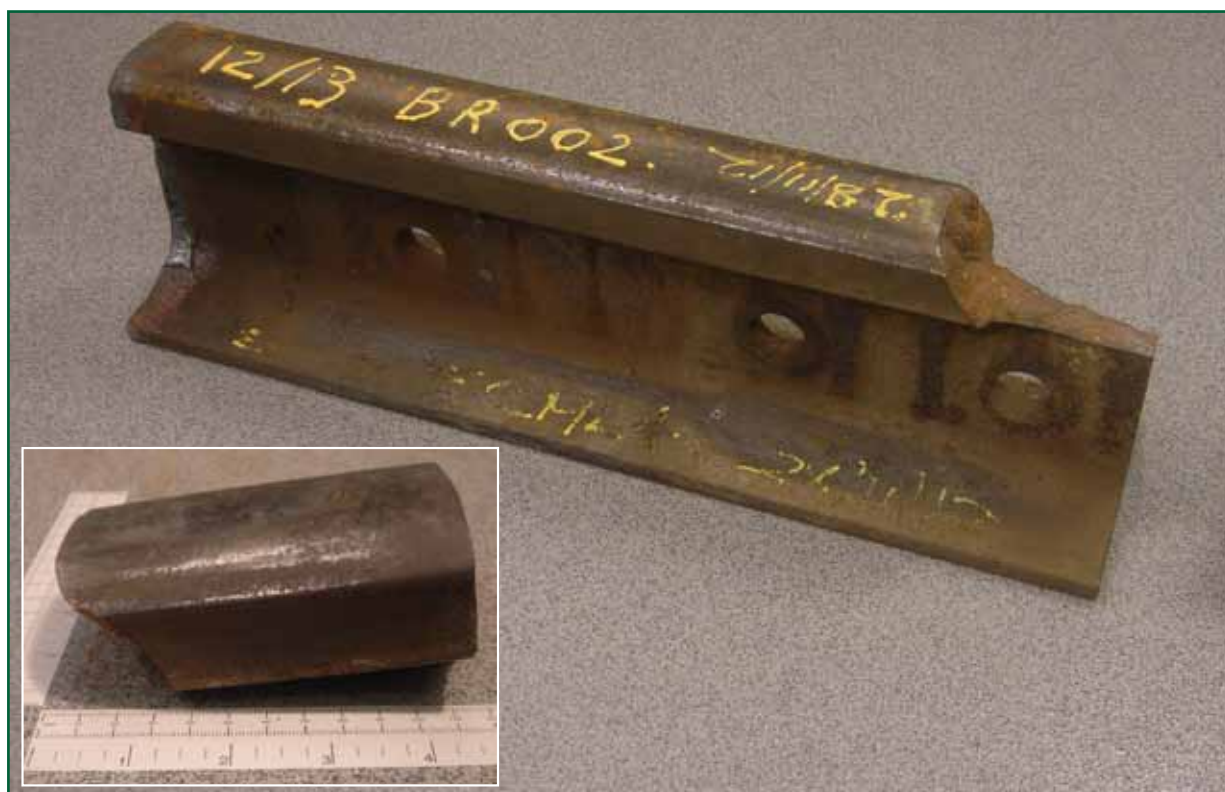
Figure 10: Copmanthorpe - Rail as received by the RAIB (no blue areas)

- 24 When inspected by the RAIB (figure 10), there were no blue paint markings, and no evidence of blue markings having been removed, on the upper surface of the portion of rail which broke away and none on the rail from which it broke.
- 25 The blue areas on the fishplates shown in all photographs taken on site correspond to locations where the blue insulating material that covers the fishplate is not obscured by dirt. The rail head covered some of these blue areas before the rail broke and this would have prevented these areas being painted (figure 5).
- 26 The images on figure 9 show that the extent of the blue area on the upper part of the rail depends on the angle from which the photograph is taken, an indication that this blueness is a consequence of light reflecting from the shiny upper surface of the rail.

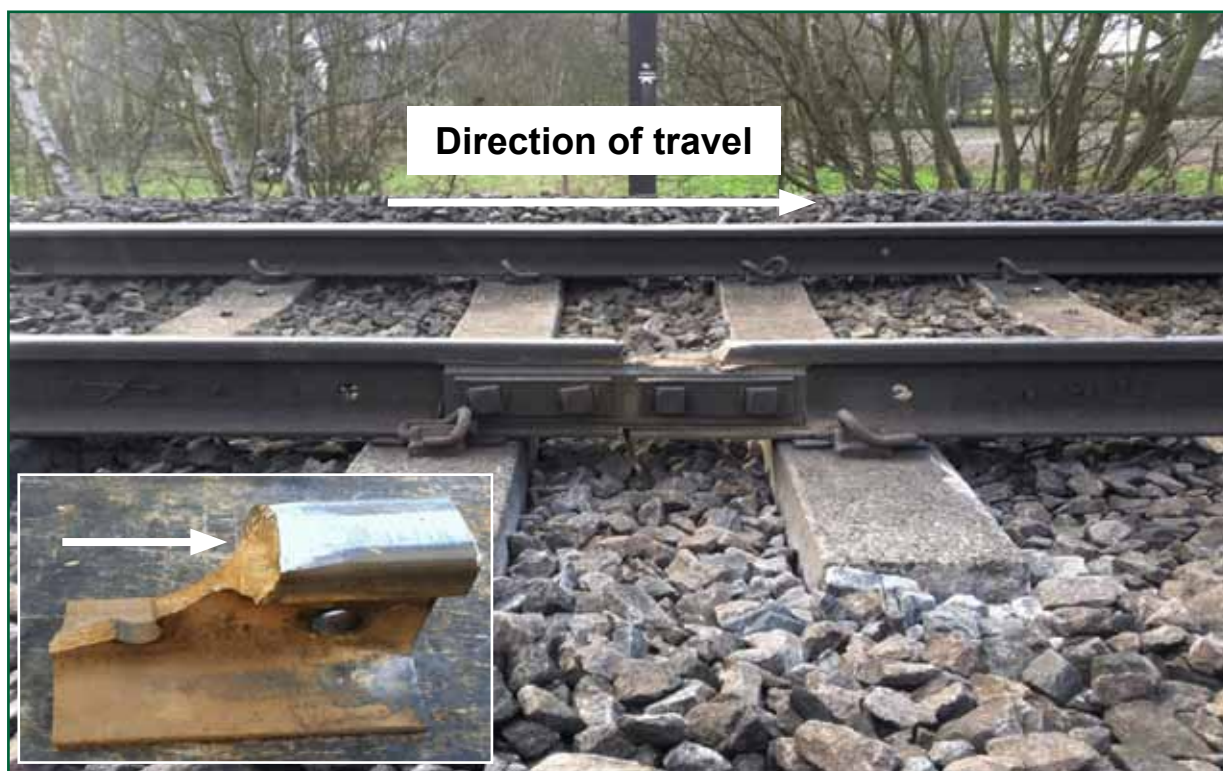
Figure 11: Hambleton - broken rail

- inadequate support to sleepers meant that part of the train loads intended to be carried by these sleepers was actually carried through the rail to adjacent, better supported, sleepers in a manner which caused additional bending at the joint (this behaviour is commonly associated with increasing track dip and has been inferred because of the increasing track dip described in paragraph 81);

- these relatively high loads overcame the securing effect of the bolts and caused movement of the fishplates and thus misalignment of the rails on each side of the joint;

- rail misalignment caused wheel impact loads which were greater than the loadings on correctly aligned track and which caused increasing movements, and thus an increasing dip;

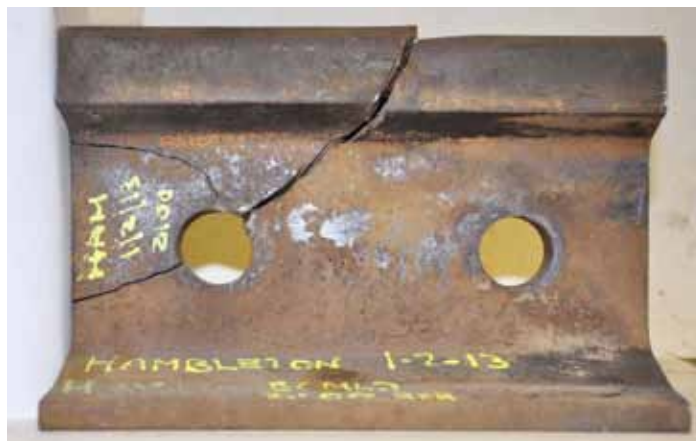
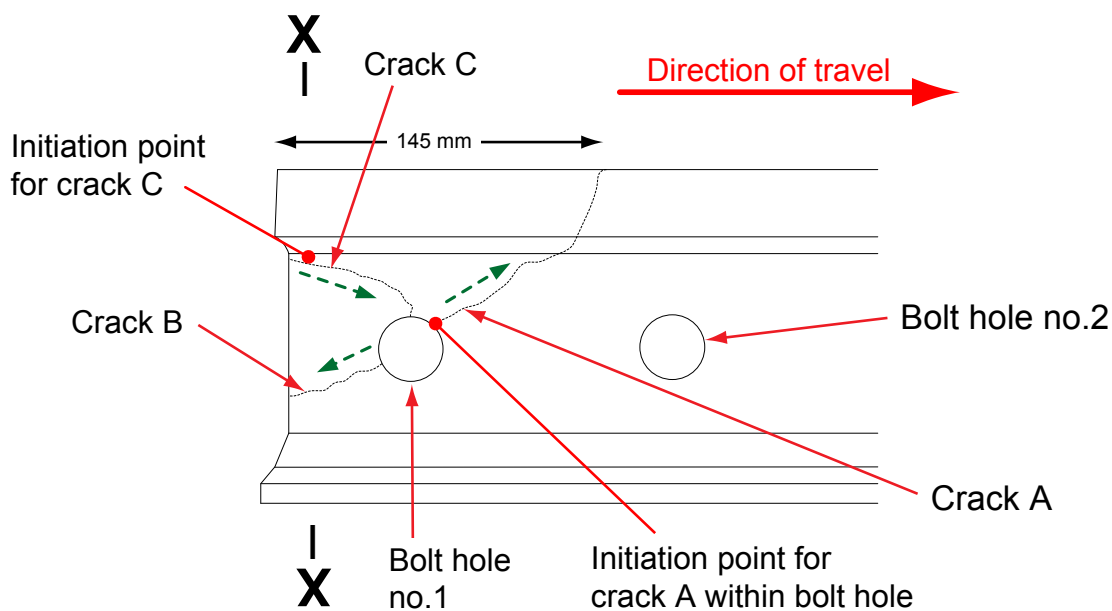
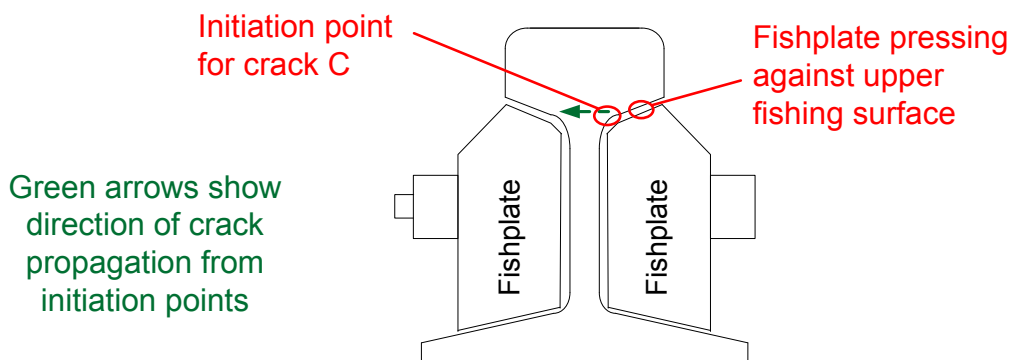
- stresses in the rail caused by these movements, coupled with the effects of wheel impacts due to the dipped joint, resulted in fatigue cracks initiating in the web of the rail, close to the underside of the rail head, at the outer end of the rail (crack C in figure 12);

- stresses due to these movements also caused a fatigue crack to initiate in the web of the rail at the 1 o'clock position of the bolt hole nearest the joint (crack A in figure 12);

- the fatigue cracks increased in size until, just before the rail broke, crack C reached a maximum size of 3 mm to 4 mm and crack A reached about 5 mm;

- rust found on the crack surfaces indicates that these cracks had probably developed slowly until this stage;
 - a 145 mm length of rail head broke off when stress concentration at the crack tips meant that the remaining intact rail was unable to carry the loads imposed by trains. It is likely that this occurred as a result of the rail end crack (crack C) extending to the nearest bolt hole followed by the 1 o'clock crack (crack A) extending to the rail head, and then a new crack developing at the 8 o'clock position on the bolt hole and extending to the rail end (crack B on figure 12);

Figure 12: Hambleton - Failure mode

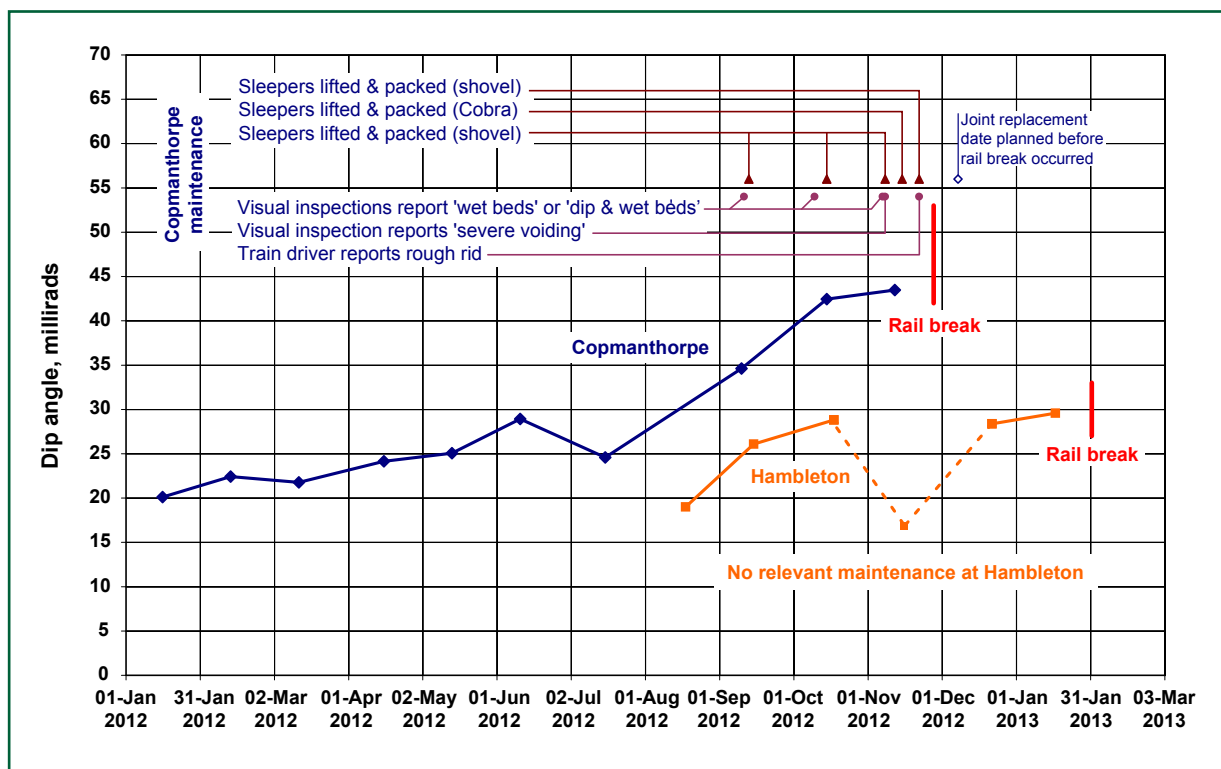
- 32 The lack of support to sleepers had caused a dip at the joint which had been recorded during monthly track geometry train runs since September 2012, with the exception of an apparently anomalous report of no dip in November 2012. The measured dip angles had risen only slightly from 26.09 mrad on 15 September 2012 to 29.58 mrad on 17 January 2013, two weeks before the broken joint was found. The final reading was just below the 30 mrad at which Network Rail standards require that action be taken.

Figure 32: Dips at Hambleton and dips plus maintenance at Copmanthorpe

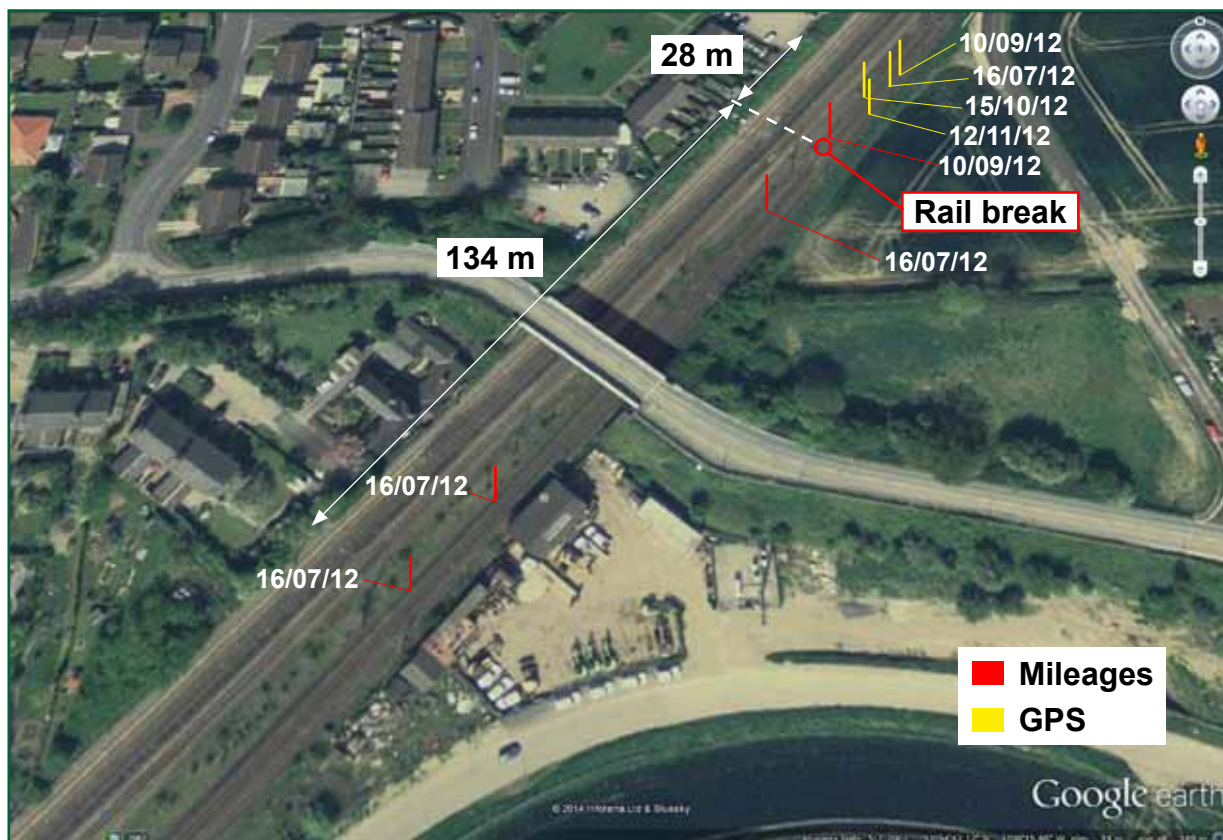
109 The difficulty of recognising repeat faults is apparent from the Copmanthorpe joint defect reports. Four track geometry recording train runs and four UTU runs were undertaken in the period from July to November 2012 and all identified the joint. The locations given by the geometry recording train and provided to track maintenance staff were spread over a distance of about 137 metres of track with a maximum distance of 134 metres from the actual position of the joint (figure 41). The UTU gave locations concentrated within a 15 metres zone but displaced from the joint such that the furthest location was 28 metres from the joint.

Figure 41: Copmanthorpe dipped joint locations from track geometry recording train output
