**Entry of a confined space on board
the cargo ship
SUNTIS
in Goole Docks, Humberside
on 26 May 2014
resulting in three fatalities**

MAIB SAFETY BULLETIN 3/2014

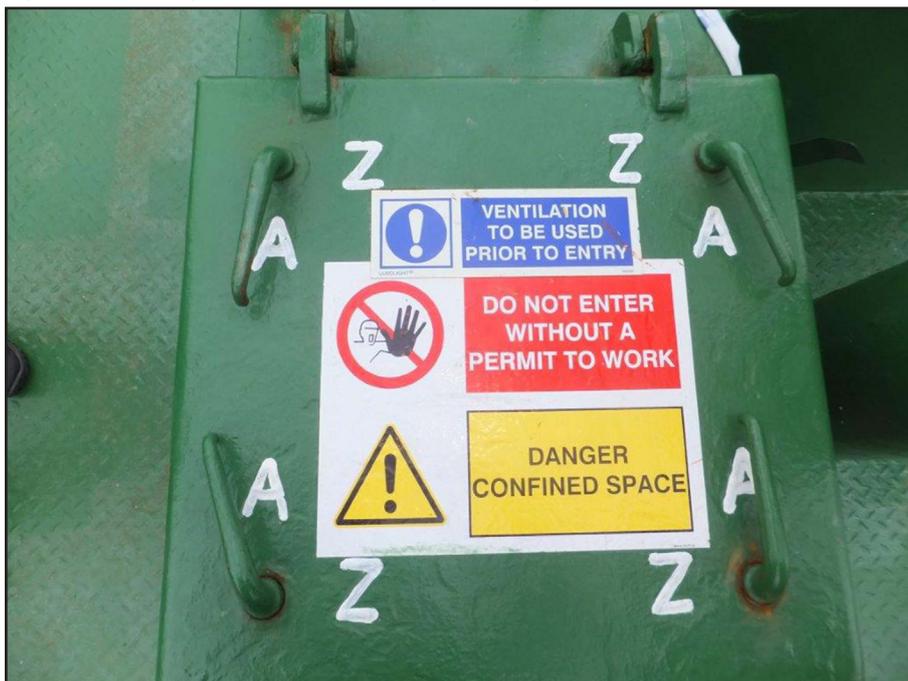
Figure 1

With a timber cargo loaded in the hold and the hatch covers closed, access to the compartment was subject to a permit-to-work and confined space entry procedures. The lid of the hatch into the compartment had signs indicating the potential dangers (**Figure 1**).

- Warning signs should not be ignored.
- If you are not part of the team designated to work in a confined space DO NOT ENTER. However compelling the desire to enter an enclosed or confined space to attempt to rescue an unconscious colleague is, it must be resisted.
- A ship should have a pre-arranged plan for the rescue of a person who has collapsed within an enclosed or confined space and regular drills should be conducted to test the plan and ensure the crew are familiar with it.
- BA is provided for fire-fighting and rescue; all crew should be trained, drilled and capable of using such critical safety equipment properly in an emergency.
- EEBDs provide a short term air supply to enable crew to escape to fresh air from a hazardous atmosphere. They should never be worn to enter, re-enter or work in a hazardous atmosphere.

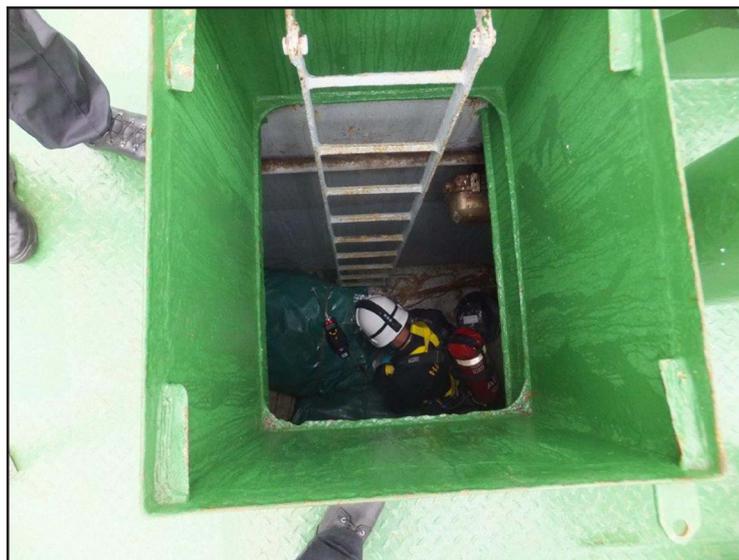
Figure 2

The Fire and Rescue Service analysis of the atmosphere after the accident showed normal readings (20.9%) of oxygen content at the access hatch; the readings reduced to 10% just below main deck level inside the hatch opening and to between 5% and 6% at the bottom of the ladder into the compartment (**Figure 2**). Such low levels of oxygen cannot support life. Anyone exposed to such levels will faint almost immediately, followed by convulsions, coma and respiratory seizure within a few minutes. It is likely that the timber cargo caused the deprivation of oxygen in the cargo hold and access compartments.

- The atmosphere within an enclosed space, such as a ship's cargo hold can change rapidly and become lethal dependent on the conditions inside and what is being stored or transported (as the tragic circumstances above illustrate).
- **NEVER** enter a confined space if safer alternatives for carrying out the work are available. If entry into a confined space is unavoidable, robust procedures should be put in place which should include emergency arrangements. These are often referred to as "Safe System of Work" or "Permit-to-Work".
