Report on the investigation of
carbon monoxide poisoning
on board the fishing vessel

Eshcol

resulting in two fatalities

on 15 January 2014

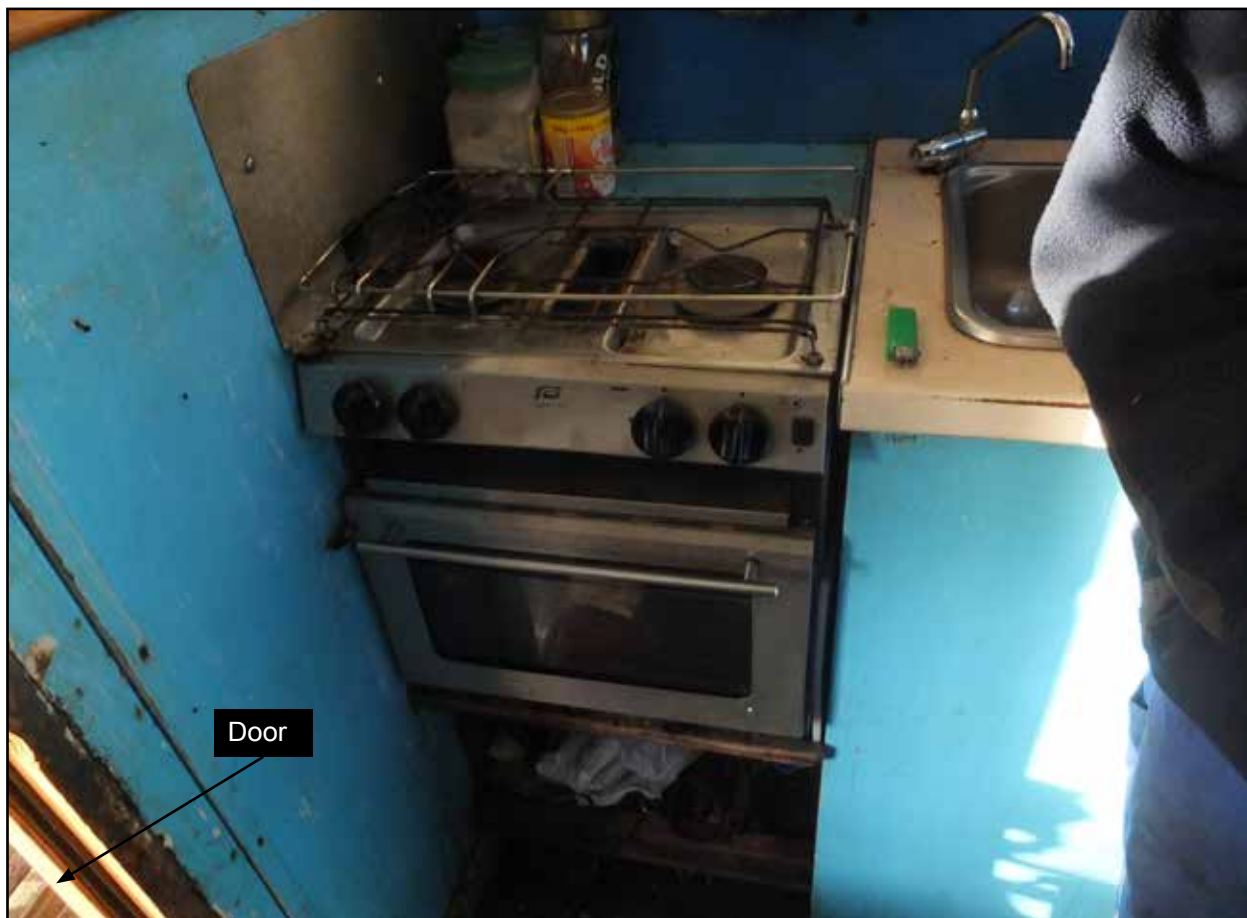
Figure 5: Position of the cooker in the wheelhouse

Access to *Eshcol*'s wheelhouse was via a door from the working deck (**Figure 4**). The wheelhouse, was above the engine room and contained a liquid petroleum gas (LPG) cooker which housed two hob rings on the top, a grill and an oven. A grill pan and several roasting tins were kept inside the oven space. The cooker was installed in the port aft corner of the wheelhouse, close by the door and next to a sink (**Figure 5**). The cooker was also below a window that could be opened.

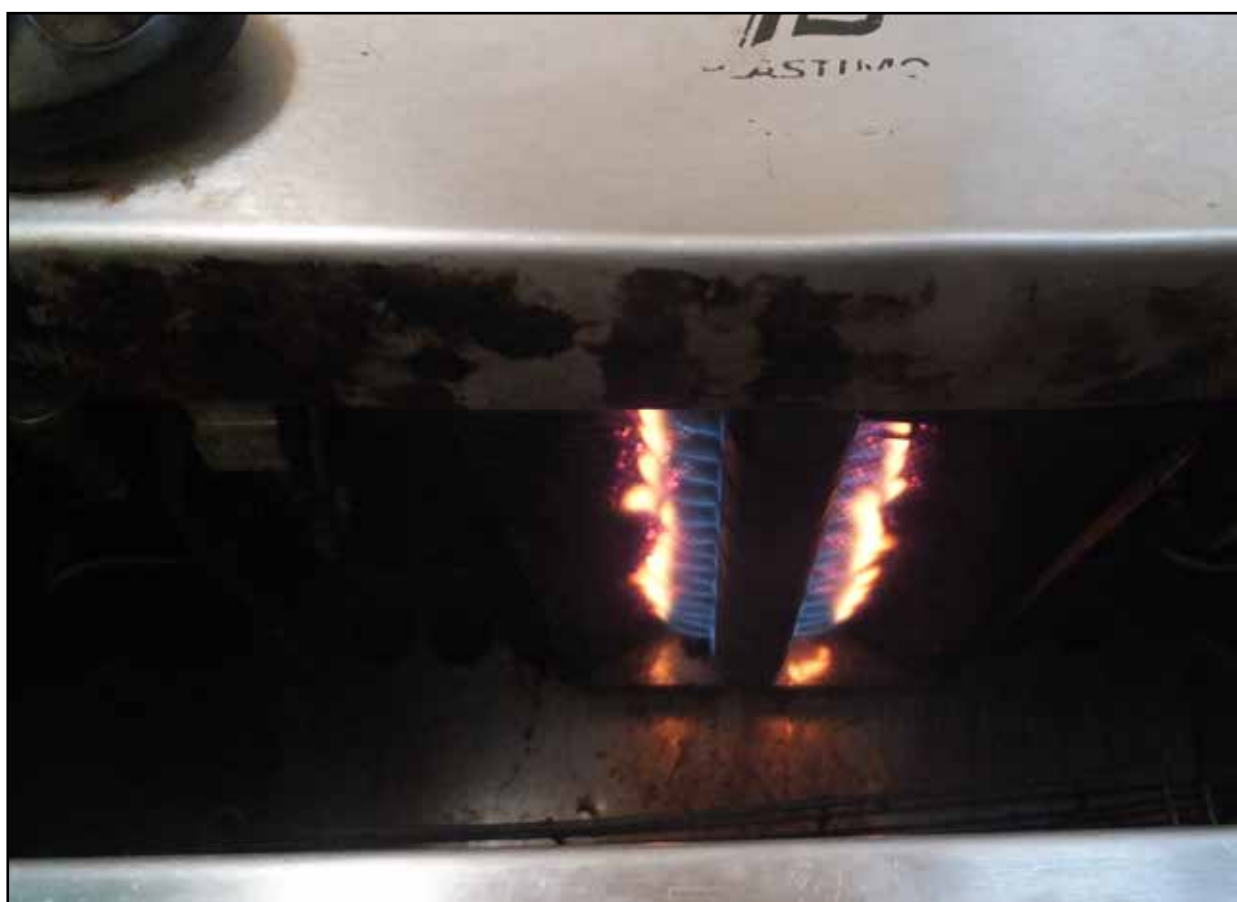
Figure 11: Yellow flames under the grill

MAIB inspectors visited *Eshcol* at the same time as the MCA surveyor. In-situ tests showed that when the grill was lit the resulting flames were predominantly yellow in colour (**Figure 11**). The grill was soon turned off following the activation of a personal gas detector which indicated that high levels of carbon monoxide were being emitted. Close inspection of the grill showed that the grill's steel mesh was corroded and holed in several places (**Figure 12**).

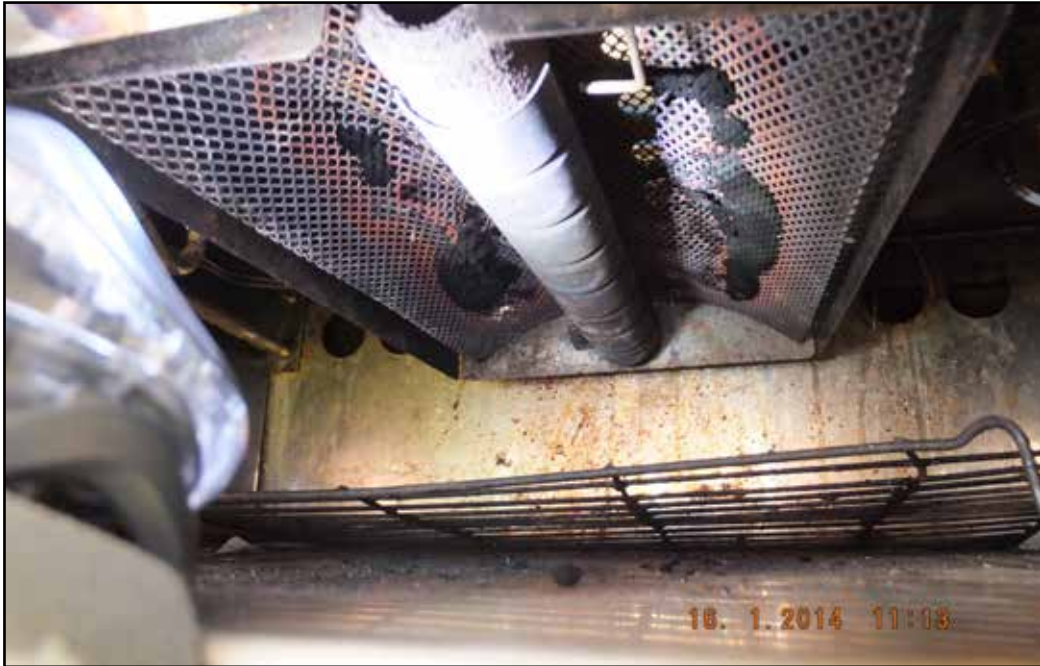
Figure 12: Gas cooker grill metal gauze

This was probably because the metal gauze was badly corroded and actually holed in four places. The latter should have been obvious during any reasonable service and/or inspection.

It is recommended that this appliance is professionally serviced at least every 2 years.

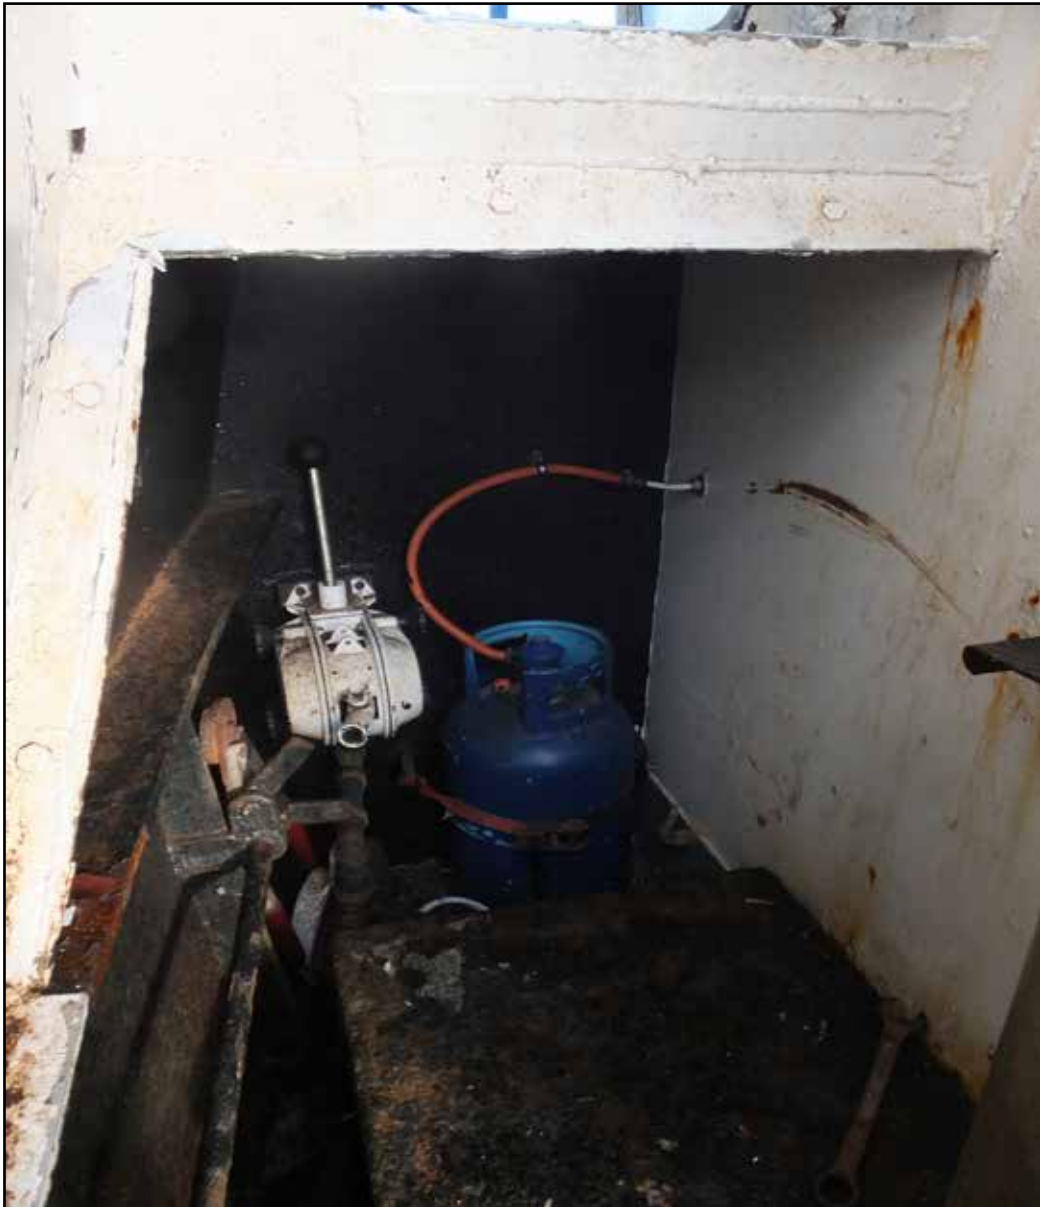
Figure 13: Butane gas cylinder stowage

The butane cylinder that supplied the gas cooker was stored on the main deck on the port side of the wheelhouse adjacent to the engine room access (**Figure 13**). Markings on the cylinder indicated that it had been purchased in Wales.

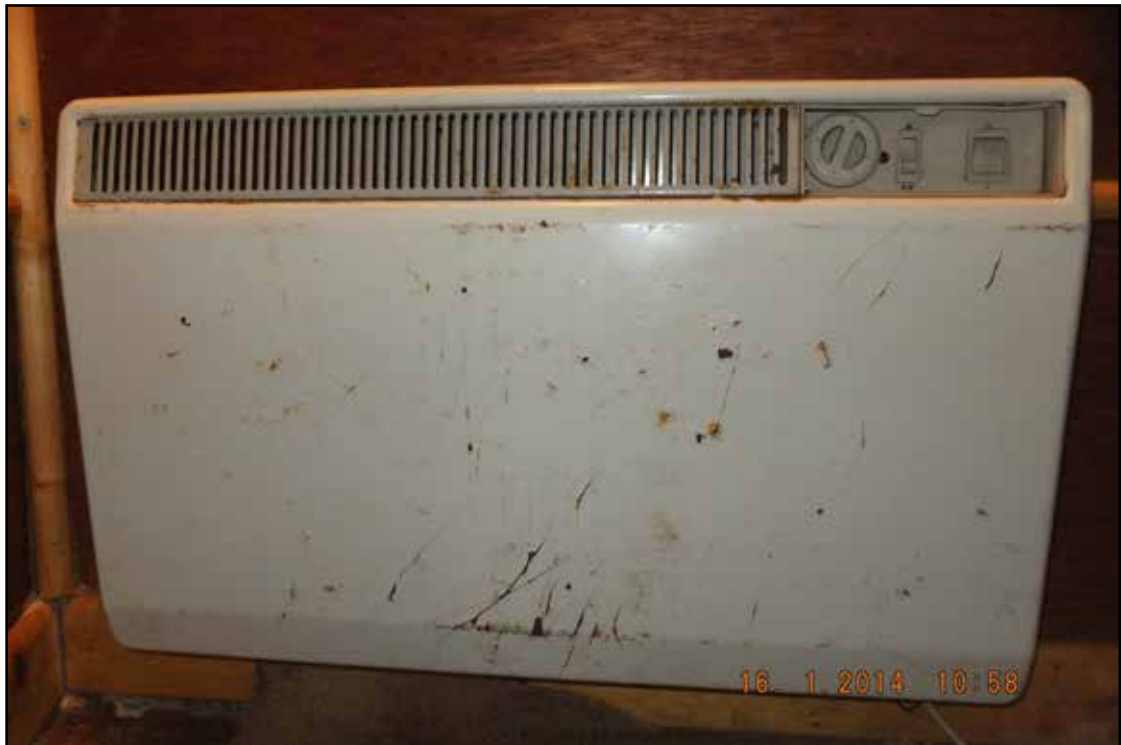
Figure 14: Heater secured on side of bunk

- There was no fixed natural or mechanical ventilation to the wheelhouse or sleeping area, other than the wheelhouse door and wheelhouse windows that opened.
- An electric heater fixed to the wooden panelling on the side of the lower starboard bunk (**Figure 14**) did not work.

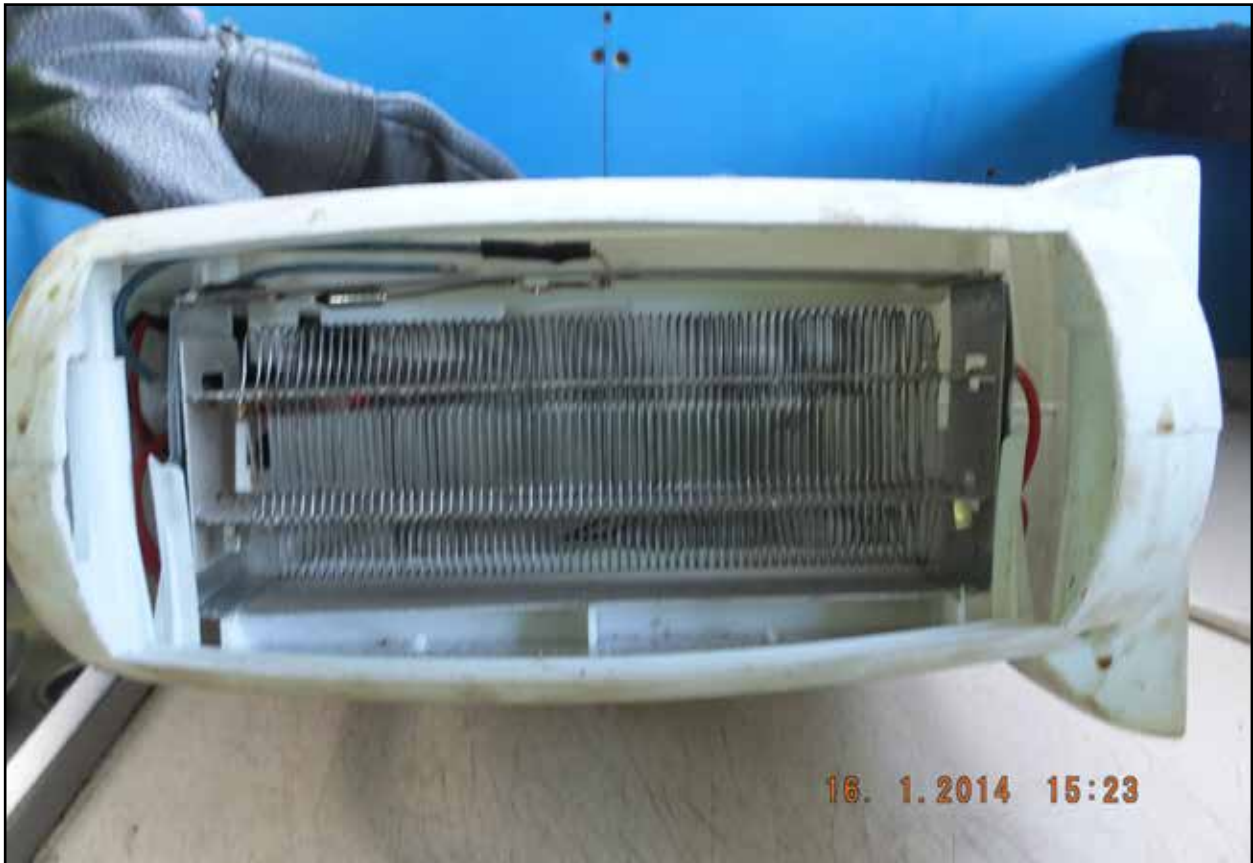
Figure 15: Electric fan heater

- A small electric fan heater was found in the sleeping area under a pile of clothing. The heater was damaged (**Figure 15**) but appeared to function when connected to a power source and switched on.
- The smoke detector fitted on the deckhead in the sleeping area did not function because its battery had been removed (**Figure 16**).
- The sleeping area was generally untidy and used for storage; few personal possessions or clothes were carried on board.
- The deck between the sleeping area and the engine room was not gas tight.
- Four automatic inflating lifejackets were stored in cupboards in the sleeping area. Two of the lifejackets were manufactured in 2005 and two in 2009. There was no record of the lifejackets being serviced and they had clearly not been used for some considerable time.

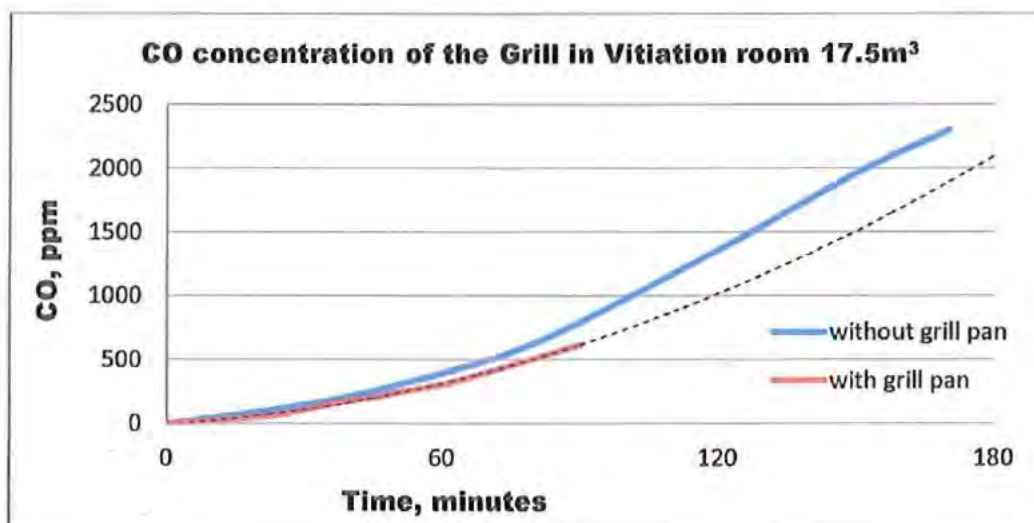
CO Concentration of the Grill in Vitiation Room

Both with and without the grill pan, the CO concentration in the room reached its limit of failure (200ppm) (based on vitiation test for Oxygen Depletion Device in BSEN509:2000) in about 37 minutes. When the test was performed for nearly 3 hours (without the grill pan) the CO concentration reached 2300ppm.

Time min	CO ppm
0	0
5	18
10	44
15	64
30	146
45	254
60	395
75	560
90	797
120	1362
150	1964
170	2300

The volume of the Wheelhouse and the Accommodation in the boat was calculated to be approximately 15.3m^3 and the volume of the Kiwa vitiation room, where the grill was tested is 17.5m^3 that is about 12% larger than the volume of the Wheelhouse and the Accommodation. Consequently this will reduce the time taken for the CO concentration to reach the level stated below
