Fire and subsequent foundering of workboat

ECC TOPAZ

on 14 January 2014

MAIB SAFETY BULLETIN 2/2014

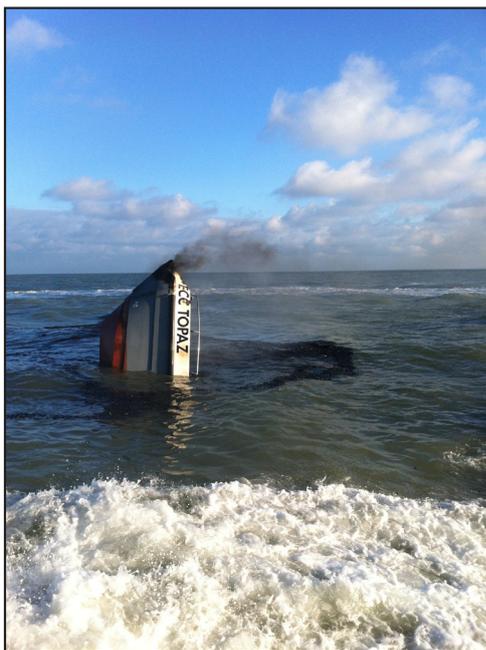
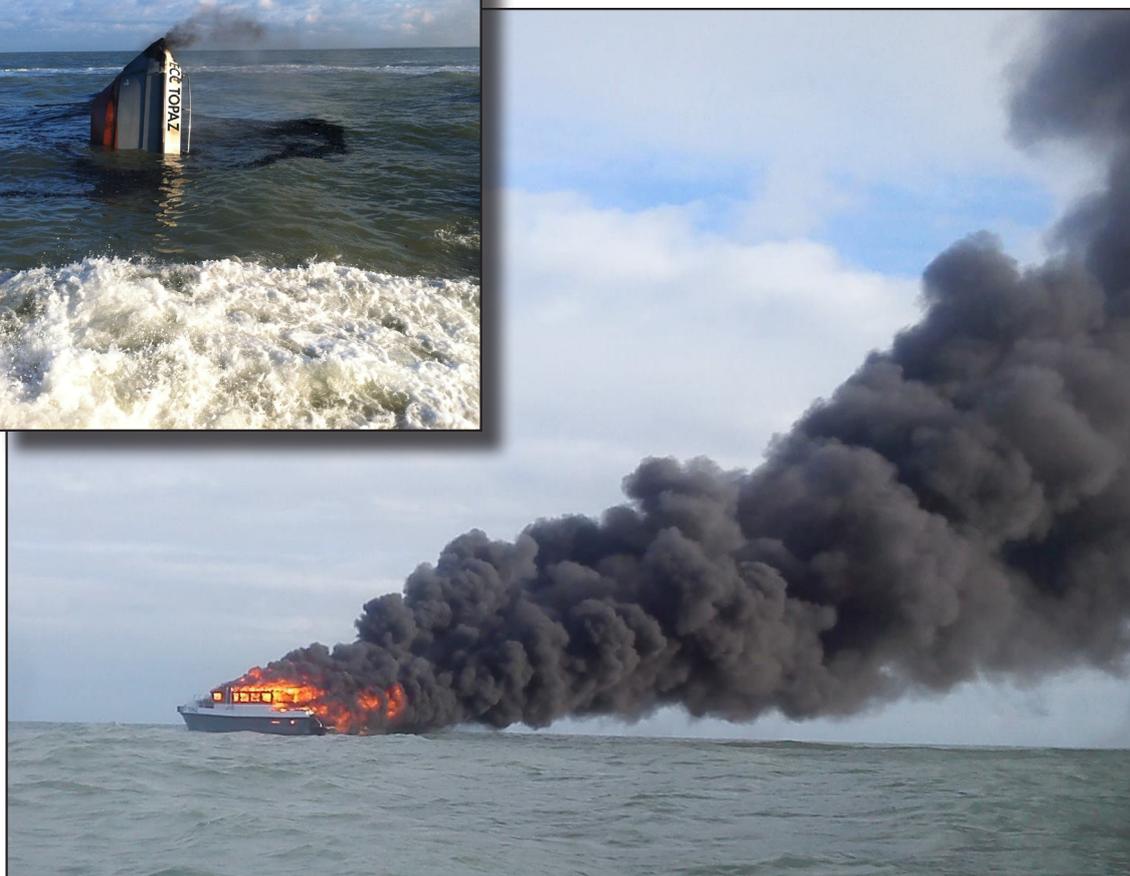
Figure 1: ECC Topaz on fire (inset: subsequent foundering)

At approximately 1230 (BST) on 14 January 2014, the 14m wind farm support catamaran, *ECC Topaz*, caught fire 11nm east of Lowestoft. The three crew members on the vessel were unable to extinguish the fire, which spread rapidly throughout its GRP structure (**Figure 1**), forcing them to abandon to a liferaft. There were no passengers on board at the time of the accident.

Once in the liferaft, the skipper transmitted a “Mayday” call using a hand-held VHF radio and then activated a Search and Rescue Transponder (SART). The crew of another vessel in the vicinity alerted the coastguard when they saw thick black smoke on the horizon. The crew of *ECC Topaz* were winched from the liferaft by helicopter and taken to a nearby hospital for treatment. The fire on *ECC Topaz* continued unabated and, at 1422, the burnt out remains of the vessel foundered in 33m of water (**Figure 1: inset**).

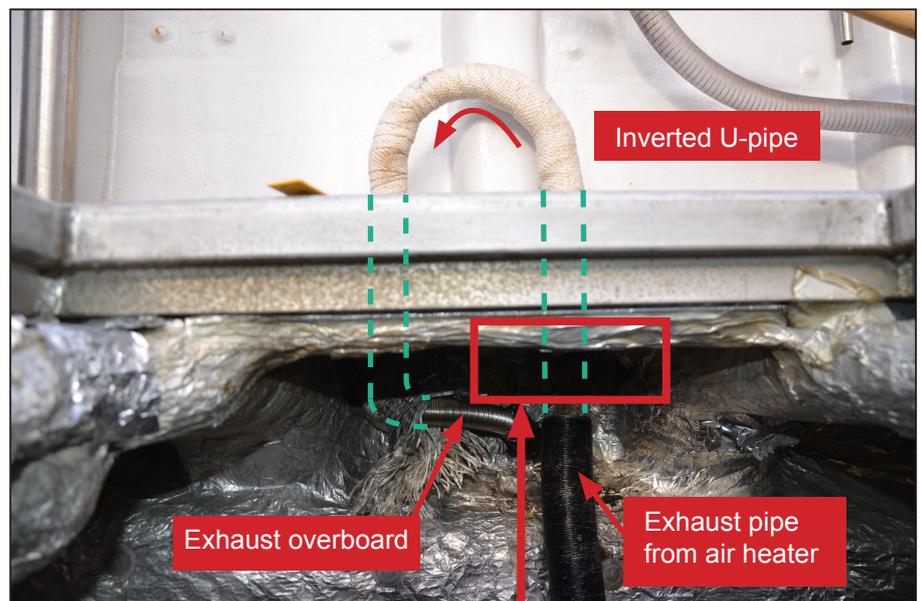
Detailed examination of one of these vessels revealed that the heater exhaust had been modified to route through a single walled, inverted U-pipe on the main deck (**Figure 2a**) to prevent sea water ingress from the exhaust overboard. As originally built, the exhaust pipe was insulated by woven glass lagging protected by an aluminium oversleeve (**Figure 3**) to prevent the hot exhaust gases (around 450°C) from heating the surrounding area. However, where the exhaust piping had been broken to route it through the main deck,

Figure 2a: Air heater exhaust pipe layout on similar vessel

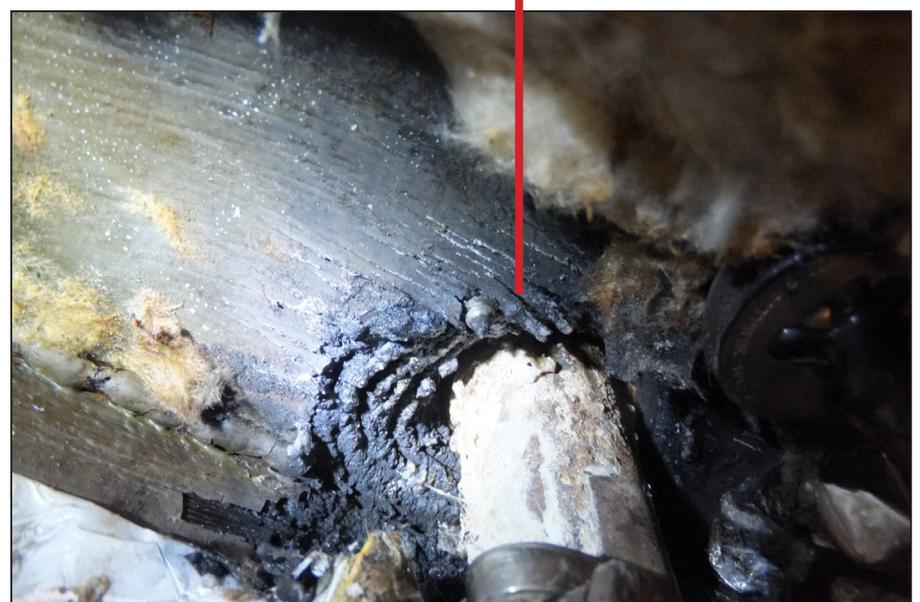
Figure 2b: Scorching under deck on similar vessel

the connection between the heater exhaust pipe and the inverted U-pipe was not insulated. Consequently, the uninsulated section of the hot exhaust pipe in close proximity to the plywood underside of the deck, caused the charring seen in **Figure 2b**.

ECC Topaz was fitted with the same model of heater and had the same exhaust configuration. The MAIB has concluded the most likely cause of the fire on board *ECC Topaz* was the poorly insulated hot exhaust pipe igniting the plywood structure of the vessel. The compartment where the heater was situated was not fitted with any fire detection or extinguishing systems, and contained several flammable items including sacks of rags, rolls of paper towels and several small drums of oil that would have provided additional fuel for the fire once it was ignited.

- Check that all exhaust pipes on their vessels are fully insulated and do not come close to combustible material.
- Fit fire/smoke detectors in enclosed spaces where diesel-fired air heaters are installed.
- Avoid placing flammable material in compartments that contain potential heat sources. A useful reference is MGN 497 (M+F): 'Dangerous Goods – including Chemicals and other Materials – Storage and Use on Board Ships.'

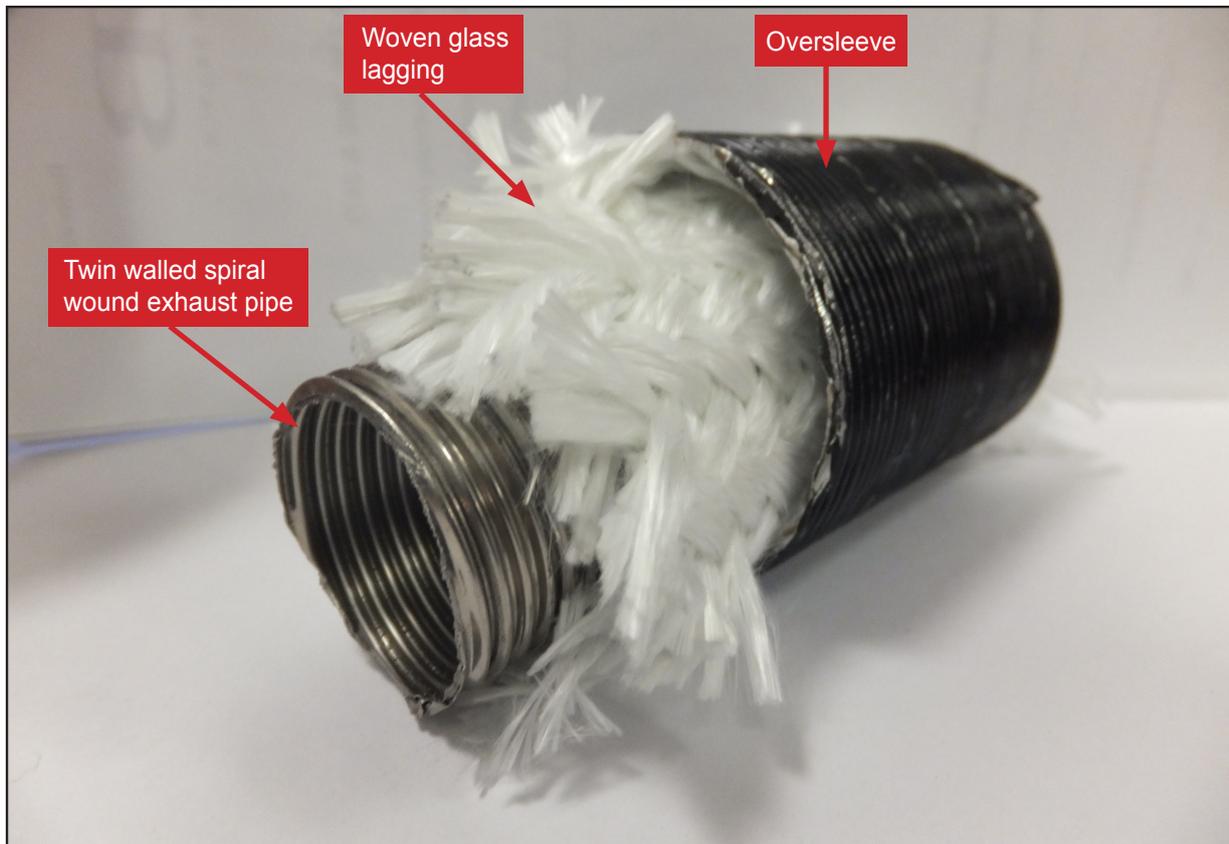
Figure 3: Heater manufacturer's supplied exhaust pipe with insulation
