Report on the investigation of the collision of

Rickmers Dubai

with the crane barge

Walcon Wizard

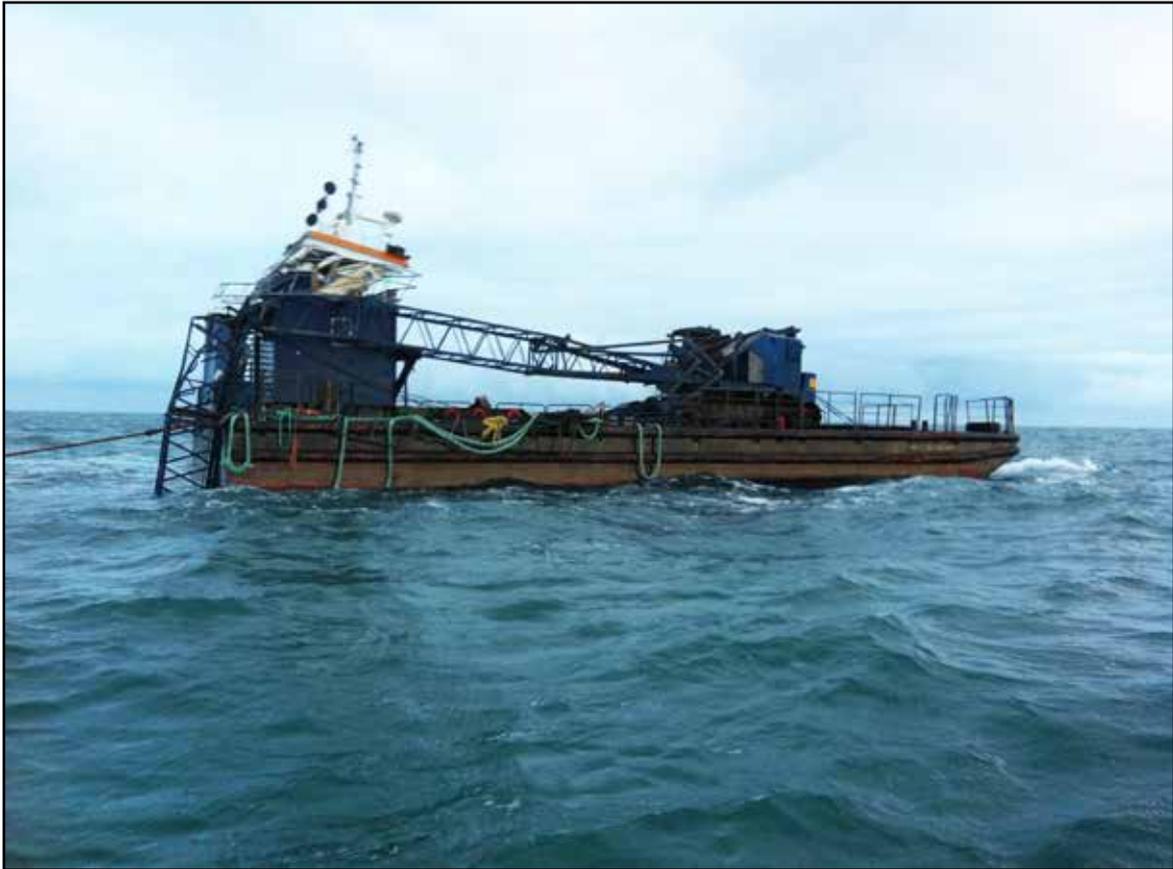
Figure 4: *Walcon Wizard* - collision damage

Walcon Wizard's wheelhouse was set forward in the collision and crushed. The jib of its crane was buckled and guardrails were also bent (**Figure 4**). *Kingston*'s hydraulic motor for the tow winch was seriously damaged and several hydraulic connections were ruptured.

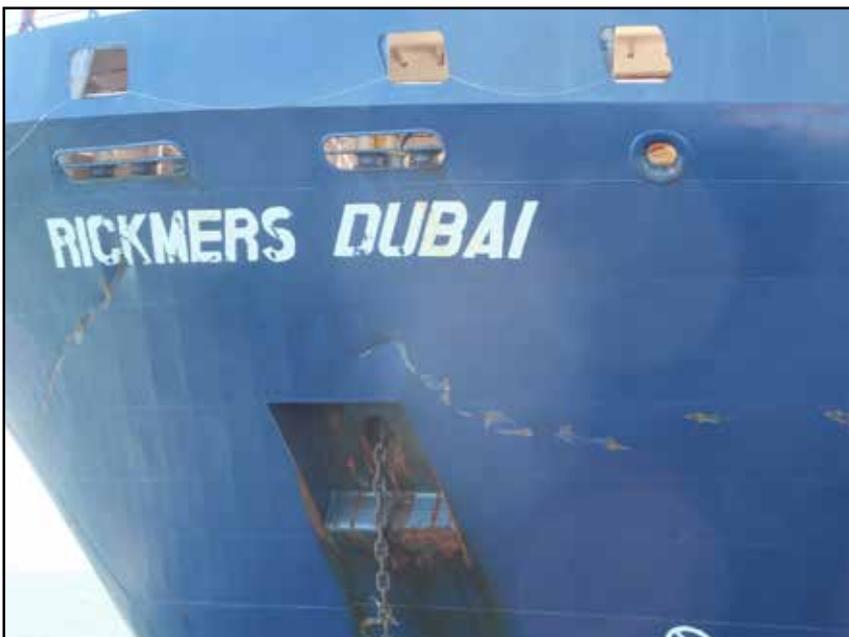
Figure 5: *Rickmers Dubai* - collision damage (external)

MAIB inspectors boarded *Rickmers Dubai* from a pilot boat at 1100 on 11 January 2014 while the ship was at anchor off Newhaven. They informed the master that damage to the bow area, above the waterline, was clearly visible (**Figure 5**). The ship's crew then identified that the vessel's hull had been punctured on its stem and port side in way of the forecastle store (**Figure 6**).

Even when the master arrived on the bridge and arranged for a more thorough damage assessment, the damage to the bow (**Figures 5 and 6**) was not identified until MAIB inspectors arrived on board 7 hours later as damage this far above the waterline was not anticipated and sea conditions were unsuitable to launch the ship's rescue boat. In the circumstances it was fortunate that the damage to *Rickmers Dubai* was not more serious and that the vessel was ordered to anchor. Otherwise, the vessel could have easily encountered difficulties in rough seas in the Bay of Biscay as it continued on passage to Genoa.

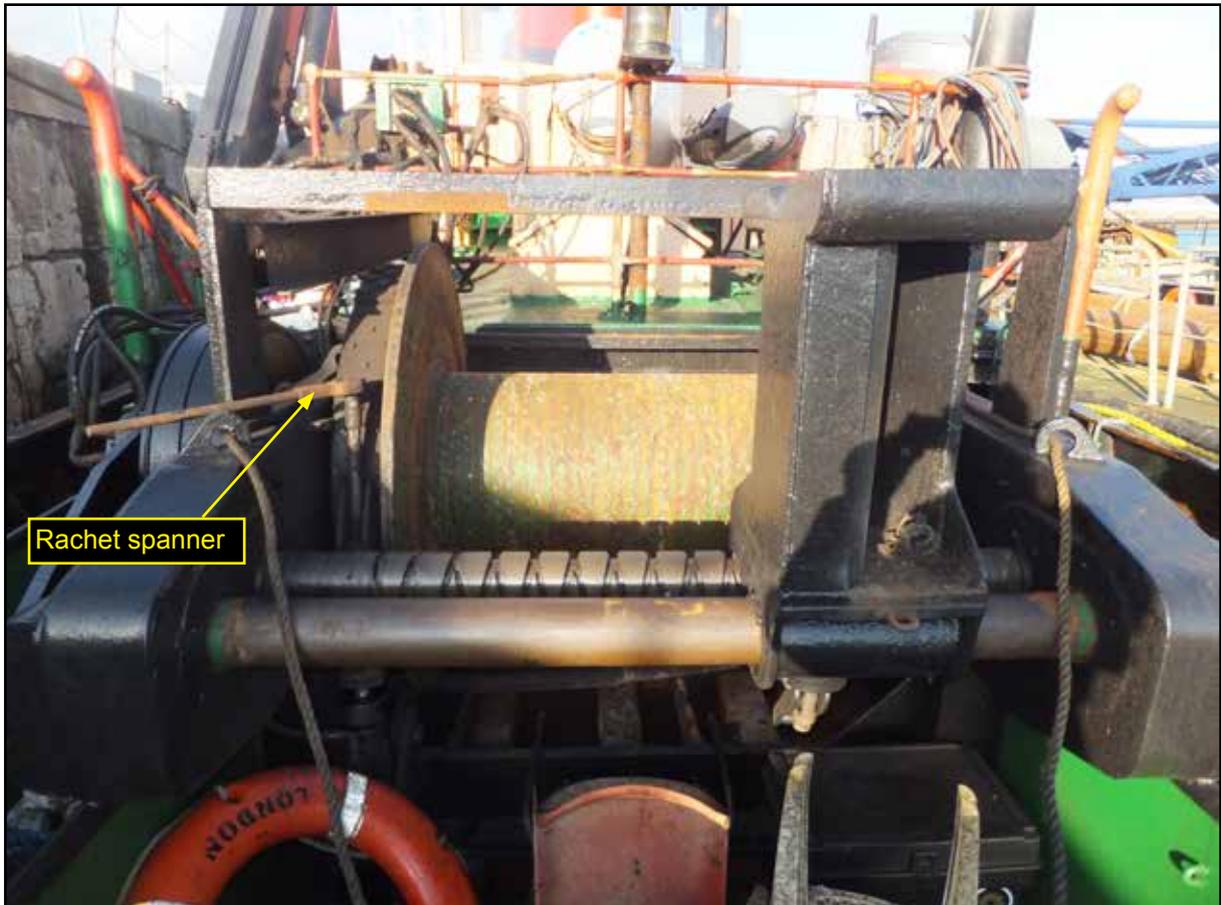
Figure 14: Kingston - towing winch

The hydraulic towing winch (**Figure 14**) was tested to cope with a bollard pull of 30t. The winch was powered by a generator in the engine room, which also powered the foredeck winch. The tow winch was fitted with a hydraulically actuated band brake. The winch drum was fitted with 500m of 38mm diameter wire with a mean breaking load of 103t. The equipment associated with the towing winch was renewed in July 2013.

At such a speed, it is not surprising that the tug's aft deck was quickly awash and that the tow winch brake started to render. As the wire was pulled from the tow winch, the resulting back pressure in the winch's hydraulic system caused joints to rupture. The smoke on the deck was caused by the tow winch brake overheating.

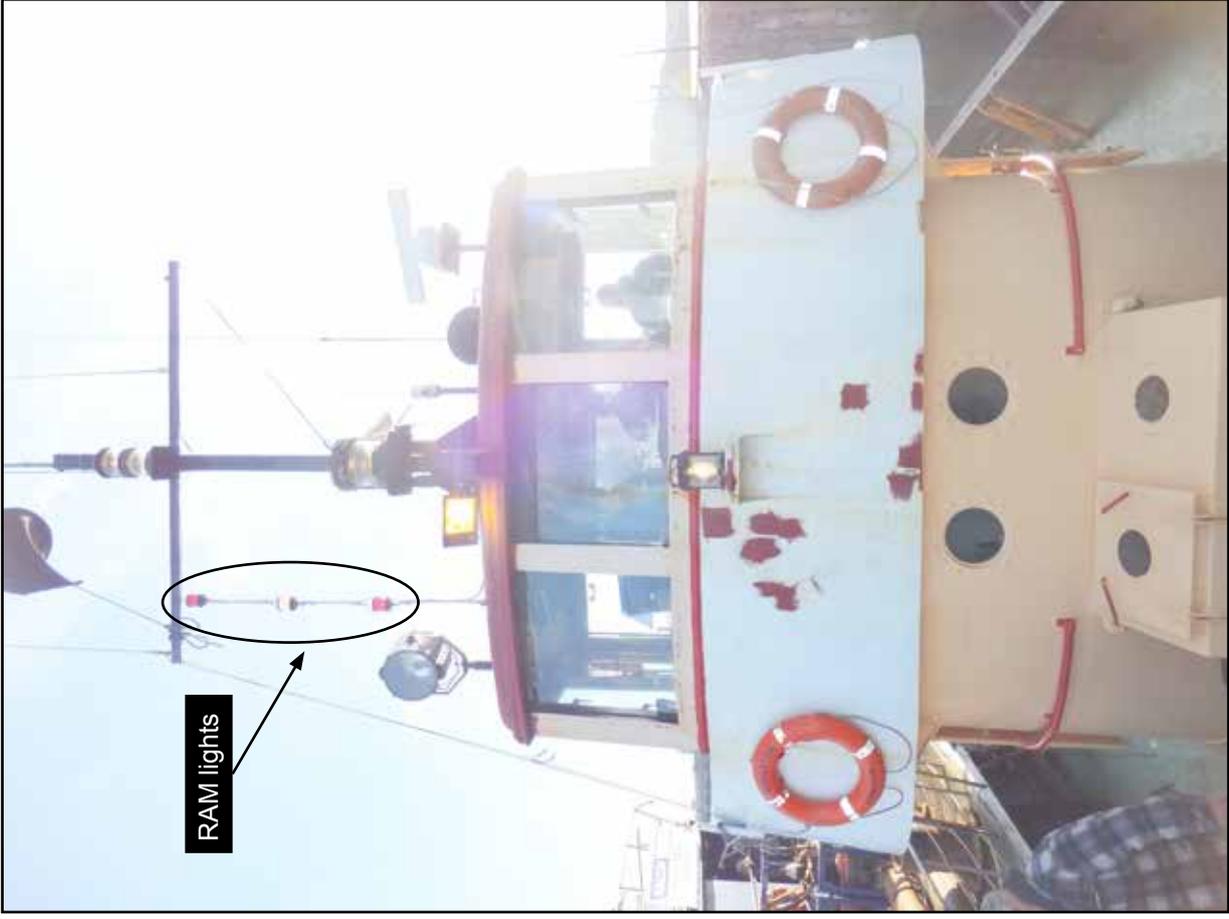
Figure 17: Kingston - Restricted in ability to manoeuvre lights

Lights indicating that the vessel was restricted in its ability to manoeuvre (RAM)⁴ were rigged from the cross-trees (**Figure 17**). However, on the day before the accident the mate had discovered that the bulb in the white RAM light was defective. Consequently, the RAM lights were not in use. It is reported that the white RAM light had been unreliable for some time. This was thought to be due to a loose electrical connection which was affected by the vessel's movement.

In addition, *Kingston*'s all-round RAM lights were not available for use due to the defective white light. However, although the RAM lights would have provided further indication to *Rickmers Dubai*'s OOW that a tug and tow lay ahead, they were only required to be displayed on board *Kingston* when the towing operation severely restricted the tug and tow's ability to deviate from their course. It is common to see many tugs engaged in towing operations routinely display RAM lights and shapes but, in this case, there is no evidence to indicate that *Kingston* would have had any difficulty in manoeuvring to keep clear of other vessels or navigational dangers.

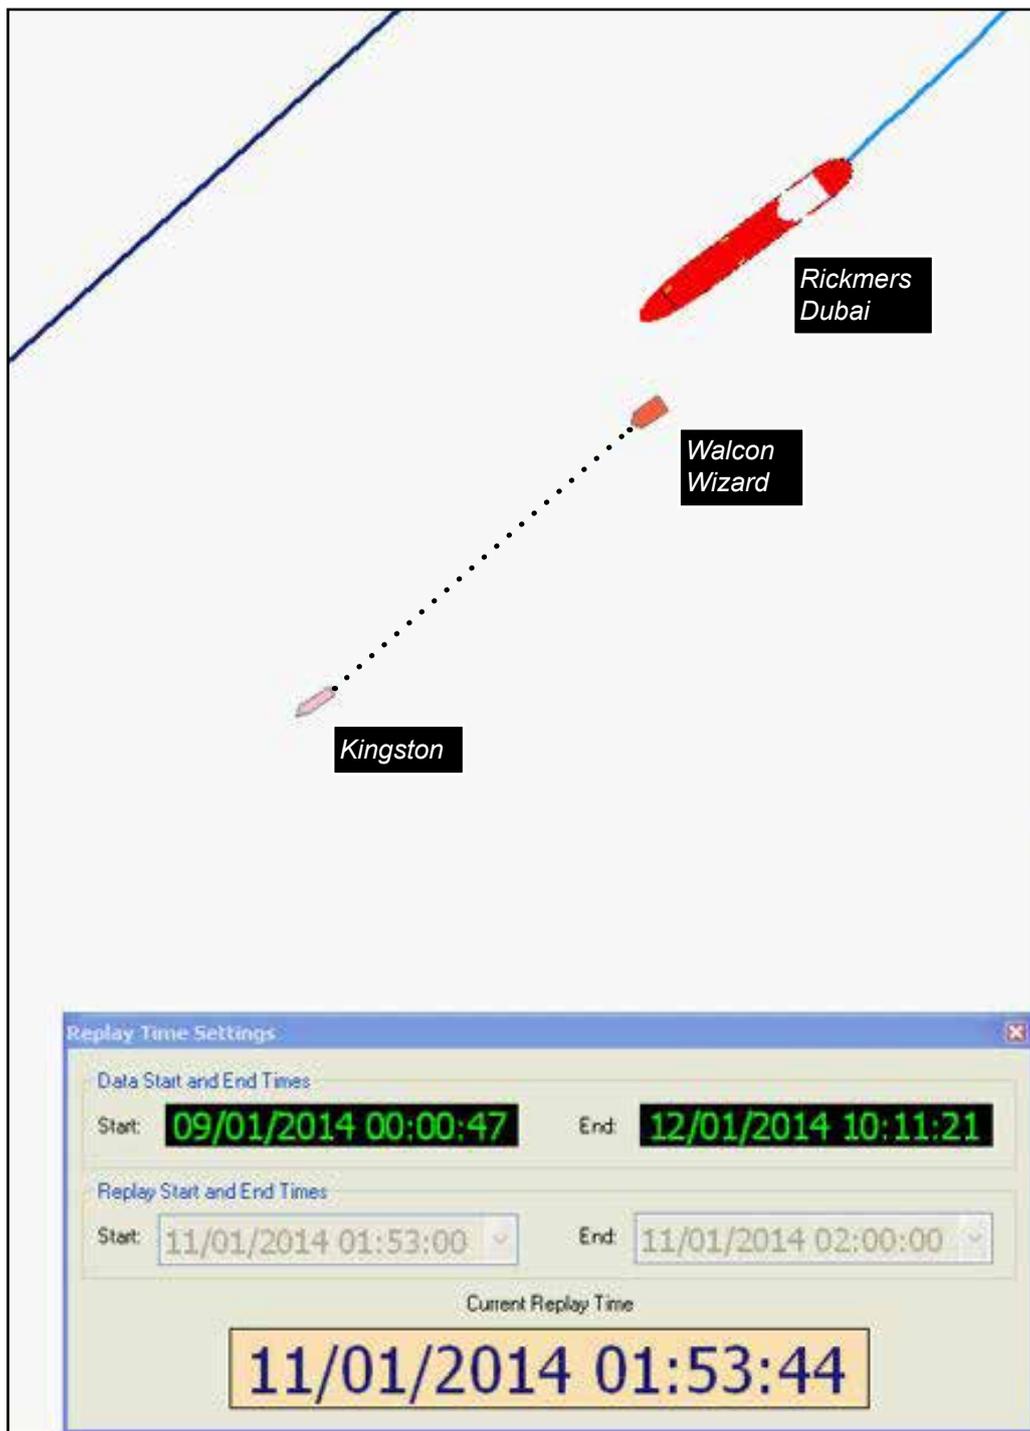
Figure 19: Simulation of the situation at 0153:44

As *Rickmers Dubai*'s heading was altered to port at 0154, in order to cross under *Kingston*'s stern, *Walcon Wizard* was very close off the cargo ship's port bow (**Figure 19**). The cargo ship's port bow struck the crane jib protruding from the stern of *Walcon Wizard*, causing the jib to buckle. The cargo ship's port bow then made heavy contact with the barge's superstructure causing considerable damage (**Figure 4**). As *Walcon Wizard* passed down the port side of *Rickmers Dubai*, the cargo ship's bow snagged the towline between the barge and *Kingston* (**Figure 20**).
