**Crewman lost overboard from
Sea Melody
Groveport, River Trent
18 December 2013**

SUMMARY

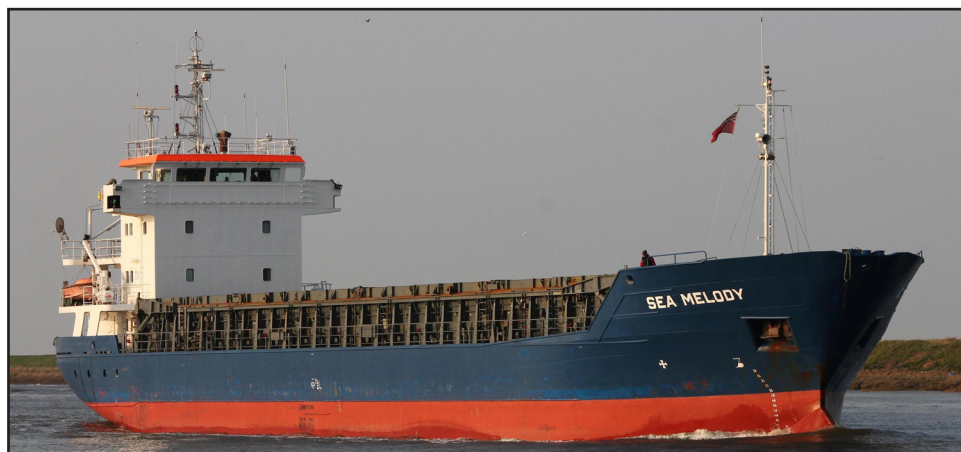
Figure 1: *Sea Melody*

At 1915 UTC¹ on 18 December 2013, crewman Sergey Gaponov was pulled overboard from the forward mooring area of the general cargo vessel *Sea Melody* (**Figure 1**) when his foot became caught in the bight of a mooring rope as the vessel was shifting berth. Despite an extensive search by the crew, a rescue helicopter, a lifeboat, coastguards and police divers the crewman's body was not found.

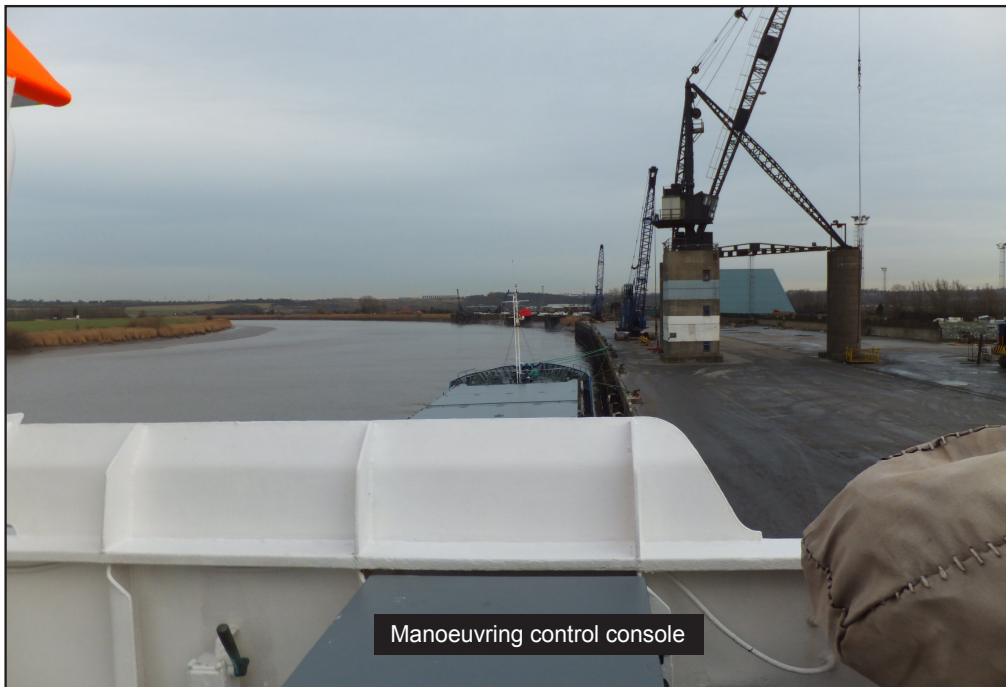
Figure 2: Starboard bridge wing

At 1830, the master called the crew and prepared to manoeuvre the vessel from the control console on the starboard bridge wing (**Figure 2**).

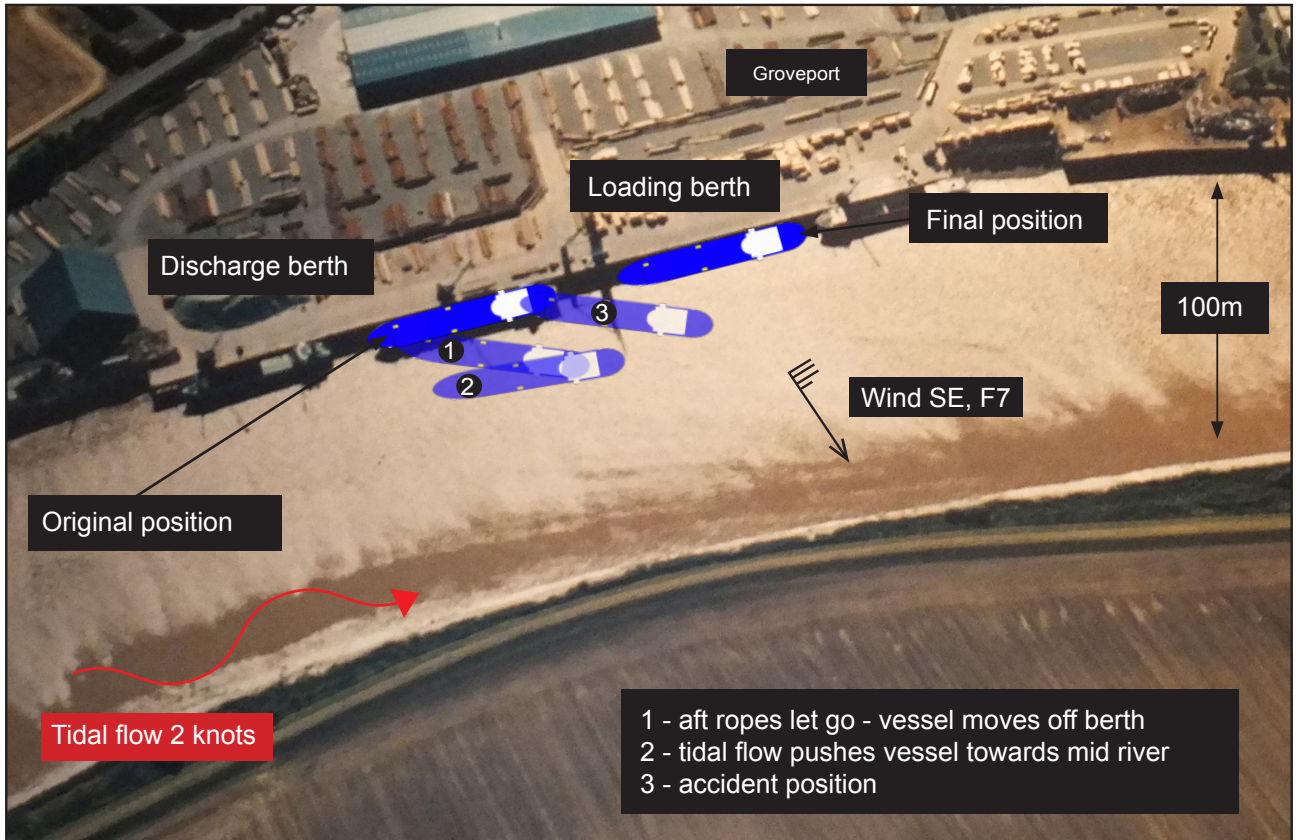
Figure 3: Reconstruction: *Sea Melody* moving berth

When the move commenced, *Sea Melody* was in a light condition, with its bow thruster just below the surface of the water. The master used the engine, helm and bow thrust to control the vessel, which was observed to move away from the berth and

into the centre of the river on three occasions during the manoeuvre (**Figure 3**).

At the time of the accident, *Sea Melody* was being moved stern first about 90 metres along the wharf which, in normal circumstances, should have been a straightforward operation. However, the vessel was in a light condition, reducing the efficiency of the bow thruster. Also, a near-gale force offshore wind and a strong tidal flow were acting on the bow, which caused the vessel to veer away from the berth towards the middle of the river on a number of occasions.

- Issued a notice to mariners (05/2014) directing that, in future, all vessels which would normally be subject to compulsory pilotage while navigating in the Humber, will be required to have on board an authorised pilot when moving from berth to berth on tidal rivers.

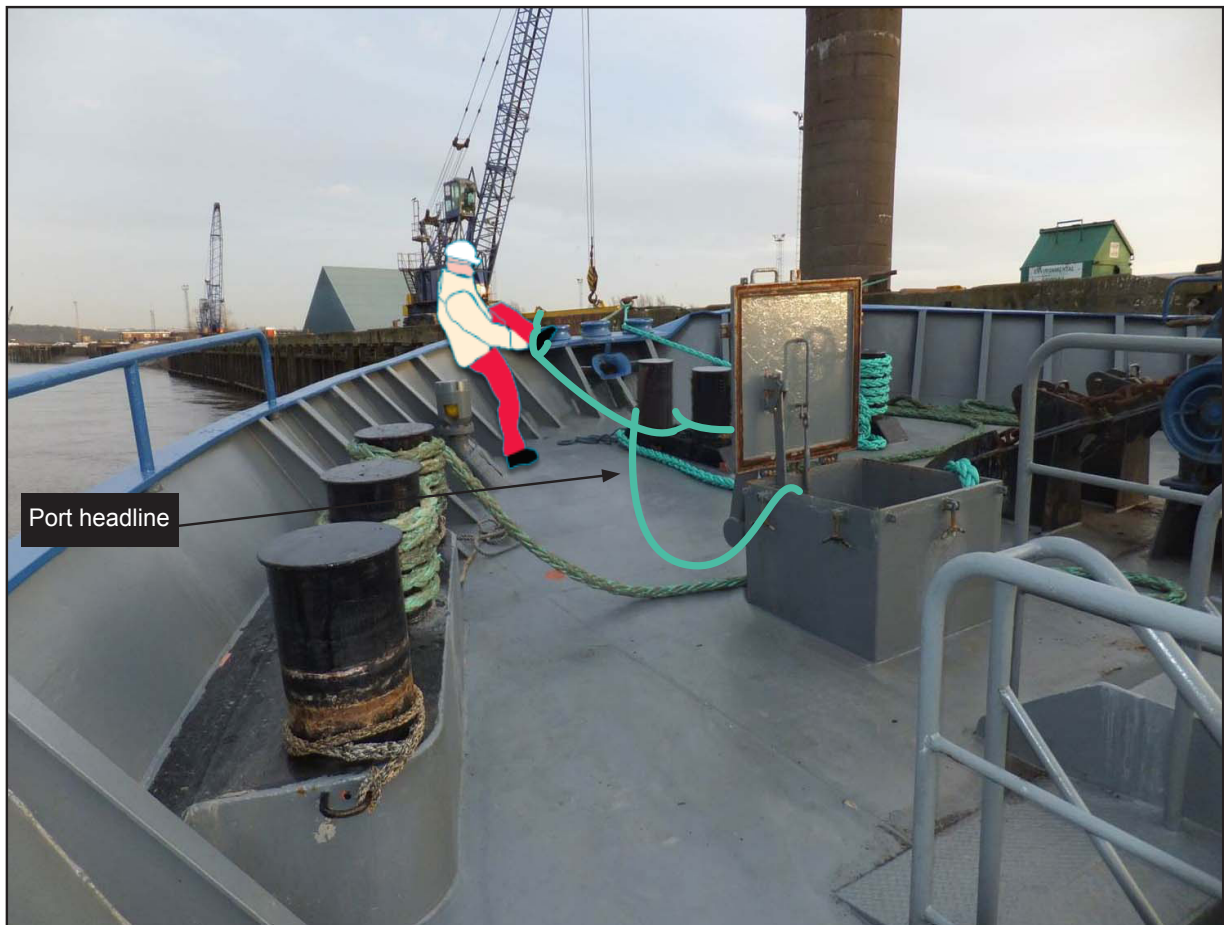
Figure 4: Reconstruction of accident scenario

At about 1915 Sergey was heard to call out for help. His colleagues turned towards him and saw that his left leg had become caught in a bight of the headline and that he was being pulled towards the bow as the vessel moved astern (**Figure 4**). The crewmen went to help Sergey, but could not prevent him from being pulled over the bow due to the weight on the headline.

The circumstances which led to Sergey's foot becoming caught in a bight of the headline cannot be known for certain as he was not supervised at the time of the accident. However, based on evidence obtained, it can be concluded that Sergey had pulled in slack rope by hand as *Sea Melody* moved ahead, and then controlled the slack rope with his foot to pay it out as the vessel dropped astern. When almost all the slack rope had payed out his foot became trapped in a bight and he was pulled overboard before other crew could assist him.

On this occasion, one of the second officers should have taken charge, but both became involved in handling the ropes themselves leaving no-one with an oversight of the operation. This resulted in Sergey working alone on the headline with no-one either to warn him that he was stepping into a bight of rope or to take rapid action once his leg was caught and he was being dragged overboard.

- Issued a fleet circular giving details of the accident and reminding crews of the SMS procedures to be followed during mooring operations.
- Informed its crews of the importance of contacting shore authorities and emergency services immediately when an emergency situation arises.
- Begun an evaluation of auto-inflation lifejackets for crew use during mooring operations.
- Considered the deployment of an axe during mooring operations for the purpose of quickly parting a mooring line in such circumstances.
