Report on the investigation of
the fire on the main deck of the ro-ro cargo ferry

Corona Seaways

in the Kattegat, Scandinavia

on 4 December 2013

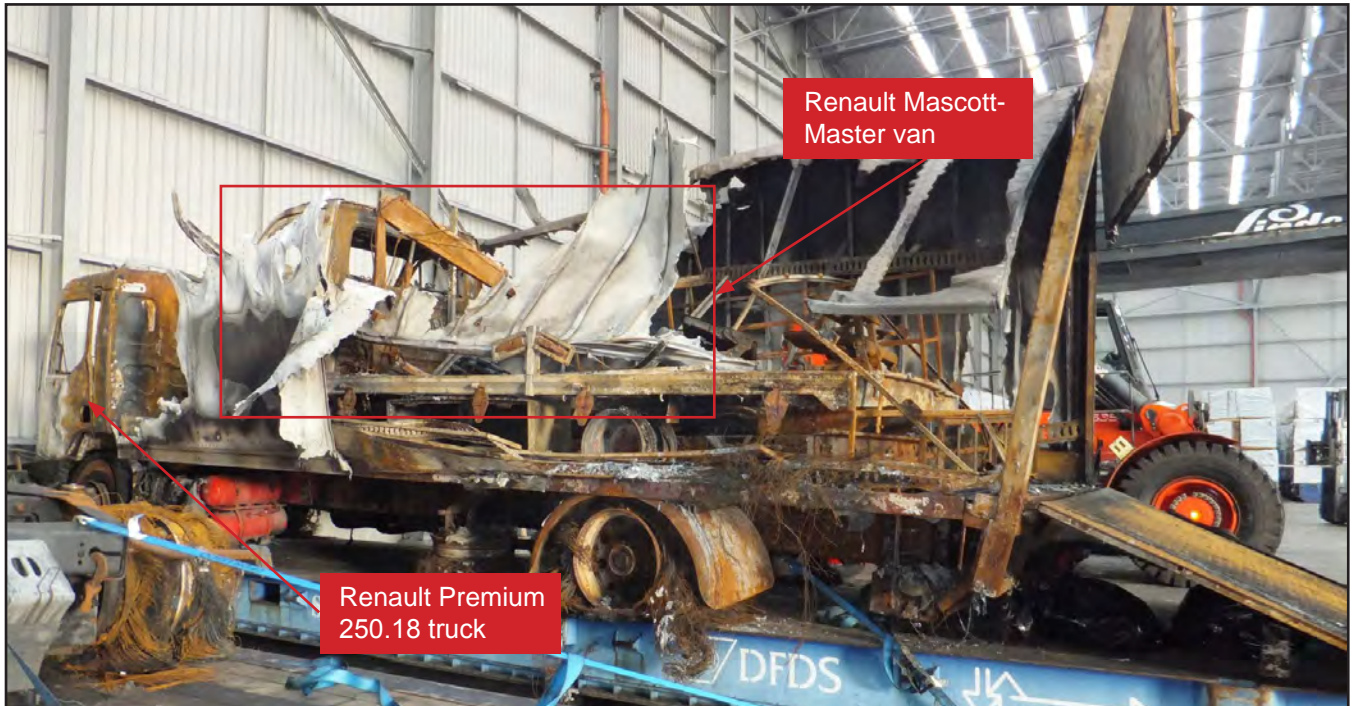
The two vehicles at the locus of the fire were a Renault Premium 250.18 truck and a Renault Mascott-Master van that it was carrying; these are termed the primary vehicles and were totally destroyed (**Figure 3**). They were positioned in Lane 8 and adjacent to frame 131 on the main deck.

Figure 3: Fire-damaged Renault Premium 250.18 truck and Renault Mascott-Master van following their removal from the vessel

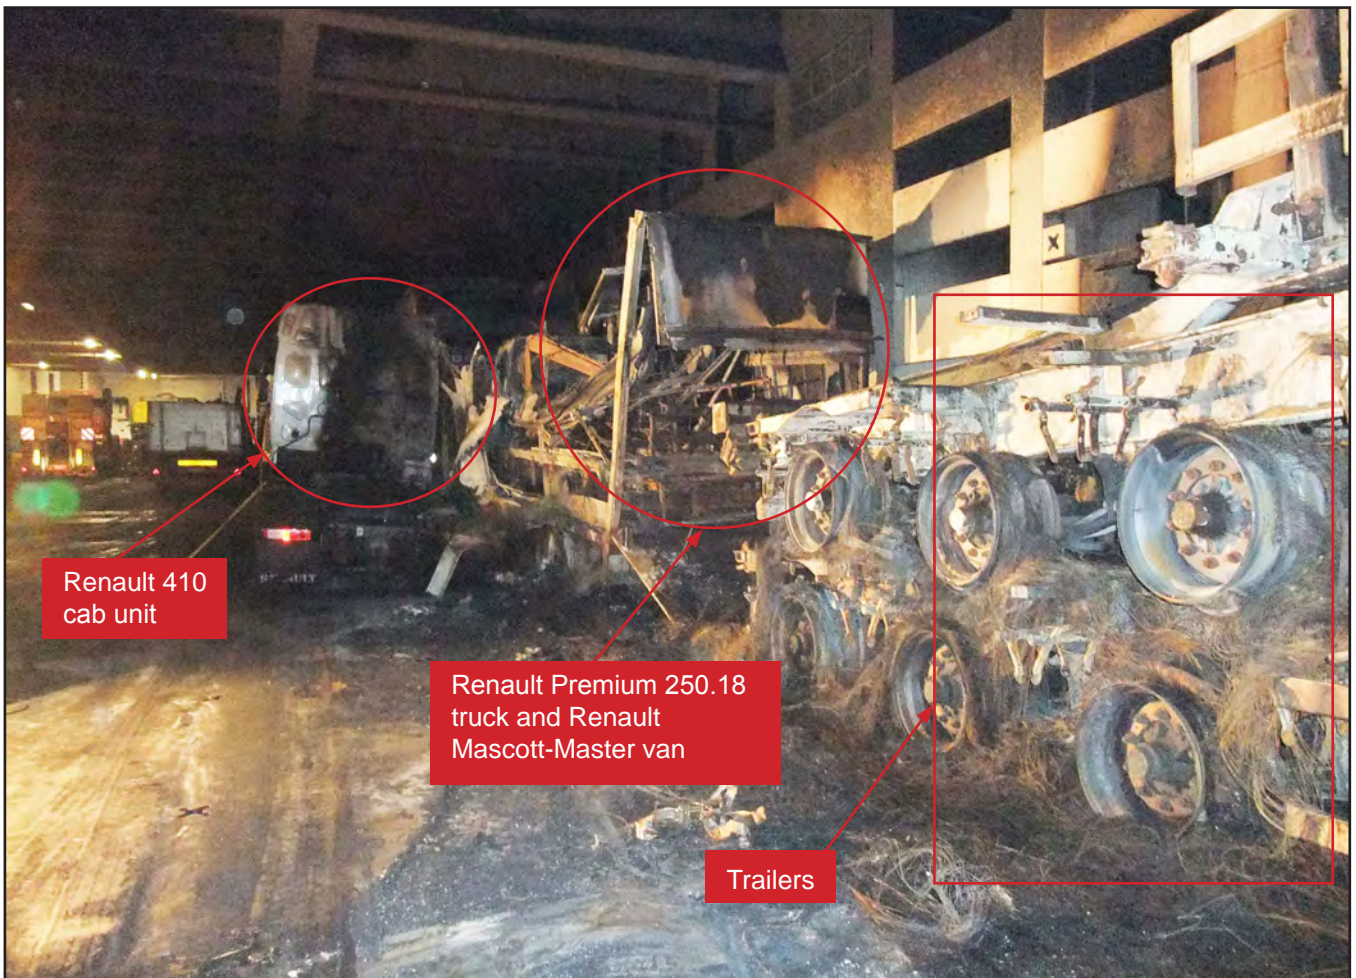
A Renault Premium 410 cab unit located alongside and inboard of the primary vehicles, in Lane 7, suffered severe fire damage to its nearside. Two 3-axle trailer units, each carrying two trailers, positioned in Lanes 7 and 8 and directly aft of the primary vehicles were also badly fire-damaged. Eighteen of the trailer tyres had been totally consumed by the fire. Other units forward of the primary vehicles suffered minor radiant heat damage (**Figure 4**).

Figure 4: Damaged vehicles and trailers on the main deck

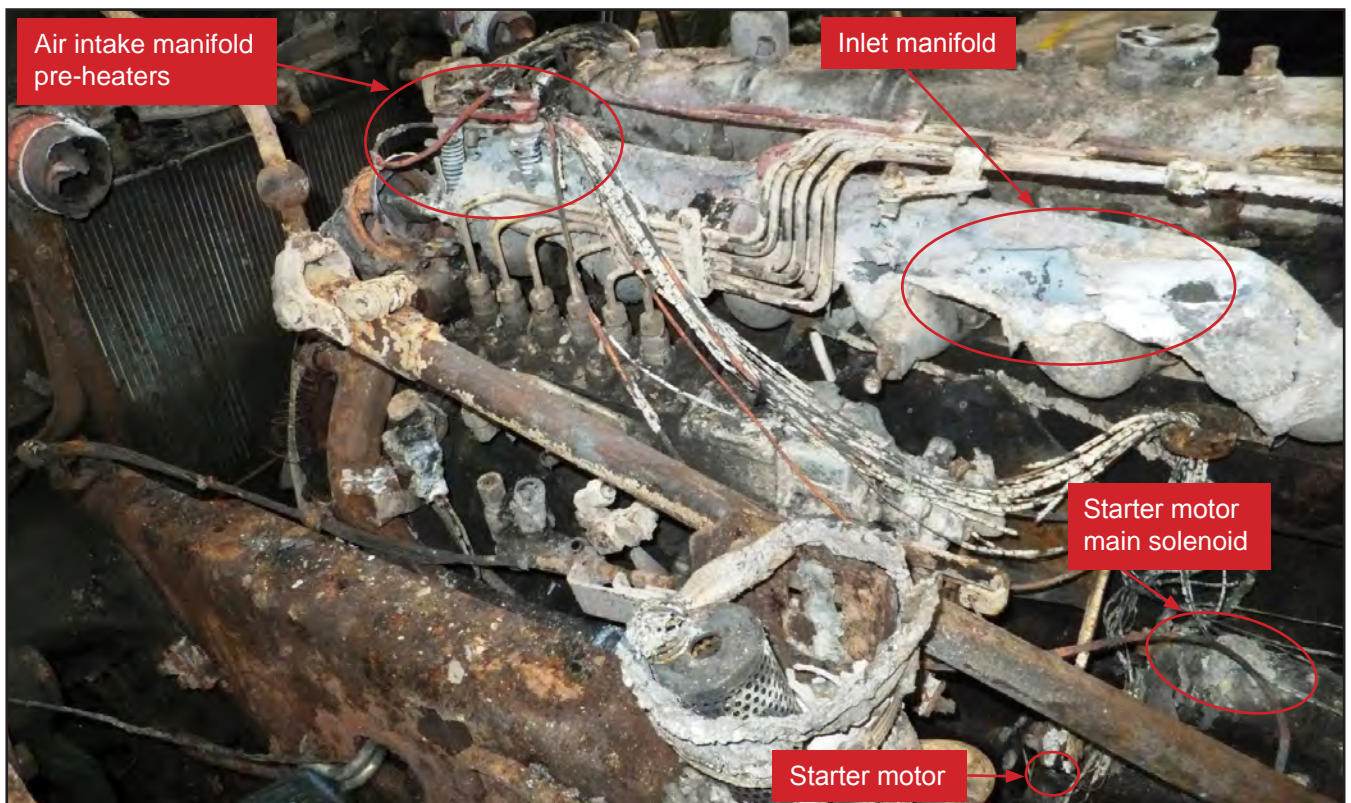
The rear part of the engine's aluminium rocker cover had melted and the upper part of the aluminium engine intake manifold had been burnt away, exposing the pre-heaters (**Figure 6**). The diesel oil fuel unit had melted. The three heating elements were still connected to their electrical cables, although the main supply electrical cable connection was loose, with about a 3mm gap between the nut and connection tab. The battery main supply cable insulation had been destroyed and the cable had welded to the chassis.

The main terminal post of the engine starter motor main solenoid was found to be extremely loose. The end Bakelite-type cap appeared brittle, and there were copper globules in the vicinity of the starter motor.

Figure 6: Fire damaged engine components

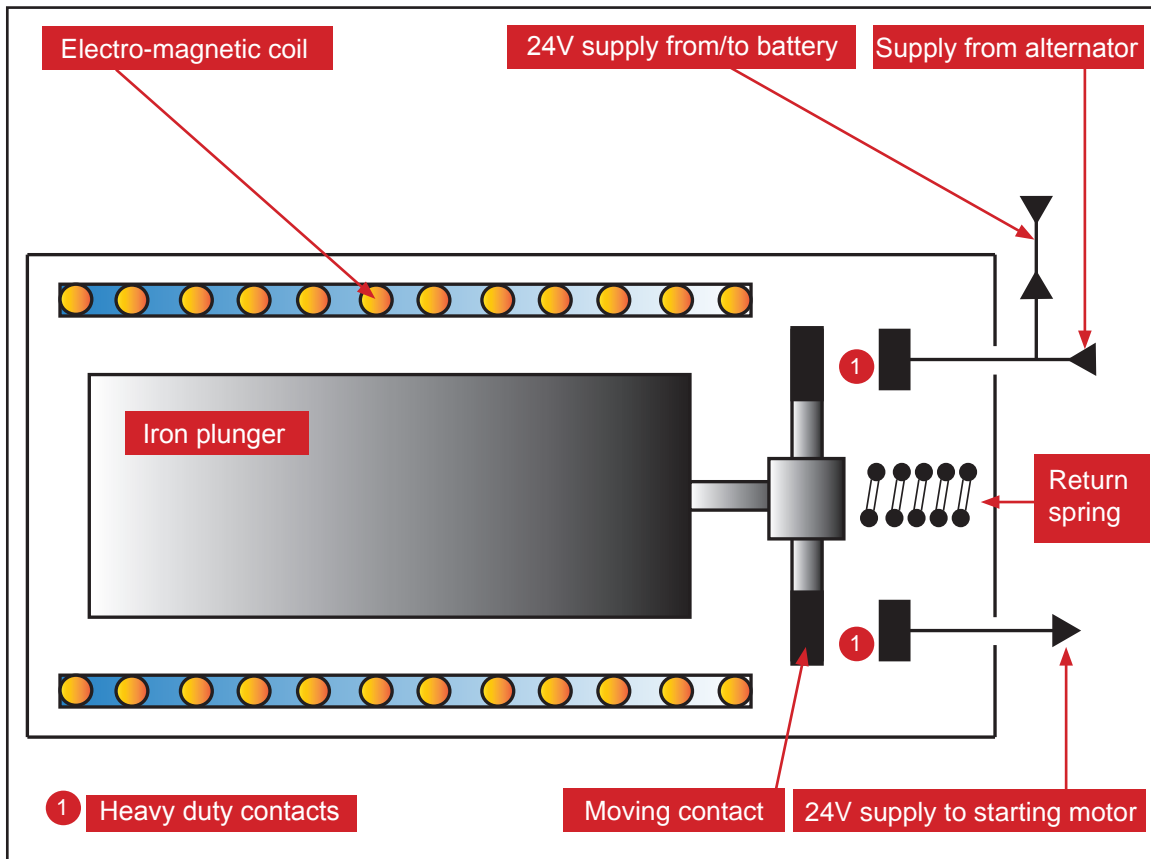
On dismantling the solenoid, the main contact post connecting the solenoid to the battery separated from the end cap, which exposed heavy arcing damage to the internal surfaces. The main contacts had suffered significant spark erosion and pitting. The moving contact had separated from its carrier, melted copper globules were found in the body of the solenoid, and the alternator connecting cable had melted through (**Figures 7 and 8**).

Figure 7: Schematic of engine starter motor main solenoid

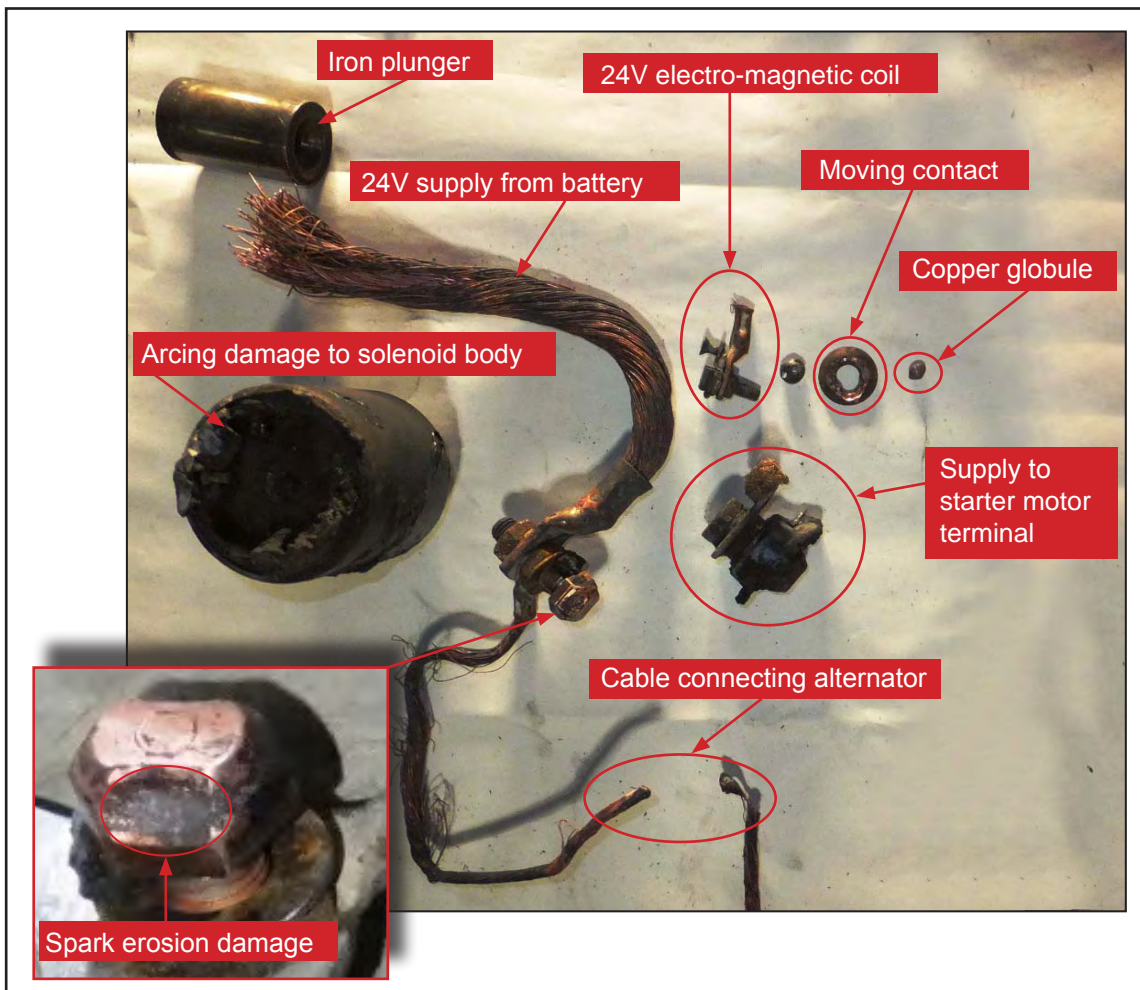
Figure 8: Damaged Renault Premium 250.18 truck engine starter motor main solenoid

All the evidence, including the area of high heat energy and the burning and heavy radiant heat damage to the engine and to the front of the cab, indicated that the seat of the fire was located around the upper half of the engine. The engine starter motor main solenoid was severely damaged by internal arcing, which had destroyed the moving contact. As the engine pre-heat solenoid was defective, the air charge could not be pre-heated and the engine would have been difficult to start: there was anecdotal evidence that the engine had to be repeatedly cranked over to start it. It is probable that the internal arcing and damage to the engine starter motor main solenoid's fixed and moving contacts were initially due to repeated attempts to start the engine. This would have resulted in a continual current flow in the heavy duty cable from the battery which would have remained live despite the ignition switch being in the 'stop/park' position. Over time, continual arc tracking within the solenoid would have caused further damage and, together with the high current flow

experienced during engine starting, would have caused the cable to overheat, ignite the insulation and initiate the fire. As the insulation burnt, the now bare cable would have shorted, causing further sparks and for it to weld against the chassis.

1. The engine starter motor main solenoid was severely damaged by internal arcing, which had destroyed the moving contact. [2.2.2]
2. The heavy duty cable connecting the battery to the engine starter motor main solenoid was live and permitted unintended electrical arcing inside the solenoid which, together with high current flow experienced during engine starting, caused the cable to overheat and initiate the fire. [2.2.2]
3. The defective engine pre-heat solenoid prevented the air charge from being pre-heated, making the engine difficult to start. [2.2.2]

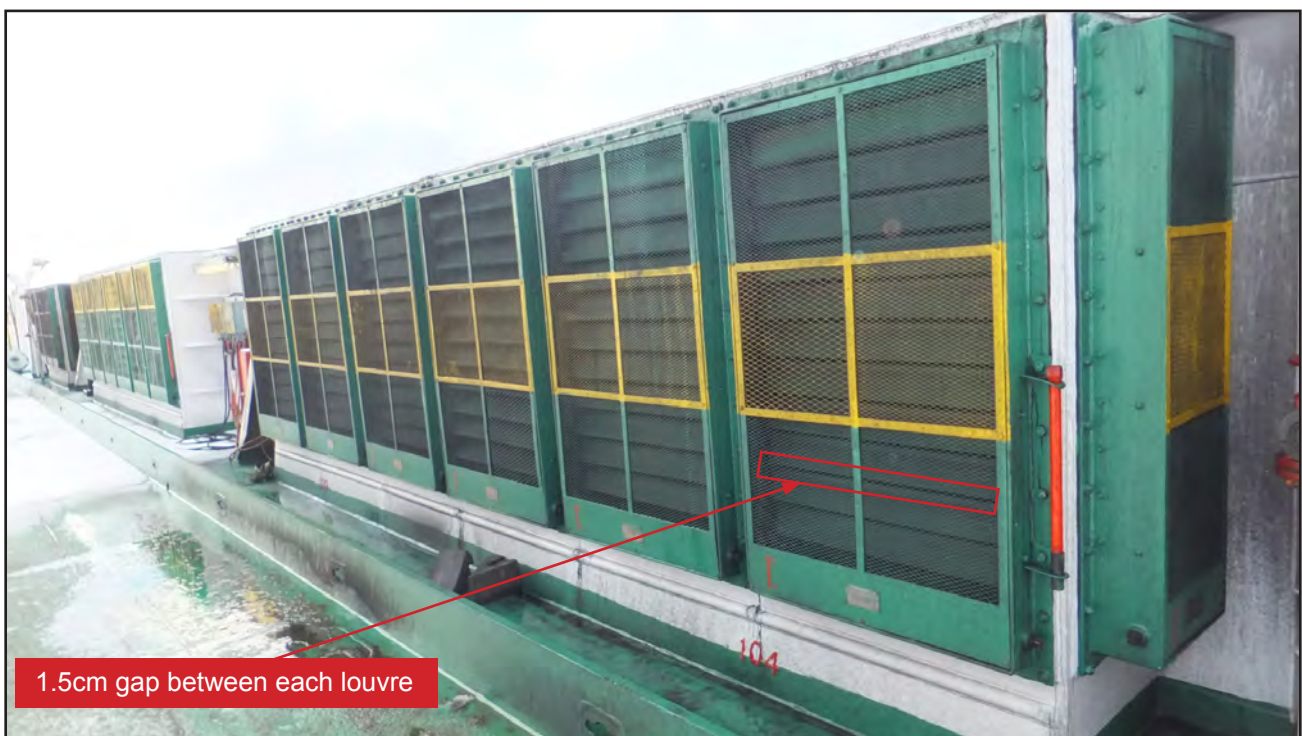
There was a total of 38 main deck ventilation jalousies. Six were located on the starboard side of the upper deck and 15 on each of the port and starboard sides of the weather deck. The jalousies serving the main deck were easily identifiable by a yellow-painted strip across their middle section¹. Each jalousie comprised 11 manually operated louvres fitted with rubber sealing strips (**Figure 9**).

Figure 9: Main deck ventilation jalousie

While the ventilation louvres were reported closed, smoke continued to emit from them for most of the incident. On investigation, it was found that there was a misunderstanding on board on how to lock the louvres in the 'closed' position. Not all crew were aware that two persons were required or of the need to rotate the operating spindle past the apparent 'closed' point to lock the louvres shut against the cam system. It was also noted that the vessel's Training Manual did not cover the process.

During trials, it was found that there was an average gap of about 1.5cm between each of the eleven louvres in each of the 34, 1-metre wide jalousies when the louvres were in the 'closed' but not 'locked' position. This equated to a hole of approximately 5m² through which CO₂ could escape, or air (oxygen) could be drawn in.
