**Anchor dragging and subsequent grounding of  
STENA ALEGRA  
Karlskrona  
28 October 2013**

**SUMMARY**

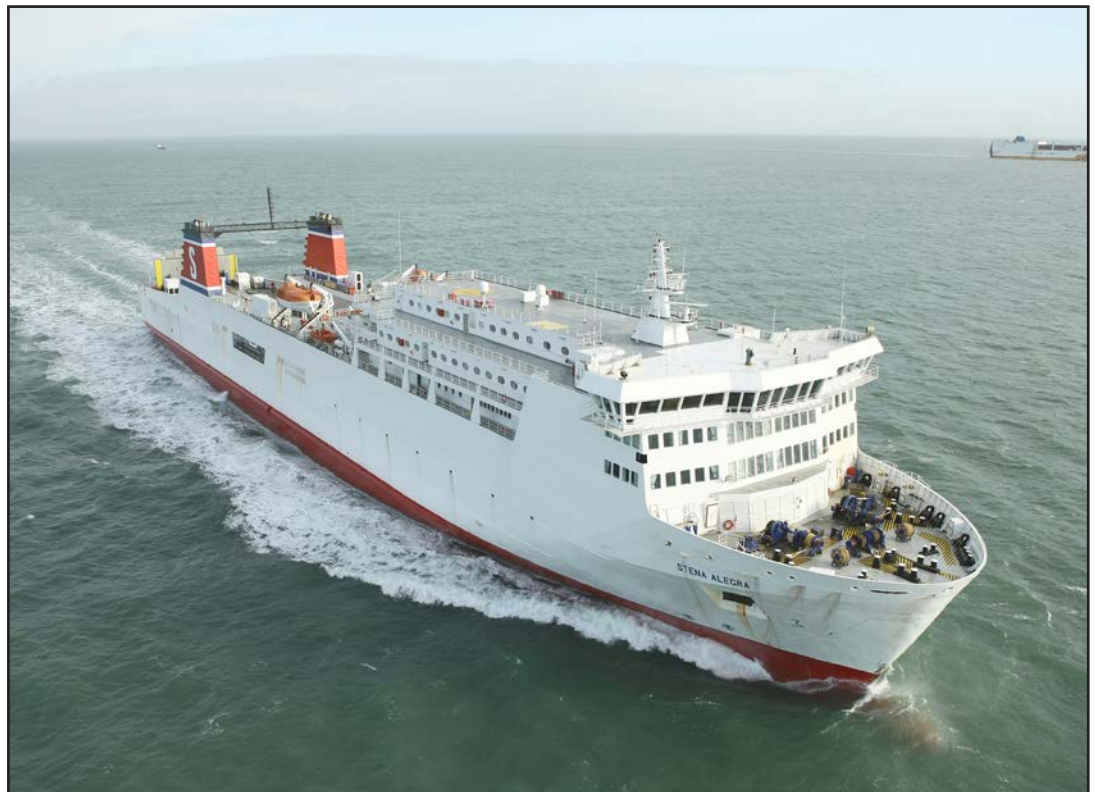
**Figure 1: Stena Alegra**

At 1851 (UTC+1) on 28 October 2013, the RoPax<sup>2</sup> ferry *Stena Alegra* (Figure 1) grounded after dragging its anchor in 76 knot winds off Karlskrona, Sweden.

The vessel's bottom plating and frames were damaged, and one ballast tank and one void space were flooded. Two tugs towed the vessel off the rocks after the weather had moderated the next day. Following an underwater inspection the vessel proceeded to Gdynia, Poland, for repair.

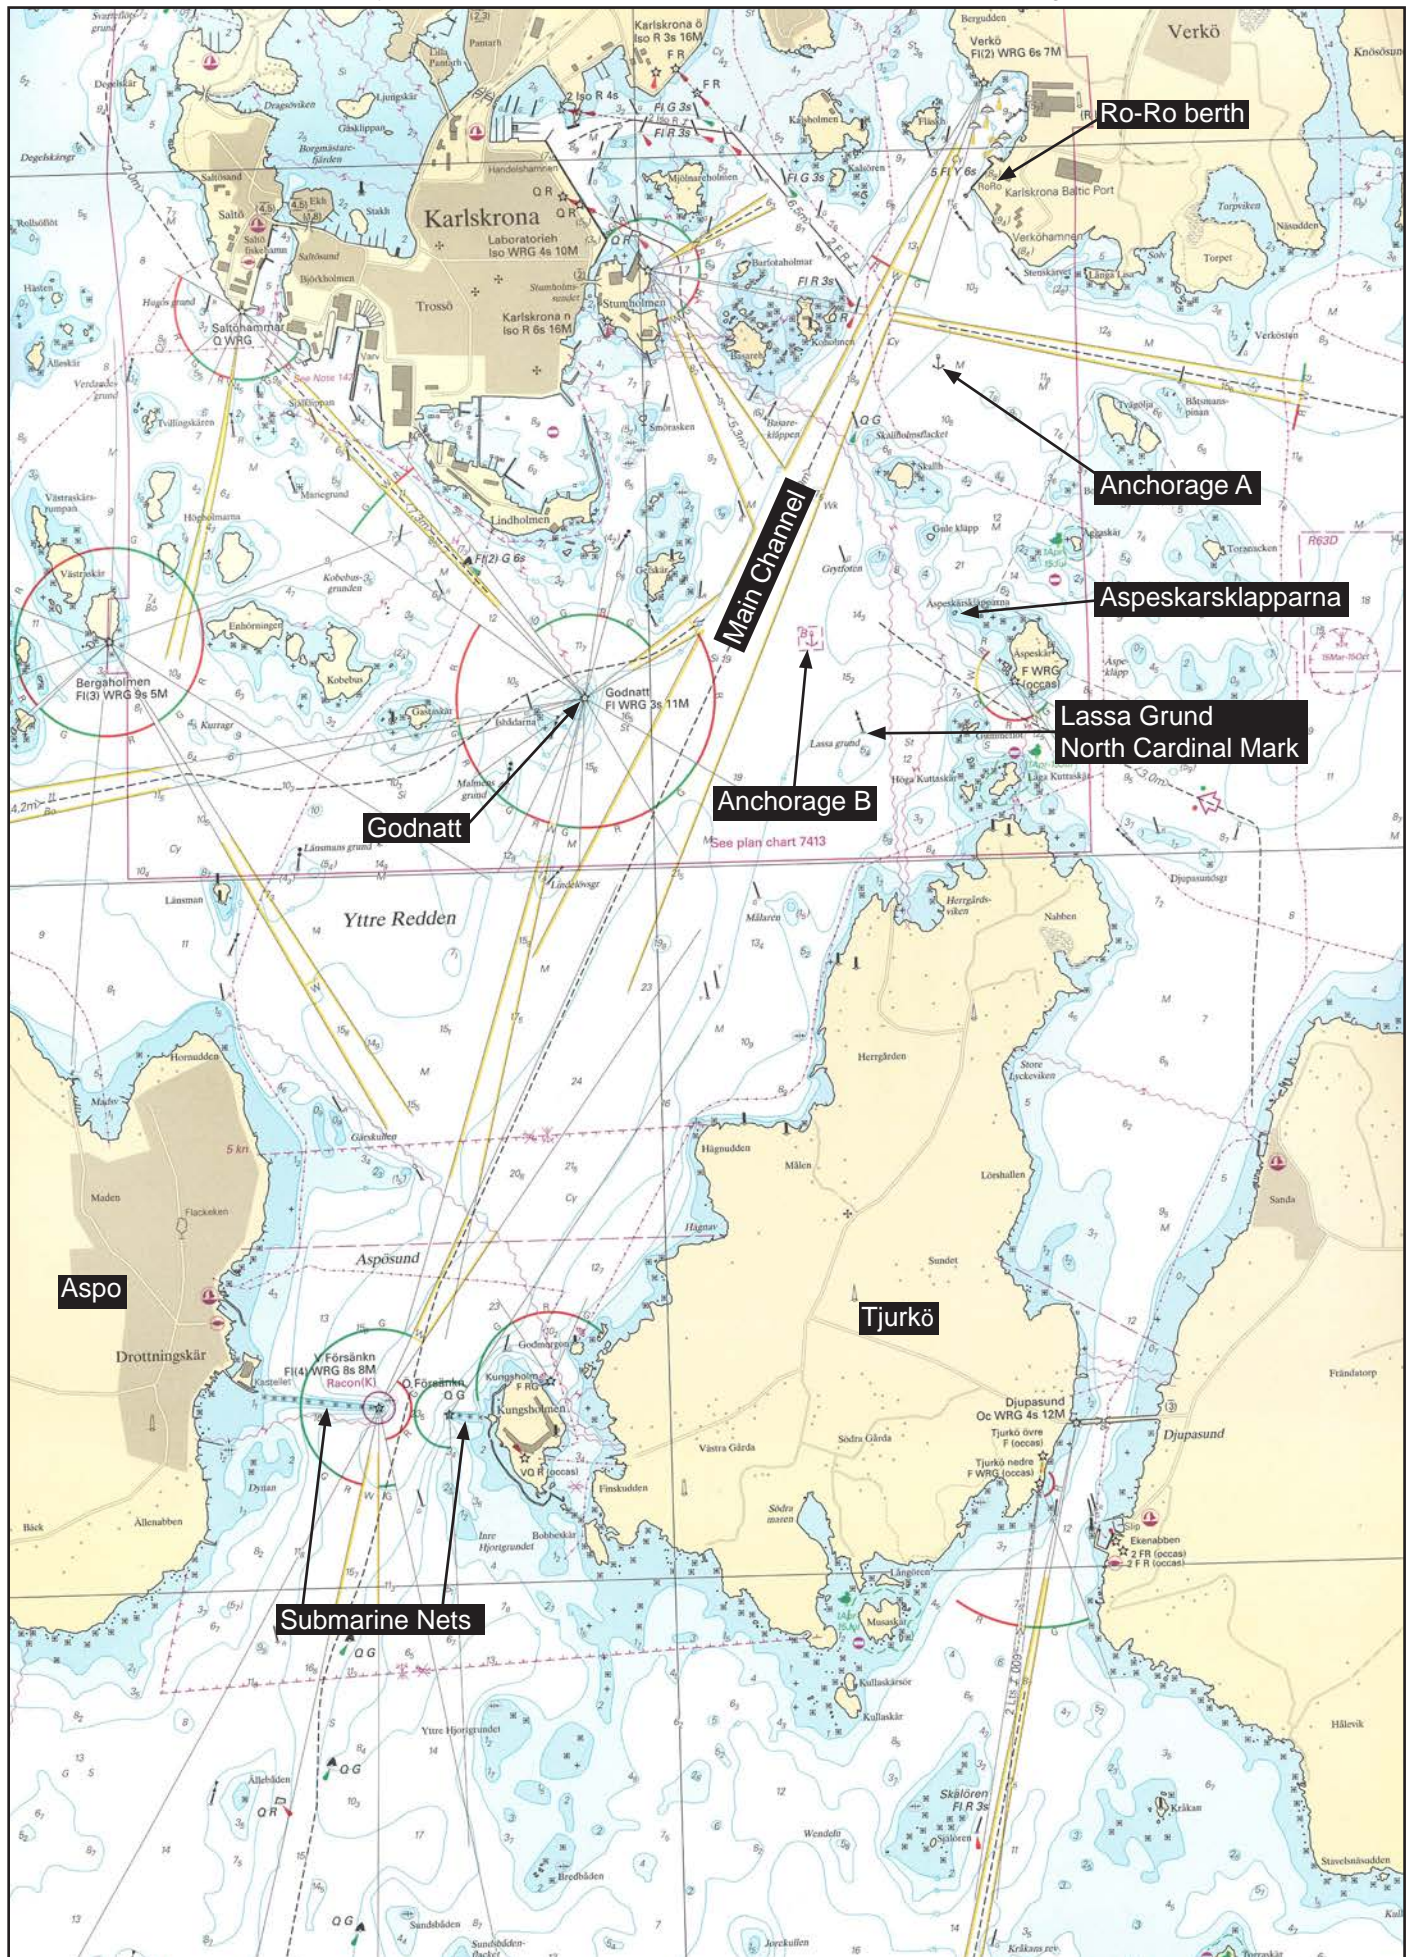
Figure 2: Chartlet showing anchorage and main features of Karlskrona and approach

During the short time alongside, the master discussed with the pilot his intention to proceed to anchor in anchorage B (**Figure 2**) for the vessel's scheduled layover period. The master proposed anchoring as close to the main channel as possible to gain maximum sea room from Aspekarsklapparna, owing to the forecast south-westerly winds. During these discussions, the pilot produced a local weather forecast

There were two designated anchorages within the approaches to Karlskrona. The master selected anchorage B because in anchorage A *Stena Alegra* would have potentially impeded the passage of other vessels using the Ro-Ro berth. He decided to anchor the vessel south-west of its normal anchoring position so as to maximise its distance from Aspekarsklapparna, without unduly encroaching into the main entrance channel. He also increased the amount of anchor cable normally used, to 8 shackles which, in a water depth of 15 metres, provided a scope of 14.7 (ie greater than the assumed maximum scope in the IACS design requirements for anchoring equipment). The pilot's comments regarding the suitability of the holding ground at the master's intended anchoring position provided tacit validation of the appropriateness of his decision to proceed to anchor in anchorage B despite the forecast weather conditions.

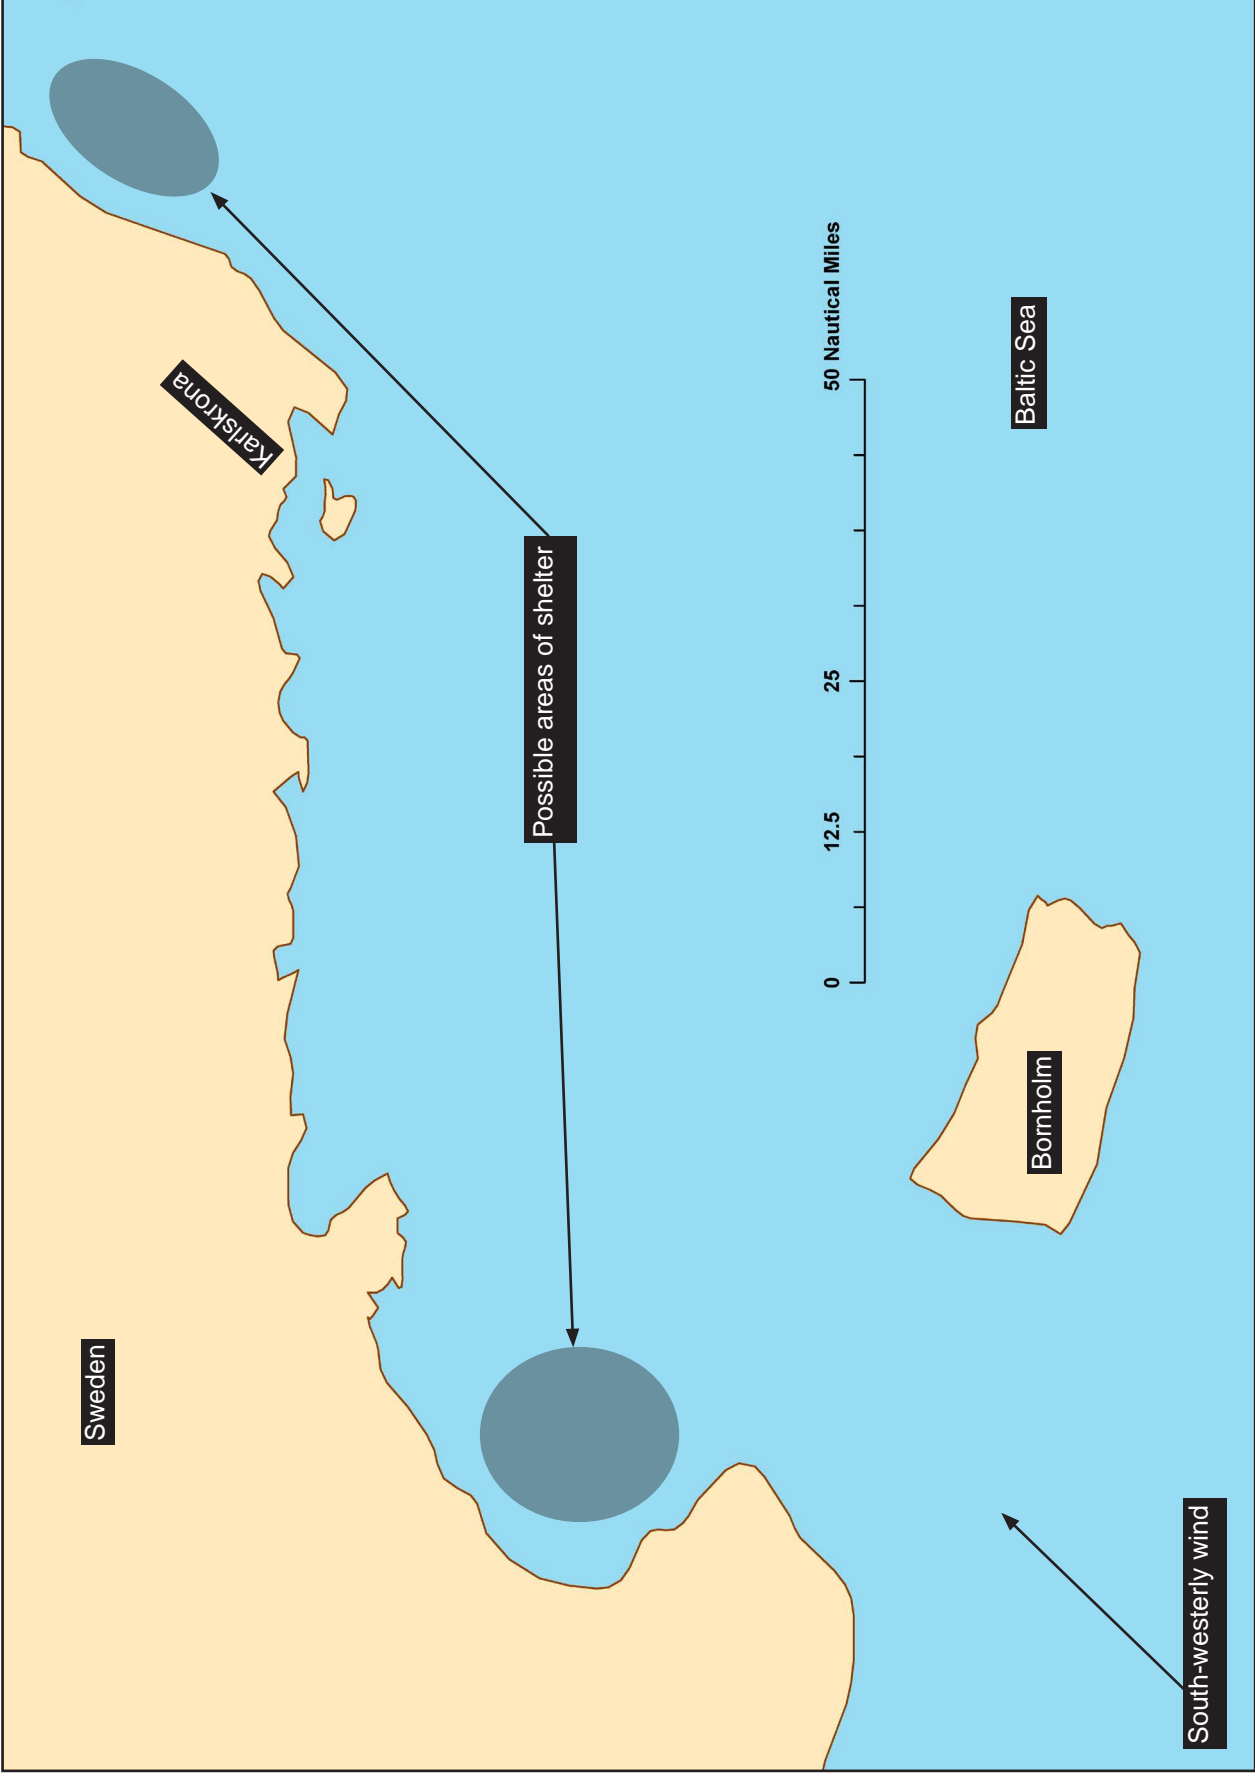
Figure 3: Swedish coast and possible areas of shelter

In dismissing the option of proceeding to sea, the master did not consider steaming east or west along the coast from Karlskrona, and then heaving to in areas where the sea conditions were likely to have been more favourable due to the shelter provided by the Swedish coast. Such an option was feasible considering the length of the layover period (**Figure 3**).
