Capsize and foundering of the beam trawler *SALLY JANE* Christchurch Bay 17 September 2013

SUMMARY

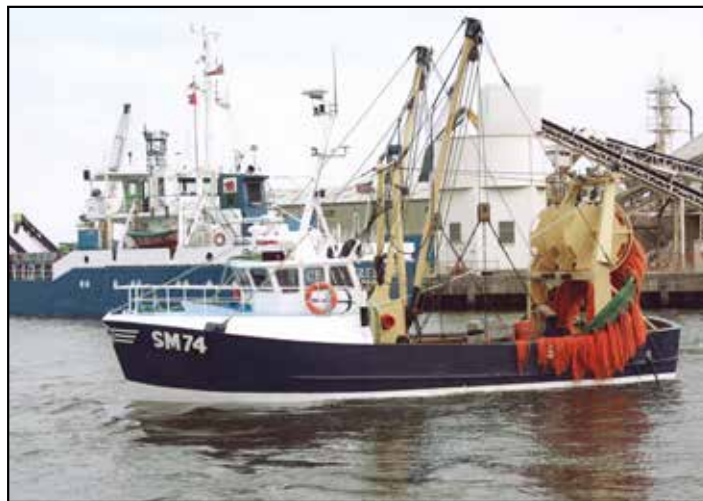
Sally Jane

- *Sally Jane* capsized due to a loss of transverse stability, probably caused by a difference in the weight of the contents of its port and starboard trawl nets.
- The uneven loading was most likely due to the contents in the starboard side trawl net breaking free.
- The vessel's heeling moment was exacerbated by the length and angle of the derricks.
- The vessel quickly flooded and sank because the hatches to the fish and engine rooms were not secured.
- The information in the stability particulars book had not been periodically verified through lightship checks and it was not used by the vessel's skippers.
- The emergency position indicating radio beacon did not activate as it probably became trapped in the starboard trawl net when the vessel capsized, inverted and then sank.

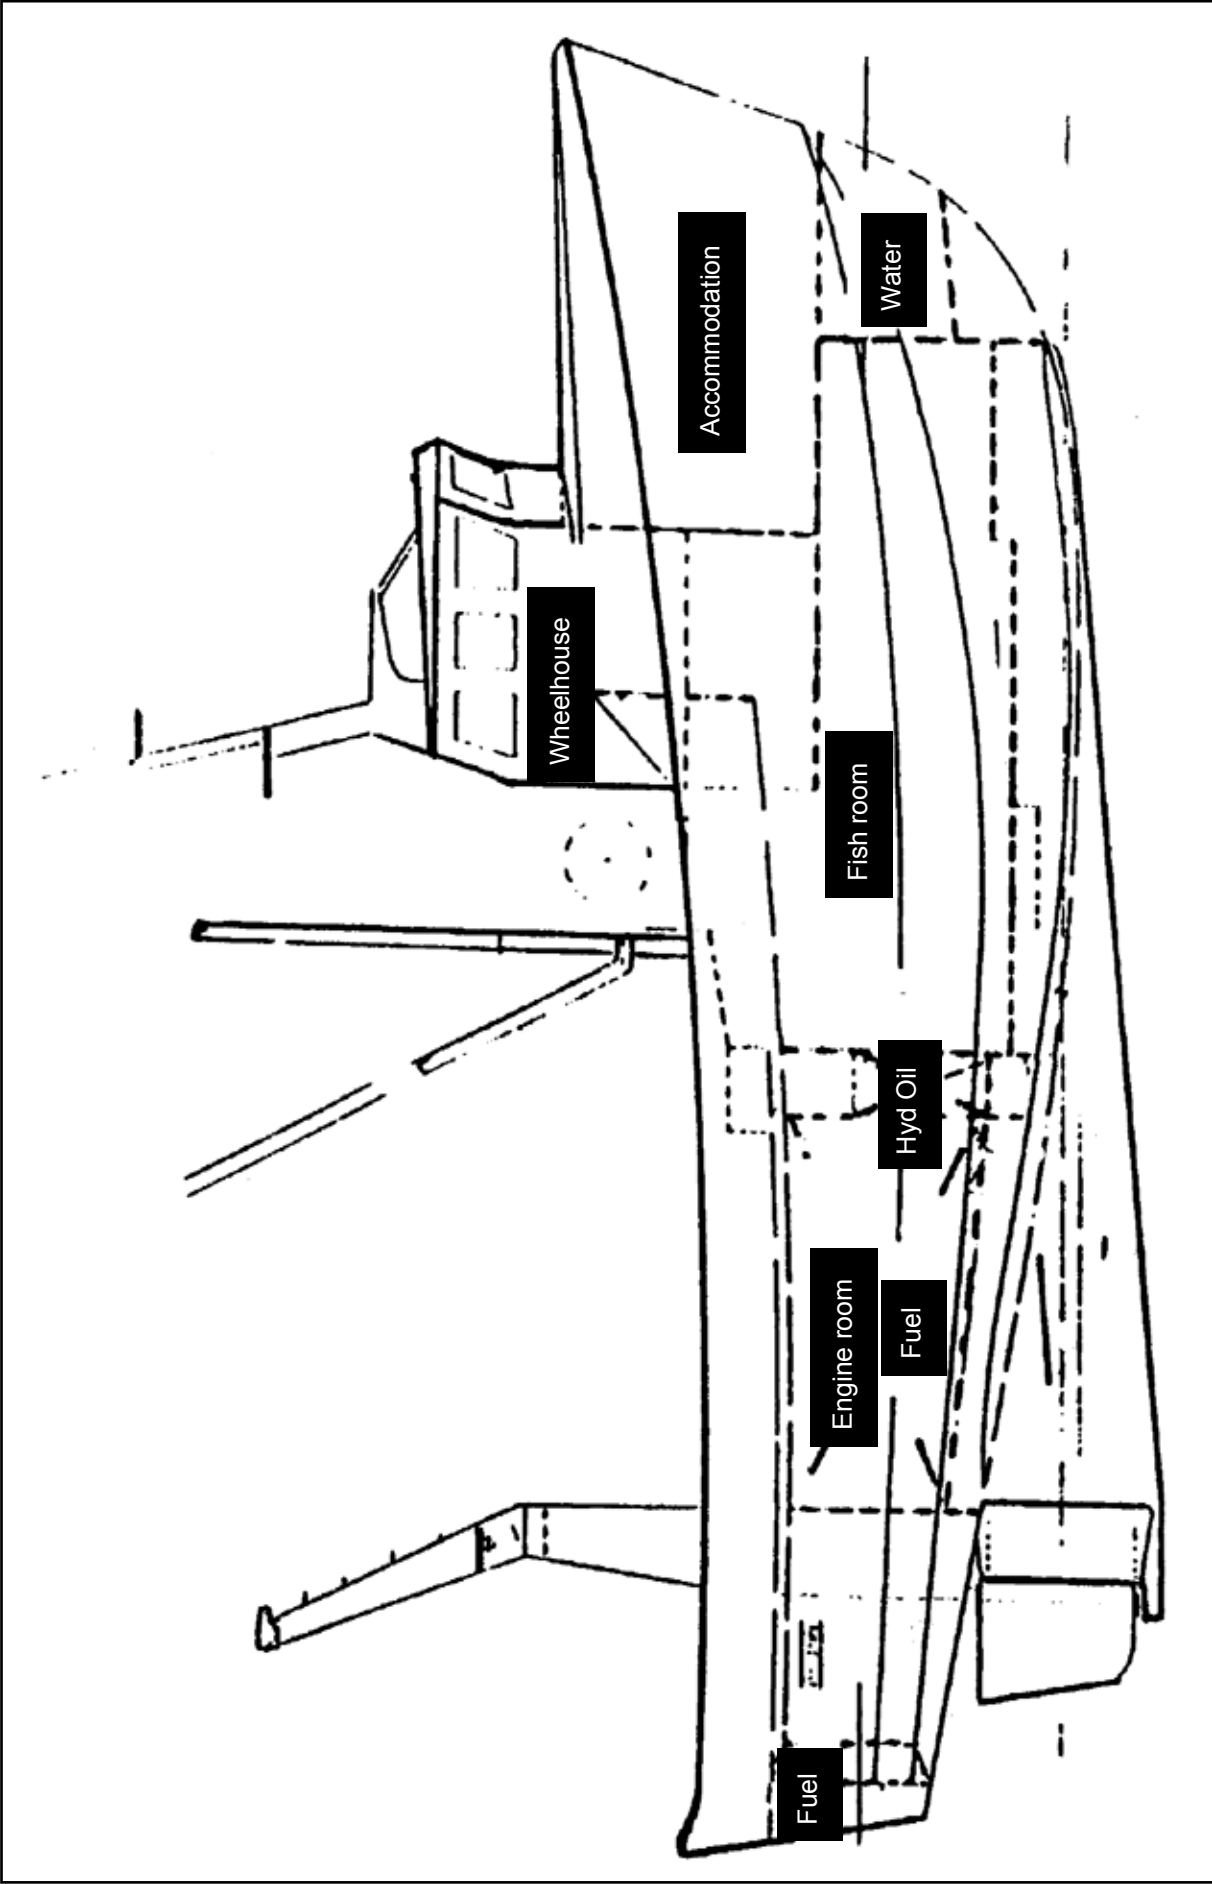
Figure 2: Layout of Sally Jane

It is evident from the dive survey of *Sally Jane* that its engine room and fish room deck hatches were not secured. Consequently, when the vessel rolled onto its port side, the hatch lids would have swung open. Sea water would have then quickly and freely flooded into the compartments and contributed to the vessel's rapid inversion. In only slightly differing circumstances, the skipper could have easily been trapped in the wheelhouse by the inrush of water rather than flushed from it.

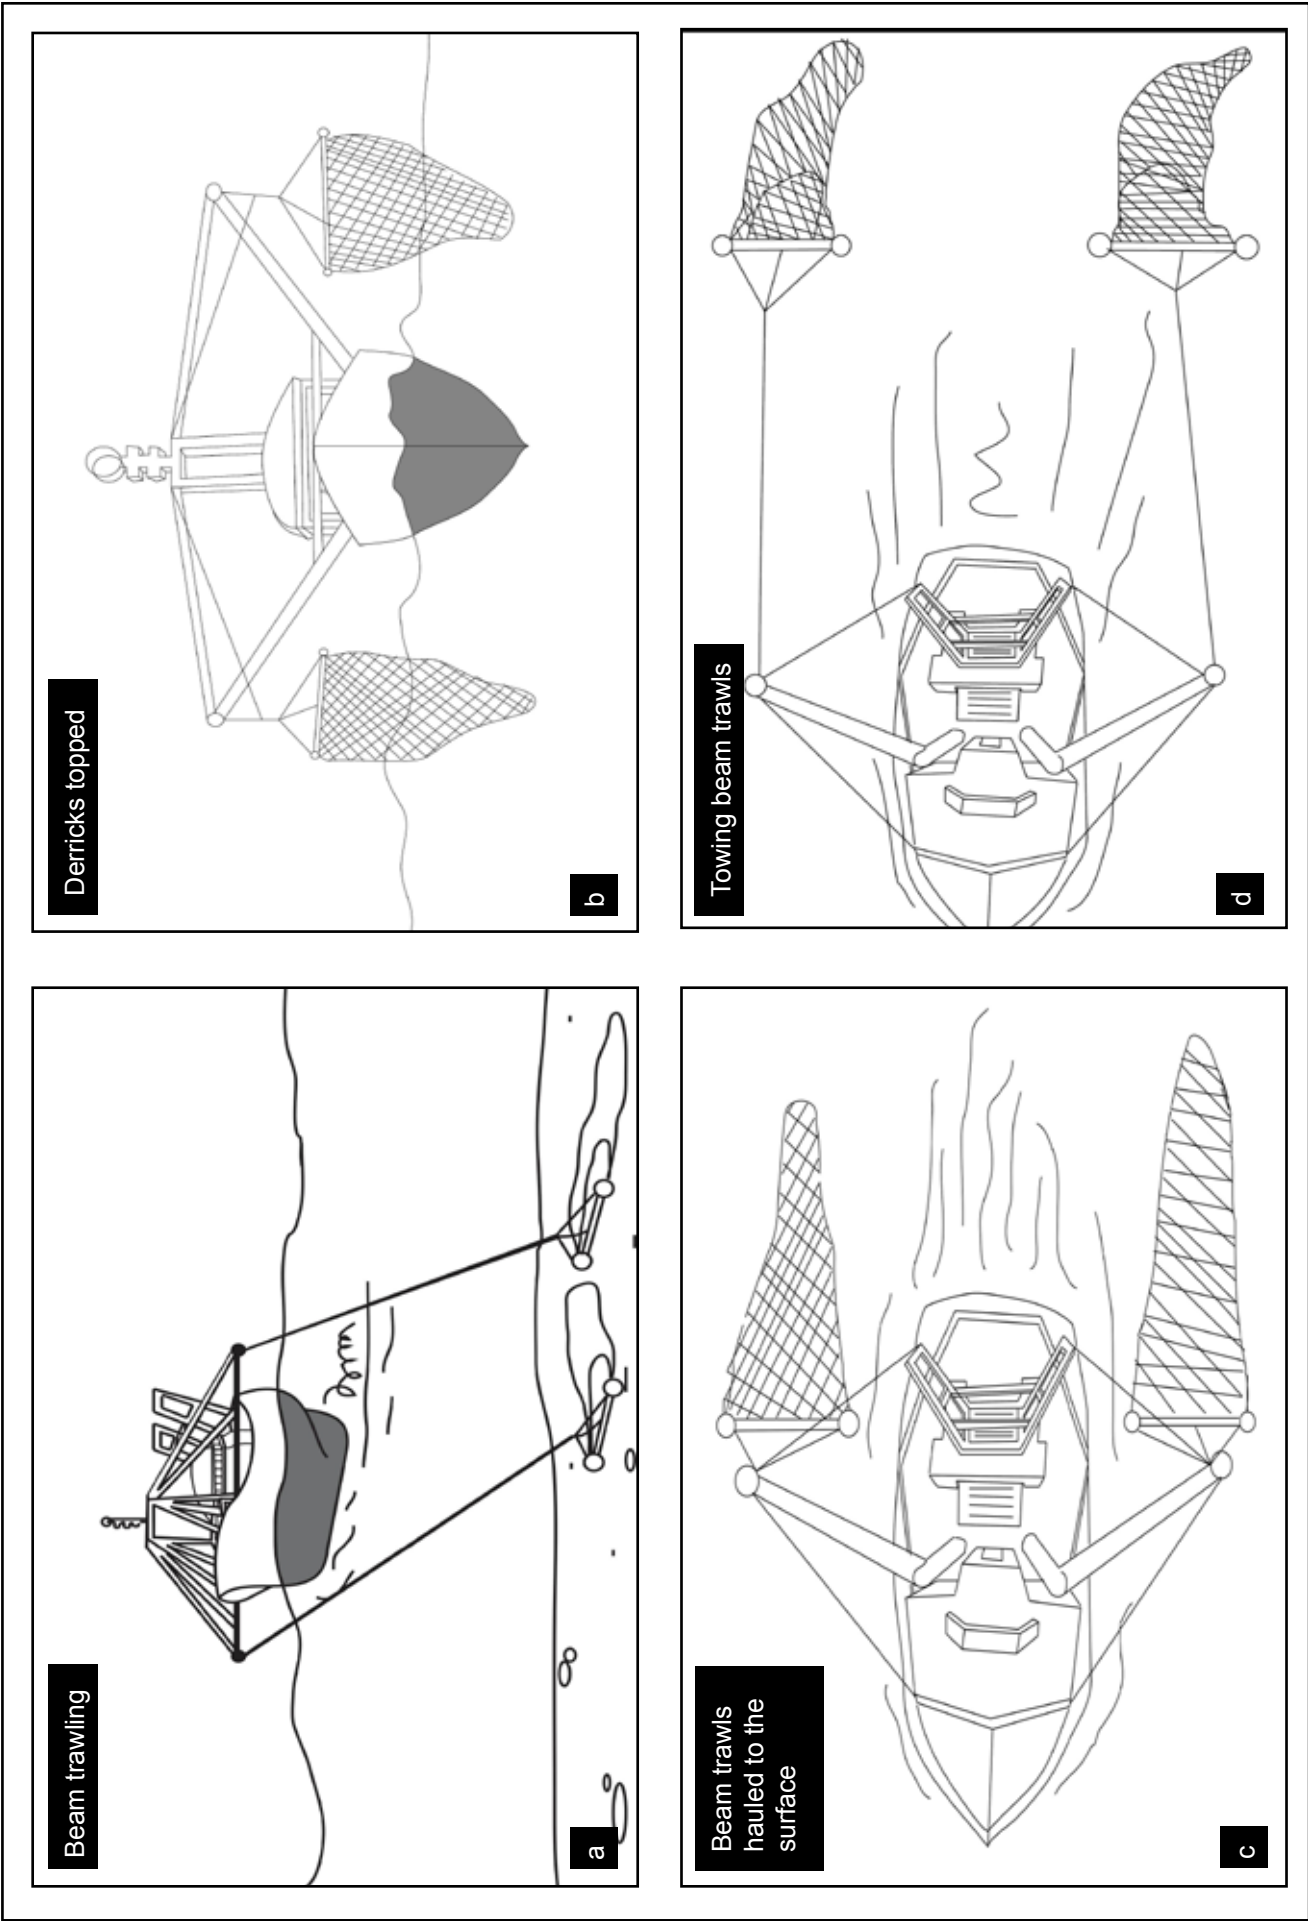
Figure 4: Beam trawling

Given the raised position of *Sally Jane*'s beam trawls (**Figure 4b** and **4c**), the depth of water in the area (**Figure 1**) and the speed of capsizing, such imbalance could only have been caused by the contents of the starboard net suddenly releasing due to the net ripping or failing in some way. Although the state of the starboard cod-end could not be verified, the free movement of the net when it was tugged by the divers seems to confirm that it was empty when the vessel sank. It is also possible that the port net came fast on an object on or near the sea surface, but there is no evidence to support this scenario.

In this case, the MAIB's basic stability analysis of *Sally Jane* showed that the length of the derricks and the topping of the derricks prior to the contents of the starboard net releasing, contributed significantly to the resulting heeling moment.

In addition, raising the derricks slightly might have seemed a sensible precaution when turning. However, as the weight of the beam trawl acted from the suspension point at the derrick head, topping the derrick just 10° lifted the outboard end of the derrick by 1.25m. Consequently, the vessel's centre of gravity was raised and its reserve of stability was reduced.

Sally Jane's derricks were 7.2m long, and trawl beams were 4.5m long. Therefore, with the derricks lowered to the horizontal when shooting and hauling the nets, the clearance between the vessel's side and the inner beam end would have been 3.5m. Such a large clearance appears excessive. Although the use of shorter derricks might have required a change in working practices to enable the fishing gear to be safely recovered on board, the use of shorter derricks would have improved the vessel's stability during such safety critical operations.

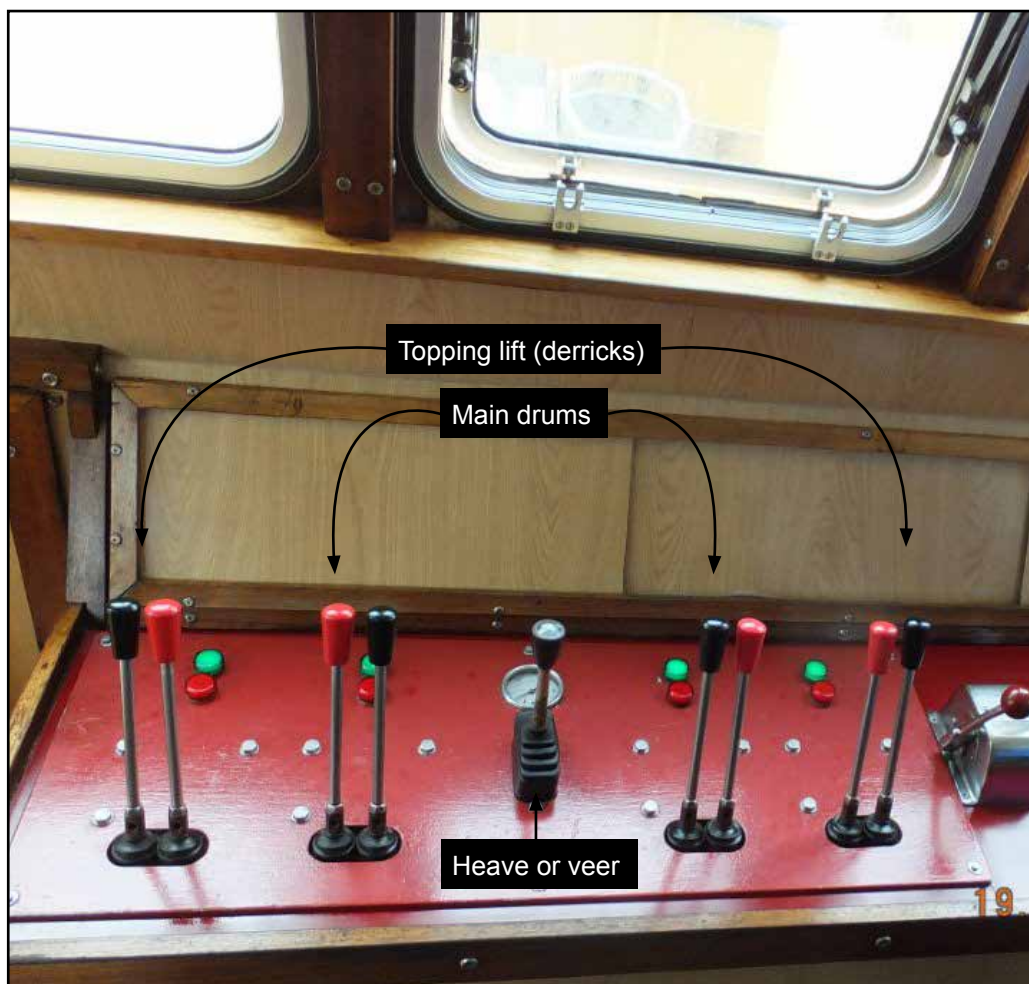
Figure 5: Winch controls (vessel similar to *Sally Jane*)

In these circumstances, the only way that capsizing could have been prevented was for the crewman in the wheelhouse to release the winch brakes. However, the vessel's slewing and rolling to port were sudden and violent. Therefore, it was not surprising that the mate was quickly knocked off balance and was unable to reach the winch controls despite the control levers being accessible and simple to operate.

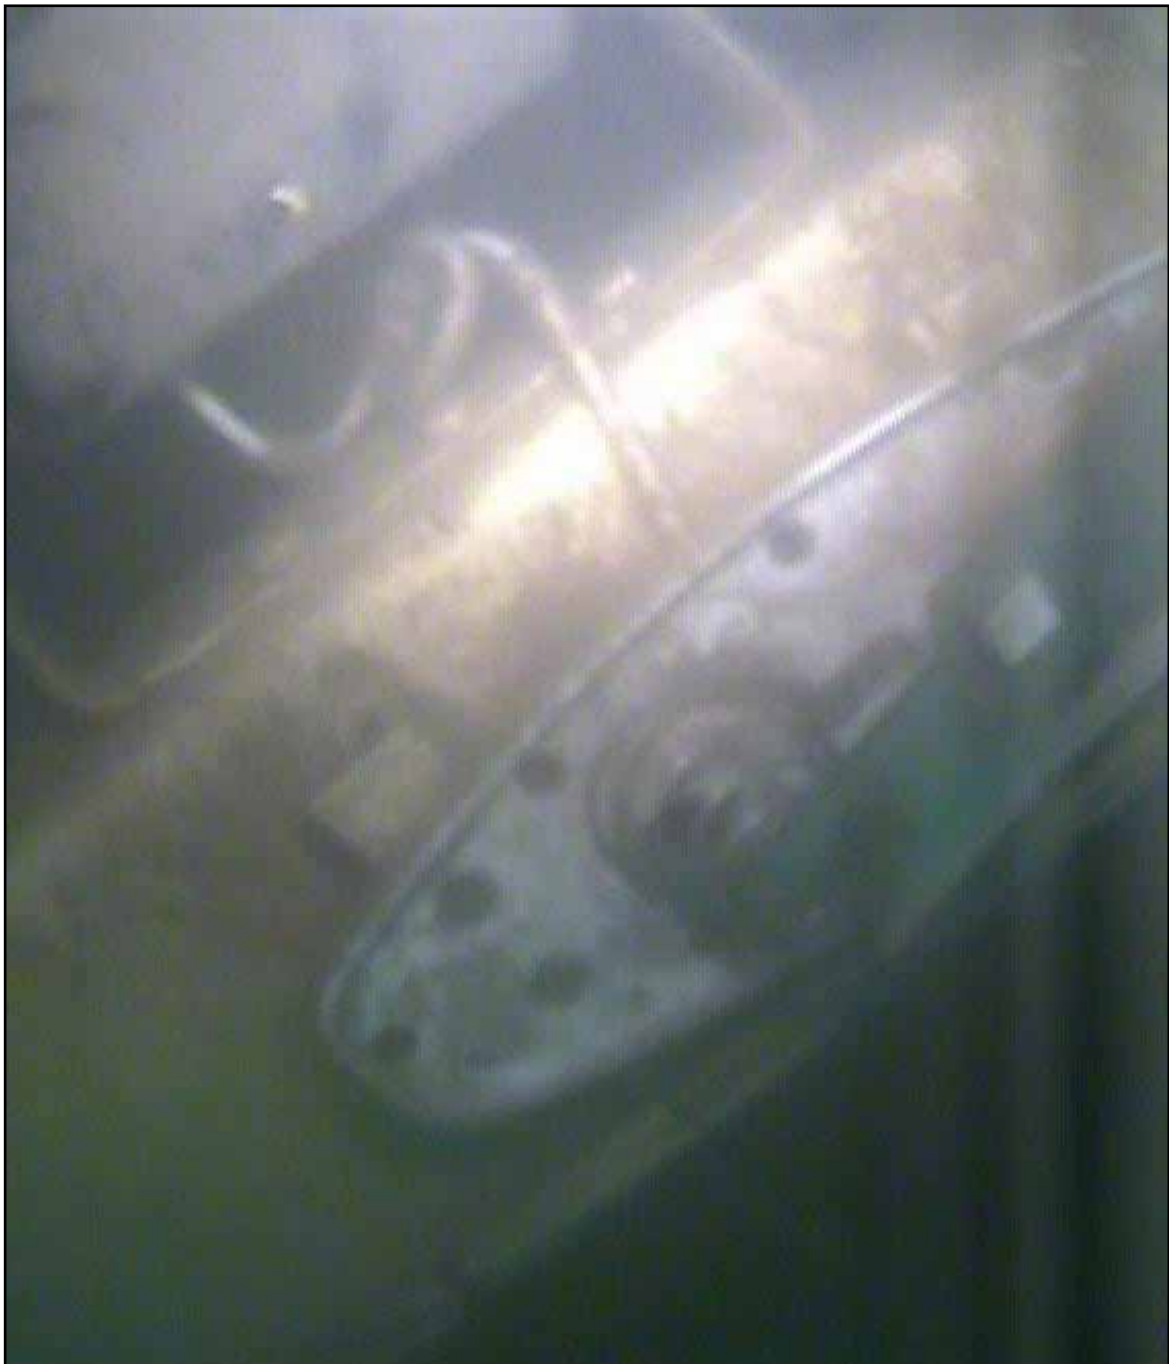
Figure 6: Empty EPIRB housing

The EPIRB fitted to *Sally Jane* did not transmit an alert and has not been found. It was over a year overdue for a service and the HRU was a month out of date. However, the most likely reason that the EPIRB did not activate as intended was because of its vulnerable position on the aft gantry. As a deck light fitting was also missing from the gantry, it is likely that when the vessel capsized to port the starboard beam and trawl swung across the top of the gantry, removing the light fitting and the EPIRB, trapping the beacon in the starboard trawl net.

Although space is at a premium on small fishing vessels and priority is given to equipment intended for fishing operations, careful consideration should be given to the siting of essential safety equipment. Apart from its vulnerability on top of the gantry it would have been very difficult for the crew to retrieve the EPIRB or release it manually in an emergency situation.

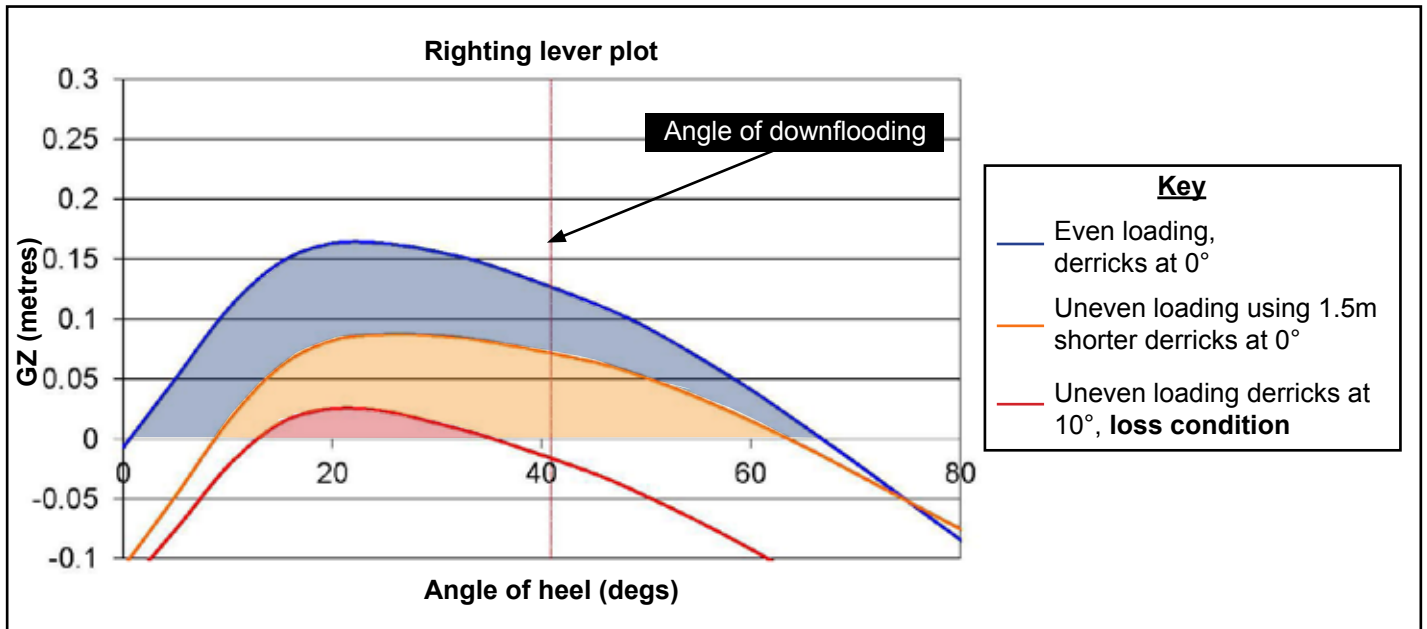
Figure 7: Righting lever plot

- The blue curve shows the righting lever with the derricks at 0° elevation and a weight of 2te in each net. The righting lever is positive and the area under the curve indicates that there is a reserve of stability.

- The red curve shows the righting lever with the derricks at 10° elevation, with 2te of weight in the port nets and 1te of weight in the starboard net (simulating 1te of its contents breaking free). In this case little righting moment remains, leading to the vessel readily capsizing. It is likely that *Sally Jane* was in a similar condition when lost.

- The orange curve shows the righting lever with shorter derricks (the derrick length used was 5.7m) at 0° elevation (providing 2m clearance between the vessel's side and the inner end of the beam trawl), with 2te of weight in the port net and 1te of weight in the starboard net. In this case, the area under the curve is larger than in the loss condition (red), therefore preventing immediate capsizing and allowing more time for corrective action, such as the release of the winch brakes, to be taken.
