## Simplified report on the investigation of the grounding of the pleasure vessel *ISAMAR* Grand écueil d'Olmeto, Corsica 17 August 2013

## Summary

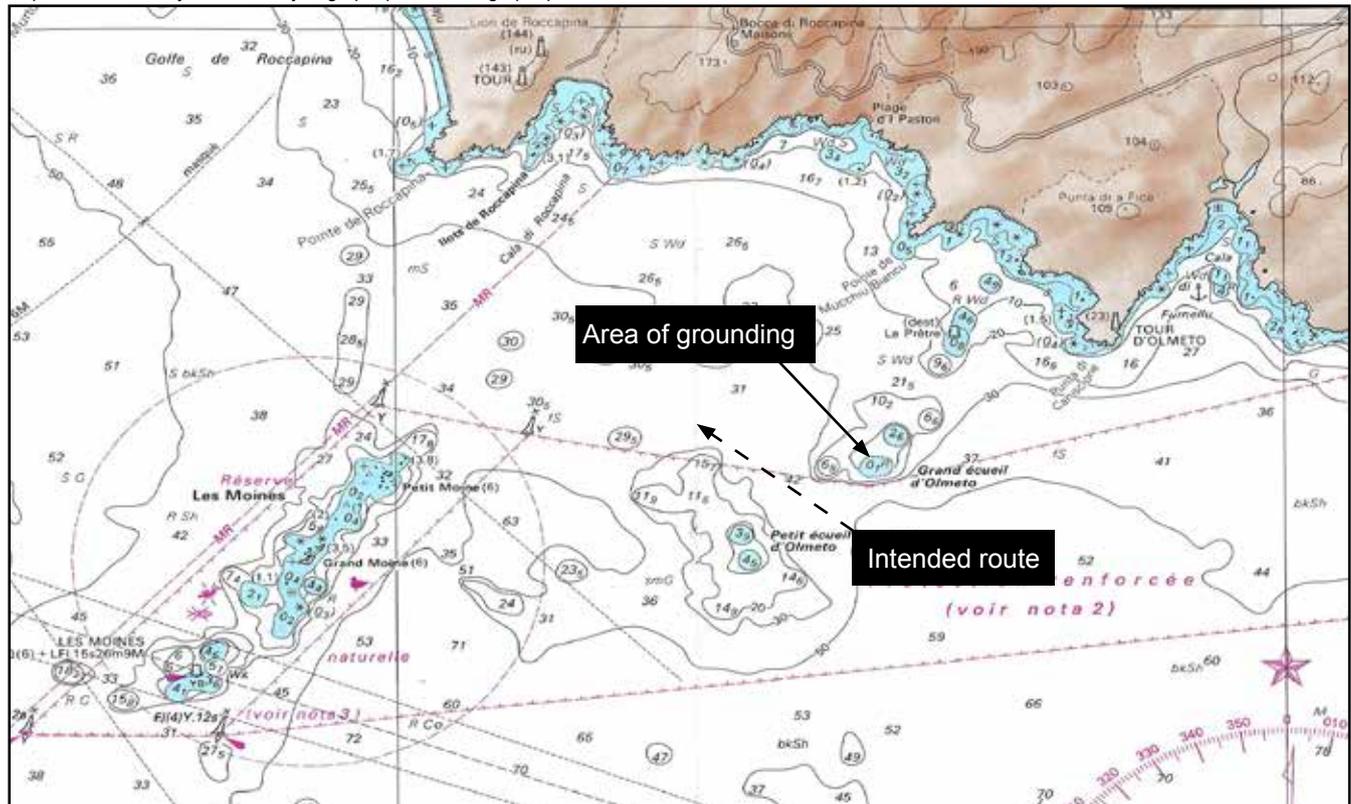
The master was on watch while the mate and stewardess attended to the passengers' needs. After clearing Cap de Feno, he set a north-westerly course at 10.5 knots to pass through the 0.5 mile wide gap between the shoals Grand écueil d'Olmeto and Petit écueil d'Olmeto (**Figure 2**). No waypoints or course lines were set on the ECS.

**Figure 2:** Intended route of *Isamar* on official chart, shoal not readily apparent on *Isamar's* chart plotter

While the master was below decks, the mate mustered the passengers and instructed them to don their lifejackets. He then checked the vessel's position on the ECS and noted that the display was on quite a large scale. By pushing the scale adjustment button four or five times, he reduced the scale to its minimum setting of 0.5 mile. At this scale, the ECS did show an area of shoal water not apparent on the larger scale. However, it did not display any depth soundings as shown on official hydrographic charts.

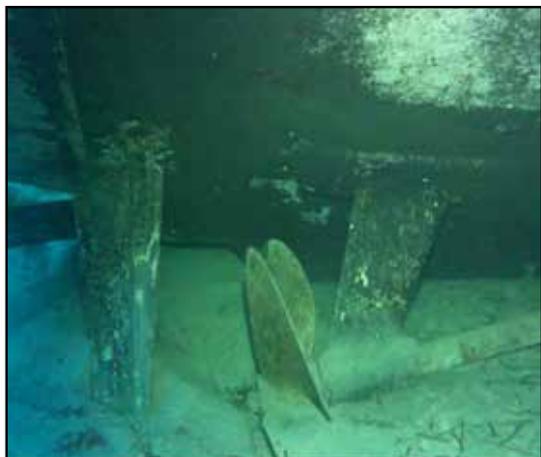
A subsequent dive inspection of the wreck showed that *Isamar*'s starboard propeller was intact (**Figure 3**) and that her port propeller and support bracket had been driven through the glass reinforced plastic hull (**Figure 4**) when the vessel struck the shallow reef.

**Figure 3:** *Isamar*'s starboard propeller and bracket (intact)

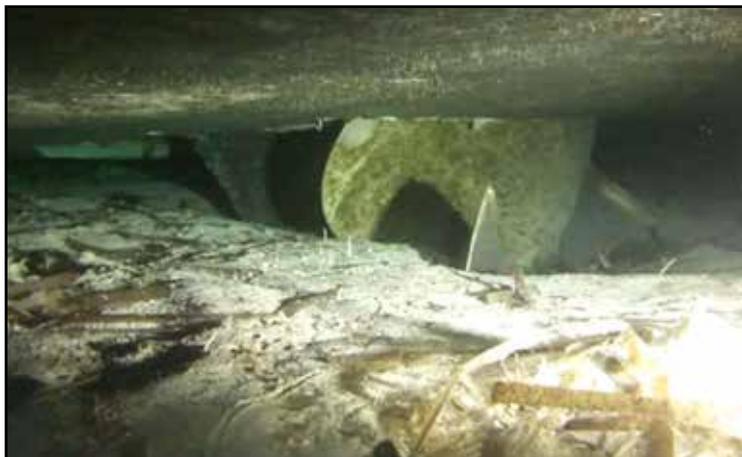
**Figure 4:** *Isamar*'s port propeller and bracket penetrating hull
