The sinking of the DUKW amphibious vehicle **WACKER QUACKER 1** in Salthouse Dock, Liverpool on 15 June 2013

The fire on board the DUKW amphibious vehicle **CLEOPATRA** on the River Thames, London on 29 September 2013

MAIB SAFETY BULLETIN 3/2013

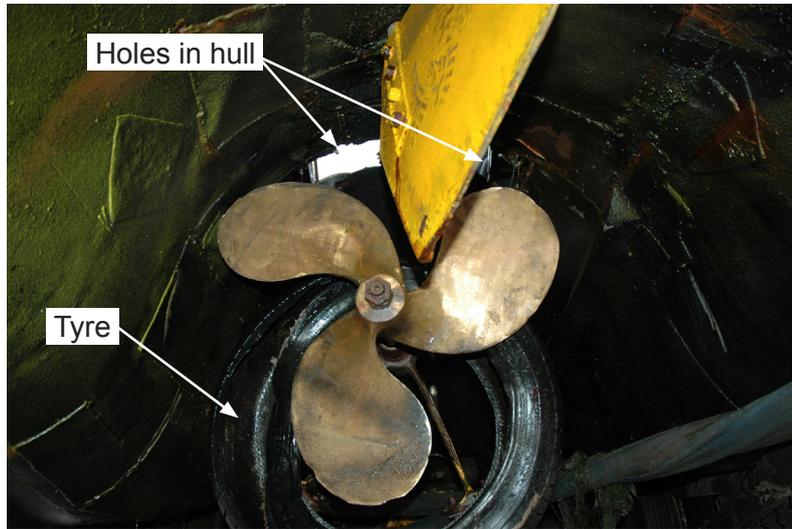
On 15 June 2013, *Wacker Quacker 1 (WQ1)* sank in Salthouse Dock, Liverpool, resulting in the DUKW's 31 passengers and two crewmen abandoning into the water; fortunately all were recovered without serious injury. After *WQ1* was recovered ashore, it was apparent that the vehicle had flooded because two large holes had been torn in the hull as a result of the forces generated when the vehicle's propeller became fouled by a tyre (**Figure 1**). As was the case with *WQ4*, *WQ1* sank because the volume of buoyancy foam fitted was insufficient to keep it afloat when flooded.

Figure 1: Holes torn into *WQ1*'s hull after the propeller was fouled by a tyre

2013/221 Require operators of DUKW passenger vessels in the UK to demonstrate that they are able to provide 110% effective residual intact buoyancy in their vessels, and where buoyancy foam is fitted for this purpose, the quantity installed is measured by volume and the foam does not impede the operation or maintenance of key equipment.
