Report on the investigation of
the fatality of an able seaman
on board ro-ro cargo ship

Tyrusland

in Tripoli, Libya

on 15 May 2013

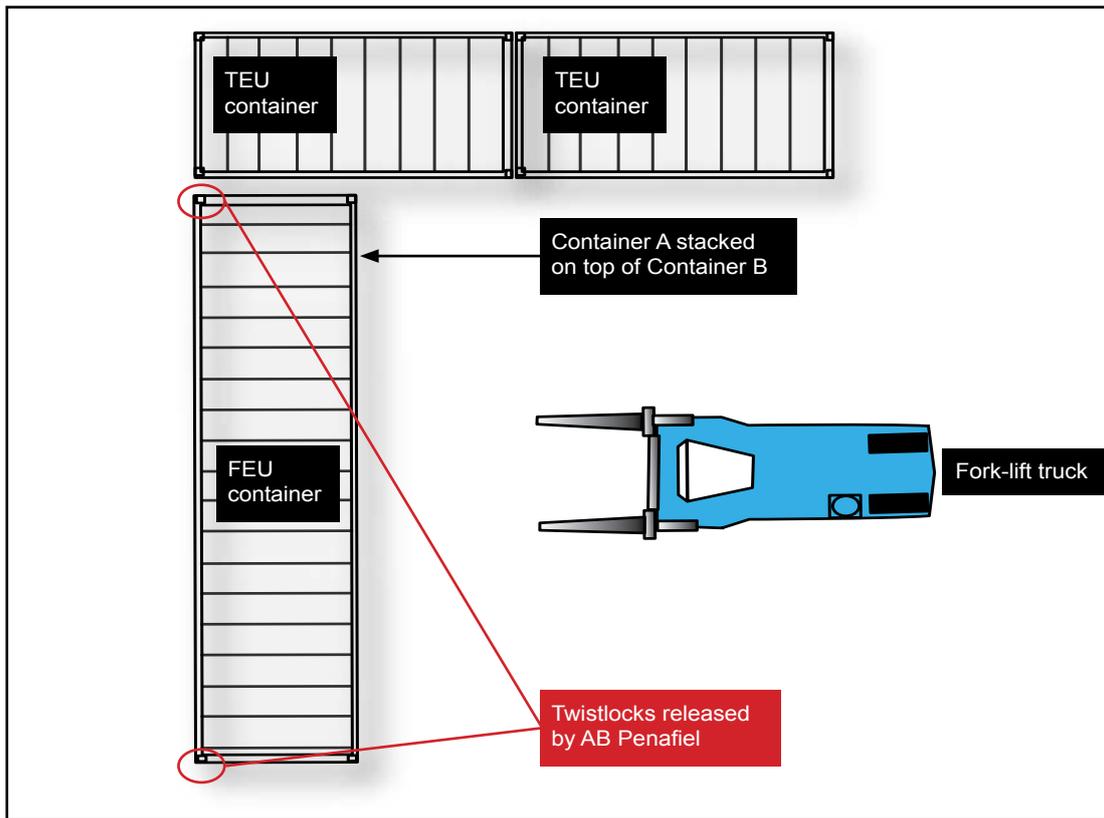
Figure 1a: Accident sequence – AB Penafiel released twistlocks securing containers A and B together

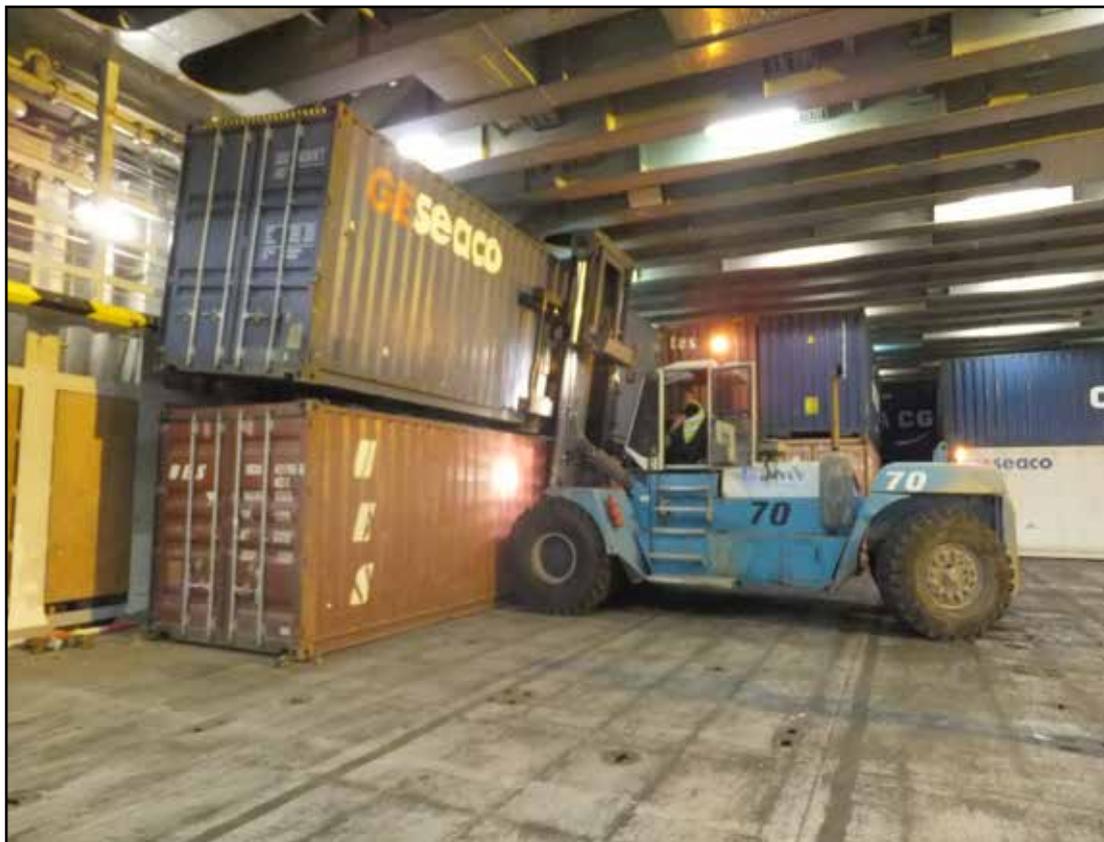
Figure 1b: Reconstruction photograph – fork-lift truck starting to lift container A from Container B

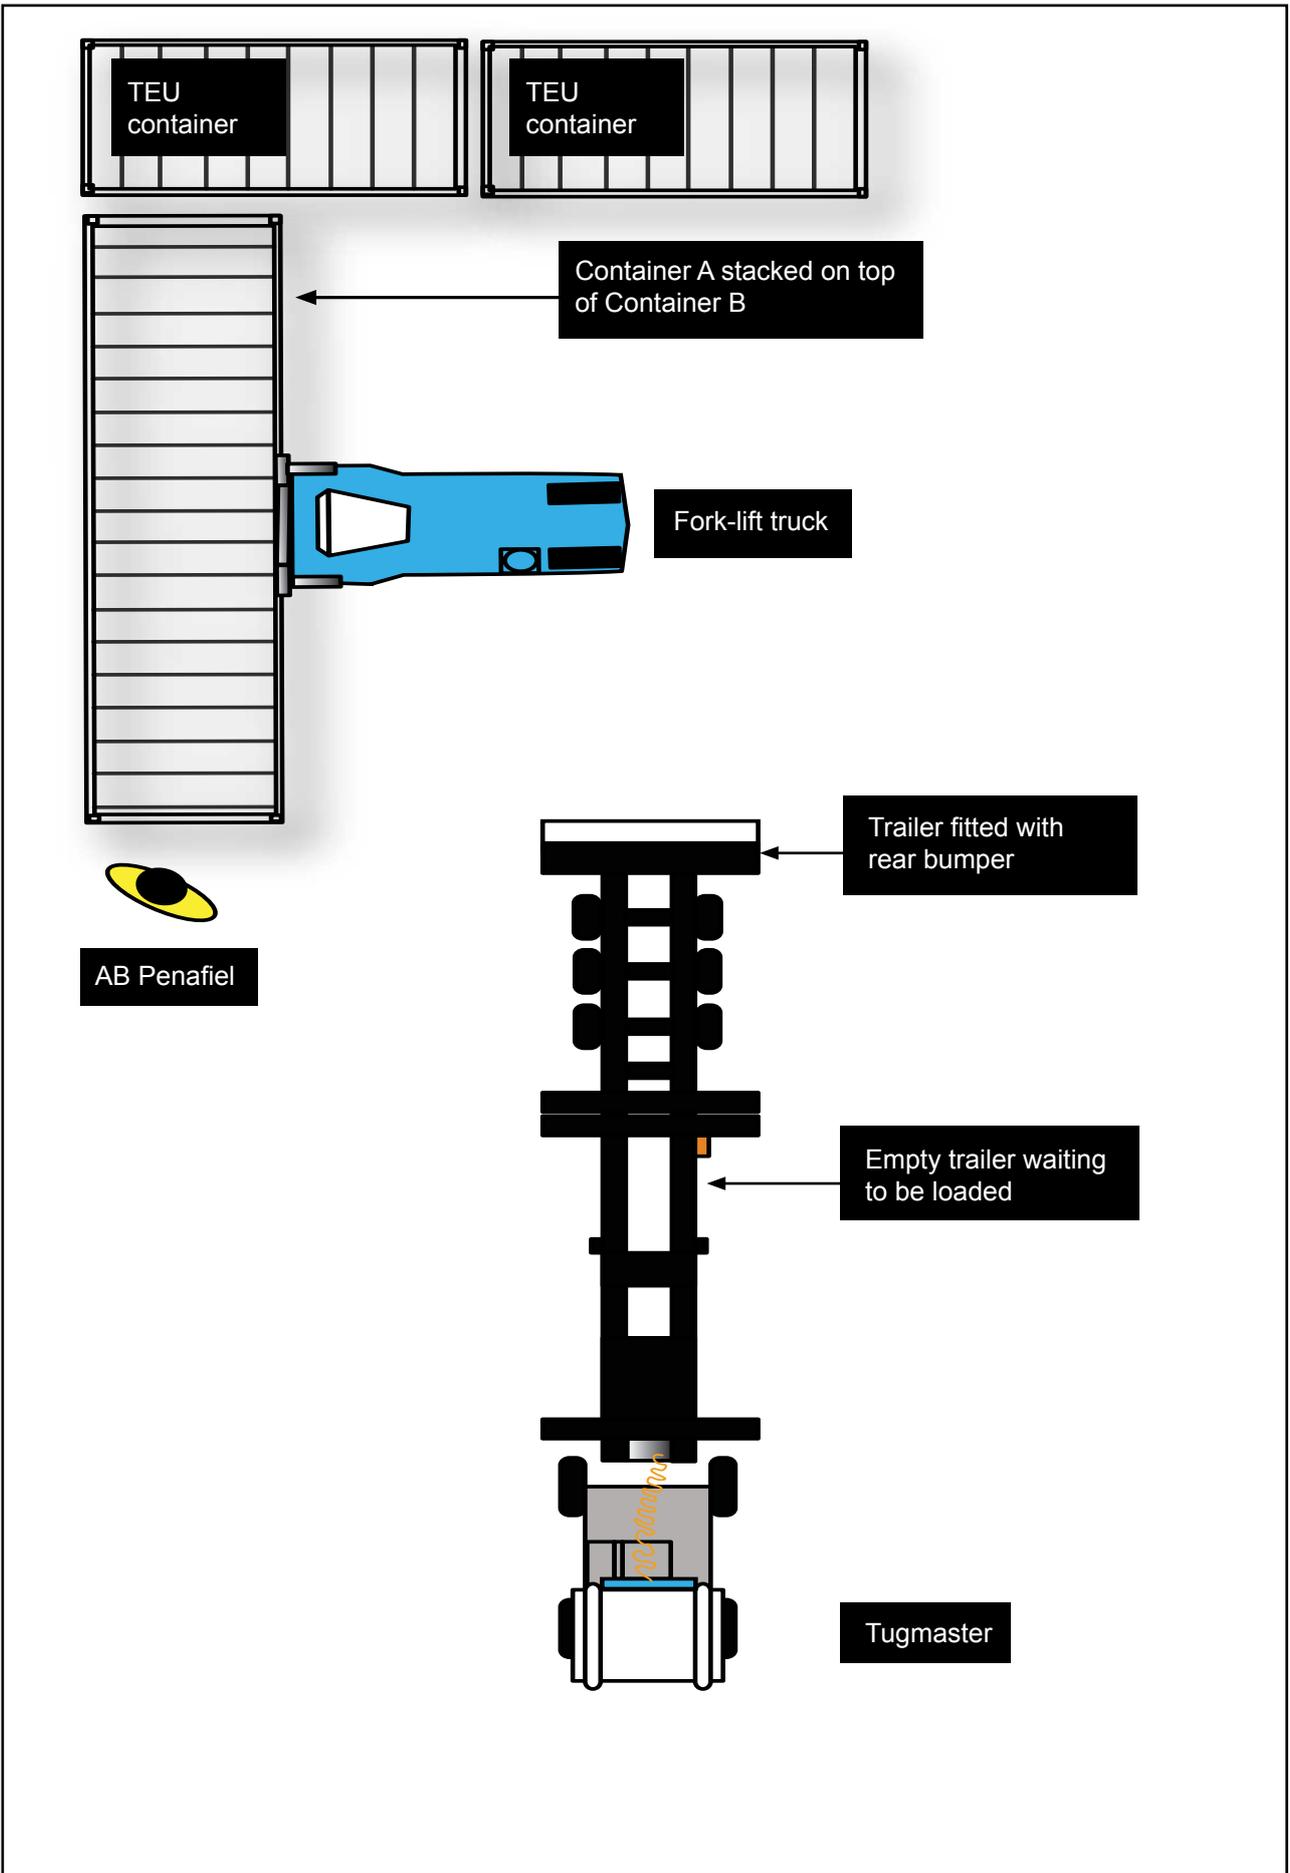
Figure 1c: Tugmaster and trailer in position for loading

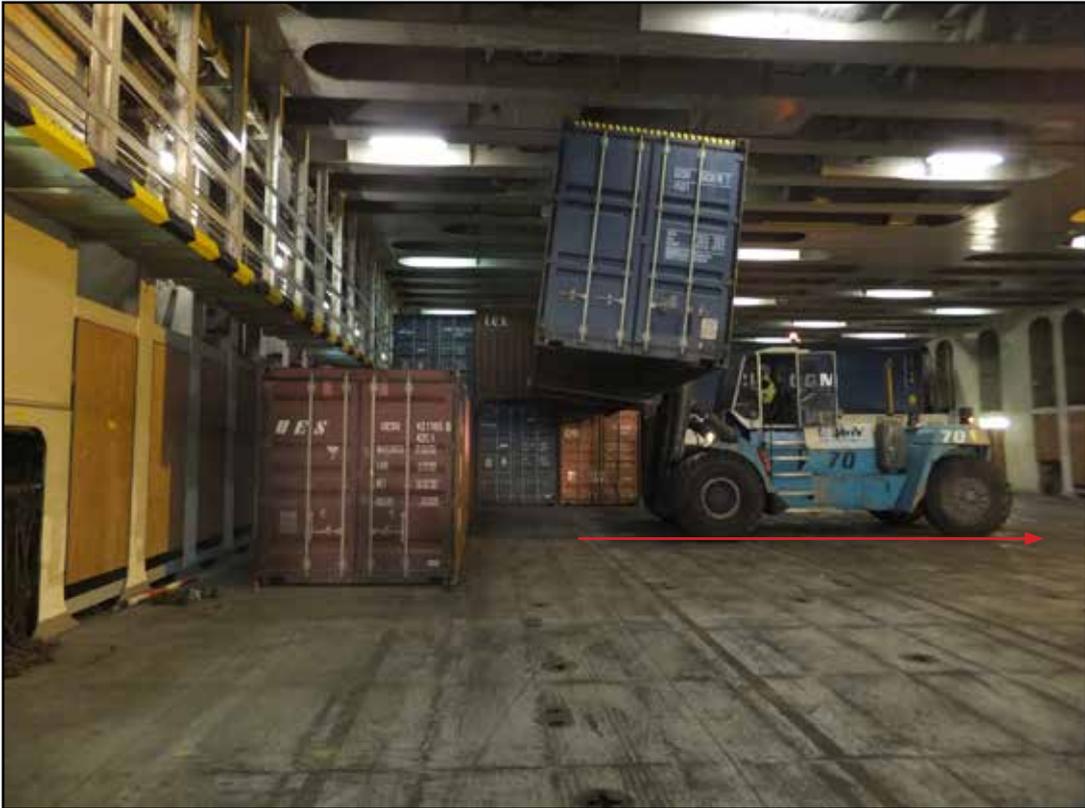
Figure 1d: Reconstruction – fork-lift truck reversing to move container A clear of container B

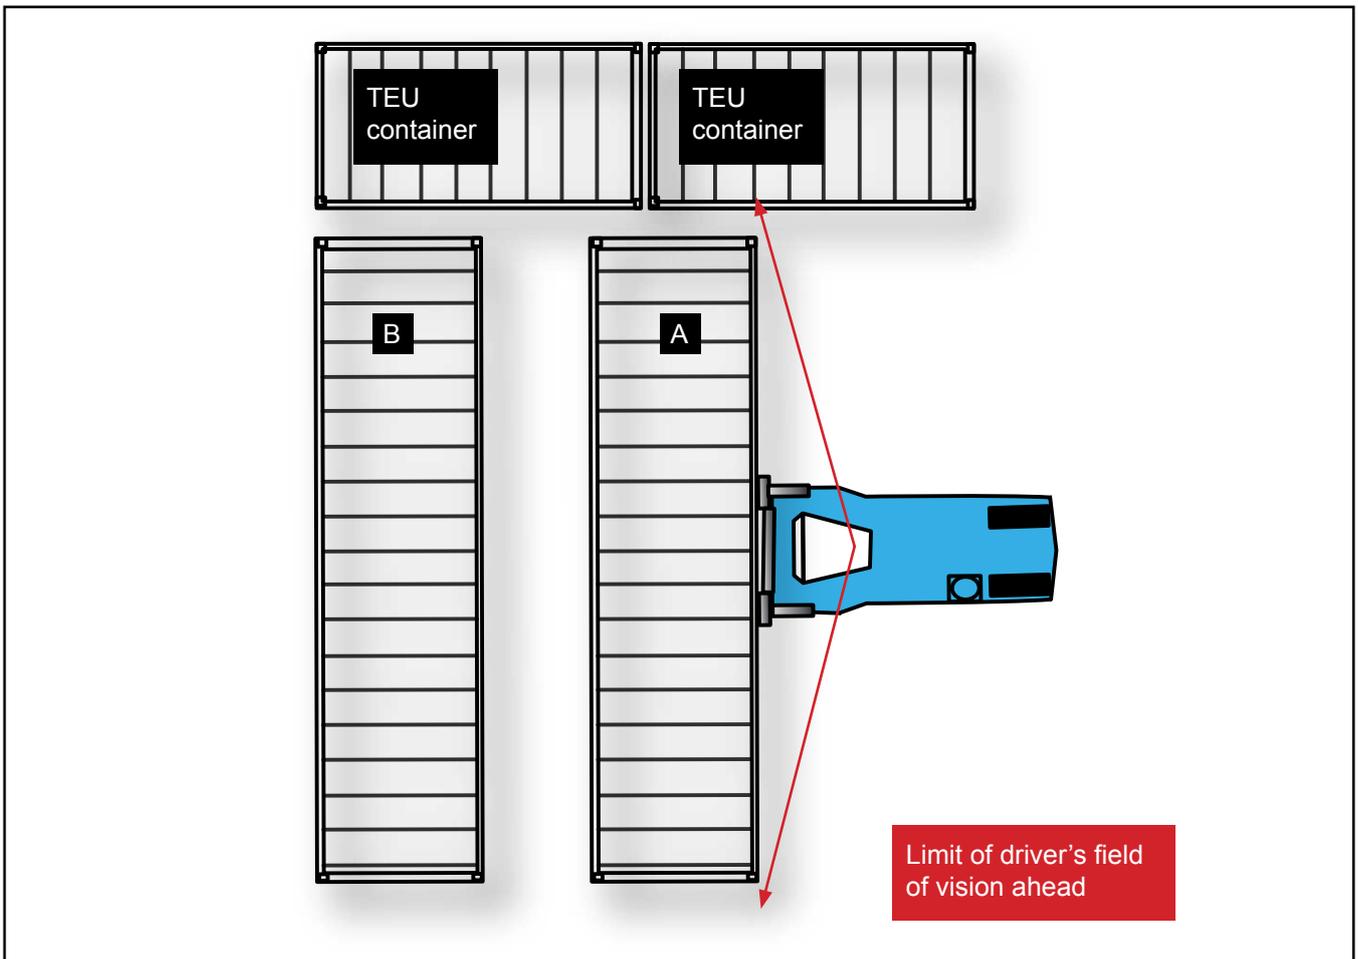
Figure 1e: Driver visibility with container lowered

After lowering container A, the fork-lift truck driver was unable to see AB Penafiel (**Figure 1e**) and had not given any signal, so he had not anticipated that AB Penafiel would move between the containers to remove the twistlocks. The absence of an appropriate safe system of work, including signals, led to an ambiguous situation where the fork-lift truck driver's expectation was different to that of his fellow worker in a very hazardous environment.

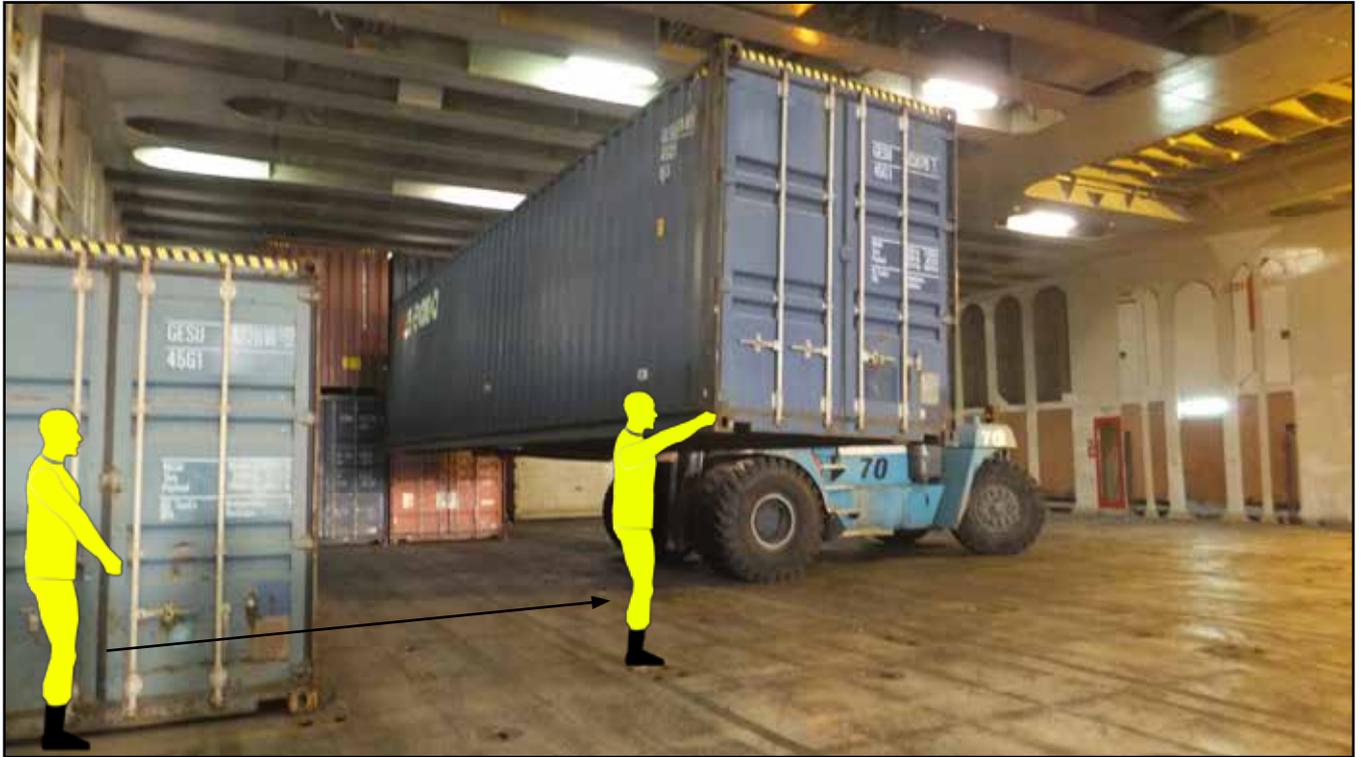
AB Penafiel then moved forward and removed a twistlock from the port side aft underside corner of container A (**Figures 1f and 1g**). He then turned round and bent down to remove twistlocks from the deck immediately in front of him (**Figure 1h**).

Figure 1f: AB Penafiel moves forward to remove twistlock

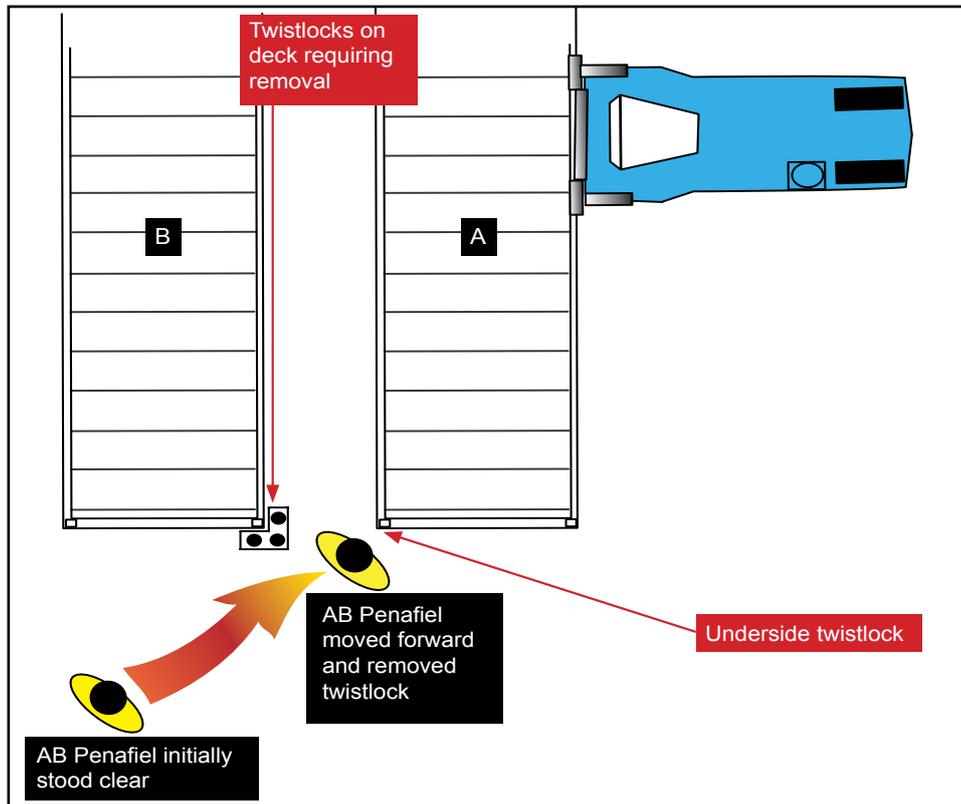
Figure 1g: AB Penafiel moves forward to remove twistlock

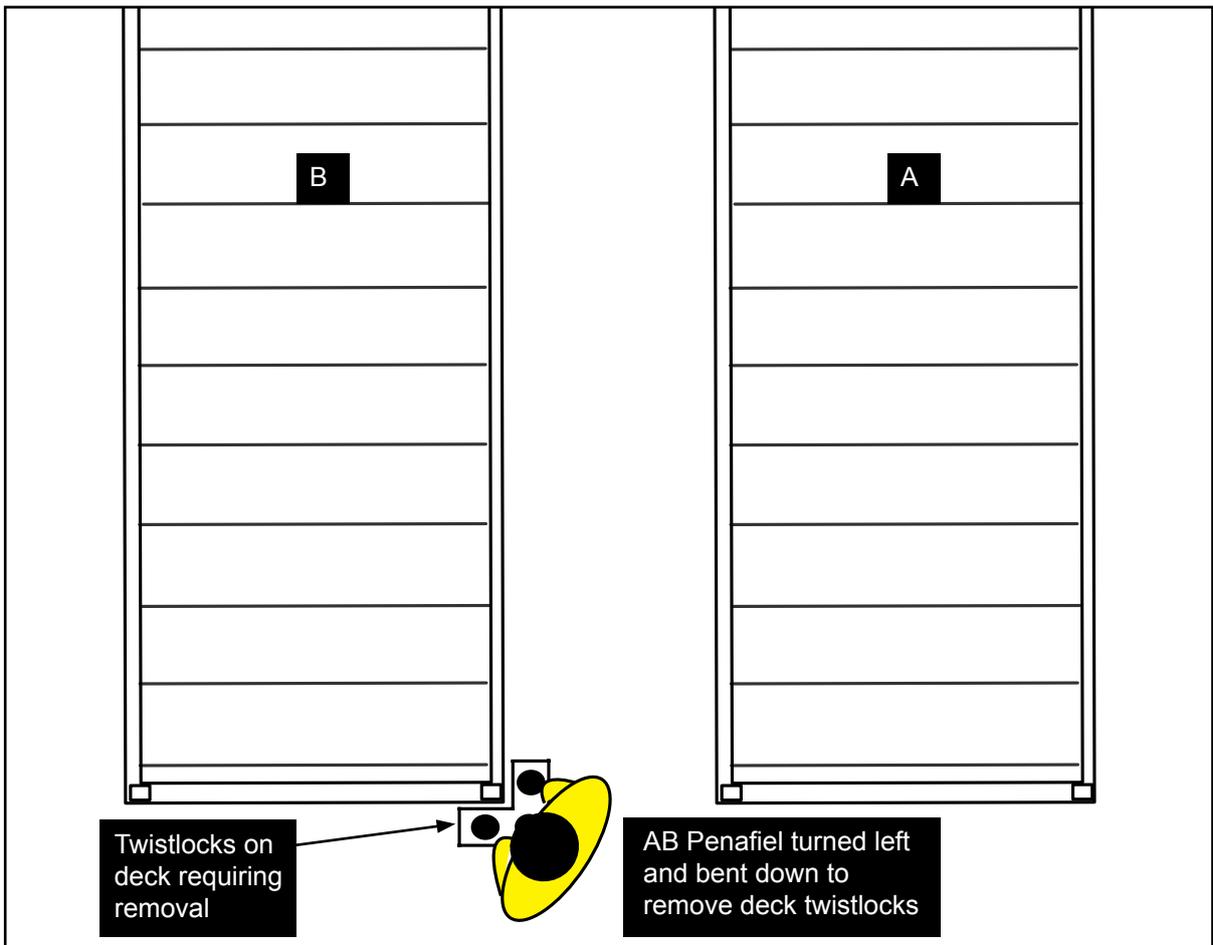
Figure 1h: AB Penafiel turned and bent down

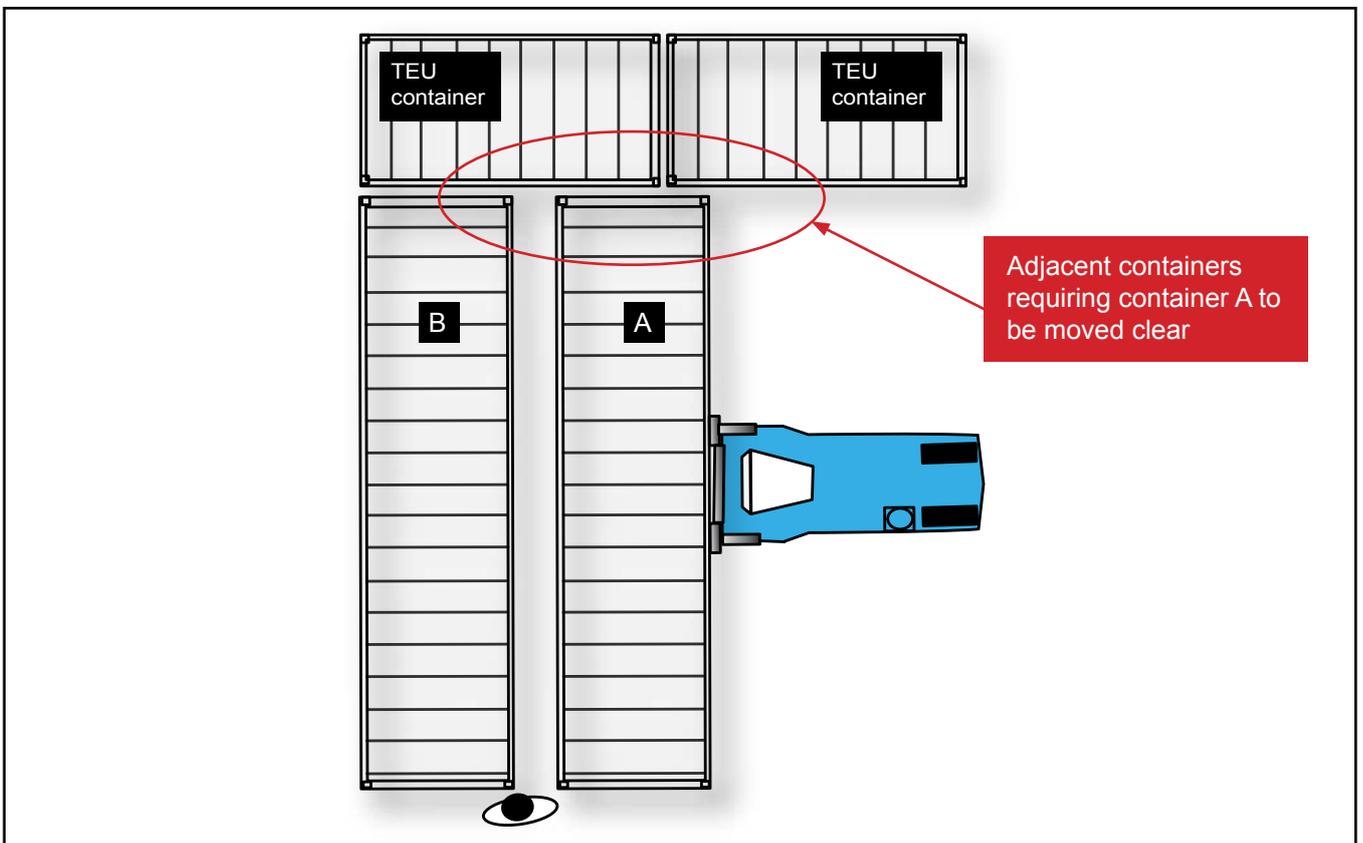
Figure 1i: Adjacent container snagging hazard

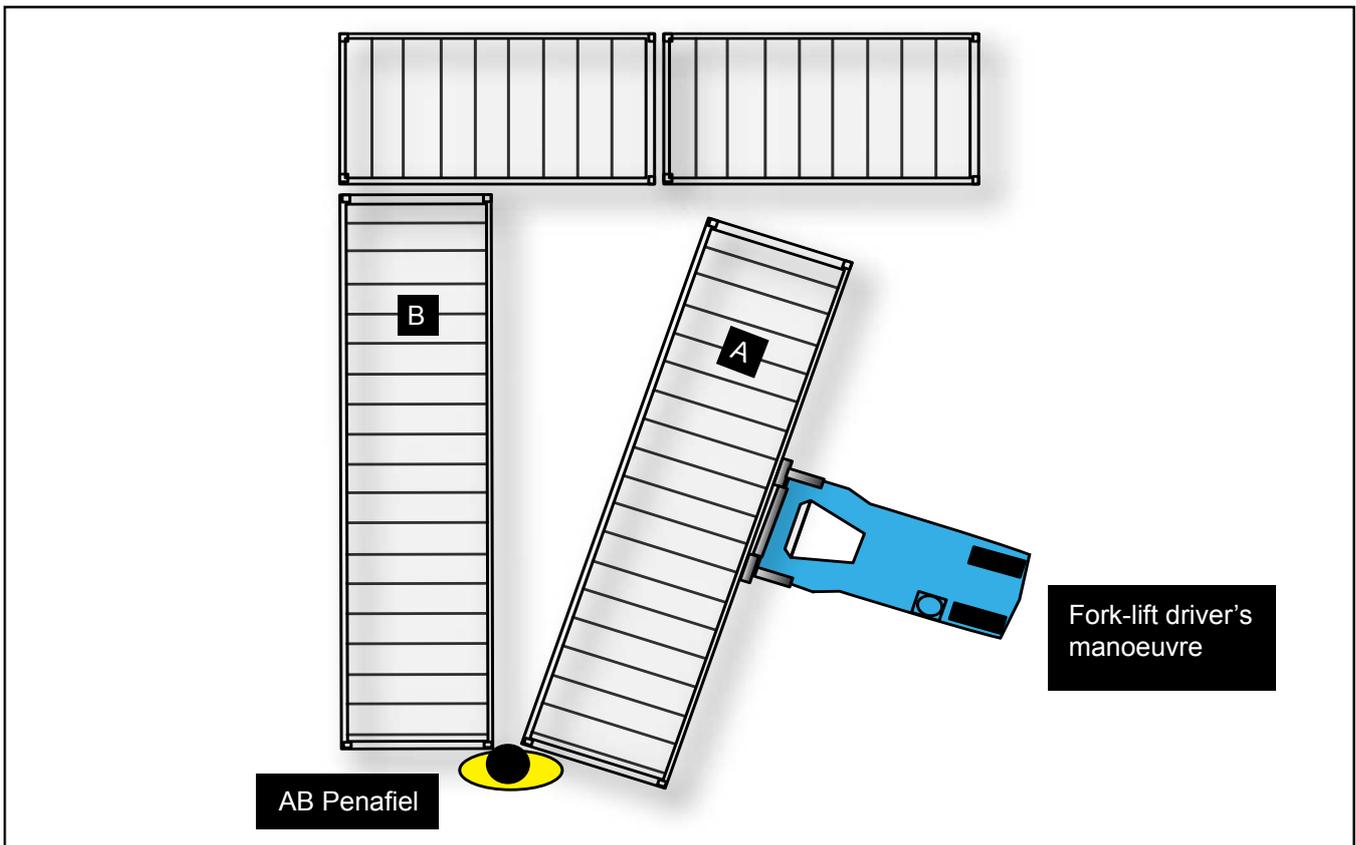
Meanwhile, the fork-lift truck driver continued to manoeuvre his vehicle in preparation for loading container A onto the waiting trailer. This manoeuvre involved a turn which was necessary for the forward end of container A to clear an adjacent stack of twenty foot equivalent unit (TEU) containers (**Figure 1i**) and to realign it for loading onto the waiting trailer. This manoeuvre caused the port side aft corner of container A to collide with container B, fatally injuring AB Penafiel, who was positioned between them (**Figure 1j**).

Figure 1j: Fatal manoeuvre

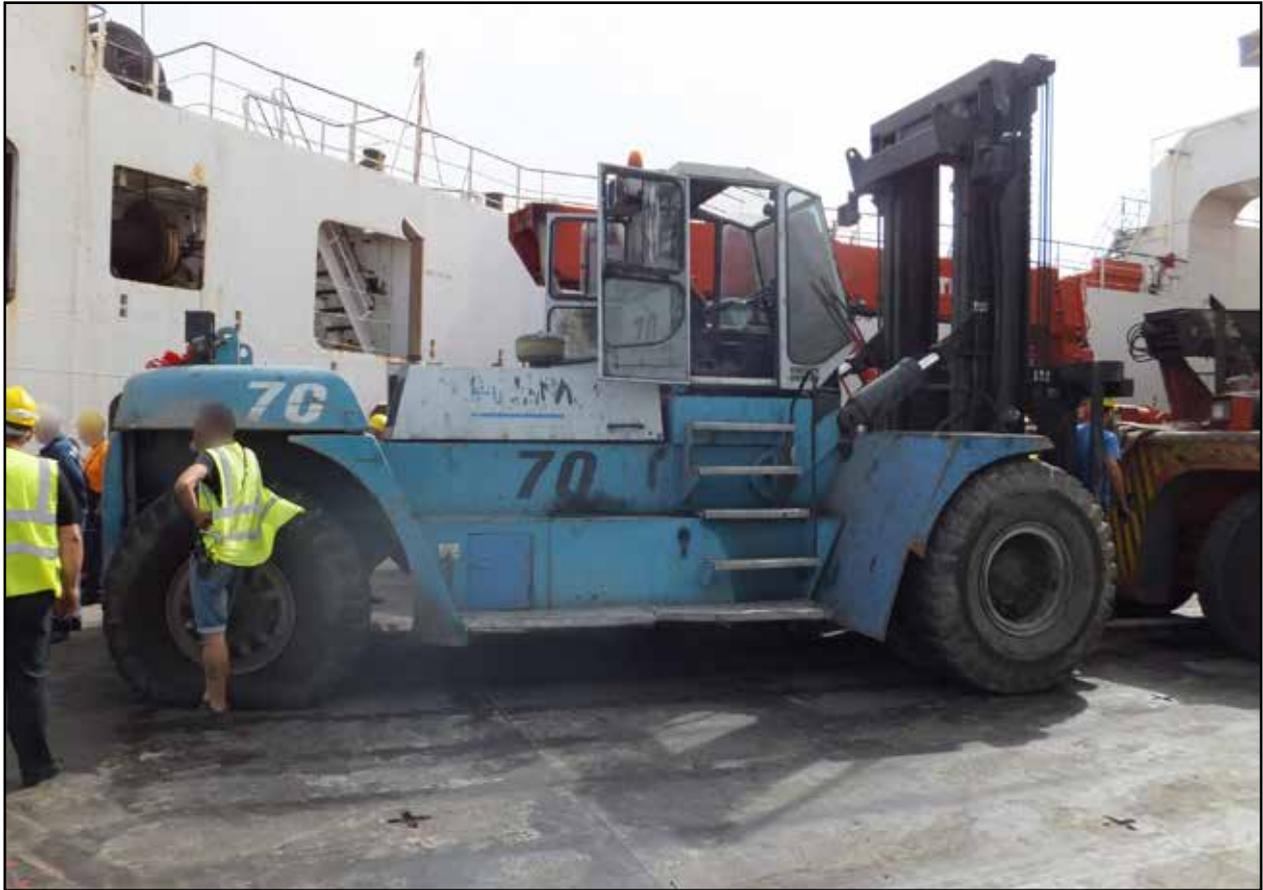
Figure 2: FL70 fork-lift truck

The vehicle being used to handle container A was an FL70 35 ton (38.58 tonne) lift capacity, rear wheel steered, fork-lift truck (**Figure 2**). This vehicle had been supplied by Malta Freeport Terminals. It was primarily used to handle containers between decks where the limited headroom precluded use of the reach-stacker or top-lifter.

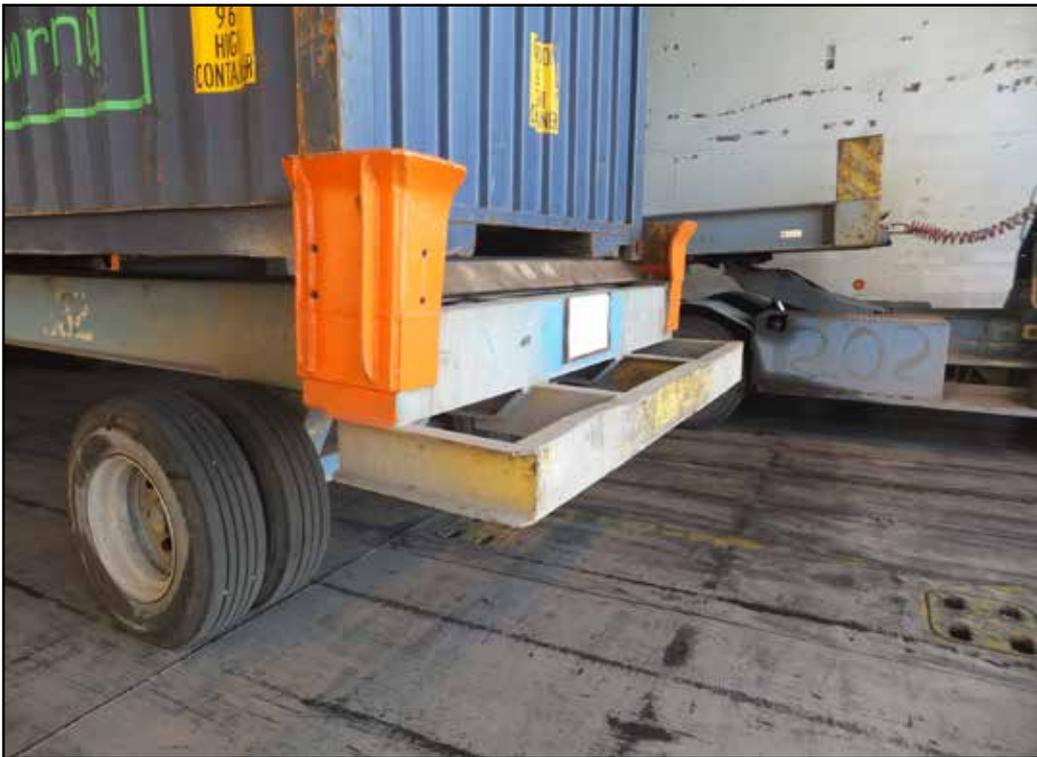
Figure 3: Trailer closed-corner and rear bumper fittings

4. The use of closed-corner trailers necessitated crew members working in close proximity to suspended containers. [2.5.3]
5. The locally arranged signalling procedure was not effectively briefed and enforced, and was potentially unsafe in that it did not require the fork-lift truck driver to stop his vehicle when the twistlock operator was no longer in his field of vision. This lack of a safe system of work led to an ambiguous situation where two operators on the same task had different expectations of each other's actions. [2.5.1, 2.5.4, 2.5.5]

- Replacement of the closed-corner style trailers by open-cornered versions in January 2014.
- Prohibition of the use of fork-lift trucks for FEU container handling.
- Supply of 600 semi-automatic twistlocks.

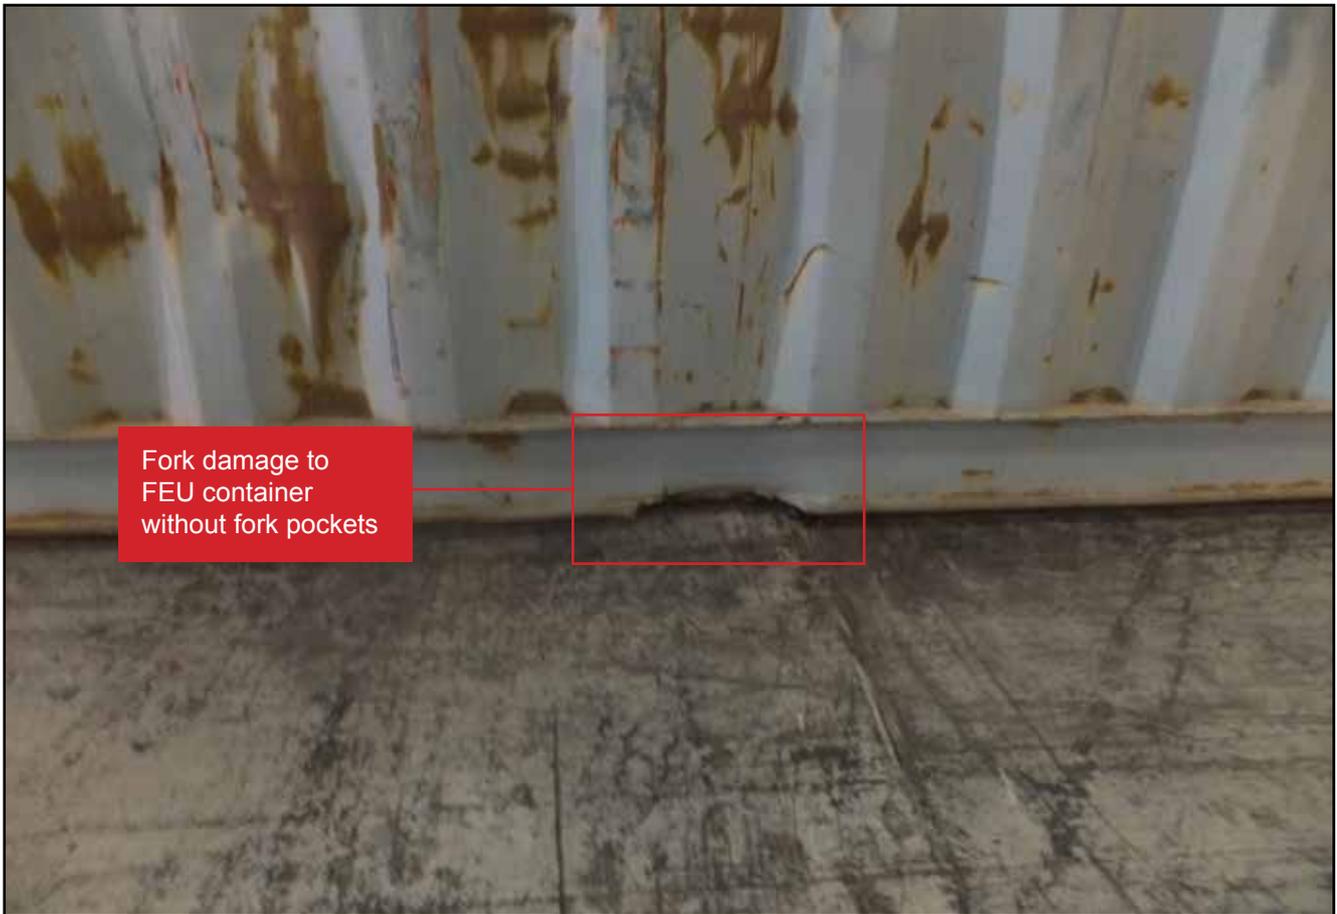
Figure 6: FEU container without fork pockets showing fork damage

The ILO's code of practice 'Safety and health in ports' advises against the use of a fork-lift truck for handling containers not fitted with pockets to accommodate the vehicle's forks. The absence of fork pockets runs the risk of a fork-lift truck damaging the lower edges of a container, and any shift or uneven distribution of the container's internal load could cause the container to fall.

1. The use of a fork-lift truck for handling containers not fitted with fork pockets runs the risk of damage to the lower edges of a container, and any shift or uneven distribution of the container's internal load could cause the container to fall. [2.5.7]

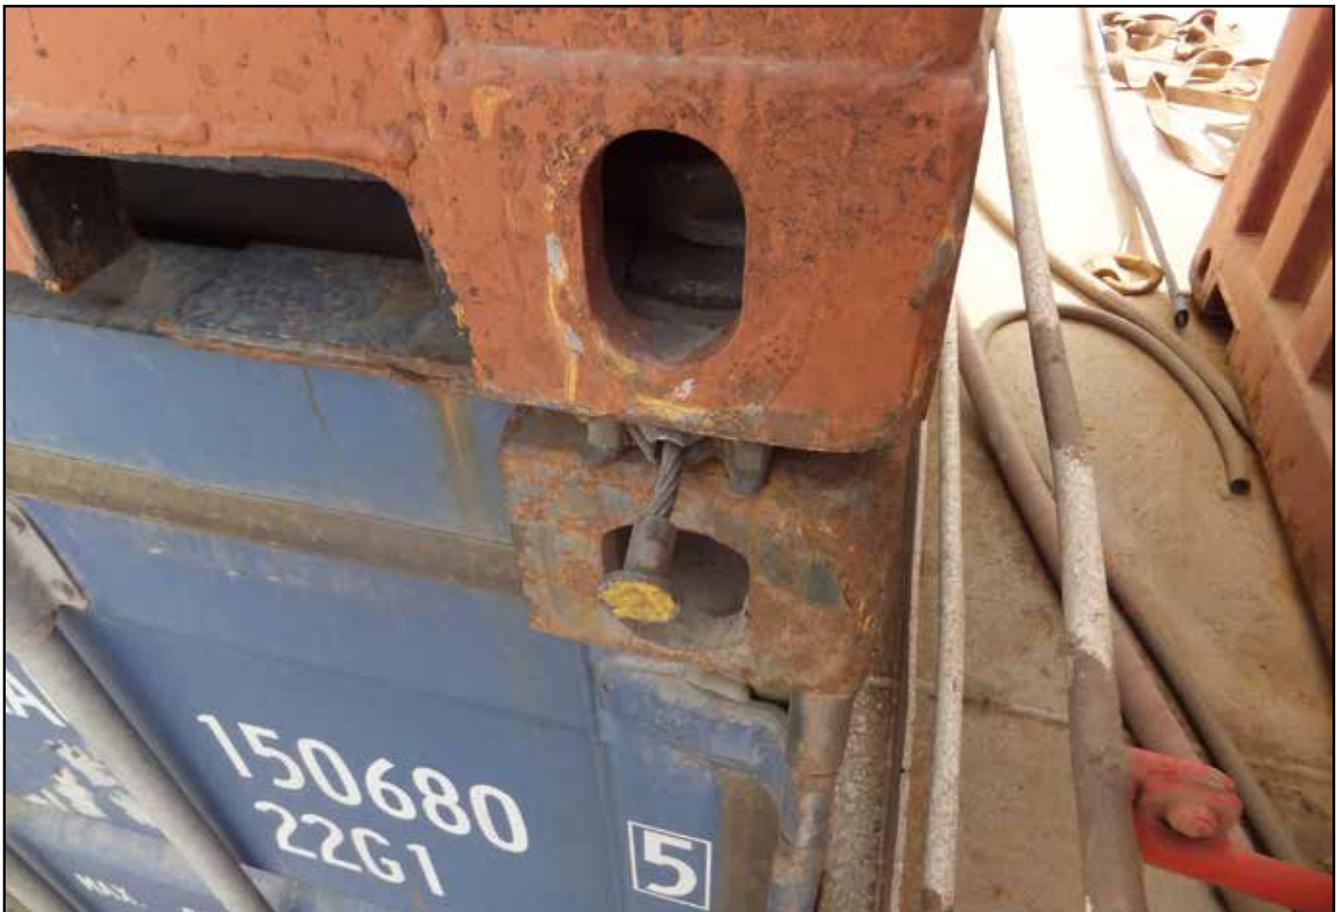
Containers A and B were secured together (on the outboard side only) using semi-automatic twistlocks (**Figure 7**). This style of twistlock was spring-loaded, locking itself automatically when a container was lowered onto it. It was unlocked manually by pulling a release wire.

Figure 7: Semi-automatic twistlock securing two containers together

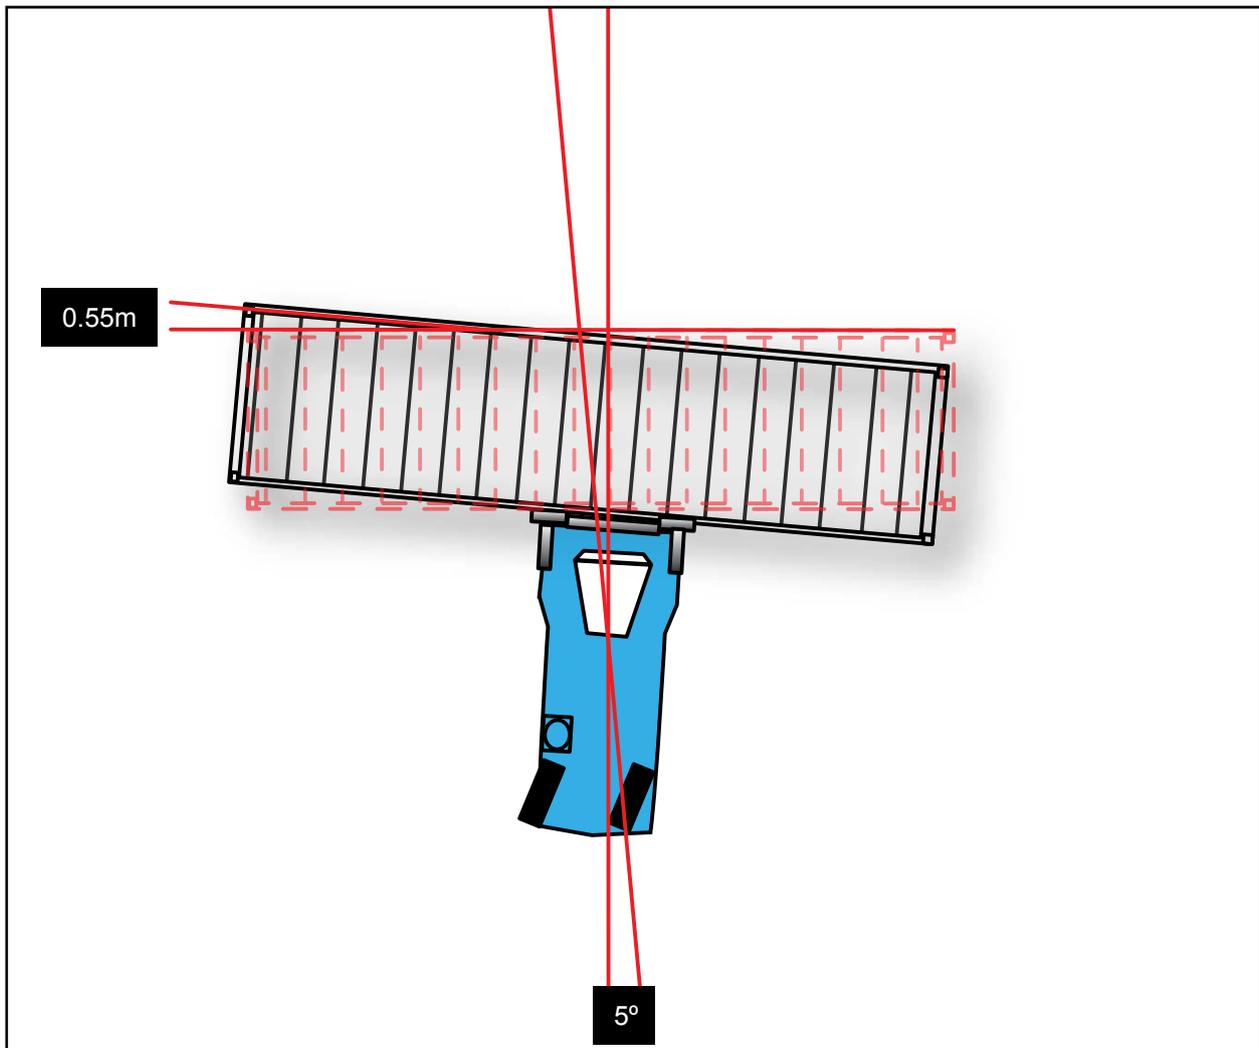
Figure 8: Diagram showing fork-lift truck turning effect

It only required a small change of heading by the fork-lift truck to create a relatively large movement of the container ends. For example, a 5° heading alteration by the fork-lift truck would have generated a container end movement of 0.55m (**Figure 8**).
