## **MAIB SAFETY BULLETIN 1/2013**

Ejection of family of six from an 8.0m RHIB in the Camel Estuary leading to two fatalities and serious injuries to two people

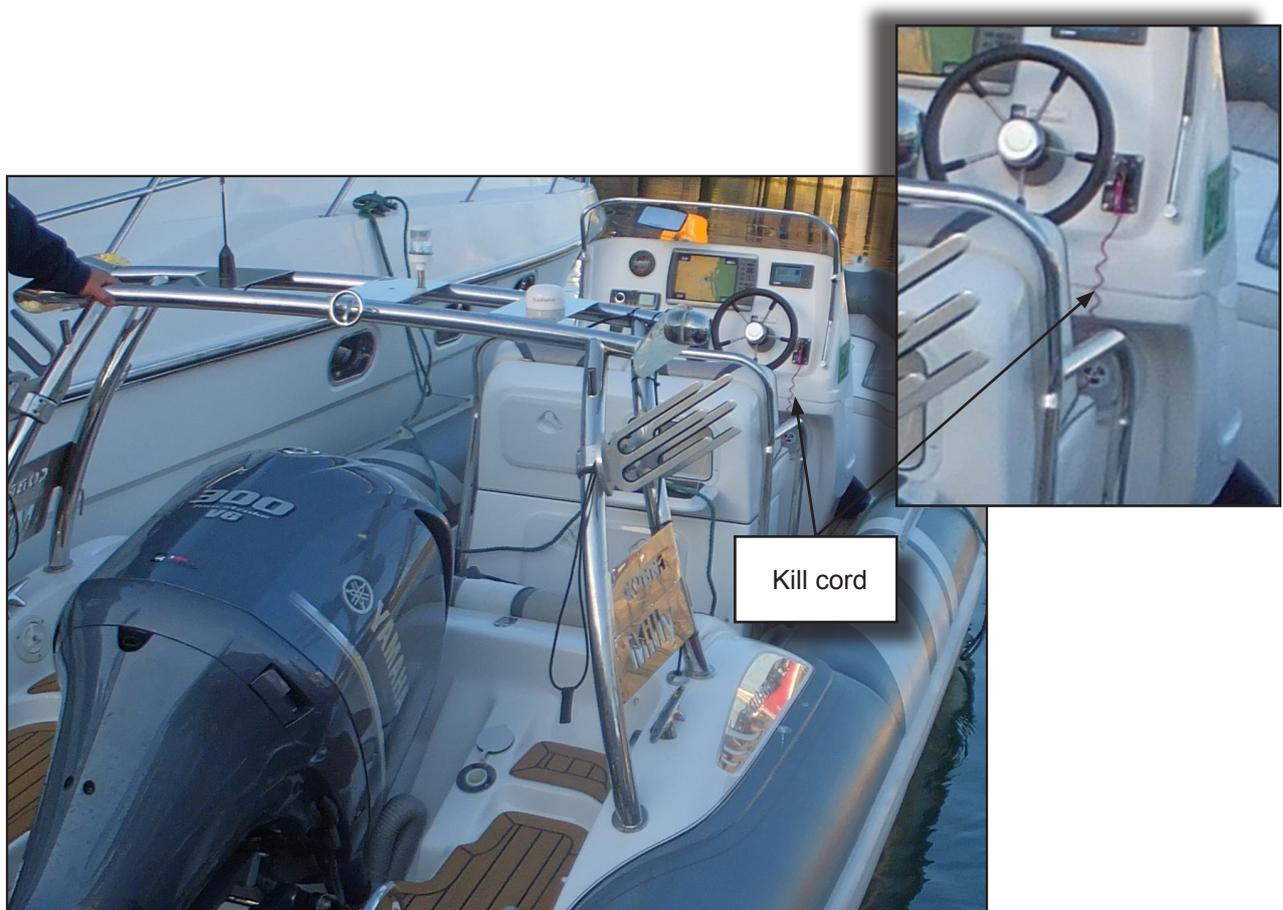
The RHIB was fitted with a kill cord (**Figure 1**), but this was not attached to the driver at the time of the accident. Consequently, when the driver was ejected from the boat, the kill cord did not operate to stop the engine and the RHIB continued to circle out of control, and at speed. As the RHIB circled, it ran over the family in the water a number of times, leading to the deaths and injuries. A few minutes later a local boatman was able to board the RHIB and bring it under control before further people were hurt.

**Figure 1:** Boat with kill cord in place

- Test them regularly to ensure that the engine stops when the kill cord mechanism is operated.
- Make sure that the cord is in good condition.
- Always attach the cord securely to the driver, ideally before the engine is started, but certainly before the boat is put in gear.
- Stop the engine before transferring the kill cord to another driver.
