## **MV FINNARROW**

### **Contact with berth and subsequent flooding**

#### **Holyhead, UK**

#### **16 February 2013**

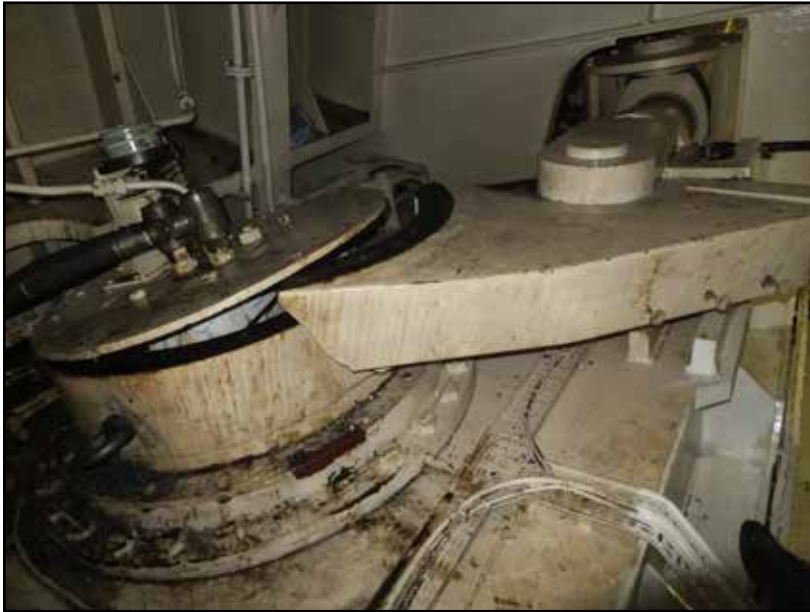
After hearing a loud noise, the second engineer on watch made his way to the separator room where he found the port fin stabiliser head severely damaged (**Figure 3**). The second engineer then returned to the engine control room (ECR), where he reported the damage to the day chief engineer. At 0606, the bilge alarm for the pump room sounded. By the time the second engineer had made his way to the pump room, the water level had risen to just below the floor plates, and he was unable to locate the source of the leak.

**Figure 3:** Port fin stabiliser head damage in separator room

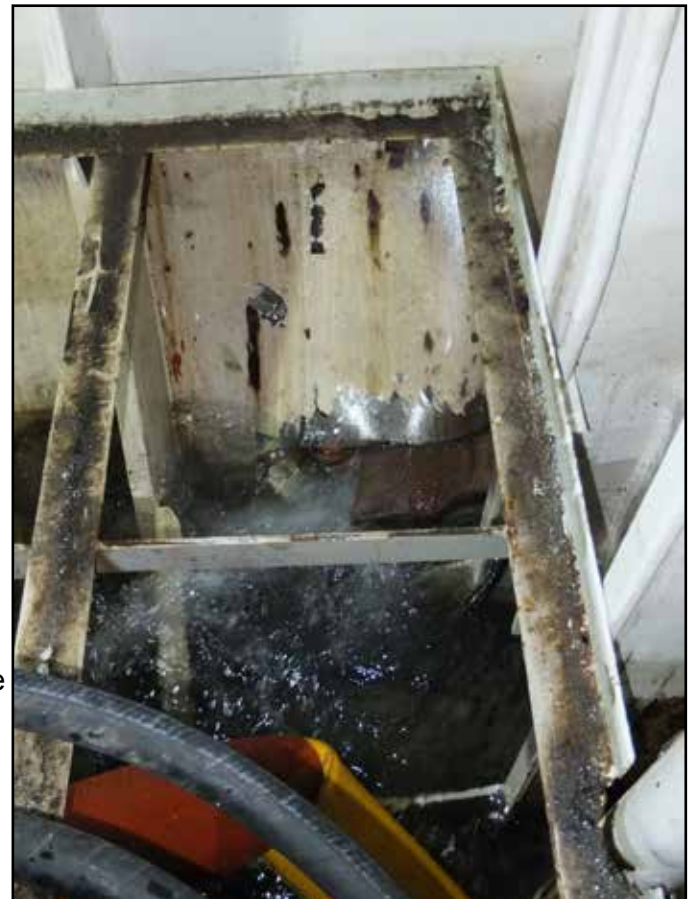
*Finnarrow's* bilge pumping system was unable to stem the rate of flooding, with Fire & Bilge pump No. 1 having failed as the water level rose in the pump room. By 0800, it was estimated that the pump room water level had equalised with the sea level outside. To increase the fire service's pumping capacity, it was requested that a high-volume pump (HVP) be delivered to the vessel. By 0830, some leakage of water from the pump room was detected entering the main engine room via pipe and cable glands, but this was reduced using rags to plug any visible gaps.

**Figure 4:** Hull shell penetration in pump room

At 1300, divers arrived and during the afternoon they managed to plug the leak into the pump room using rags. The water level in the pump room was then steadily reduced to below the floor plates, at which point the damaged area became visible (**Figure 4**). It took until the evening of 17 February to construct an effective cement box around the damaged area. This allowed the vessel to sail for repairs at Greenock.

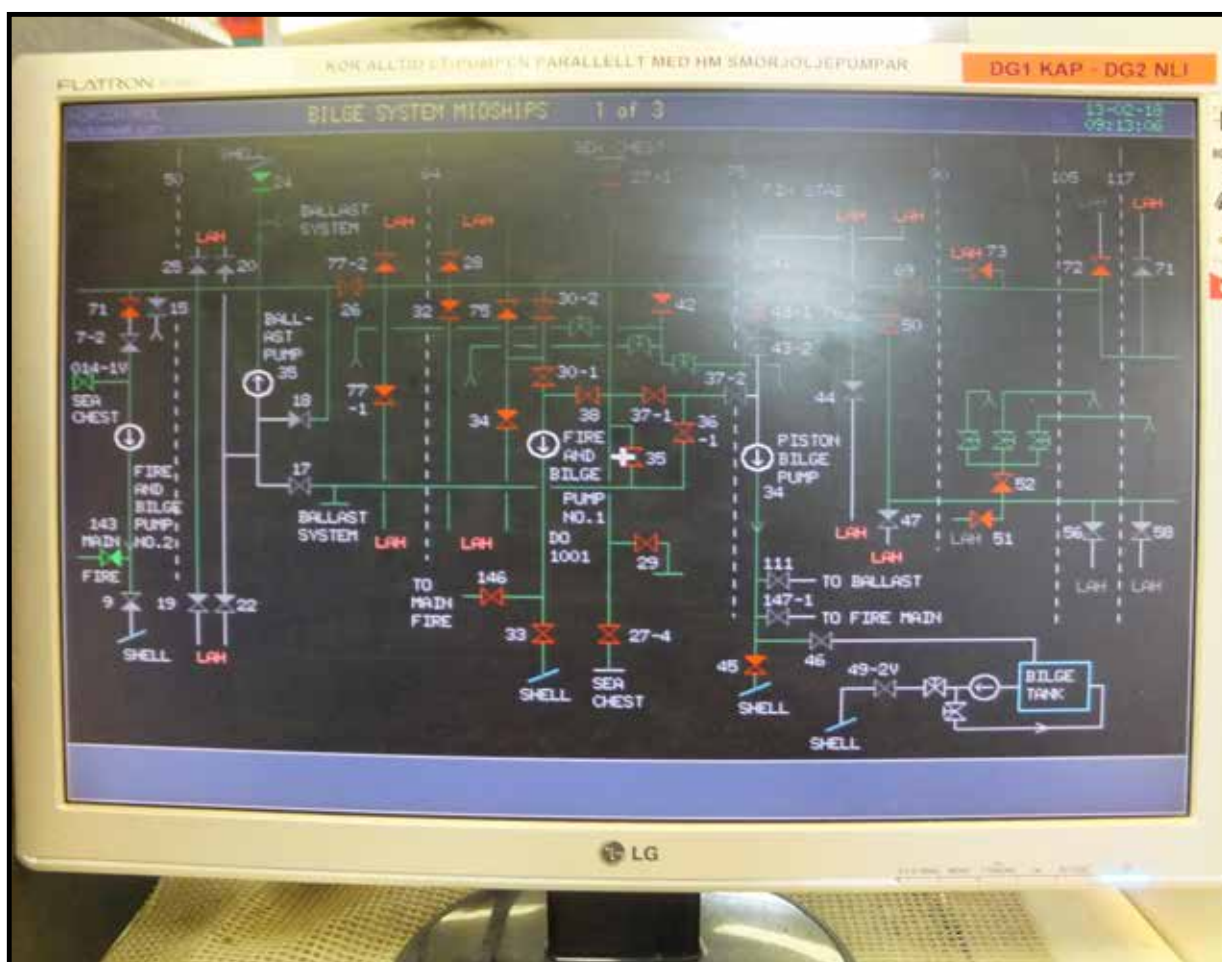
The vessel was fitted with a Norcontrol system, which allowed the bilge and ballast system to be operated from the ECR (**Figure 6**). Most of the system's valves and pumps could be controlled remotely using this system. The piston bilge pump, which had a nominal 130m<sup>3</sup>/hr capacity, was situated in the separator room. It was normally used to pump bilge water into a bilge tank from where it could be pumped either ashore or overboard via oily water separators. The overboard discharge from the piston bilge pump in the separator room had been blanked off to prevent the inadvertent discharge of oily water overboard.

**Figure 6:** Bilge and ballast system Norcontrol screen

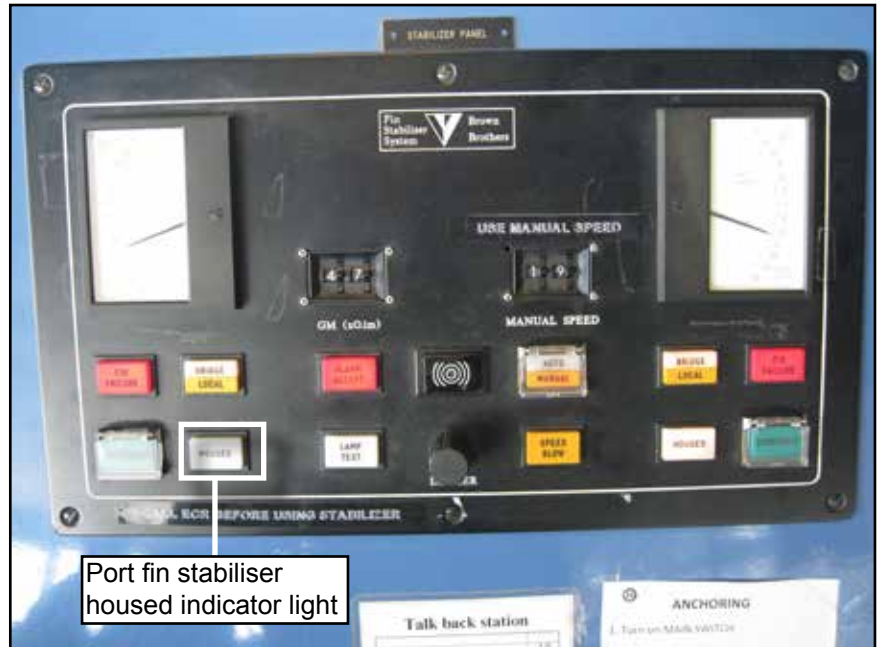
**Figure 7:** Fin stabiliser panel on the bridge centre console

Thirdly, the only visual indication that the port fin stabiliser was deployed was a small indicator light on the fin stabiliser panel situated on the centre console (**Figure 7**) and another small indicator light on the damage control console. As soon as the day master and chief officer had moved away from the centre console, these warning lights ceased to be effective. No thought had been given to providing a more obvious reminder that fin stabilisers were deployed.

- 2013/242** As part of the process of developing robust arrival procedures, ensure the status of the fin stabilisers has sufficient procedural and visual checks to prevent them being left deployed when the vessel enters port.
- 2013/243** Review and amend emergency response procedures to ensure ship's staff are adequately supported during emergencies, and to require regular flooding drills to be conducted on board to enhance crew familiarisation.
- 2013/244** Ensure robust project management procedures are used when changing flag and/or routes to capture the need for providing crews with:
- Adequate vessel familiarisation.
  - Sufficient rest periods in accordance with the requirements of the International Convention on Standards of Training, Certification and Watchkeeping for Seafarers 1978 (STCW).

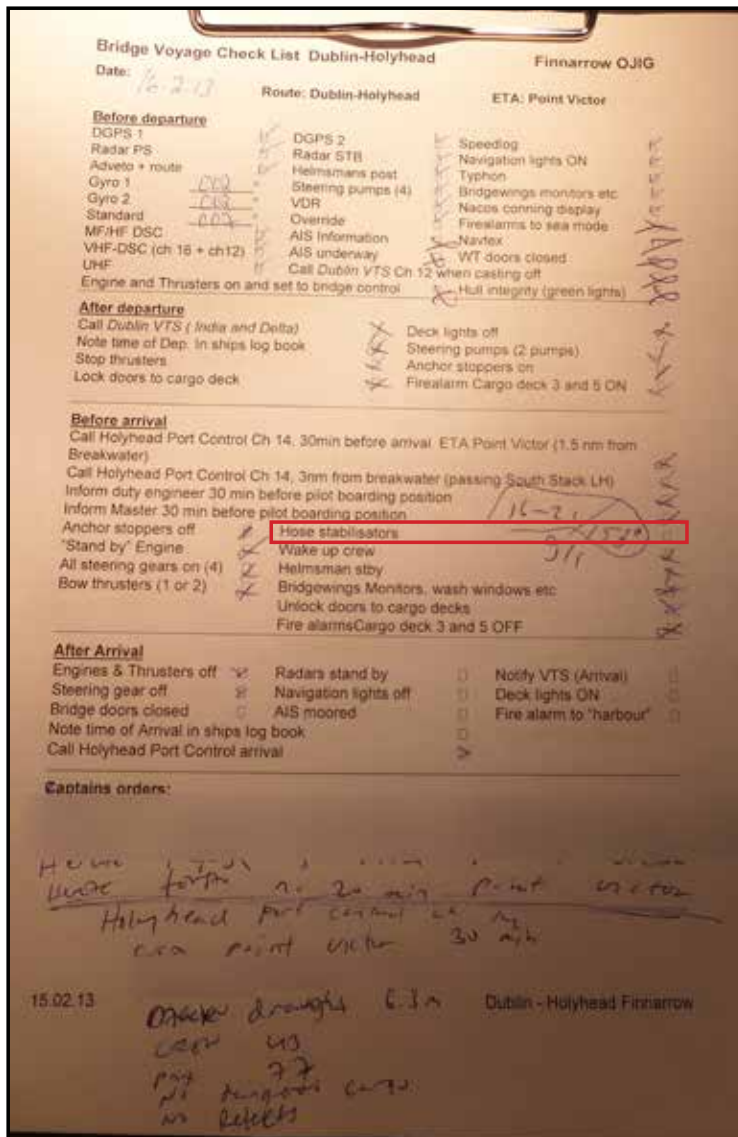
**Figure 8:** Completed bridge voyage checklist

Secondly, a tick box on the voyage checklist to confirm that the fin stabilisers were housed, was not completed (**Figure 8**). This failed to act as a prompt to either the day master or chief officer to check that the fin stabilisers were housed. The SMS did not include any reference as to when specific aspects of the day voyage checklist should be completed. The voyage checklist for the Dublin-Holyhead route had been created by ship's staff and was similar to another checklist in the SMS, but it was an informal document and not part of the approved SMS documentation.
