MV FINNARROW

Contact with berth and subsequent flooding

Holyhead, UK

16 February 2013

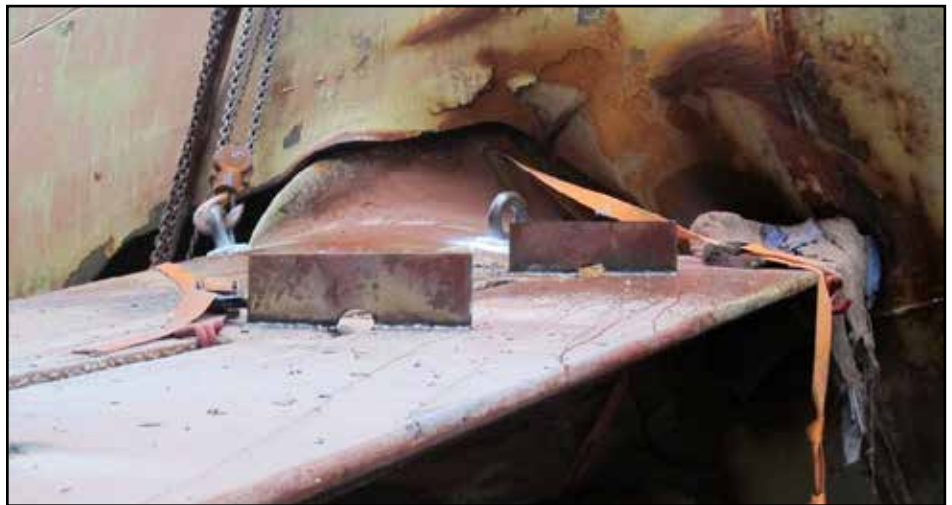
The port fin stabiliser was extensively damaged as it was driven against the berth and forced backwards (**Figure 5**). In the process, the inboard/trailing edge of the fin punctured the hull, causing a 0.5m by 0.2m hole, approximately 3m below the waterline. As a result of the subsequent flooding in the pump room, numerous electric motors and other electrical equipment were also damaged.

Figure 5: Port fin stabiliser and hull damage
