Report on the investigation of
the loss of a crewman overboard

from the motor tug

Endurance

2.3 miles west-south-west of Beachy Head,

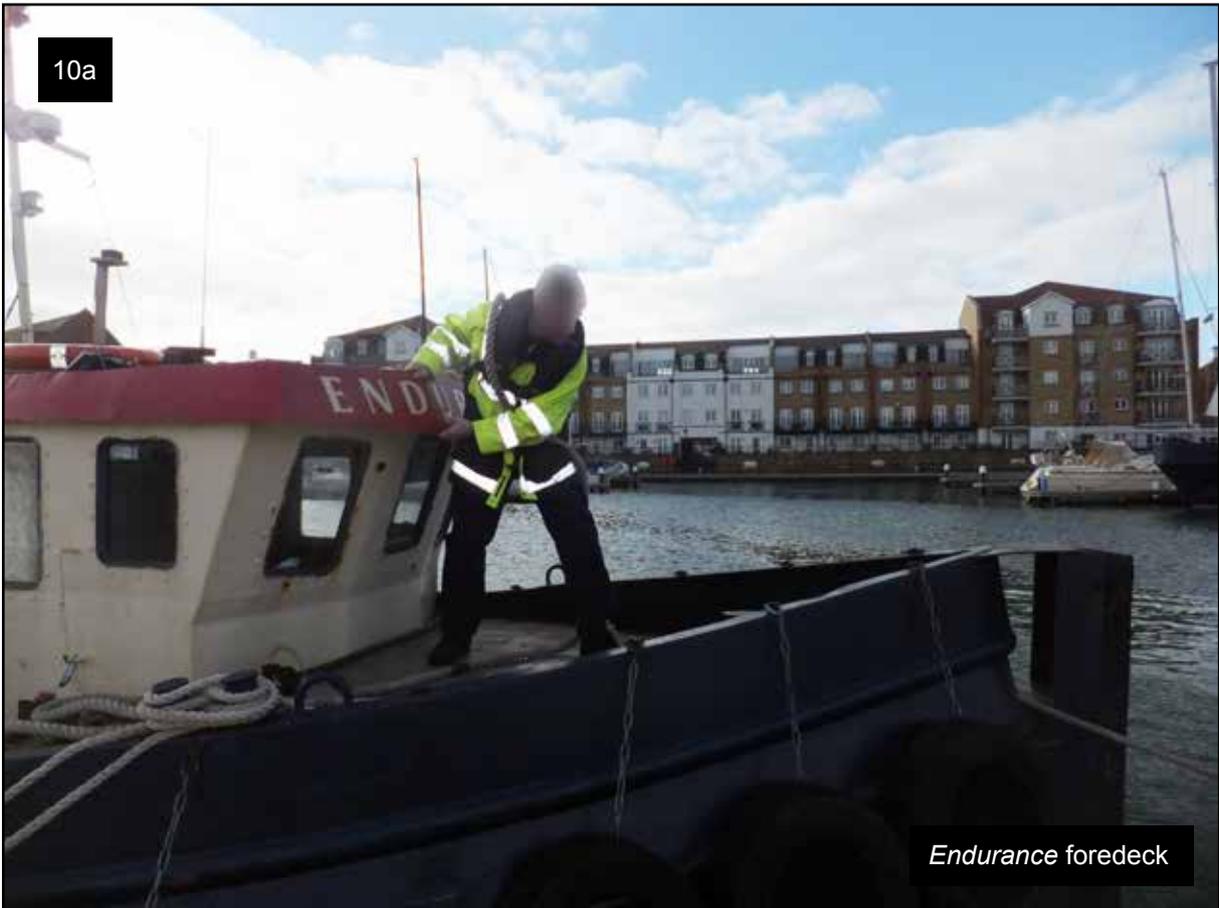
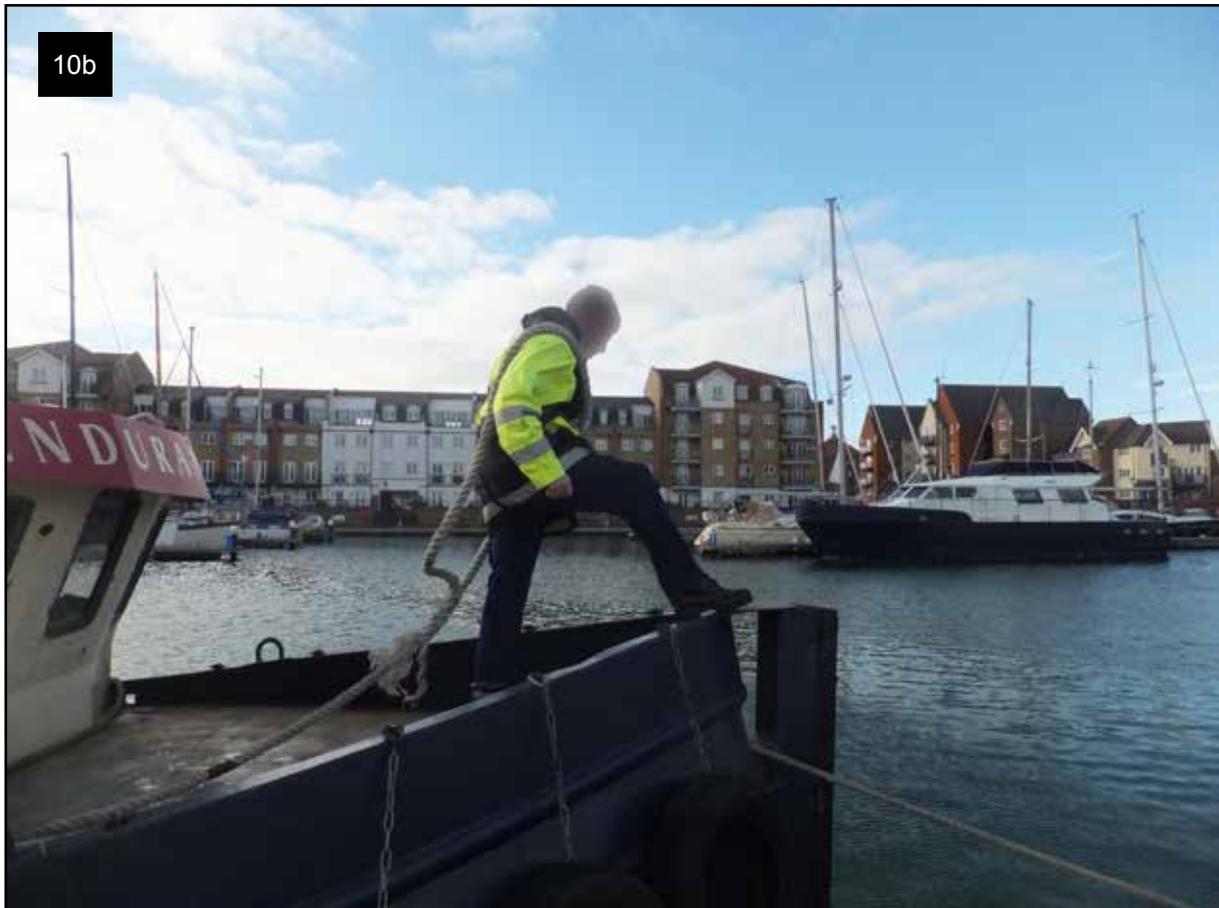
Figure 10a and 10b: Reconstruction of Steven's position on *Endurance's* foredeck in preparation to step across to *Sirius M*

In view of the danger caused by the relative movement of the vessels in the rough seas, the darkness, and the difficulty in carrying the towline, it is clear that Steven's transfer across to *Sirius M* should not have been attempted. This is endorsed by the fact that during the SAR the coxswain of the Eastbourne ALB would not transfer one

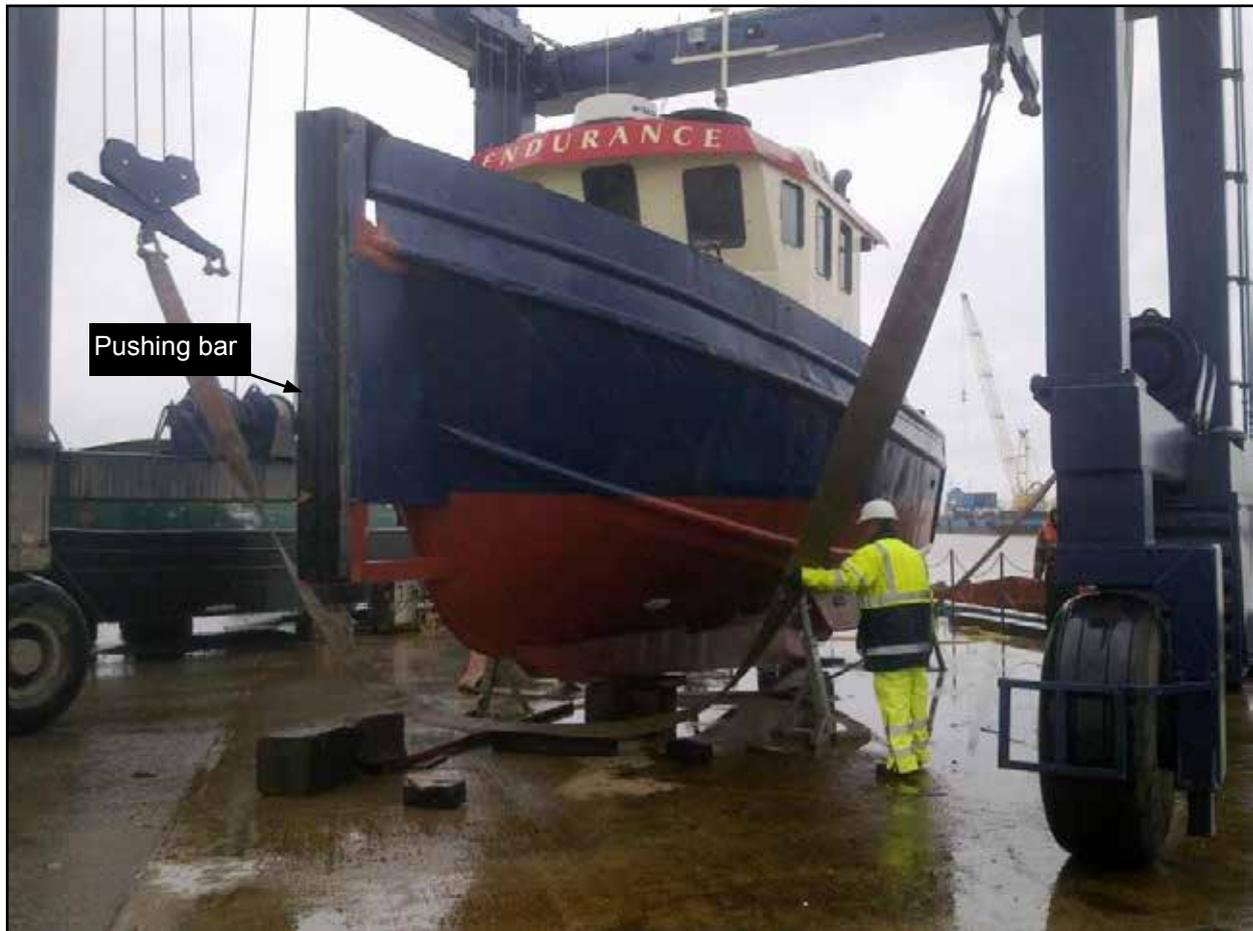
Figure 16: *Endurance* out of the water in 2012 - pushing bar fitted

In 2009, *Endurance* was bought by the current owner who spent 2 years converting the vessel to a motor tug. The aft deck was strengthened and a three pillar towing post was installed (**Figure 7**). A new deck winch was also fitted and a section of the bulwark at the stern of the vessel was cut away to enable buoys to be recovered on board. In 2012, a steel pushing bar was fitted to the stem (**Figure 16**).

The bulwarks along the sides of *Endurance*'s aft deck were 600mm high and there was no bulwark or guardrails fitted around the raised foredeck or at the transom.

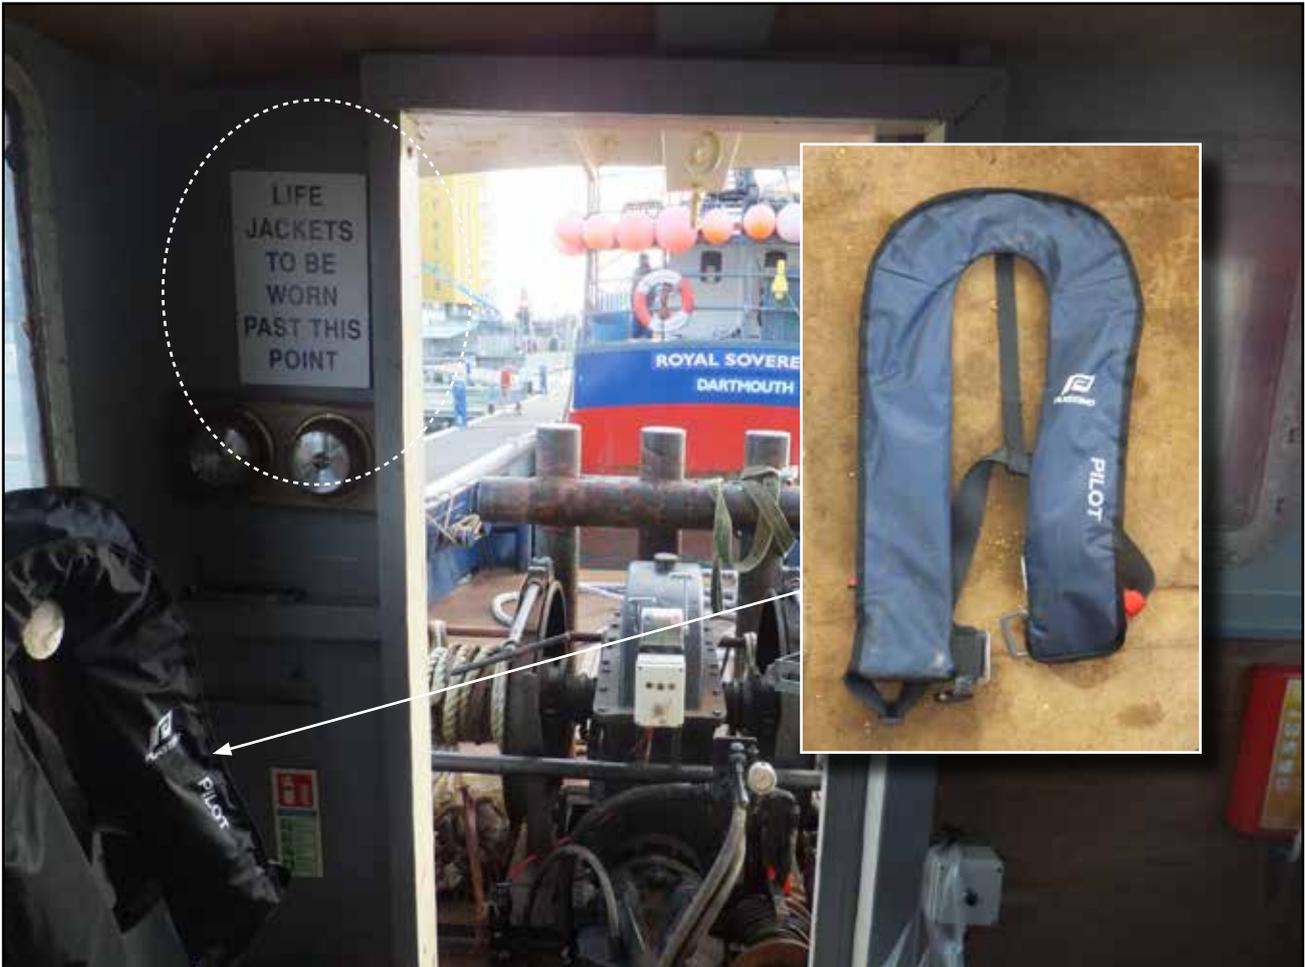
Figure 17: Lifejackets carried on board *Endurance*

Endurance carried three self-inflating lifejackets, which were kept on a hook in the wheelhouse close to the wheelhouse door (**Figure 17**). A sign next to the wheelhouse door indicated that the lifejackets must be worn at all times when working on deck. The waist belt on each of the lifejackets had a steel eyelet that was designed to allow yachtsmen to attach themselves, via a lifeline/lanyard, to their boat. The vessel had not been fitted with jackstays and no lanyards or safety harnesses were carried on board.

Endurance's skipper was required to wear a self-inflating lifejacket at all times when working on board PLA vessels. However, neither he nor his crewman usually wore lifejackets or other personal flotation devices (PFD)¹⁹ on board *Endurance*.

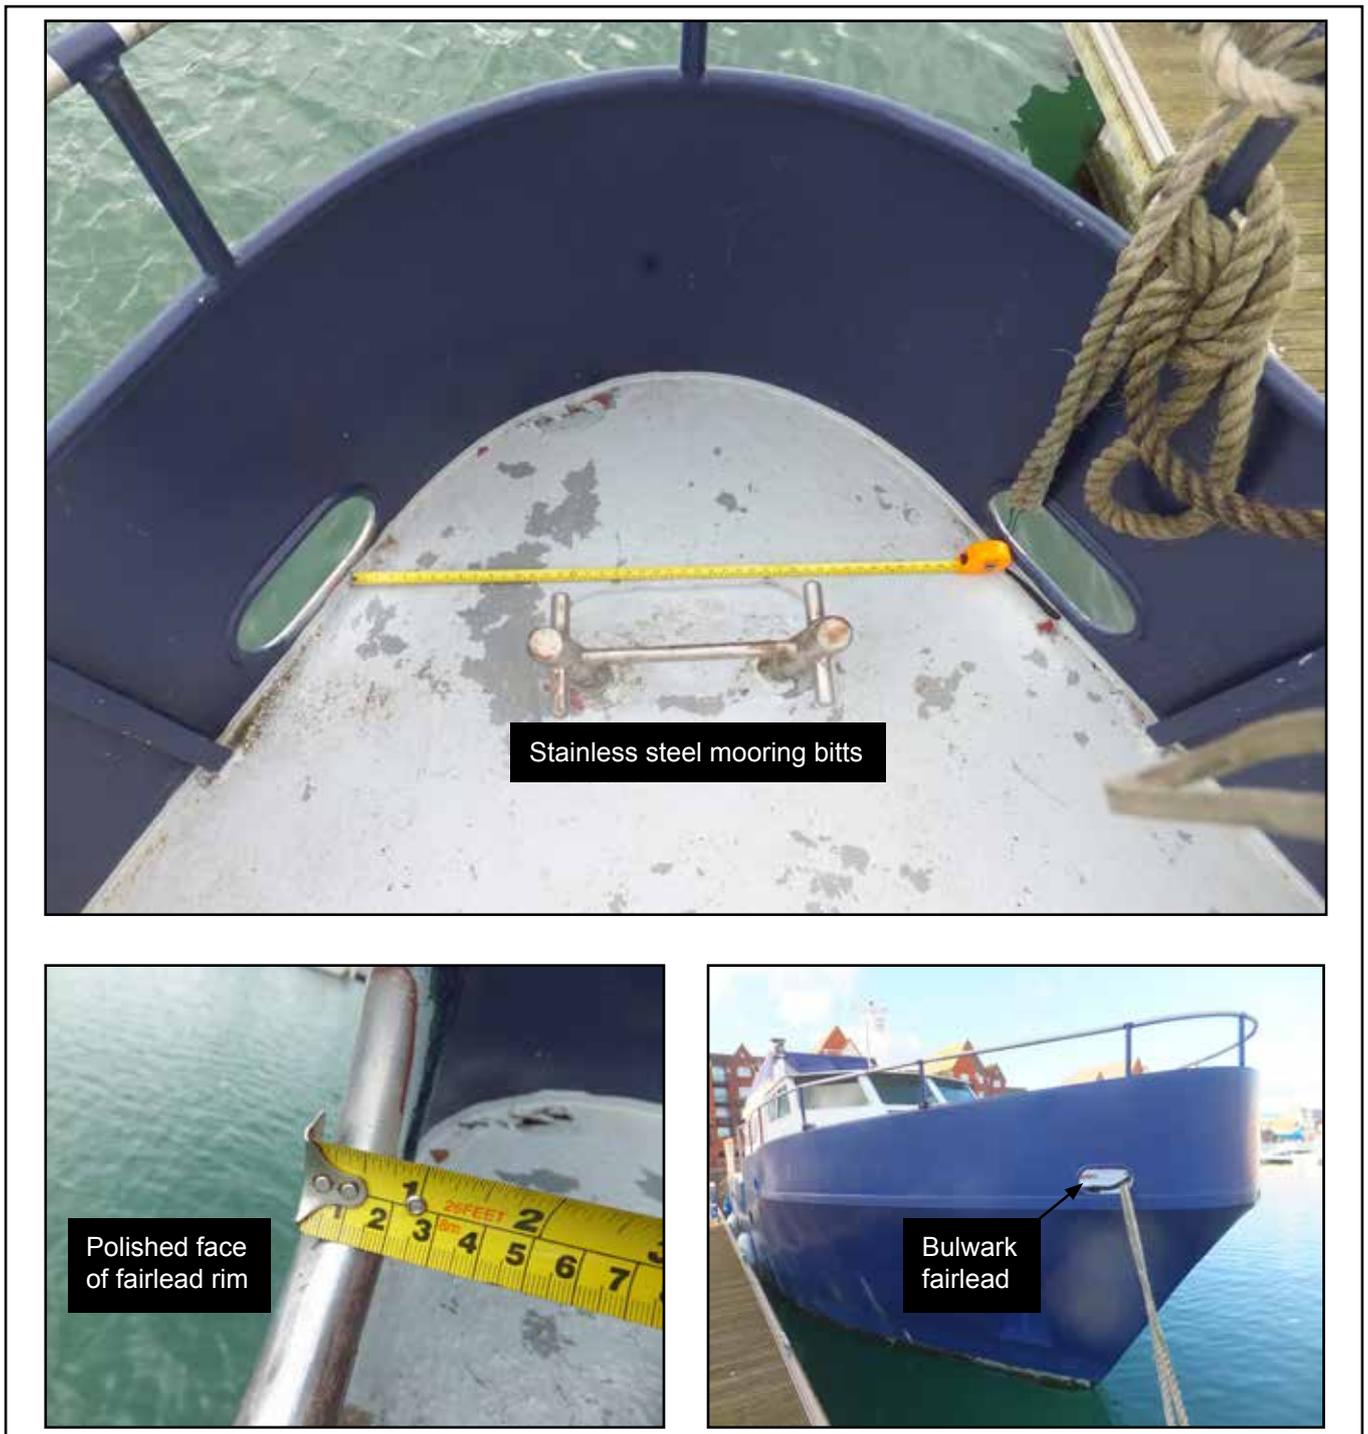
Figure 20: *Sirius M*'s foredeck layout

Sirius M had through bulwark fairleads sited on the port and starboard sides of the foredeck (**Figure 20**). The vessel's forward mooring ropes were typically reeved through the fairleads and secured to a set of stainless steel bits located on the centreline of the foredeck. The edges of the bulwark fairleads had 20mm diameter steel rims to strengthen the structure and to help reduce the risk of rope chafe.

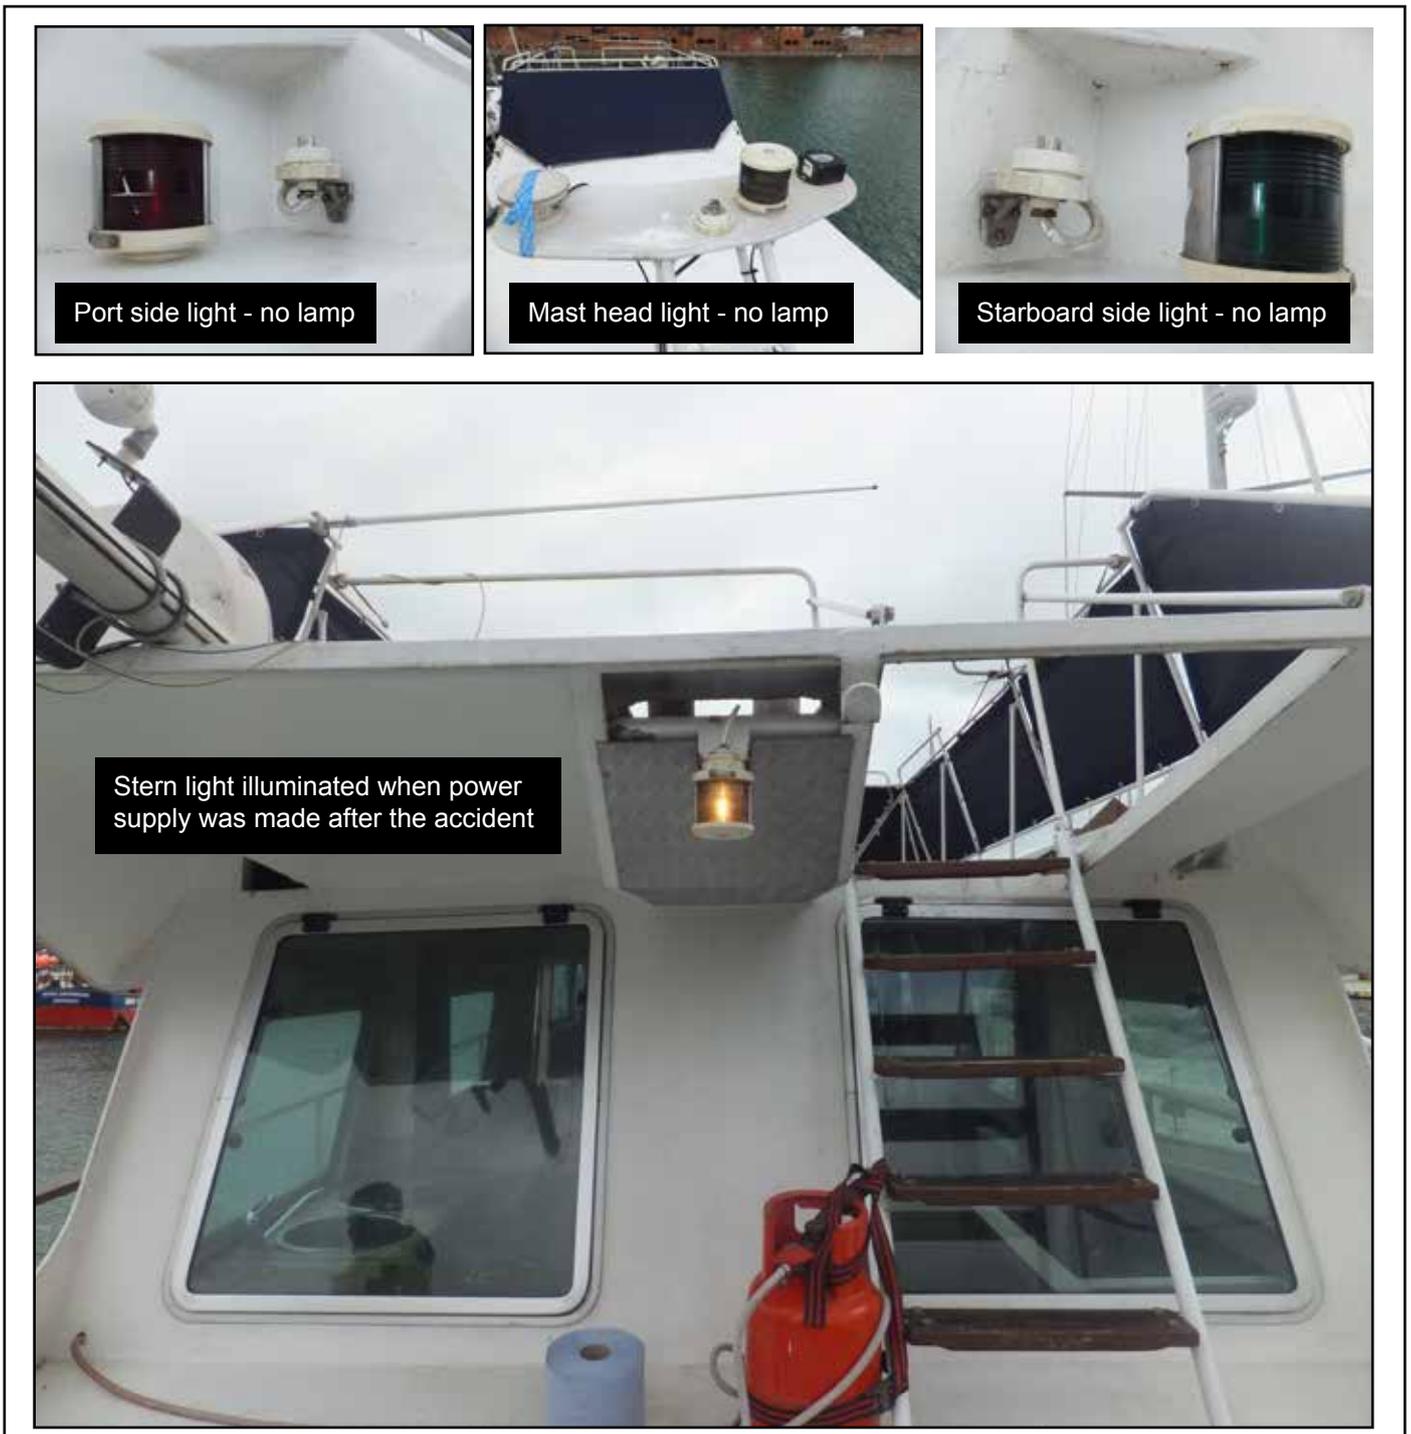
Figure 21: *Sirius M's* navigation lights

Sirius M was fitted with navigation lights appropriate for its length, but the lamps were removed from the vessel's side navigation lights by *Endurance's* skipper before the motor cruiser was moved from Rochester (**Figure 21**). When *Sirius M* was towed down the River Medway, only its stern light was illuminated (**Figure 4**).

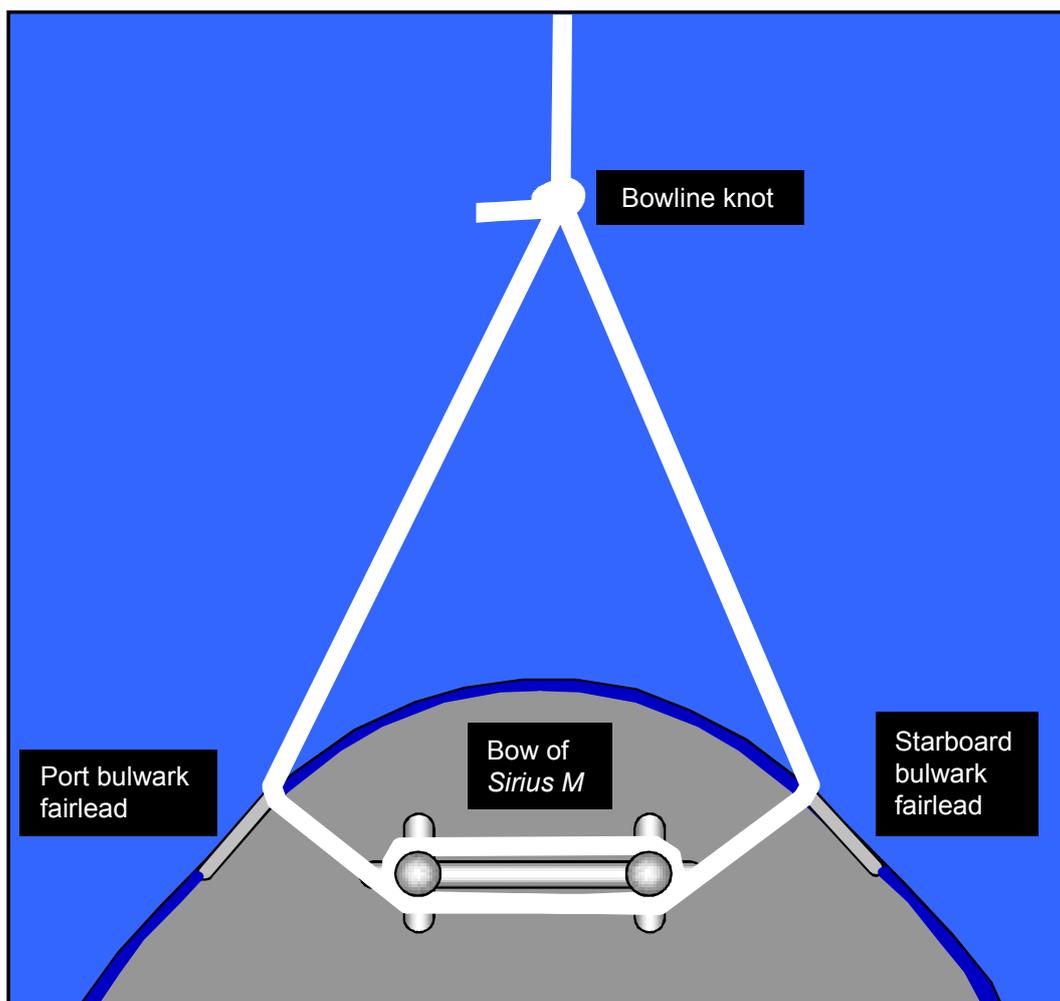
Figure 22: Towline securing arrangement

Endurance's skipper intended to rig a towing bridle¹⁶ to the bow of *Sirius M* for the tow to Brighton. However, after assessing the foredeck arrangement when he arrived on board the vessel at Medway Marina, he decided against this option. Instead, a towing eye was formed on the motor cruiser's bow using a 50mm diameter 8-strand polypropylene rope as shown at **Figure 22**. The bight of the towline was made fast to *Endurance's* towing post, leaving approximately 18m of rope between the vessels. The towline used was the largest diameter rope carried on board *Endurance*.

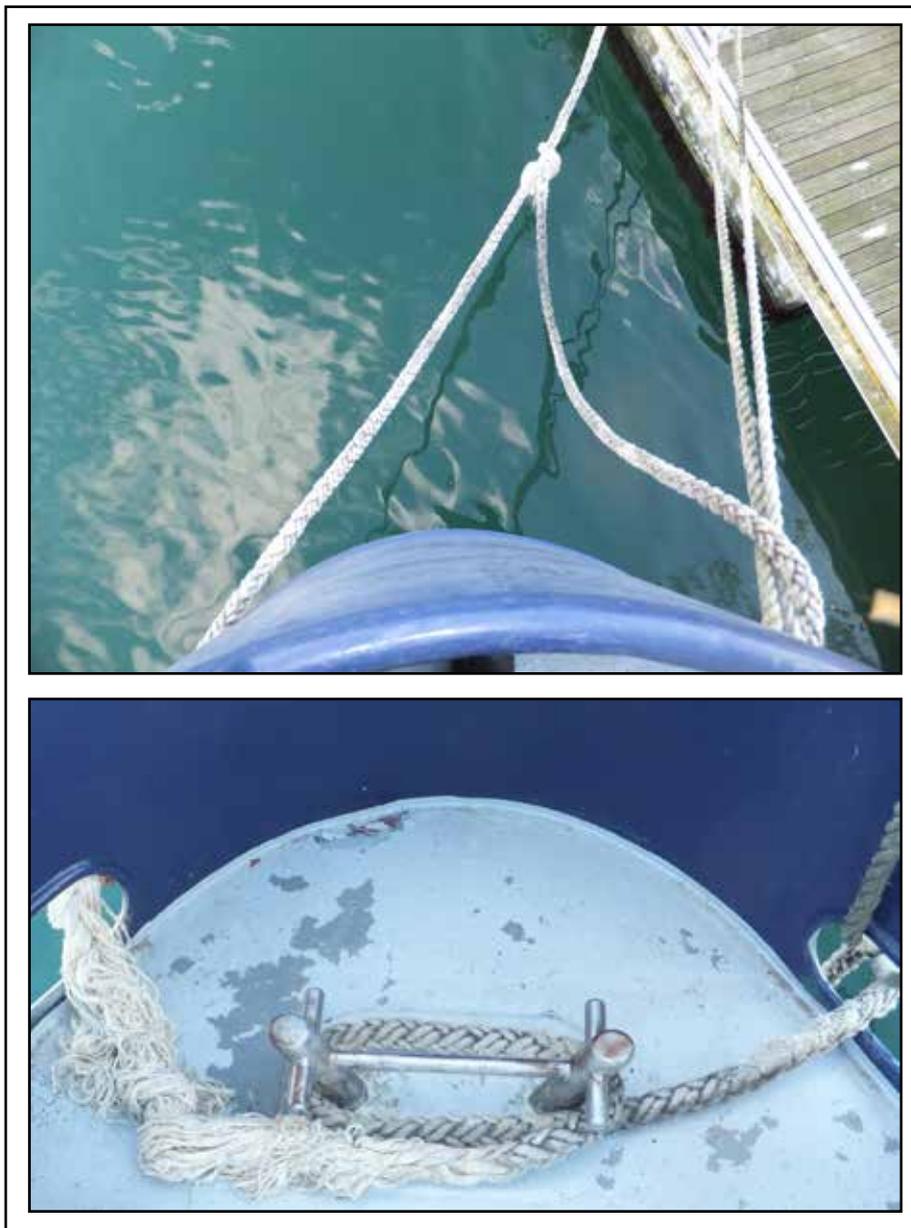
Figure 24: Tow rope securing arrangement reconstructed on *Sirius M's* foredeck

Examination of the parted towline indicated that the rope was old and in poor condition. MAIB inspectors reconstructed the towing eye in situ (**Figure 24**), and it was evident that the rope had parted at a point where it had been in contact with the steel rim of one of the motor cruiser's fairleads. The rope was also damaged where it had been in contact with the other fairlead (**Figure 25**). Paint on the forward edge of both fairleads had been removed and the base steel had a freshly polished

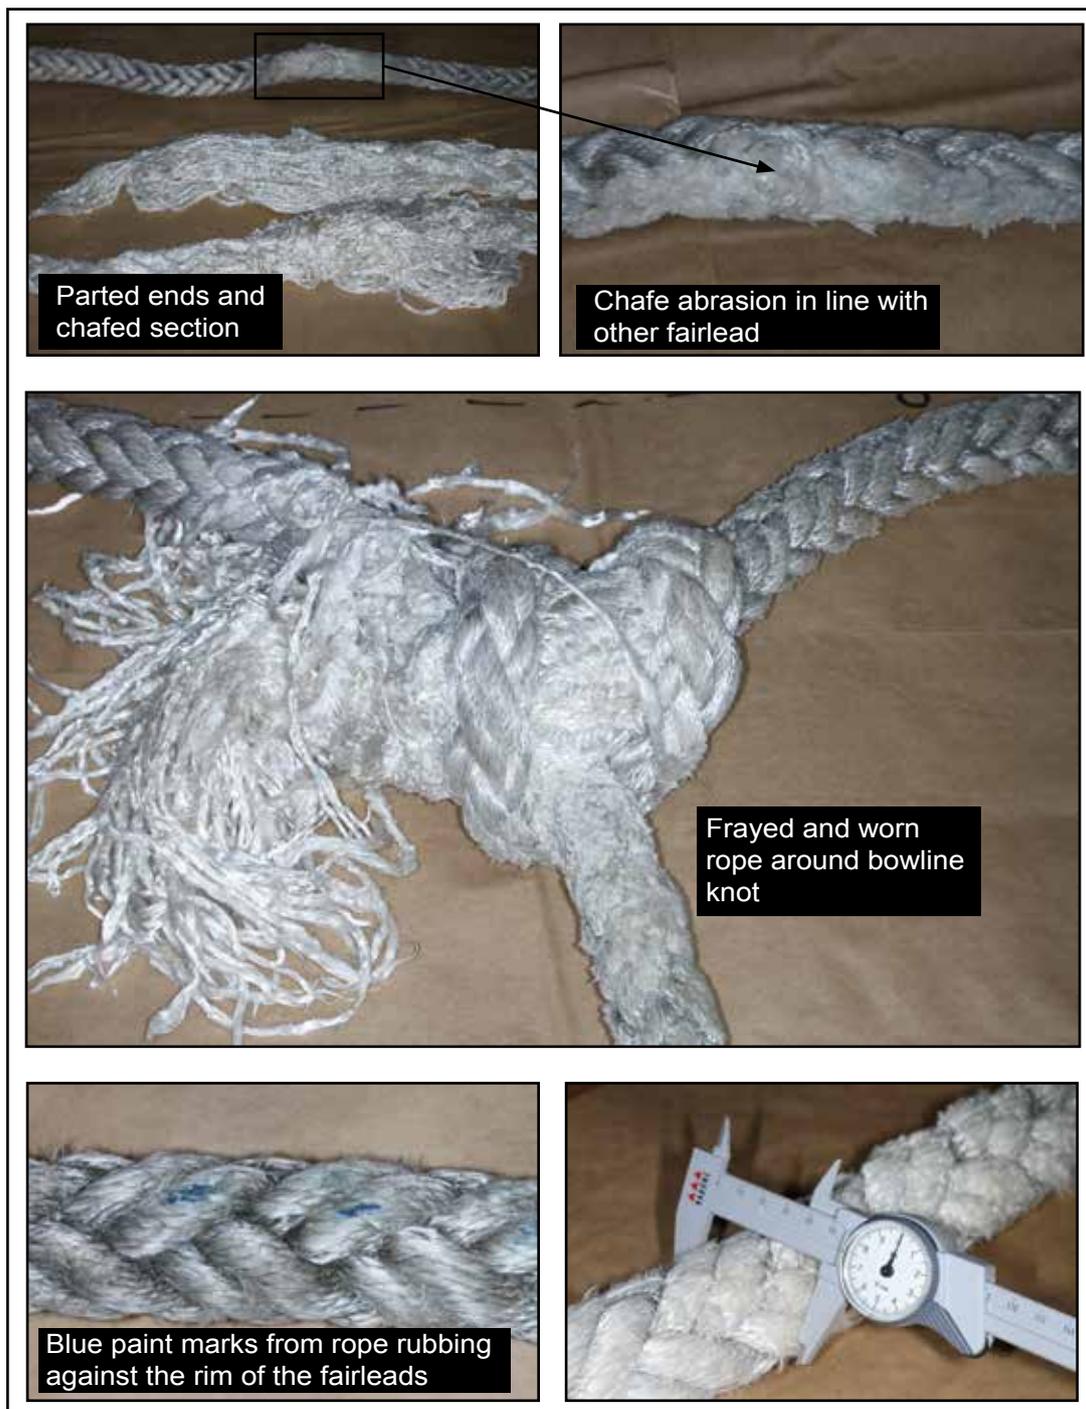
Figure 25: Tow rope chafe marks and frayed ends, and fraying at the bowline knot used to form the towing eye

appearance. Blue paint could be seen on the rope in the areas where it had rubbed against the steel rim of the fairleads. It was also noted that the length of rope within and around the bowline had started to fray and wear.

In particular, the towing eye arrangement had several potential chaffing points, but no chaffing protection devices were fitted. Towlines are particularly vulnerable to chafe abrasion, and potential chafe points must be identified and eliminated. When a chafe hazard cannot be avoided, it is common practice to use chafe protection devices such as chafe chains and chafe abrasion protection sleeves (**Figure 30**). Many seafarers also make their own chafe protection sleeves using materials such as plastic hoses, nylon rope, canvas sheets and leather.
