**Fatal man overboard from the trawler
VIDAR
off Milford Haven
28 January 2013**

SUMMARY

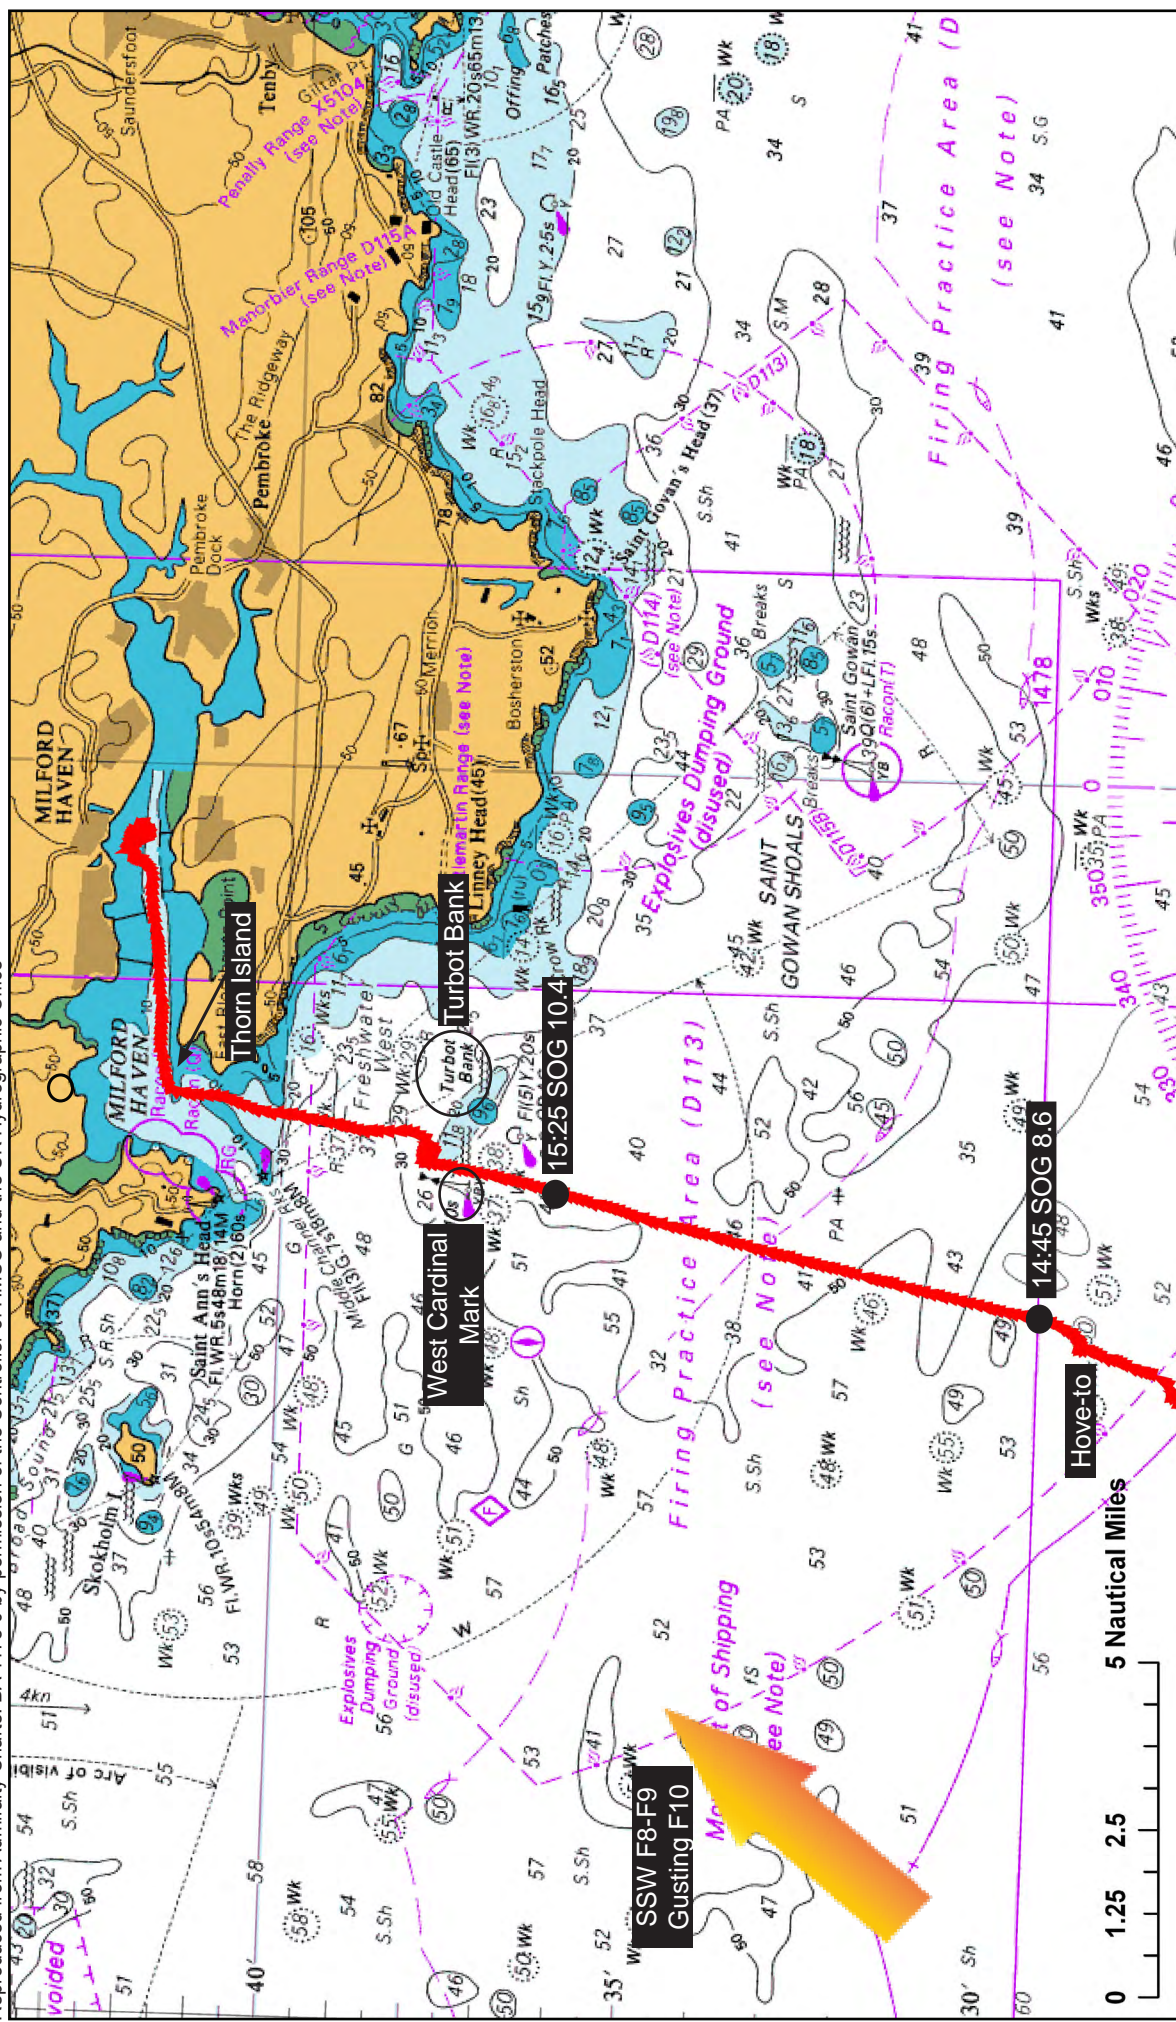
Figure 1: Vidar AIS track

At 1445 on 28 January 2013, the Belgian beam trawler *Vidar* was returning to Milford Haven at the end of a 5-day fishing trip. The vessel was on a northerly heading towards Milford Haven, Wales (**Figure 1**). The autopilot was engaged and *Vidar* was making good a course of 014° at a speed of 11 knots. The wind was gusting up to 50 knots from the south-south-west and the sea swell was 5m from the south-west. The tidal stream was setting to the east at 0.7 knots. To help stabilise *Vidar*'s movement in the very rough seas, the vessel's derricks had been lowered to an angle of approximately 80° from the vertical.

Although a northerly course was set on the autopilot, and *Vidar* was initially heading to the west of the cardinal buoy marking the Turbot Bank (**Figure 1**), the vessel was set to the east by the tidal stream, swell and wind. As a result, the course made good (014°) meant that *Vidar* passed to the east of the buoy and crossed the western end of the bank.

In itself this was not dangerous as *Vidar* had a draught of 4.6m and so there was ample under keel clearance. Also, in allowing the vessel to pass to the east of the cardinal buoy, the skipper avoided steering further to the west thus exacerbating the vessel's roll. Nevertheless, given the advice in the Admiralty Sailing Directions, which includes *Bad weather causes a short and dangerous sea over the bank*, this was an area to be avoided, particularly with crew working on the deck. Therefore, the failure to alter course to avoid the bank or to get the crew off the deck sooner, were significant oversights.

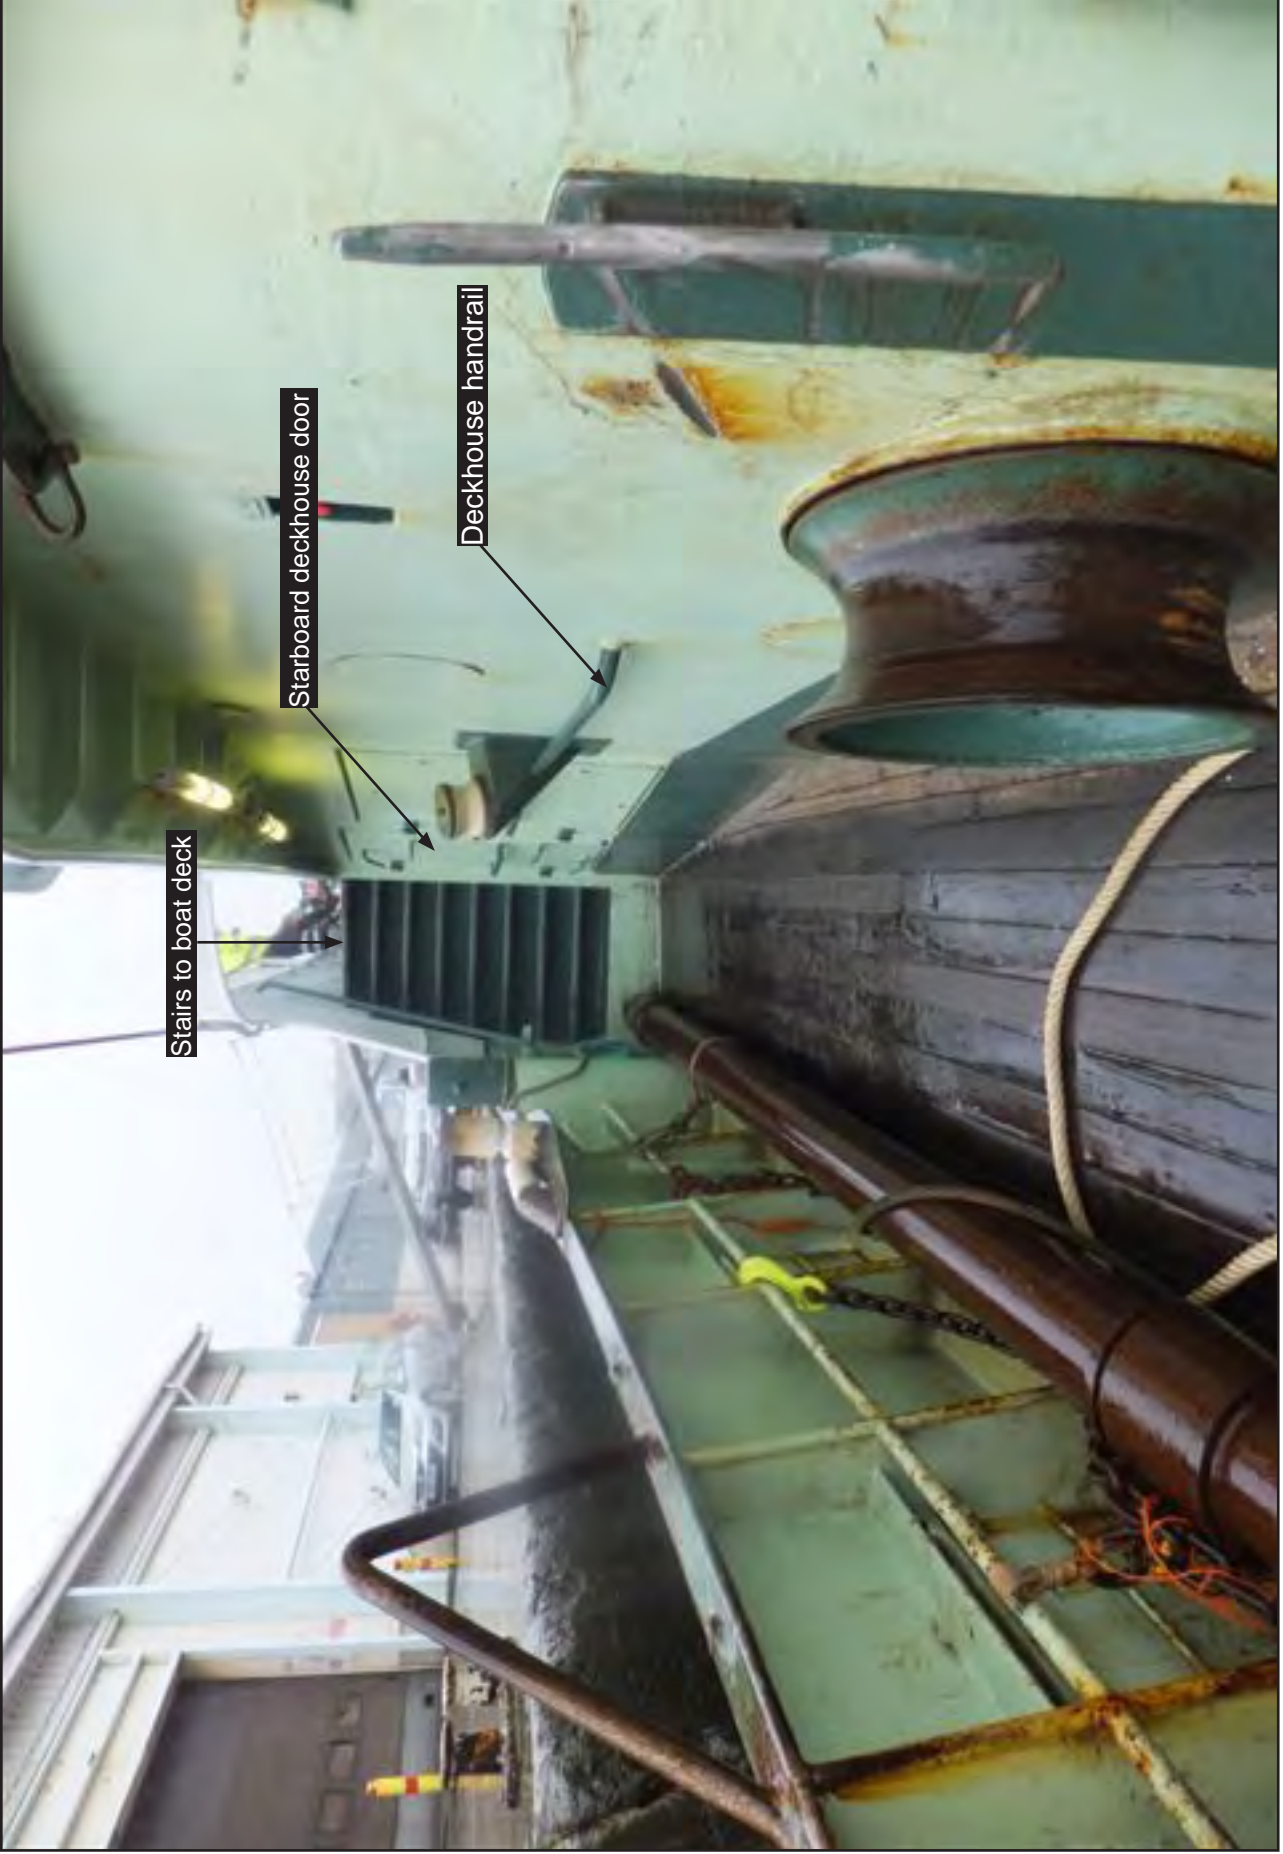
Figure 2: Starboard walkway

In response, the two ABs, one of whom was Luc De Craemer, put their tools away, then walked aft along the starboard side of the main deck in order to climb the stairway (**Figure 2**) to the boat deck and access the accommodation through the wheelhouse. As the two men walked between the deckhouse and the starboard gunwale, a wave hit the vessel on the port quarter and *Vidar* rolled heavily to starboard. The starboard gunwale was immersed under the sea and a large volume of swirling water engulfed the walkway. Luc reached out for a handhold on the deckhouse door (**Figure 2**) while the second AB, who was just behind Luc,

grabbed the deckhouse handrail. Luc and the AB were rapidly lifted off their feet by in-rushing water. The AB was able to maintain his grip on the handrail but, at about 1536, Luc was swept overboard into the sea (**Figure 3**).

Luc was swept into the sea after *Vidar* had rolled heavily to starboard. With the vessel's speed at about 11 knots, the starboard gunwale was immersed in the sea and the deck area between the gunwale and the deckhouse immediately filled with water. It was not surprising that Luc either did not have the time to grab, or was unable to hold onto the deckhouse door, and was quickly taken over the side despite the gunwale being 1.06m high. Indeed, it was fortunate that the other AB was not swept into the sea as well.

- Luc was swept overboard as *Vidar* rolled heavily to starboard and a large volume of water came over the gunwale and into the starboard walkway by the deckhouse.

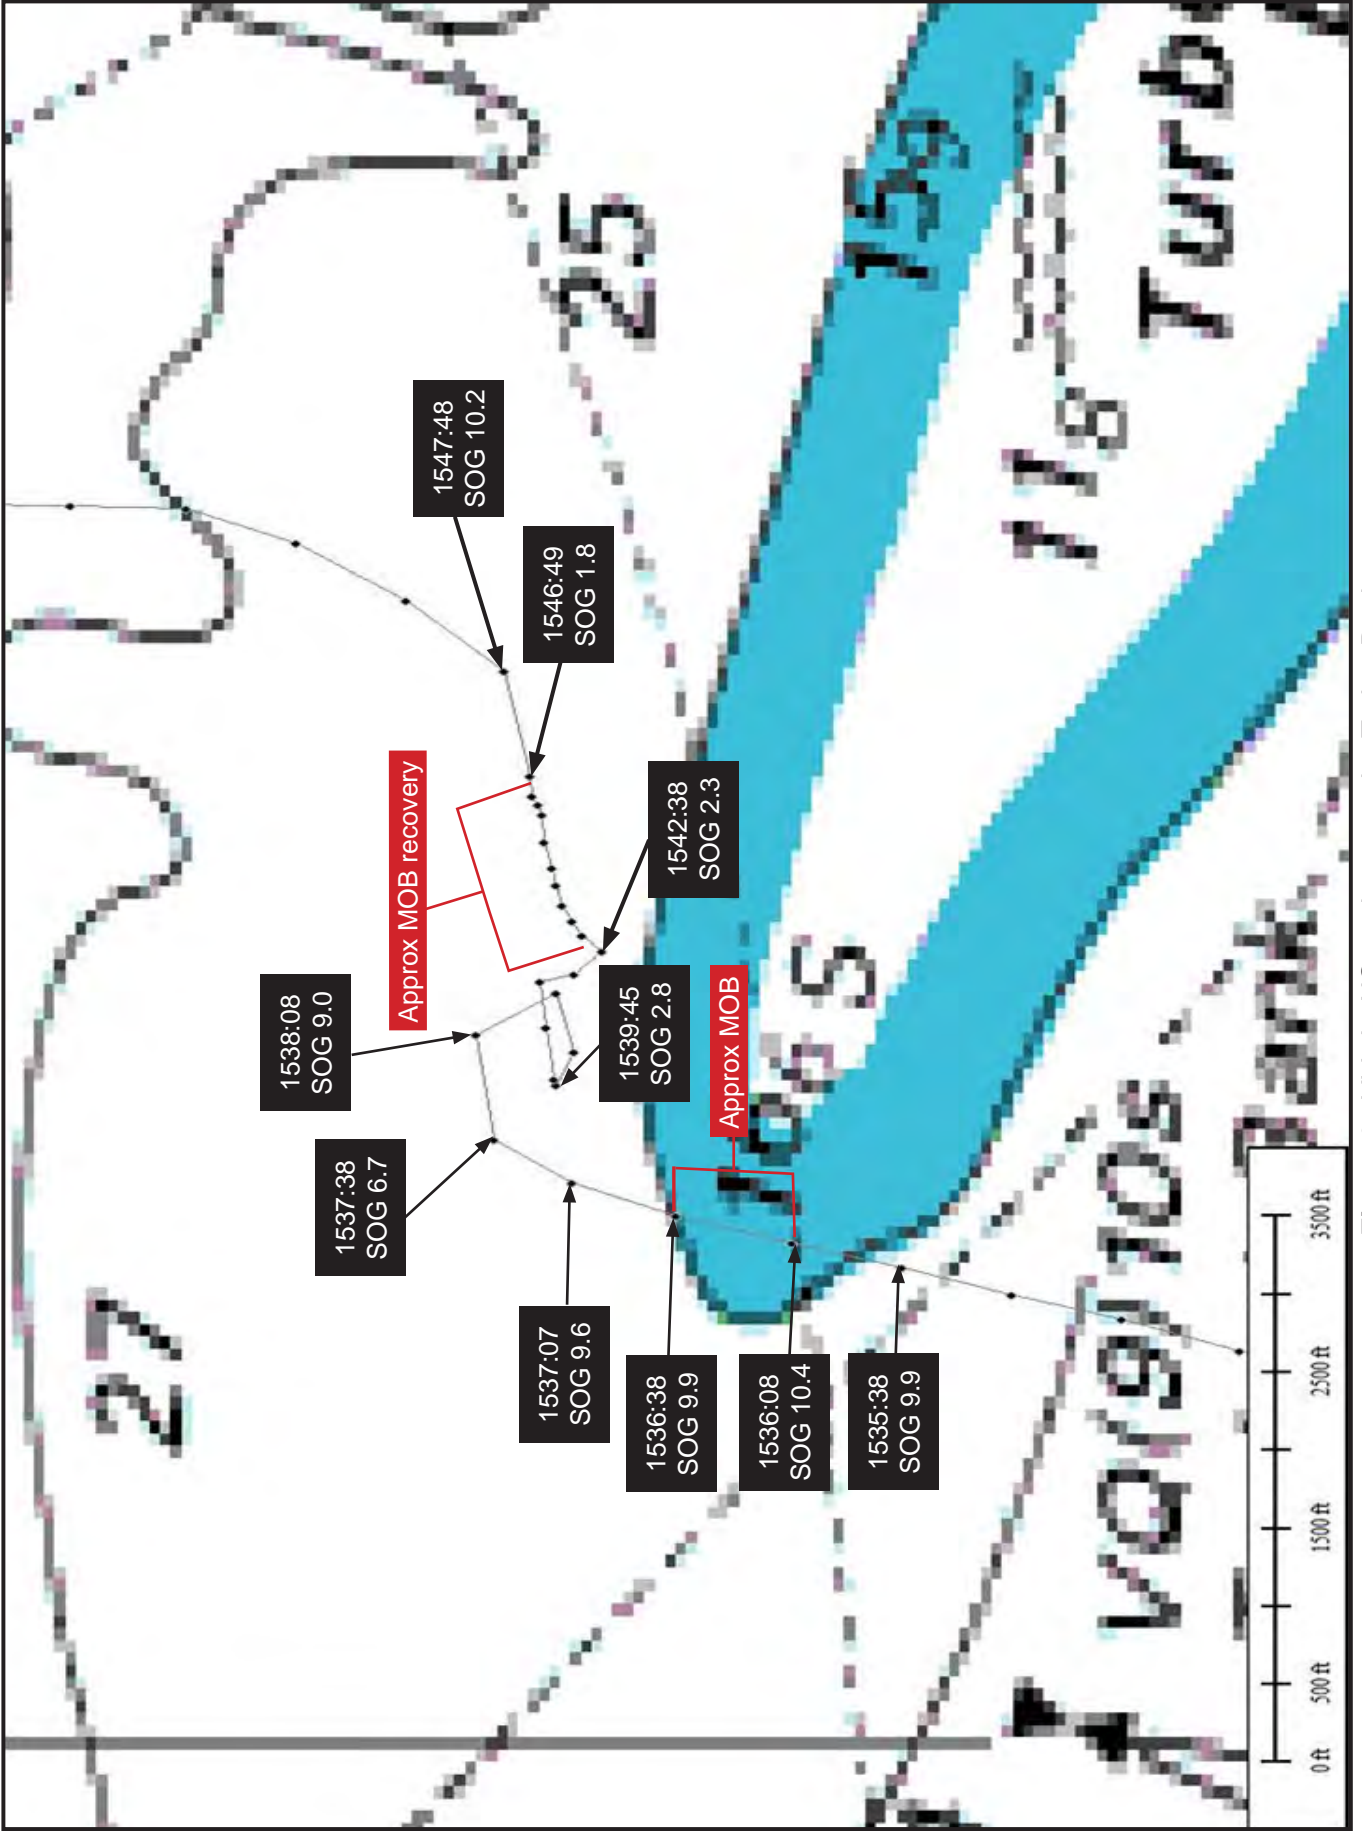
Figure 3: Vidar's AIS track across the Turbot Bank

By 1543 (**Figure 3**), the skipper had manoeuvred *Vidar*'s port quarter to between 10m and 15m from Luc, who was floating on his back and was waving his arms. The mate threw a recovery rope from a lifebuoy to Luc, which he managed to catch. At this point, Luc seemed to stop moving and appeared to swallow seawater.

At the time, *Vidar* was running with the swell waves predominantly approaching on the vessel's port quarter. However, the vessel was also crossing the western edge of the Turbot Bank, where the shoaling seabed is likely to have caused the swell waves to become steeper and less predictable. Therefore, the probability of sea water breaking over the gunwales in way of the forward end of the deckhouse, which is a phenomenon on board many Belgium registered beam trawlers of similar design, was increased. Although *Vidar's* crew were used to assessing the wave period and judging when it was safe to transit the walkways, this accident clearly shows that such action is neither an effective nor an acceptable solution.

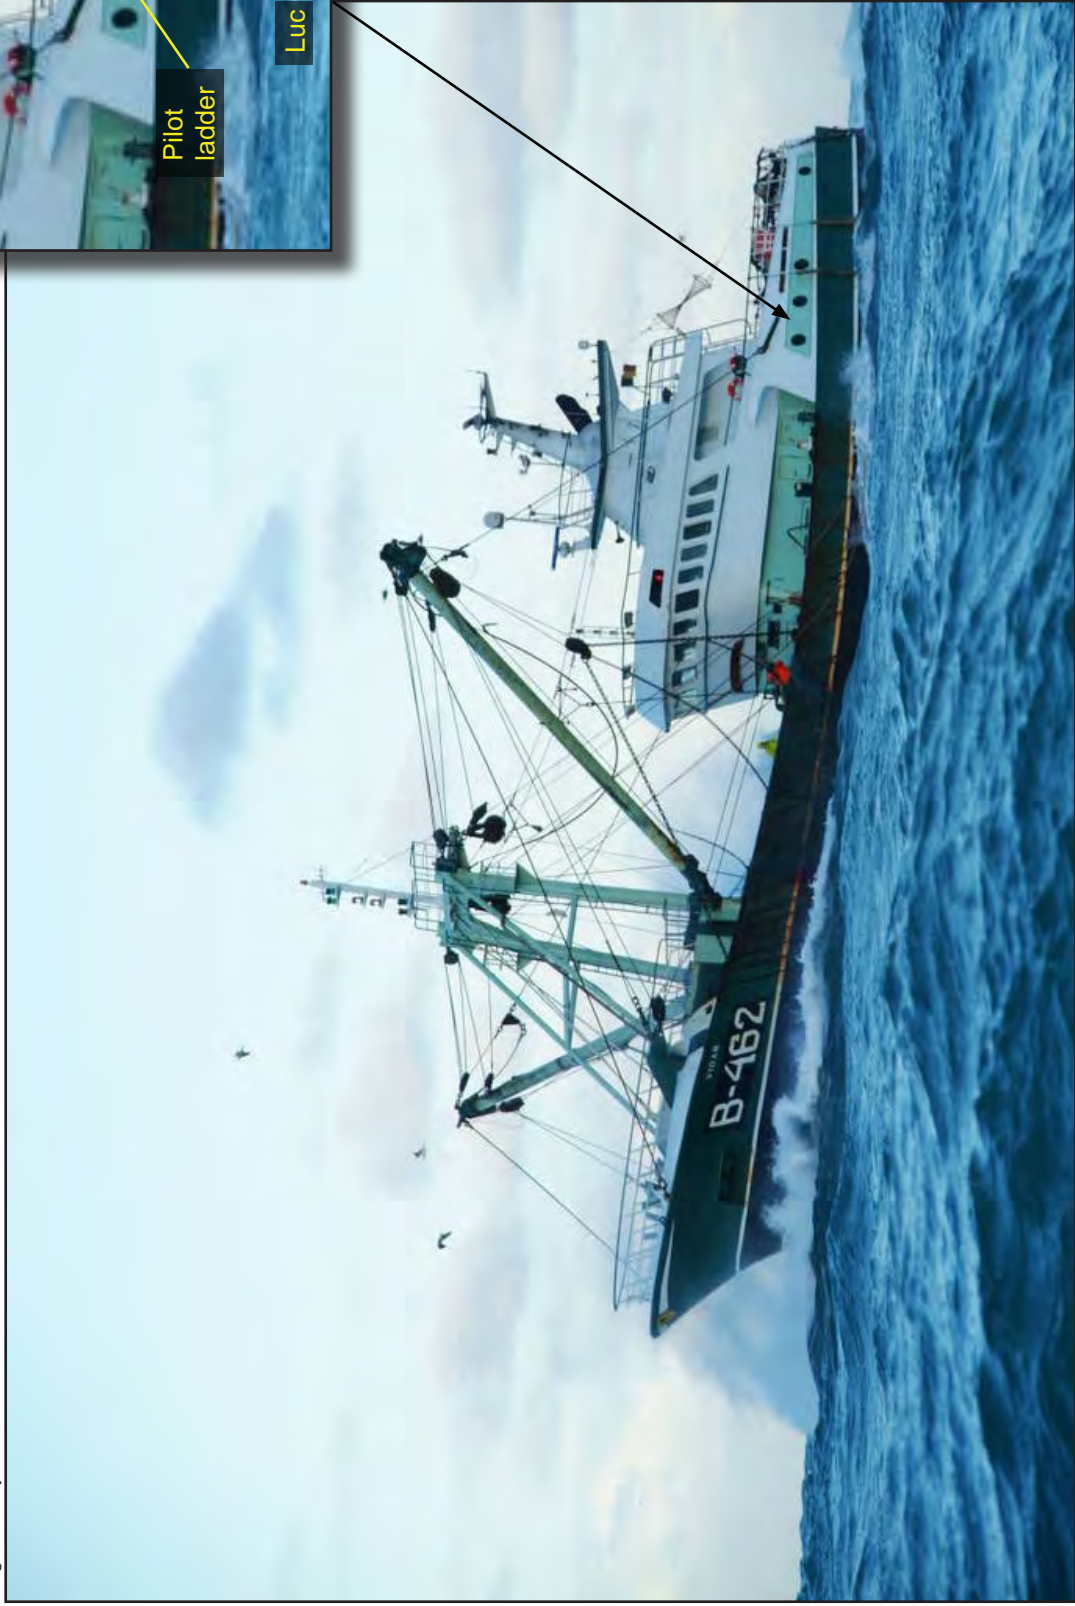
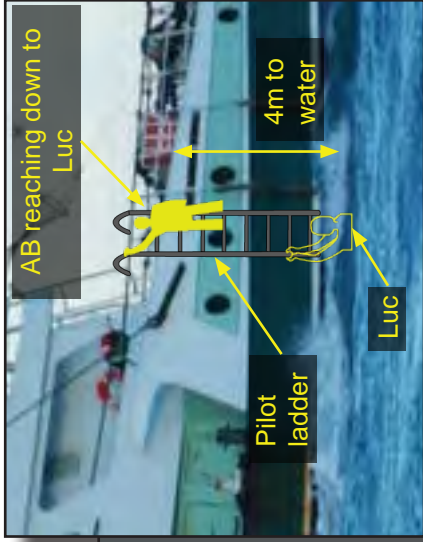
Figure 4: Pilot ladder from port quarter

As Luc was pulled towards *Vidar* with the recovery line, a pilot ladder was put over the boat deck rail on the port quarter (**Figure 4**); the top of the ladder was about 4m from the waterline. The AB climbed part way down the ladder and held out his hand as the vessel moved up and down in the waves, but he was unable to reach Luc.

The skipper left the wheelhouse and told the AB to return on board. The ladder was then moved to the main deck below the port stairway where the vessel's freeboard was approximately 0.9m. As Luc was pulled forward towards the re-positioned ladder, he briefly disappeared underneath the vessel as it rolled, and he hit his head on the curvature of the steel hull. When he re-appeared he seemed to be unconscious and had let go of the rope.

Nonetheless, despite *Vidar* being manoeuvred sufficiently close to Luc for the mate to throw him a line and pull him towards the vessel's side, *Vidar's* crew had great difficulty in recovering Luc from the water. Consequently, by the time the ladder had been moved down from the boat deck quarter to the main deck, Luc was unconscious and at the limits of his endurance; his impact with *Vidar's* hull did not result in a serious injury but it undoubtedly reduced his already slim chance of survival.

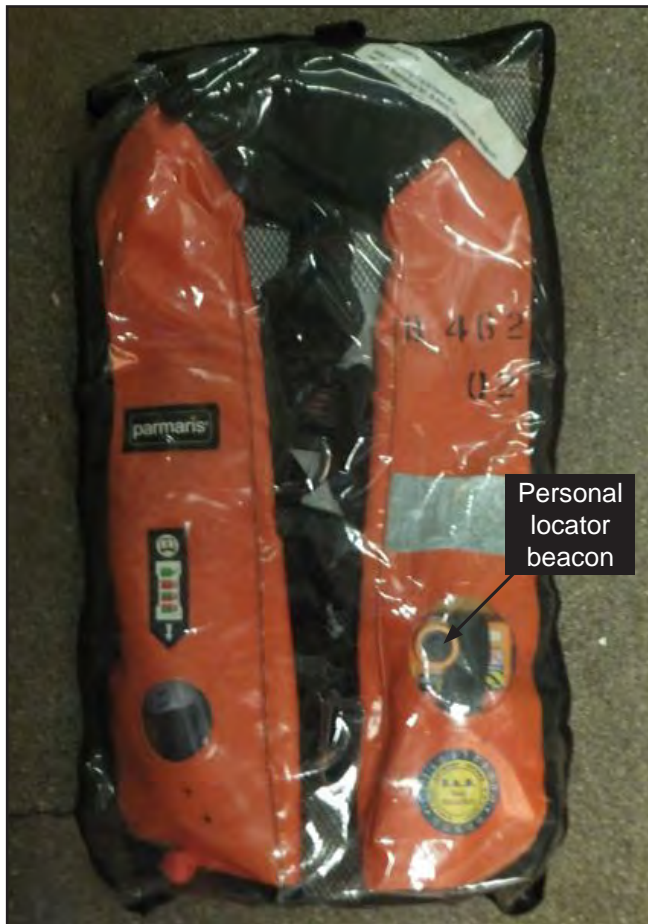
Figure 5: Lifejacket and PLB in original packing

Vidar had been provided with 150N self-inflating lifejackets and SEA Marshall personal locator beacons (PLB) by the Foundation for Sustainable Fishery Development (SDVO³) in Belgium. The PLB could be tracked using a receiver unit fitted in the wheelhouse. *Vidar's* crew did not wear the lifejackets when working on deck because they considered them to be uncomfortable and increased the chance of being dragged overboard if the lifejacket became snagged in the fishing gear. Consequently, the lifejackets and PLB's on board remained unused and stored within their original packaging (**Figure 5**). Due to an increasing difficulty in recruiting and retaining qualified crew, the skipper was reluctant to insist that the crew wore lifejackets when working on deck.

It is astonishing that no consideration had been given to wearing lifejackets prior to the mate advising the skipper that it was too dangerous for the crew to continue working on deck. Fishermen are required by Belgian regulations to wear PFDs when working on deck, yet the lifejackets the SDVO provided to *Vidar* (**Figure 5**) were never used. In this respect, the reasons given by the crew for not wearing lifejackets are similar across the fishing industry. Although regulation and the provision of lifejackets promote the wearing of lifejackets, these actions alone are not enough. The culture of the industry also needs to change to make wearing a PFD a matter of routine.
