## SUMMARY

## Grounding of MV *BEAUMONT* Cabo Negro, Spain 12 December 2012

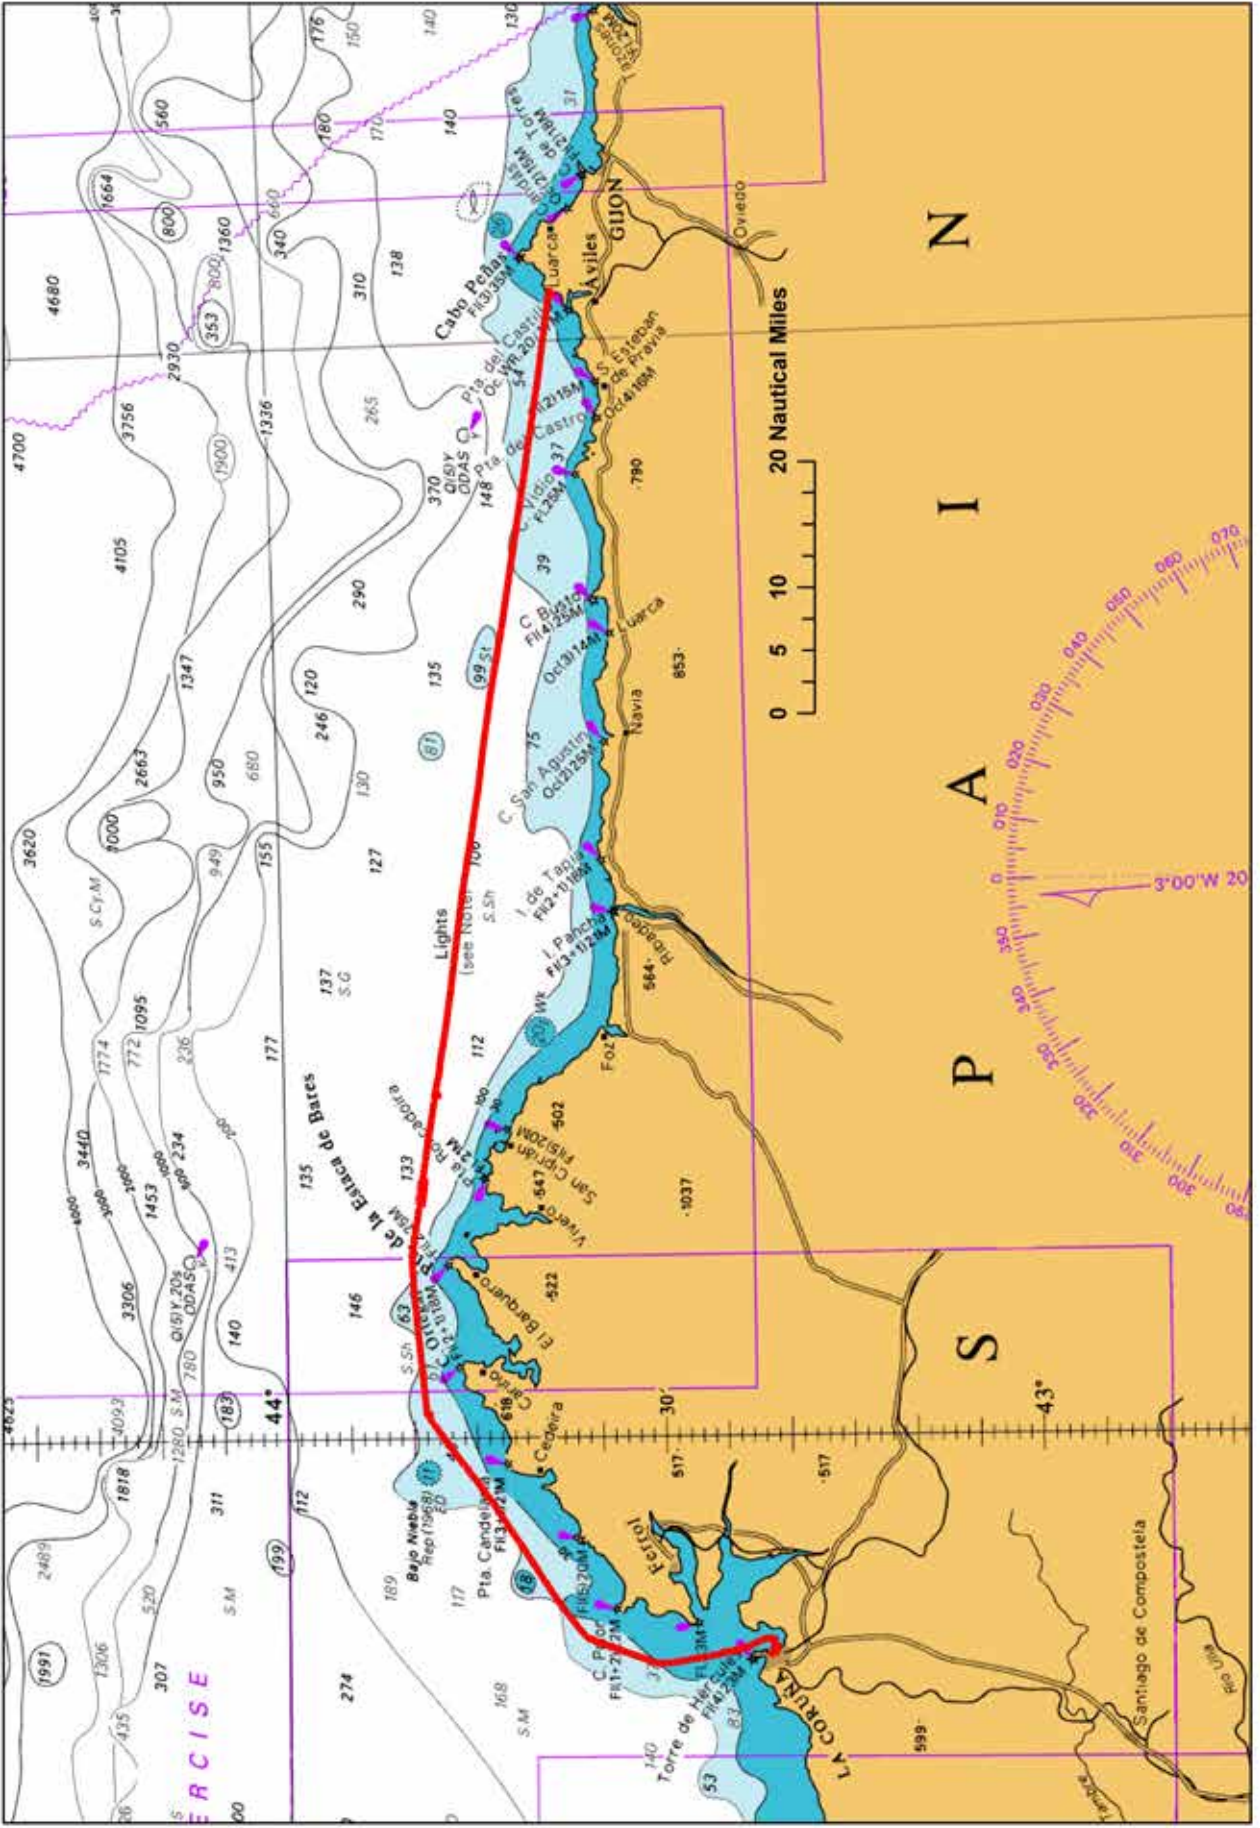
Figure 1: Beaumont's track from La Coruna to grounding

At 0308 UTC on 12 December 2012, the dry cargo vessel *Beaumont* ran aground on Cabo Negro on the north Spanish coast while on passage from La Coruña to Avilés (**Figure 1** overleaf). At the time of the grounding she was proceeding at full speed, and the officer of the watch (OOW) was asleep.

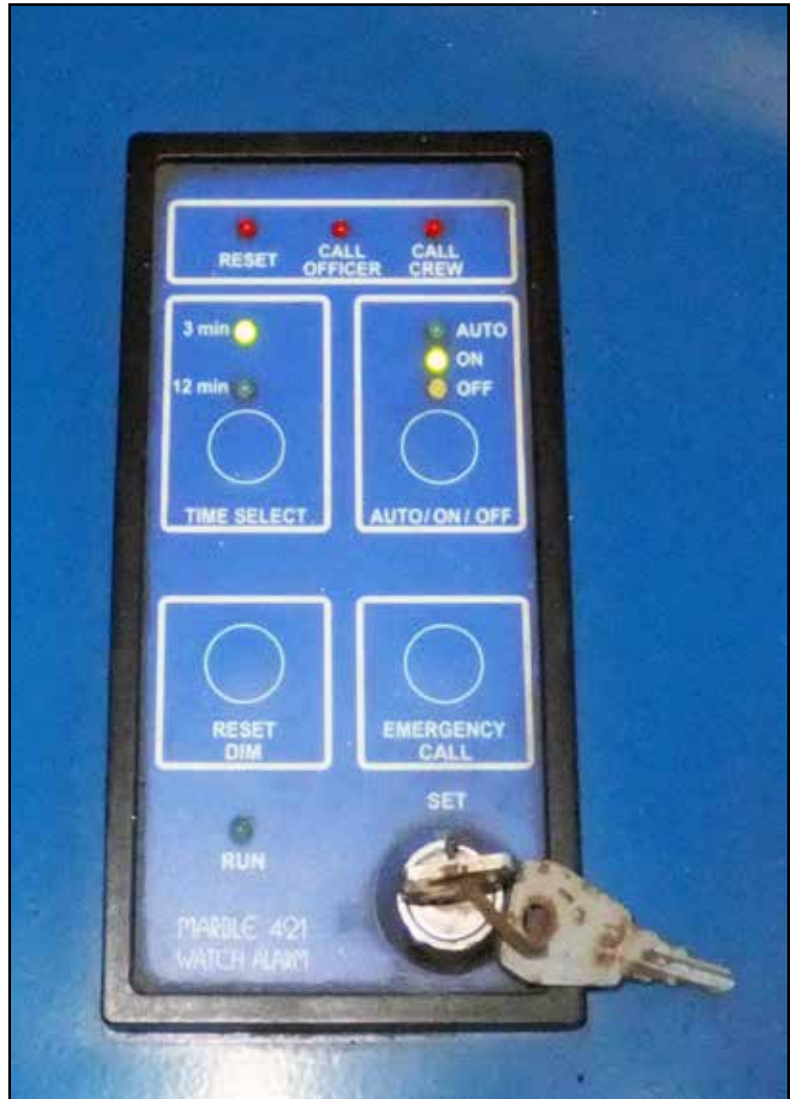
**Figure 2:** Bridge navigation watch alarm system's control

Notwithstanding the benefits of these systems, it is possible that the chief officer could have slept through these alarms, given the depth of his slumber. However, though not required by regulation at the time of the accident, *Beaumont* was also equipped with a BNWAS. This device was specifically designed and fitted to alert or draw attention to an incapacitated OOW. However, the vessel's managers did not specifically require the BNWAS to be in operation at sea and consequently it was seldom, if ever, used by the bridge watchkeepers.

- Navigational aids were not used effectively to ensure a vigilant and effective watch was maintained at all times.
- The vessel was equipped with a BNWAS. However the ship's managers did not require that this equipment was used at sea and it was seldom, if ever used by the bridge watchkeepers.

- Revised its SMS to require:
  - The use of lookouts during the hours of darkness
  - The use of radar and echo sounder alarm facilities
  - The use of BNWAS when vessels are underway.

- Paper charts are used as the primary means of navigation.
- Where technically possible, linked BNWAS systems with autopilots so that the watch keeping alarm is operational whenever the autopilot is in use.

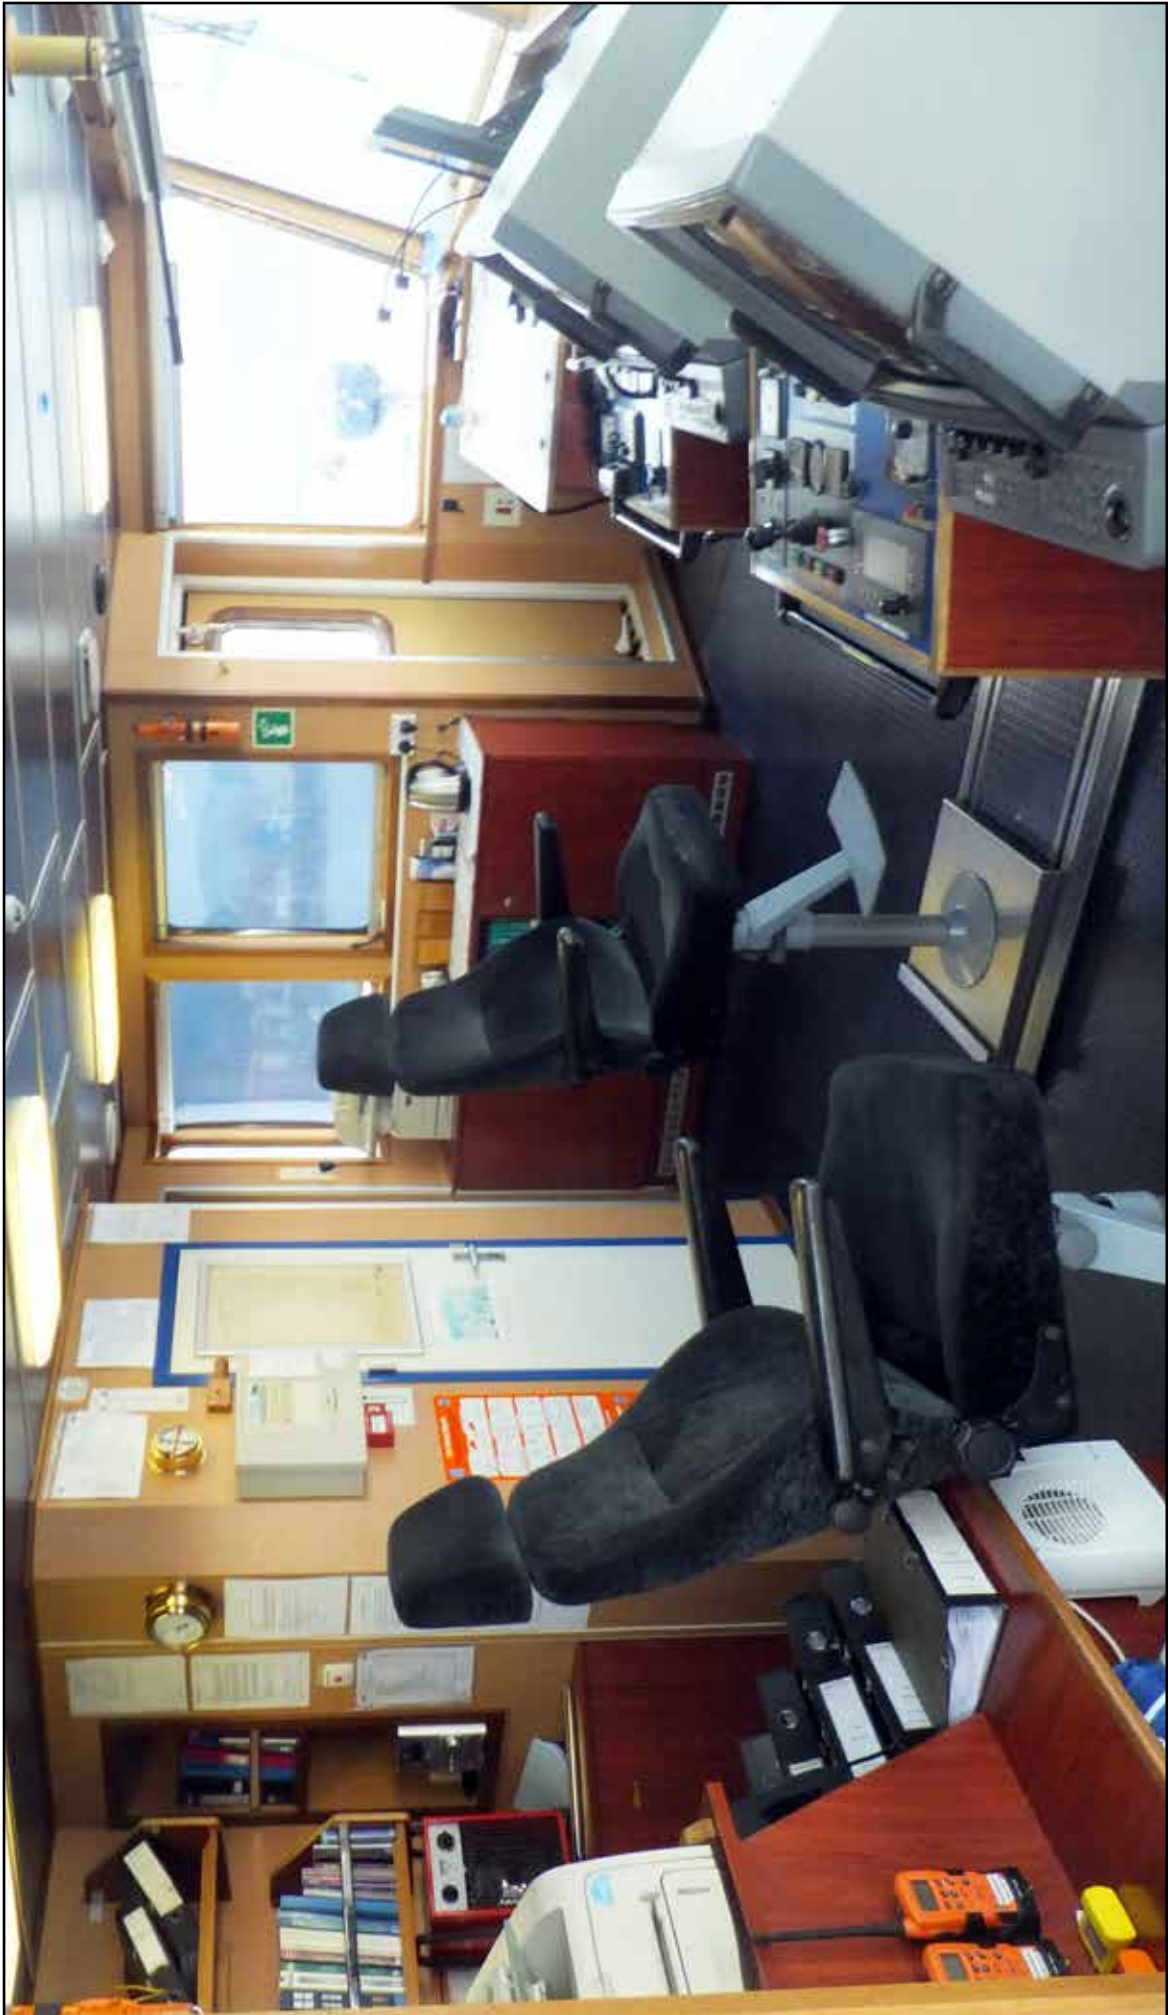
Figure 4: Bridge chairs

*Beaumont's* bridge environment was described as 'pleasant'; it was quiet, and the starboard bridge wing door was about 75mm ajar to provide some limited ventilation.

*Beaumont* ran aground after the chief officer fell asleep on watch due to lack of stimulation and probable fatigue. Lack of stimulation occurred as a result of being alone in a quiet, cosy bridge environment where none of the available safeguards had been utilised. The chief officer's fatigue would appear to be a result of the change to his pattern of work and rest on the day preceding the grounding.

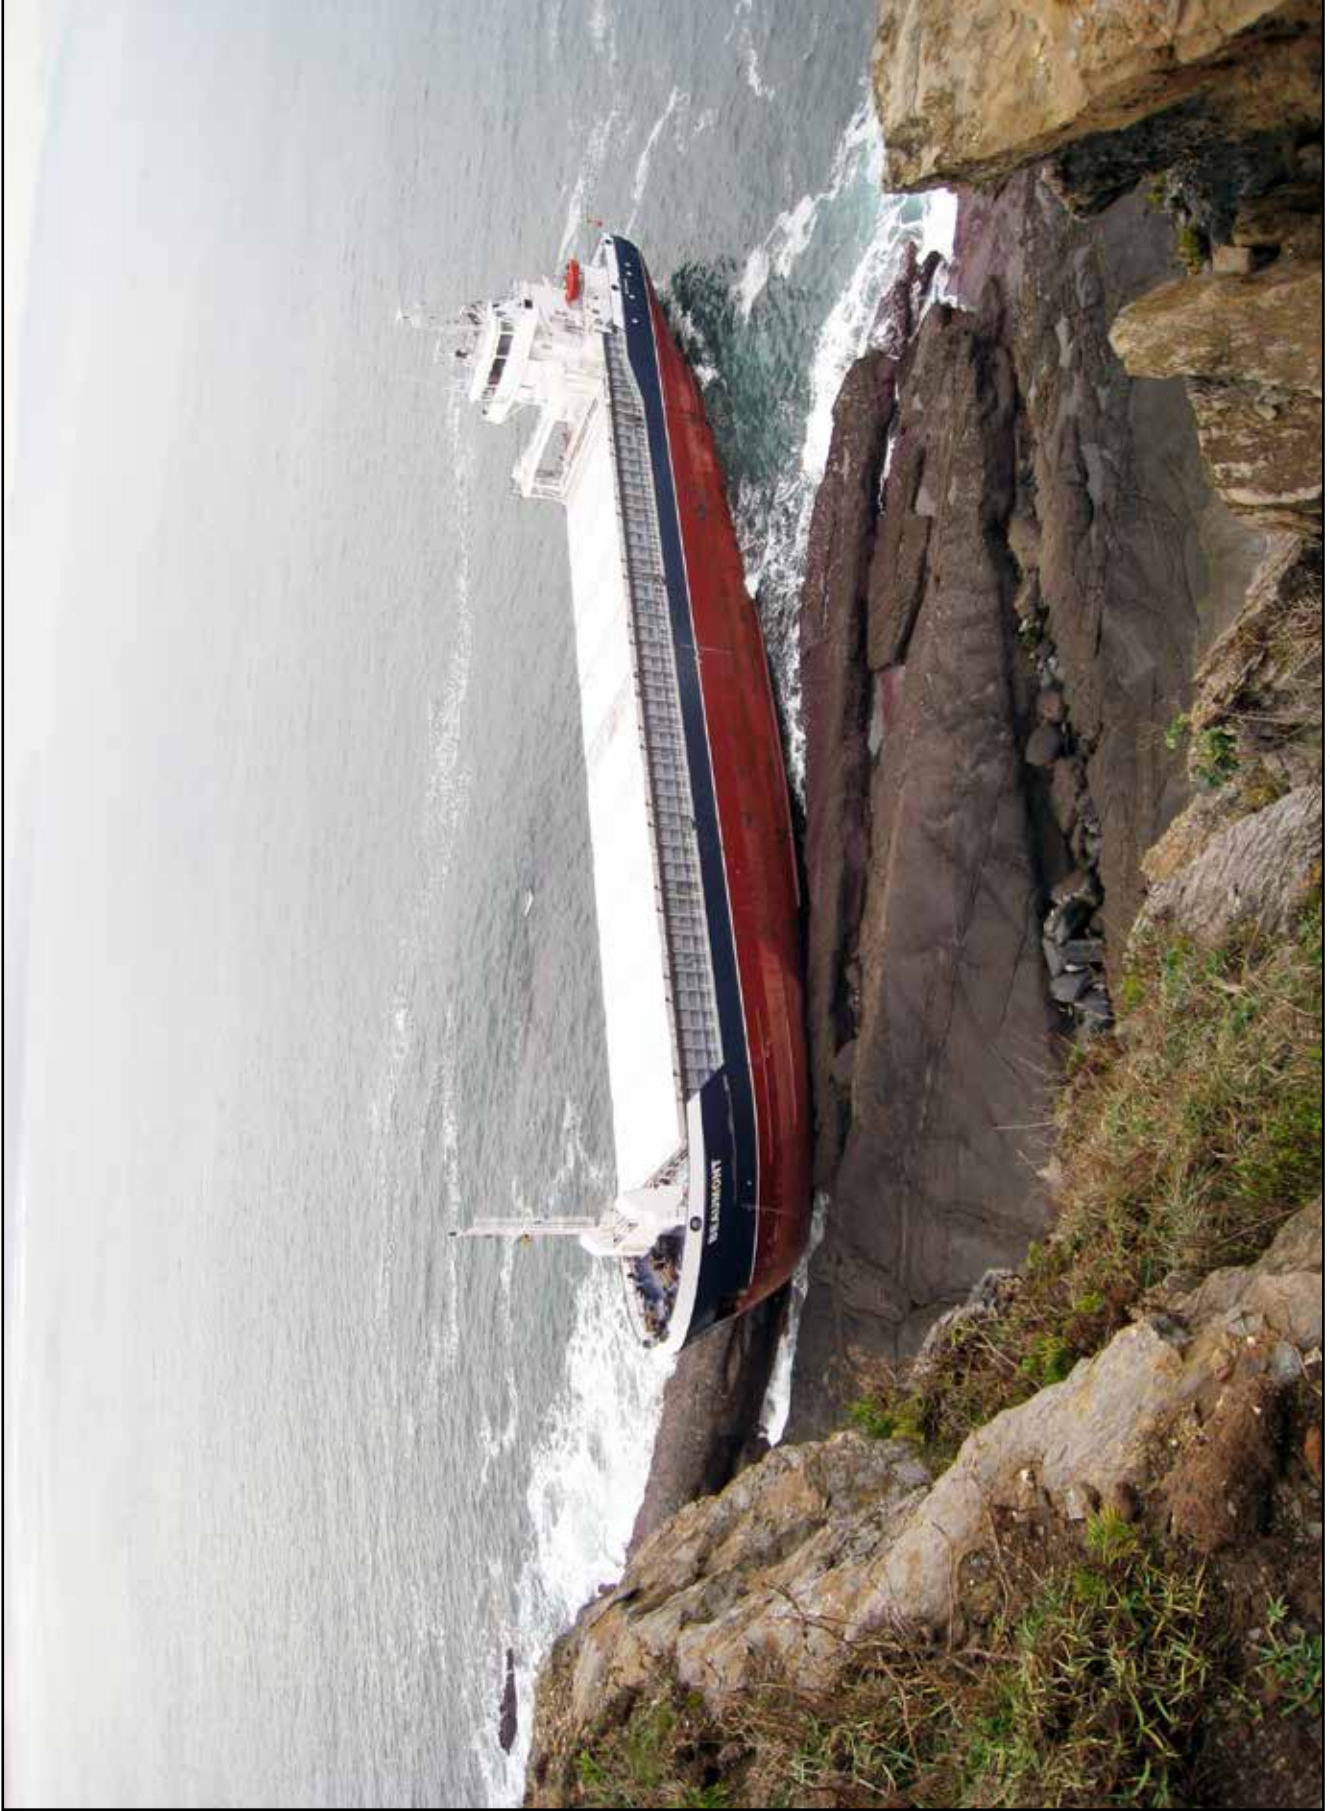
Figure 5: Beaumont aground on Cabo Negro

After ballast water had been pumped out, further internal inspection revealed that although *Beaumont's* double-bottom tanks and bow thruster compartment had been damaged, the vessel was not holed.

As daylight broke and the tide continued to fall, *Beaumont's* situation became more apparent (**Figure 5**), with much of her underwater hull visible. During the early morning, the tug *Maria de Maeztu* arrived on scene and passed a tow line to *Beaumont*. Low water was at 0806 and as the tide rose *Beaumont* began to refloat. At 1216 *Beaumont* came free of Cabo Negro with the use of her own engines and the assistance of *Maria de*
