Combined report on the investigation of the contact with a floating target by the wind farm passenger transfer catamaran

Windcat 9

while transiting Donna Nook Air Weapons Range in the south-west approaches to the River Humber on 21 November 2012

with turbine I-6, in Sheringham Shoal Wind Farm on 21 November 2012

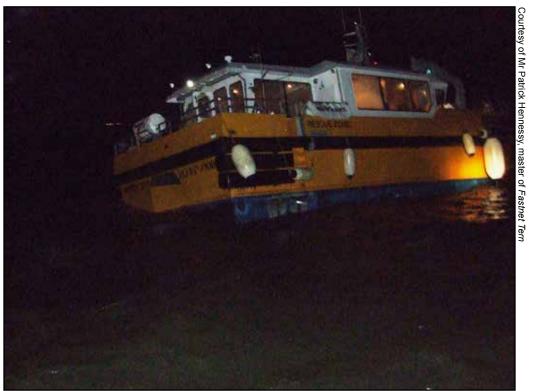
Figure 10: Windcat 9 stable with a 12-15° list to port

scene within 20 minutes. The master decided that nothing more could be done to deal with the flooding and he, the trainee master and deckhand transferred to the safety of *Fastnet Tern*. The control room was advised of the situation and that the vessel appeared to be stable and had settled with a 12-15° list to port (**Figure 10**).

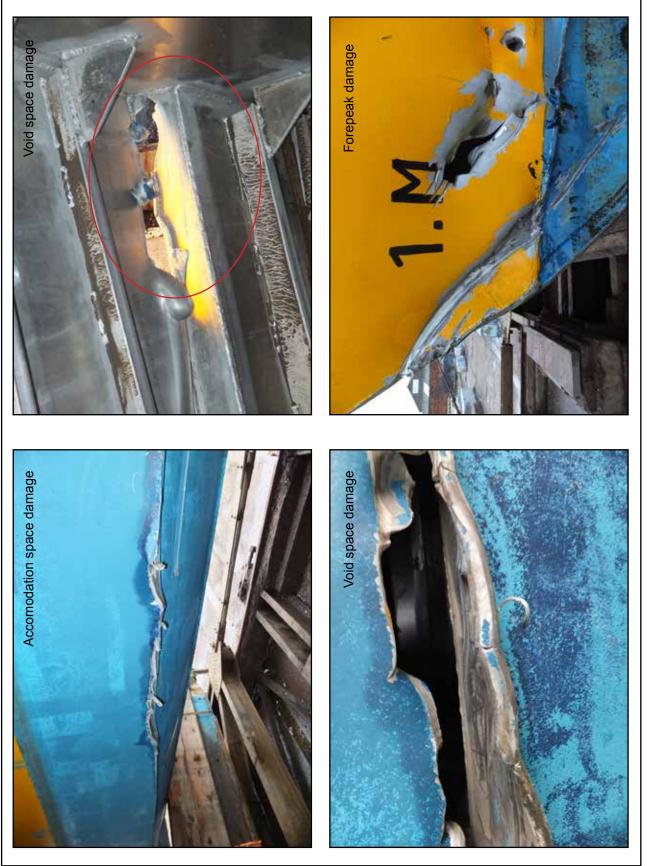
The contact damage sustained by *Windcat 9* was extensive throughout the port hull aluminium shell plating in way of the forepeak, accommodation space and engine room. The accommodation space also suffered frame damage. Numerous electrical fittings were water-damaged as was the port main engine.

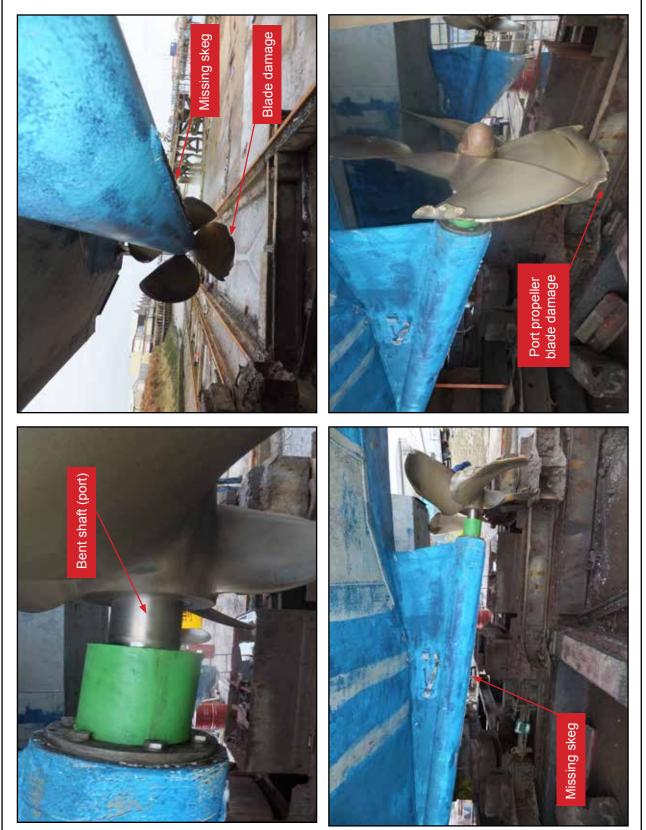
Figure 12: Composite image of the external damage

Externally, the port shaft tube skeg was detached. The port propeller shaft was bent and the port propeller blades suffered major distortion. Composite images of the hull shell plate and external damage are at **Figures 11** and **12** respectively.

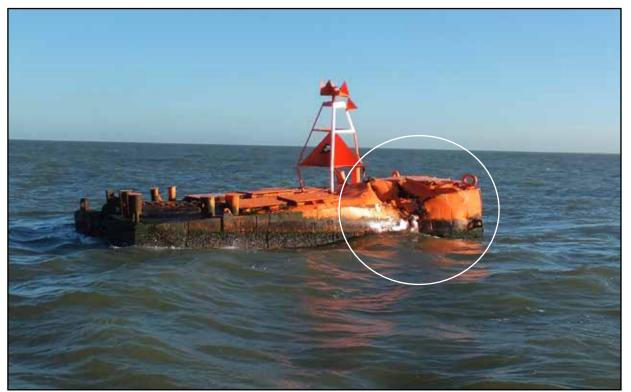
Figure 13: Target 3 general damage

Target 3 suffered extensive damage to one of its sides, which fractured a number of doubler plates as well as the original plating **(Figure 13)**. The impact caused the plates to be set back by about 1m and the deck to be raised by about 0.75m.

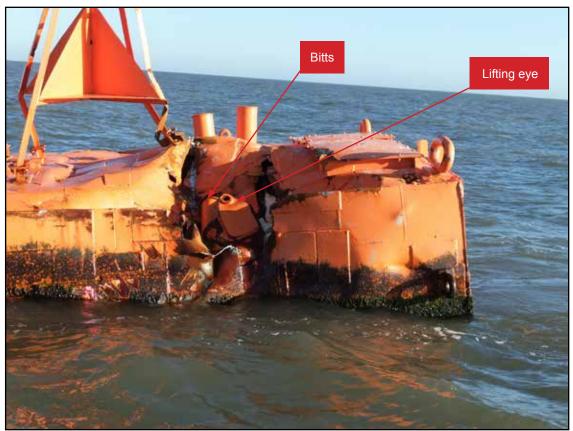
Figure 14: Target 3 damage showing displaced bitts and lifting eye

The radar reflector supporting structure was damaged and one set of bitts and a lifting eye plate were displaced (**Figure 14**). The target's foam-filled cavity provided sufficient buoyancy to enable it to remain afloat despite the damage it had sustained.

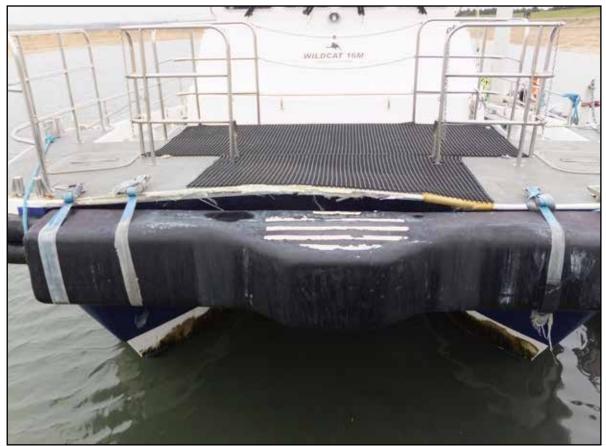
The major damage to the vessel occurred to the bow area immediately aft of the bow fender, which had absorbed some of the impact (Figures 33 to 35). The damage to the starboard hull was worse than that to the port hull, indicating the contact was to the starboard side of the centreline. The forward deck had lifted because the deck/hull joint had been split as the fender housing took the impact.

Figure 33: Damage to bow

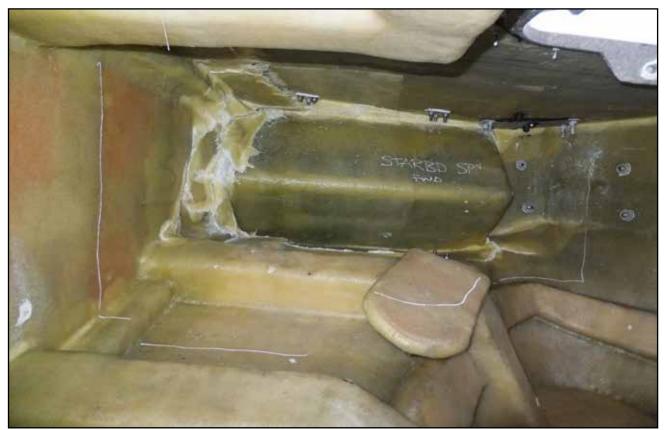
Figure 34: Damage within starboard outboard void

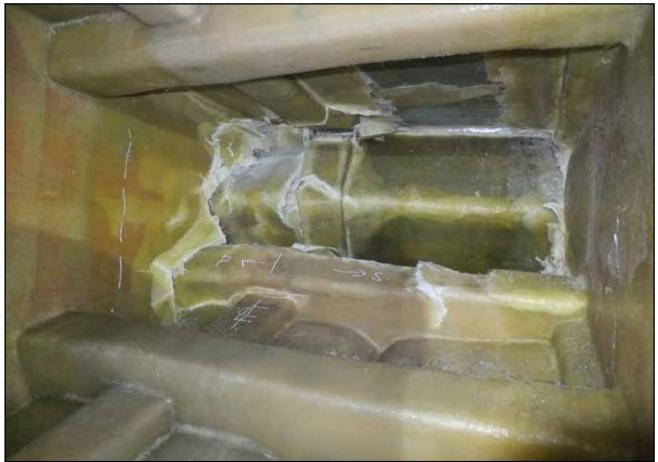
Figure 35: Damage within starboard inboard void
