Report on the investigation of
the contact and grounding of
the bulk carrier

Amber

at Gravesend Reach, River Thames

on 15 November 2012

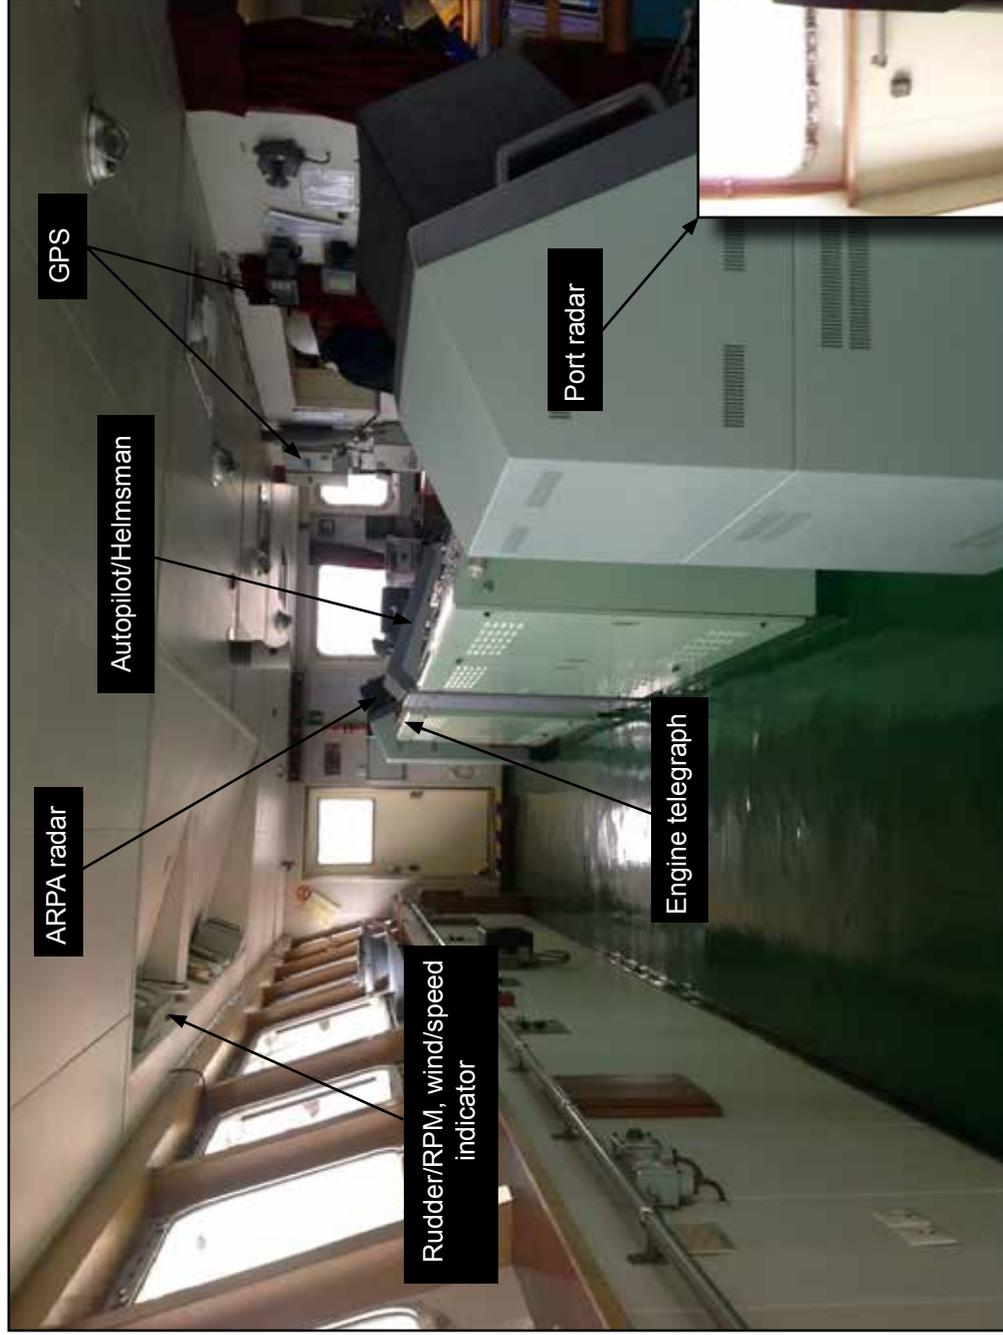
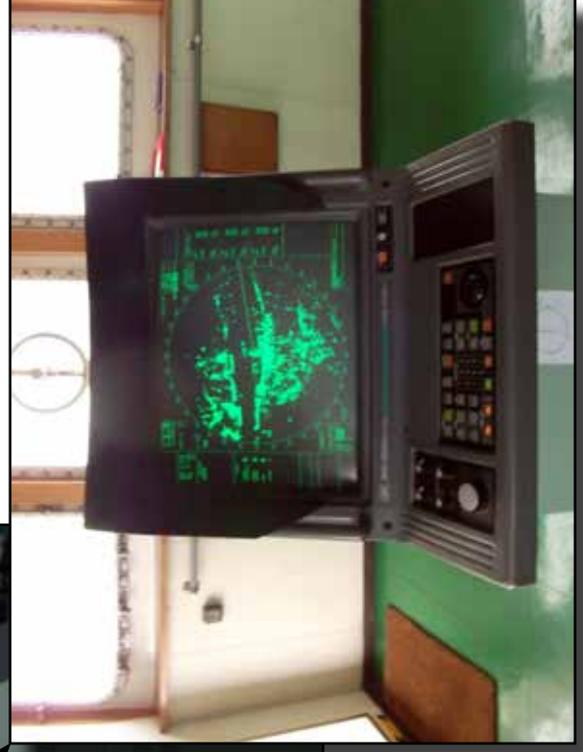
Figure 3: Amber's bridge showing port radar set

The vessel's bridge equipment was prepared for departure and the pilot requested the radar (**Figure 3**) to be set up on the 1.5nm range, north-up with the variable range marker (VRM) set to 0.14nm and the electronic bearing line (EBL) set to 090°.

The OOW was unable to set up the VRM and EBL as requested and the pilot, master and OOW spent several minutes at the radar until the settings requested by the pilot were achieved.

Amber arrived in the Thames estuary without an operational 3GHz radar and consequently also without an operational ARPA. This deficiency was recorded on the PLA's internal pilotage records but was not reported to the MCA, contrary to the Merchant Shipping (Port State Control) regulations. Had *Amber's* defective radar defect been reported to the MCA, this would have triggered a Port State Control inspection of the vessel that would have resulted in the vessel being detained in port until the radar was repaired.

That *Amber* had been operating for several weeks without a functioning ARPA, contrary to SOLAS requirements, also indicates that the vessel's defect reporting procedures, as specified in its Safety Management System (SMS), were not being complied with.

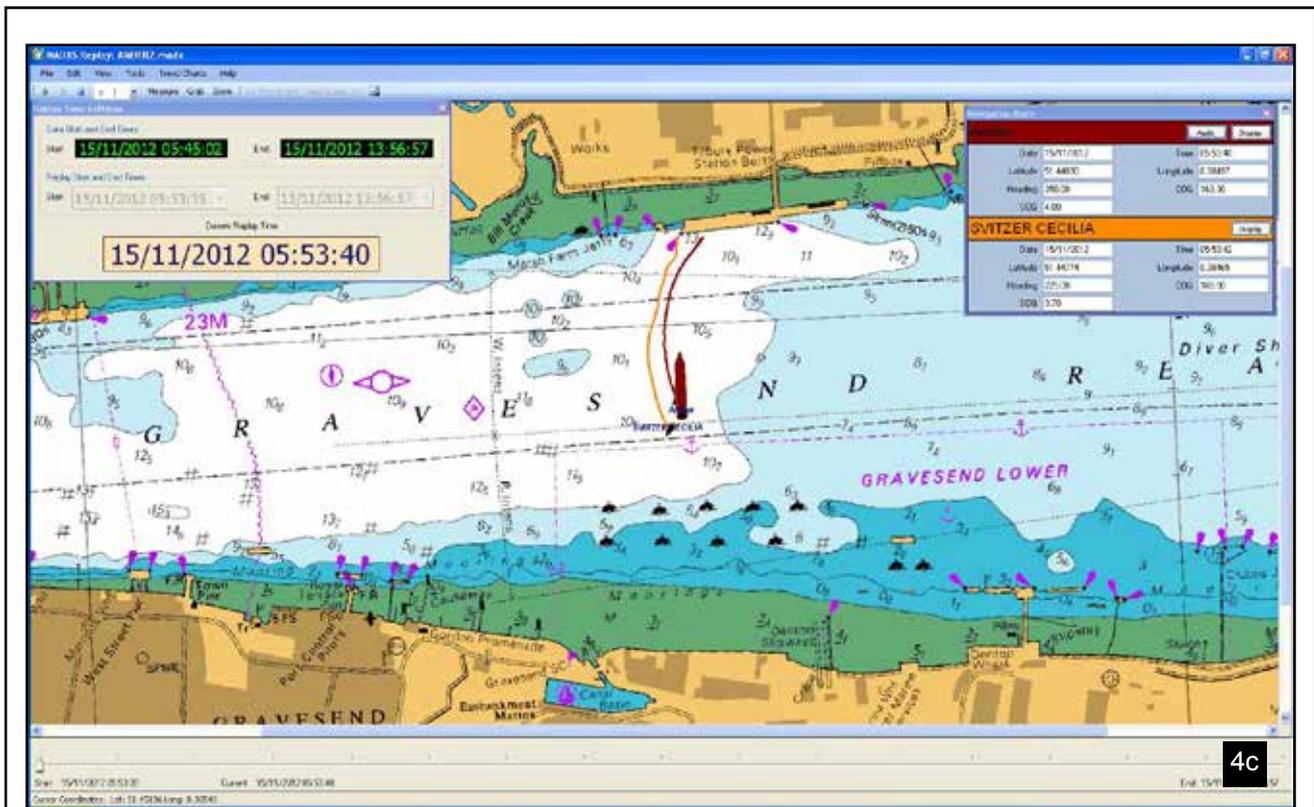
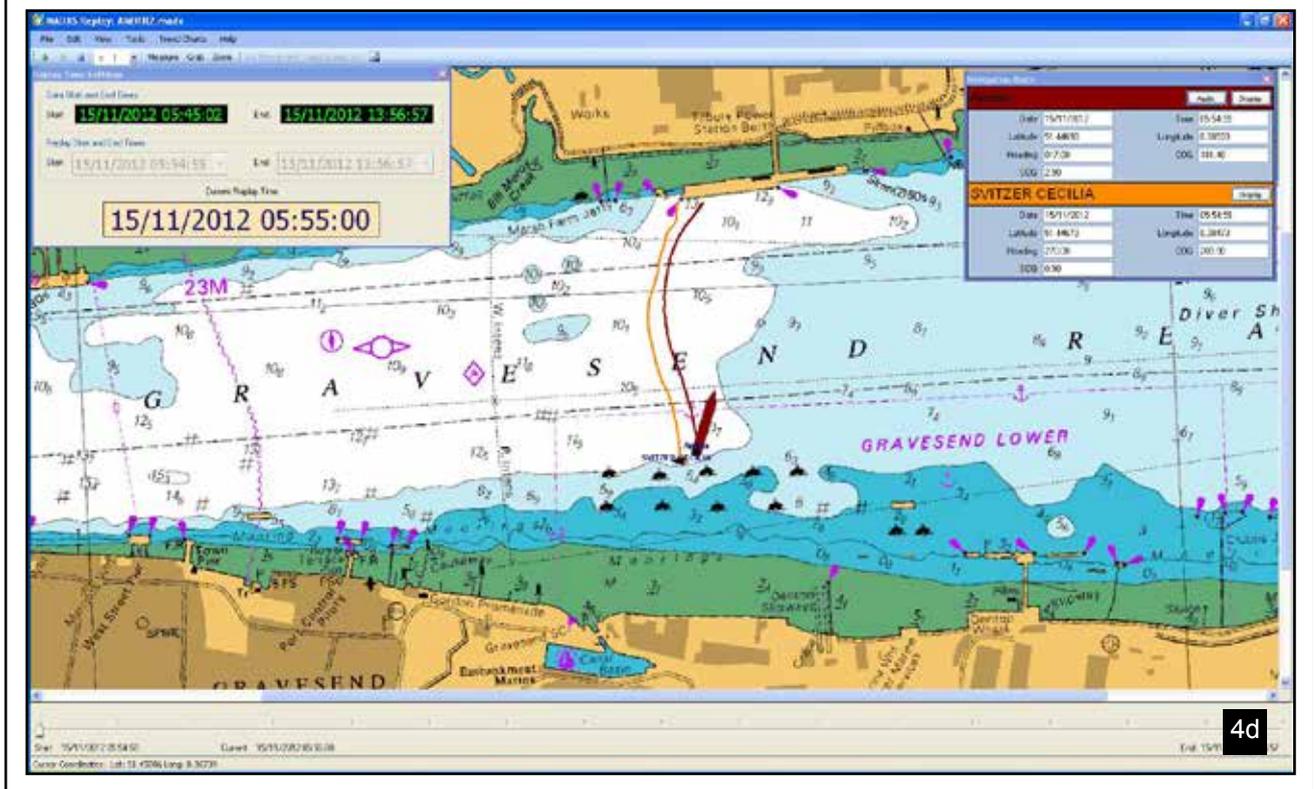
Figures 4c and 4d: Amber's manoeuvre from departure to accident

At 0555 VTS warned *Amber's* pilot by VHF that the vessel was south of the fairway (**Figure 4d**). The pilot attempted to reply from the VHF radio set in the centre of the bridge. However, the handset was defective, so he moved to use the set on the starboard side of the wheelhouse from where he informed VTS that he was aware of the vessel's position. The pilot then ordered *Amber's* engine to full ahead and for the OOW to steer a heading of 073°.

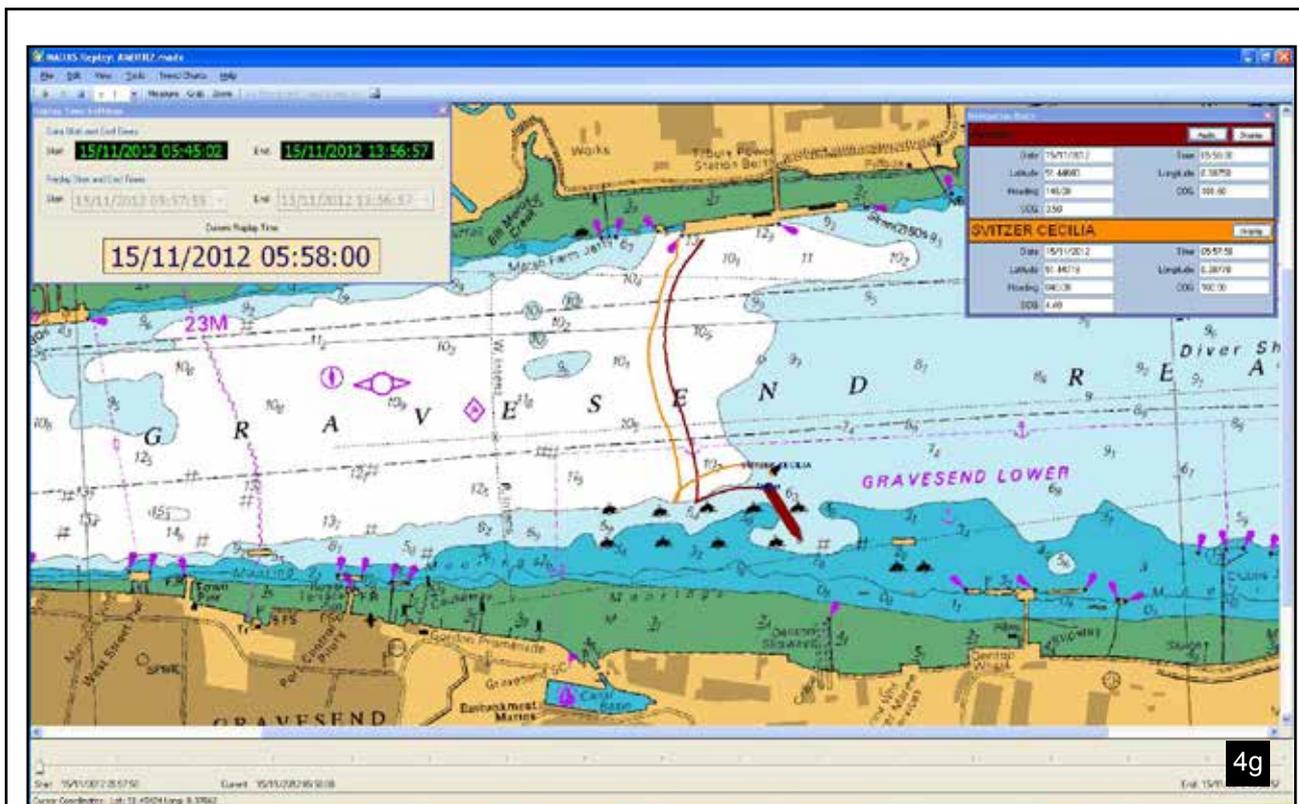
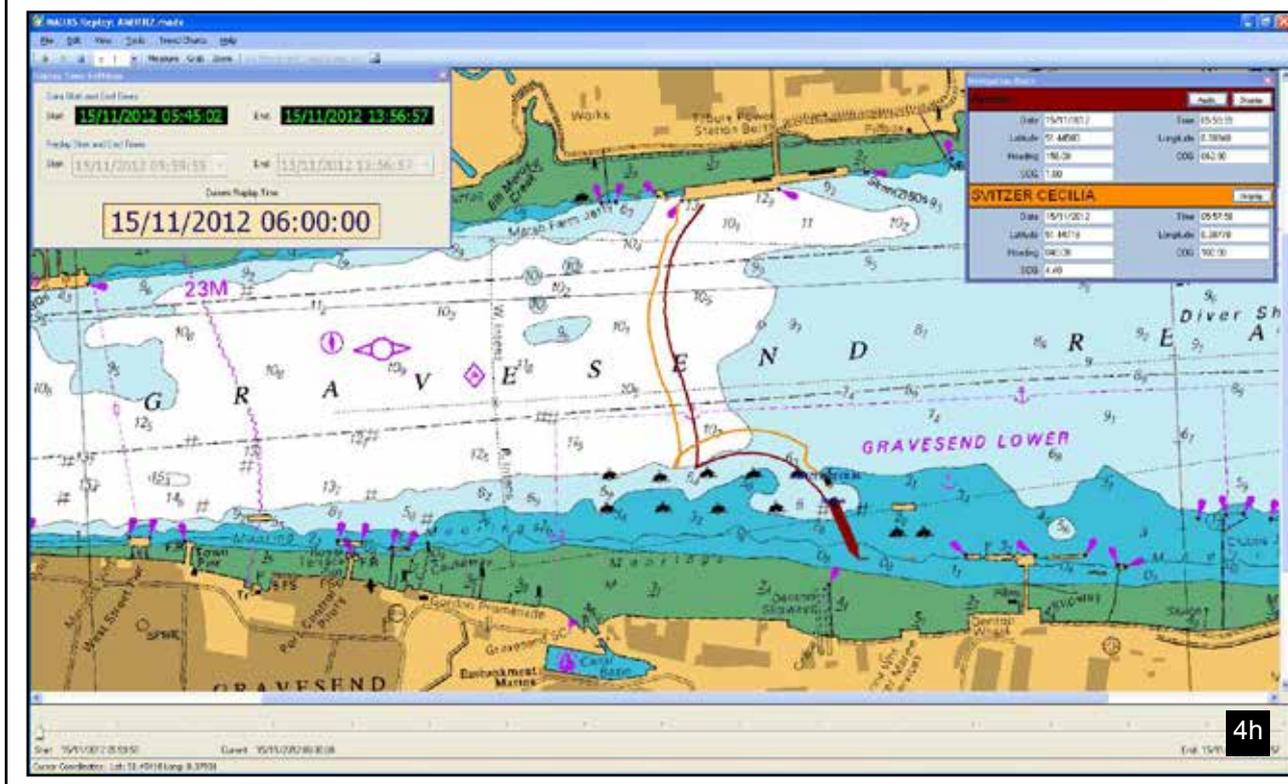
Figures 4g and 4h: Amber's manoeuvre from departure to accident

At 0558 (**Figure 4g**) *Amber* was continuing to swing to starboard at 3.5 knots SOG, the helm was hard-to-port and the engine was set to full-ahead, when the helmsman arrived on the bridge to replace the OOW at the helm. At 05:58:20 the master informed the pilot that the vessel's engine was working normally and that he had instructed the engineers to increase power to full sea speed³.

A short time later *Amber*'s master suggested, in a soft voice, that the engine should be stopped, but no action was taken. At 0559 the forward mooring party reported that there were small craft close ahead and recommended that the vessel be stopped. The master relayed this information to the pilot, who responded that he was aware of the situation but that there was nothing that could be done.

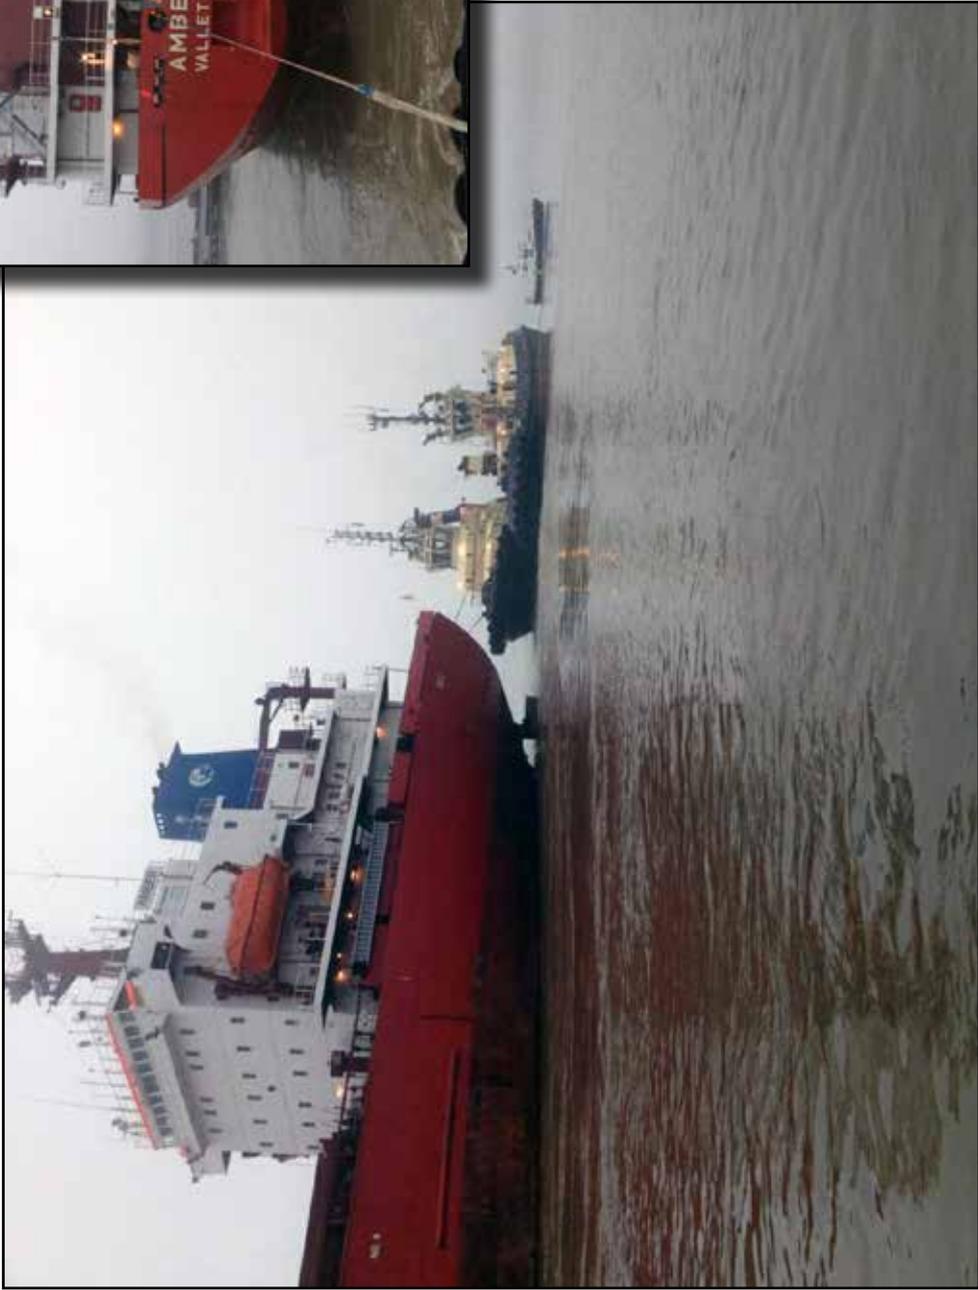
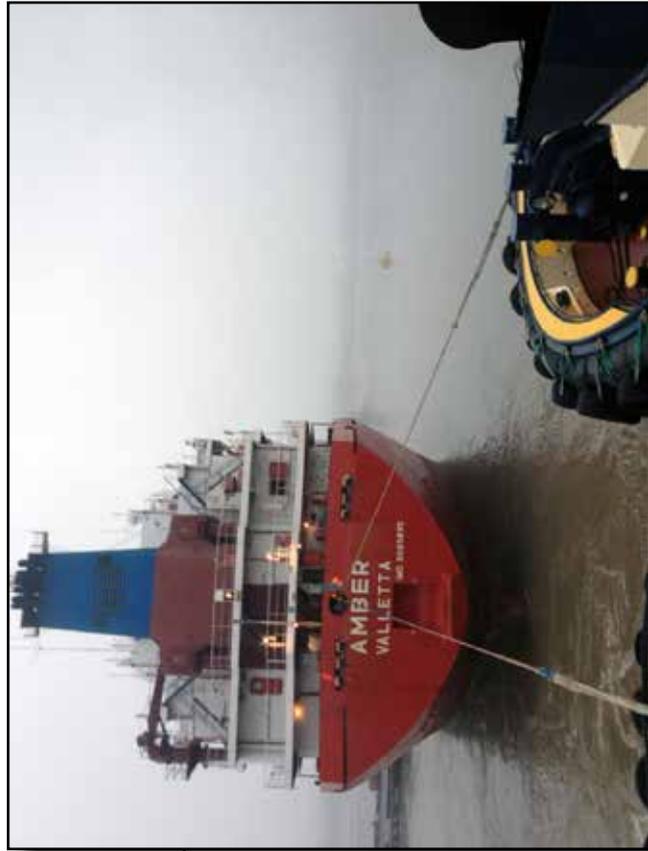
Figure 5: Tugs attempting to refloat Amber

Svitzer Cecilia continued to pull astern, with no movement from *Amber*, and at 0642 the tug *Millgarth* was also made fast aft. Both tugs were ordered to apply 75% power and *Amber*'s engine was put to full astern, but the vessel did not move (**Figure 5**). The forward mooring party reported that a barge, which had been close to the vessel's port side, made further contact with the vessel's hull at this time.

The immediate attempt to refloat *Amber* was ill considered and contrary to both PLA instructions and the company's SMS. In this case, the attempt to refloat continued for some time and a second tug was connected to provide further assistance. Ironically, it is probable that the considerable wash generated by the tugs while attempting to pull *Amber* clear, caused the barges to make further contact with the vessel's hull, resulting in further damage.

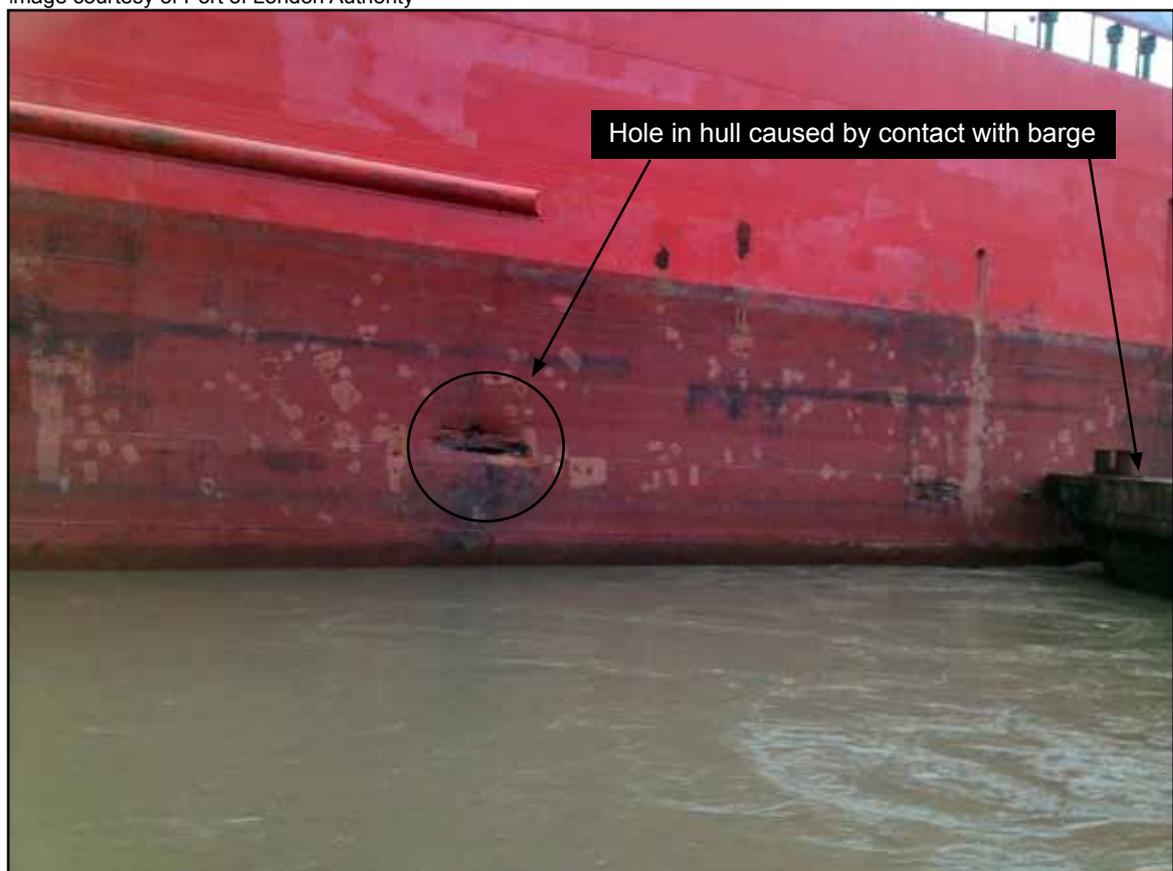
Figure 6: Shell plating damage to *Amber*

Amber's shell plating was holed above the waterline as a result of the contact damage, and the vessel was out of service for 2 weeks while repairs were carried out. A number of barges and other craft were damaged by the contact and one was set adrift when its moorings were broken. No environmental damage occurred as a result of the accident.

PLA marine services staff were mobilised to recover the barge that had broken adrift and to check the damage caused to other moored craft in the area. At 0745 it was noted and reported to *Amber* that the vessel had been holed on the port side, above the waterline, in way of number 2 cargo hold (**Figure 6**). The pilot and ship's staff were unaware of this damage before they received this report.

Maritime and Coastguard Agency (MCA) surveyors boarded *Amber* and completed a port state control inspection, after which the vessel was moved into Tilbury Dock for repairs to the hull and the 3GHz radar.

Repairs to *Amber* were successfully completed on 30 November when the vessel left port to resume service.
