Fatal injuries to a crewman while securing a tug's tow wire on board the bulk carrier **WAH SHAN** River Humber 2 October 2012

SUMMARY

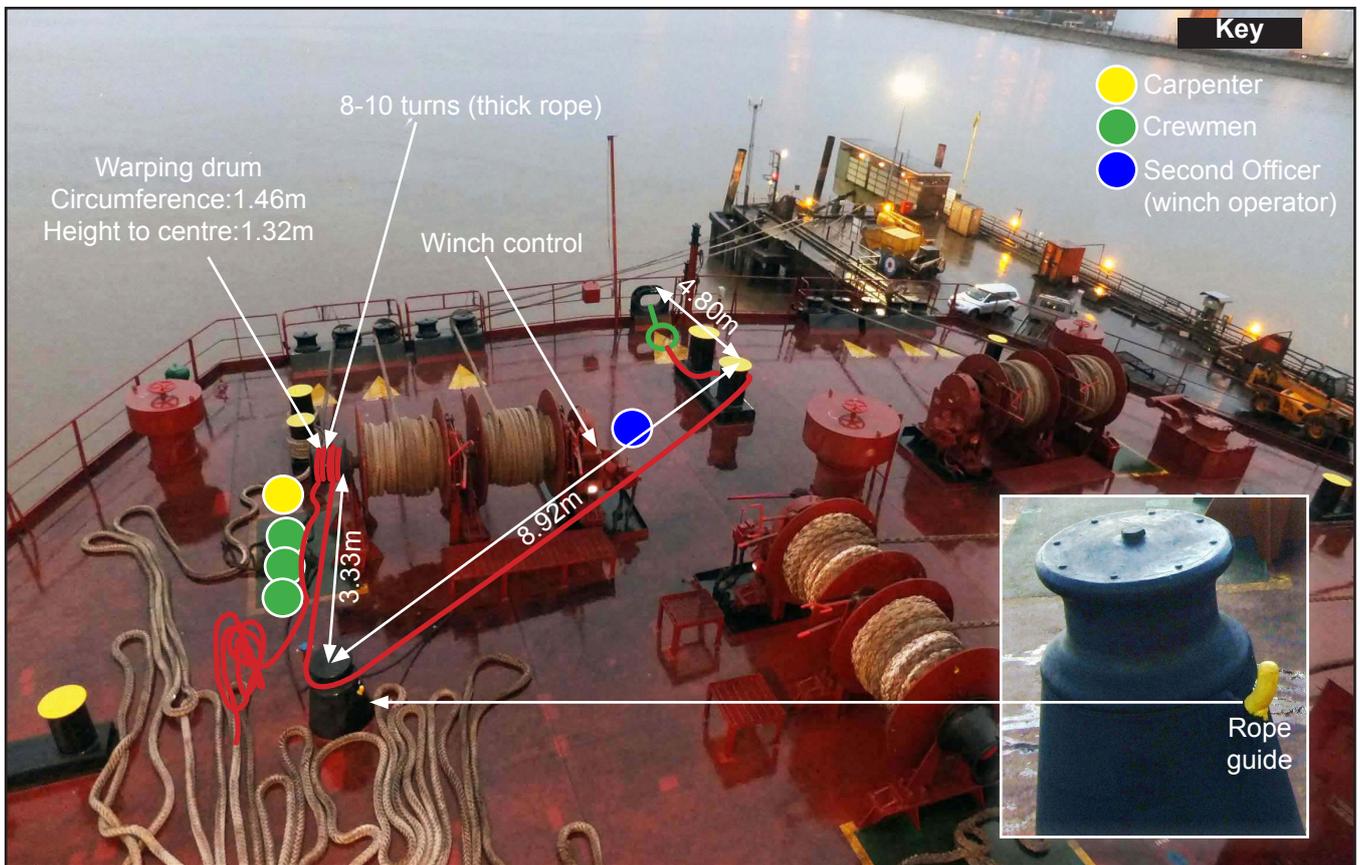
Figure 2: Layout of mooring equipment and messenger line routing at the time of the accident

The carpenter passed the messenger lines through the aft centreline bits and then diagonally across the deck, past the inboard side of the starboard winch, to a pedestal fairlead which was forward of the winch. He then passed the messenger line around the pedestal fairlead so it led off the outboard side of the fairlead to the warping drum (**Figure 2**). He then piled the free end of the

Once the aft mooring team decided to use the starboard winch to heave up the tow wire, they chose, and then persisted with, an unsuitable lead for the messenger line. The messenger line not only damaged the winch's hydraulic pipes, but also led onto the pedestal fairlead from the wrong direction. The pedestal fairlead was designed to assist in taking a breast or spring mooring line from ashore, with the line exiting from the pedestal on its inboard side. If it was used in this way, the line would lead onto the winch at a suitable fleet angle. There was also a rope guide positioned on the pedestal to support any slack lines when it was being used in this configuration (**Figure 2**). Routing the messenger line around the pedestal fairlead from the inboard to the outboard side caused it to have a lead angle onto the warping drum of more than 1.5° . This made the messenger line accumulate at the outer end of the warping drum as it rotated. In this state, the messenger line was far more likely to develop riding turns and, or, slip off the outer edge of the warping drum.

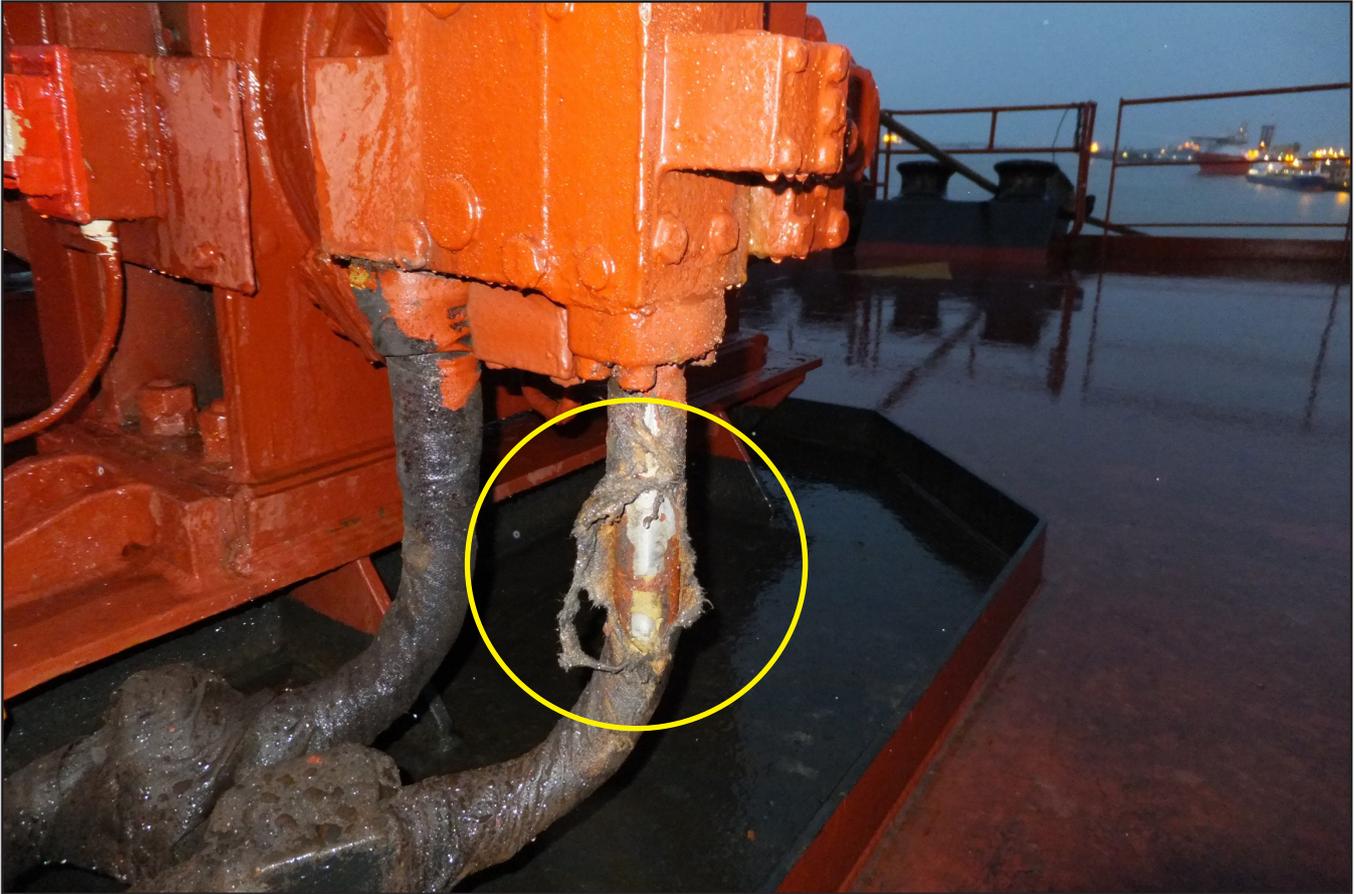
Figure 3: Chaffing marks on hydraulic pipe of starboard winch

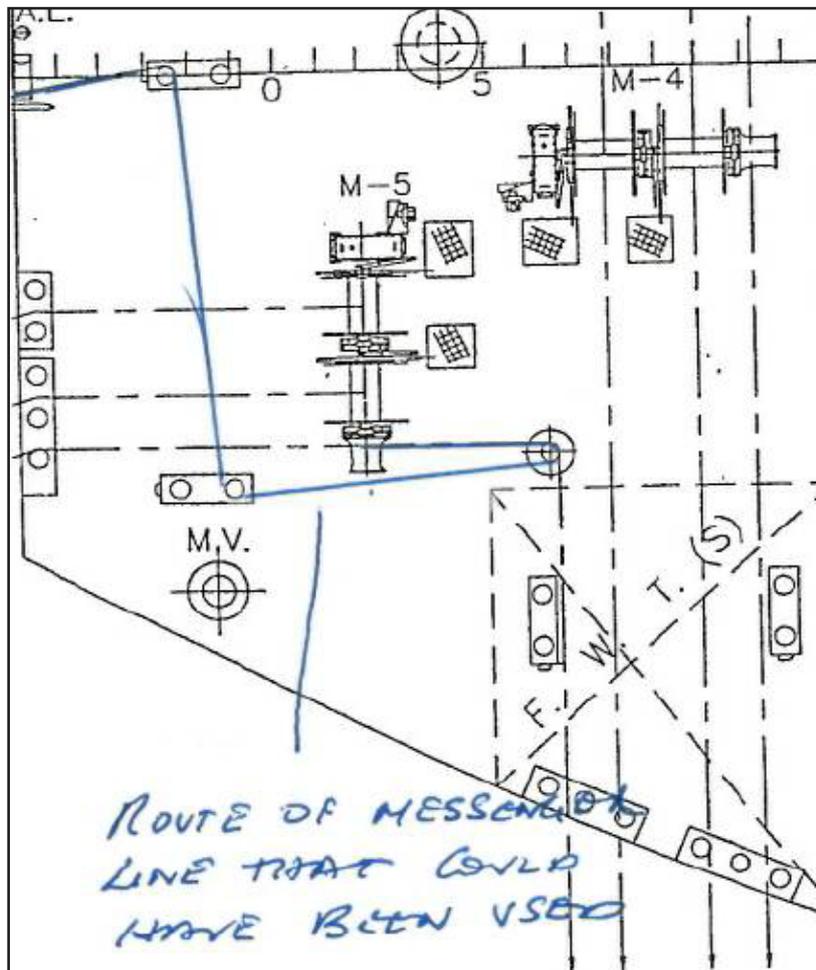
Shortly after the accident, *Wah Shan's* master in consultation with marine surveyors acting on behalf of the ship owner produced a sketch showing what he considered to be a better alternative method of heaving in a tow wire (**Figure 4**). The designated person ashore (DPA) from Sincere Navigation carried out an investigation on board after the accident and produced a different plan showing the method that he thought to be 'correct' (**Figure 5**). The forward mooring and towing arrangements were more simply arranged and are shown in (**Figure 6**).

Figure 4: Initial suggestion for an alternative method to take the towline

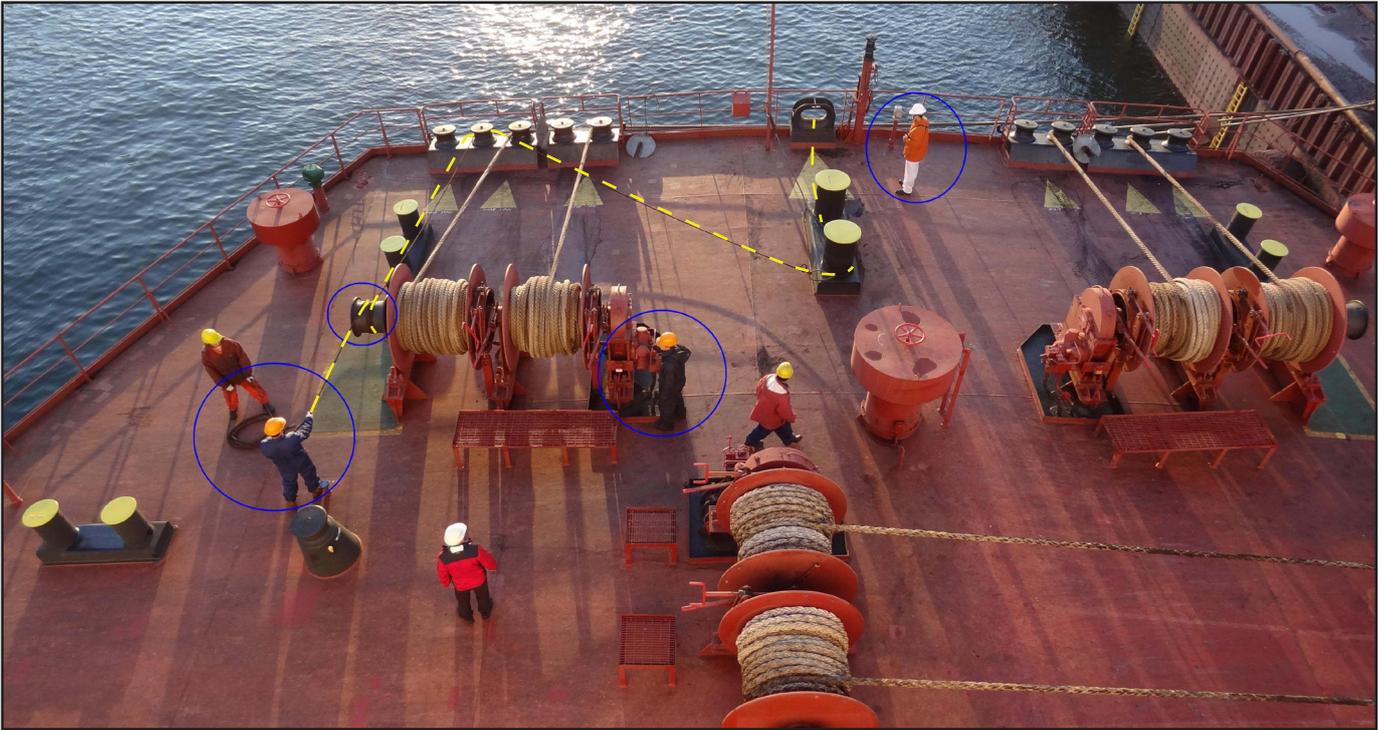
Figure 5: DPA's suggestion for the 'correct' method to take the towline

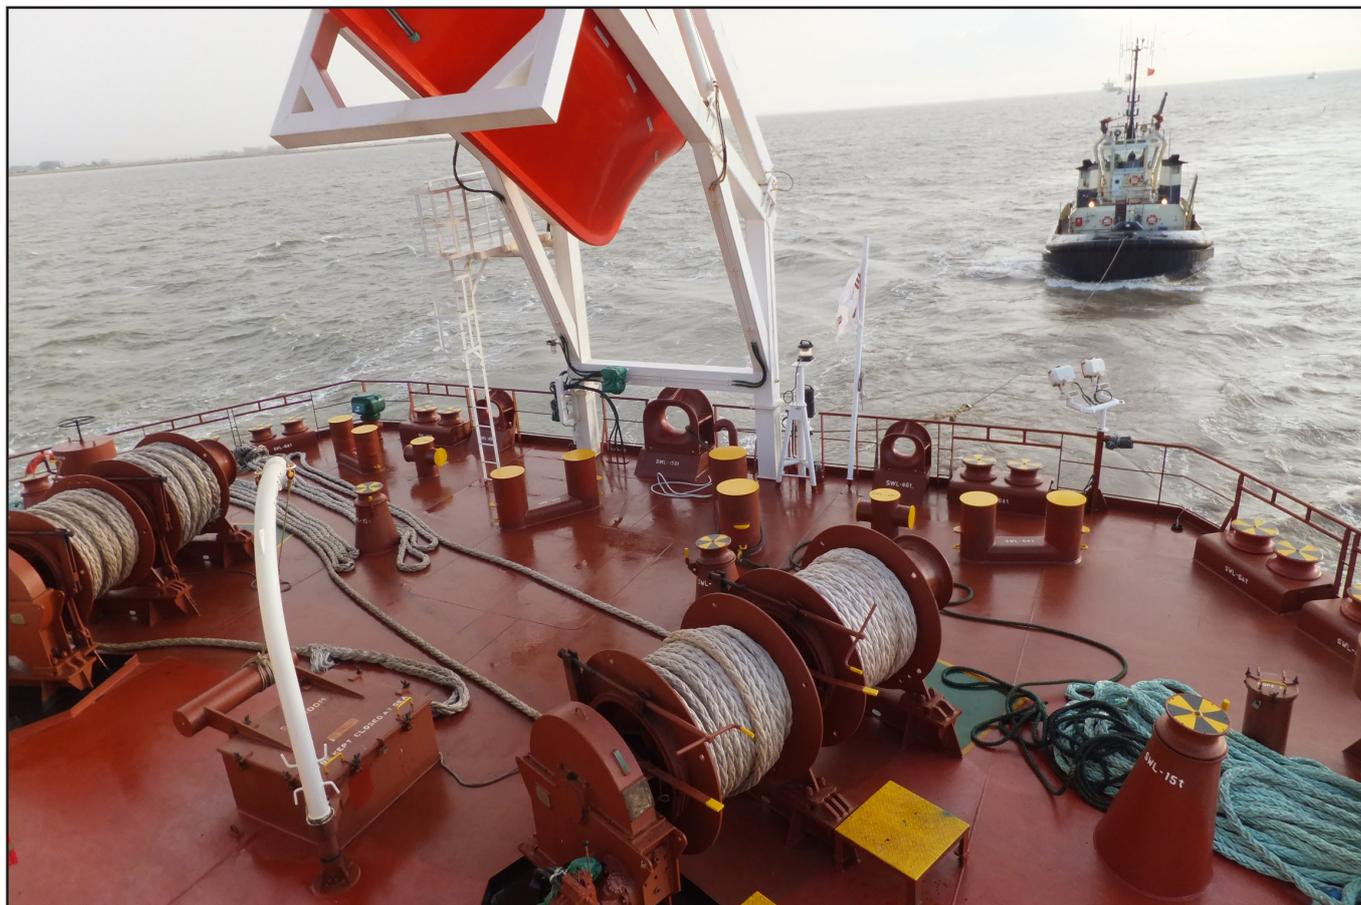
MAIB inspectors went on board a randomly selected bulk carrier arriving at Immingham to study the process used to secure a tug aft. The selected vessel was a Panamax⁷ size bulk carrier and the tug *Alma* was in attendance. The mooring equipment on this vessel was well positioned, making it readily apparent how a messenger line should be led from the centreline fairlead to the warping drum. The entire operation, beginning with sending a heaving line to the tug and ending with the eye of the towing pennant on the bitts, took less than 5 minutes. The mooring equipment on the bulk carrier's aft deck is shown in (**Figure 7**).

Figure 7: Aft mooring deck on a bulk carrier visited by MAIB
