Fatal injuries to a crewman while securing a tug's tow wire on board the bulk carrier **WAH SHAN** River Humber 2 October 2012

SUMMARY

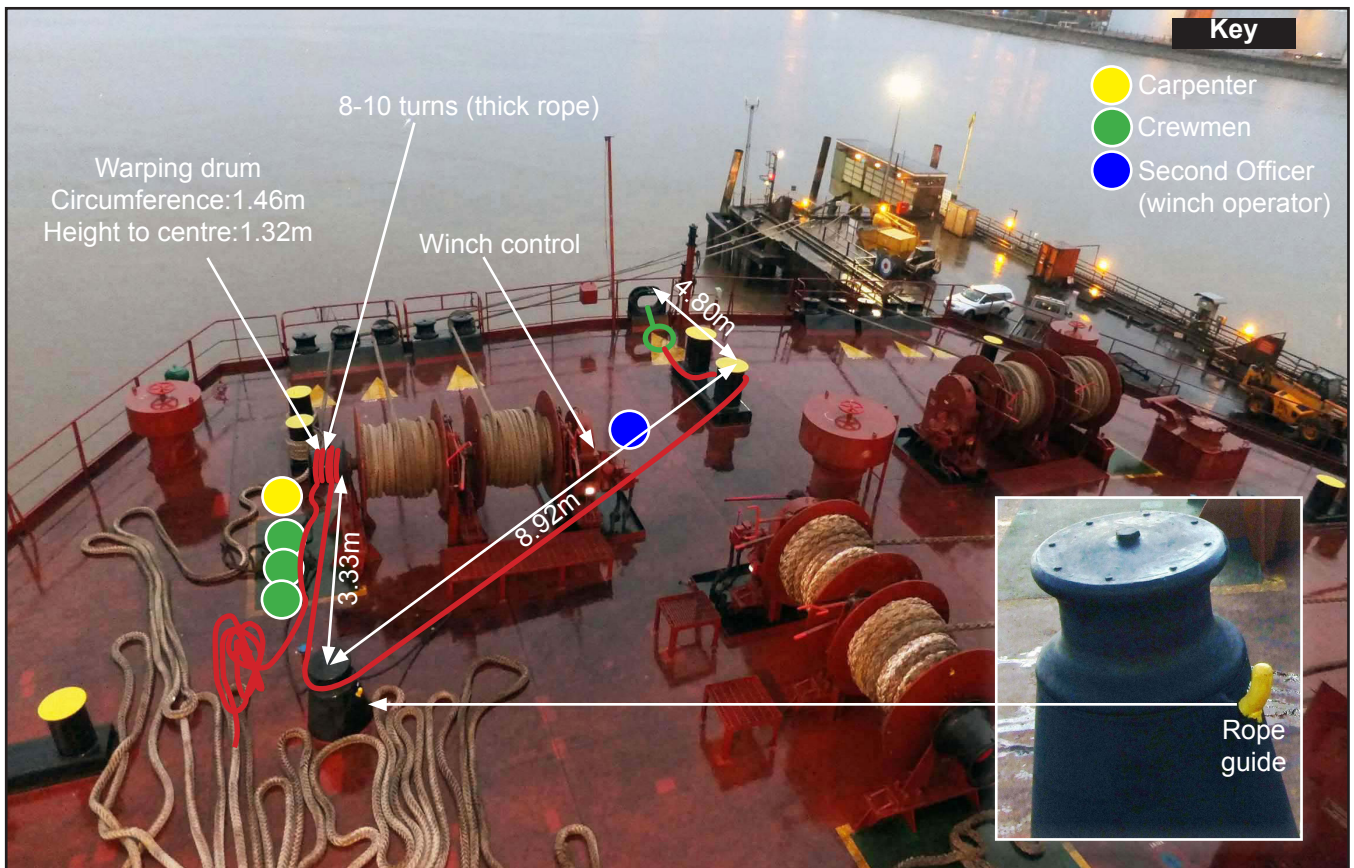
The carpenter passed the messenger lines through the aft centreline bits and then diagonally across the deck, past the inboard side of the starboard winch, to a pedestal fairlead which was forward of the winch. He then passed the messenger line around the pedestal fairlead so it led off the outboard side of the fairlead to the warping drum (**Figure 2**). He then piled the free end of the

Figure 2: Layout of mooring equipment and messenger line routing at the time of the accident

The carpenter had taken approximately eight to ten turns of the messenger line around the drum; and these turns accumulated towards the outboard end of the drum as it rotated due to the angle of the lead from the pedestal fairlead. The free end of the messenger line then became entangled in 'riding turns'², causing it to be heaved back into the

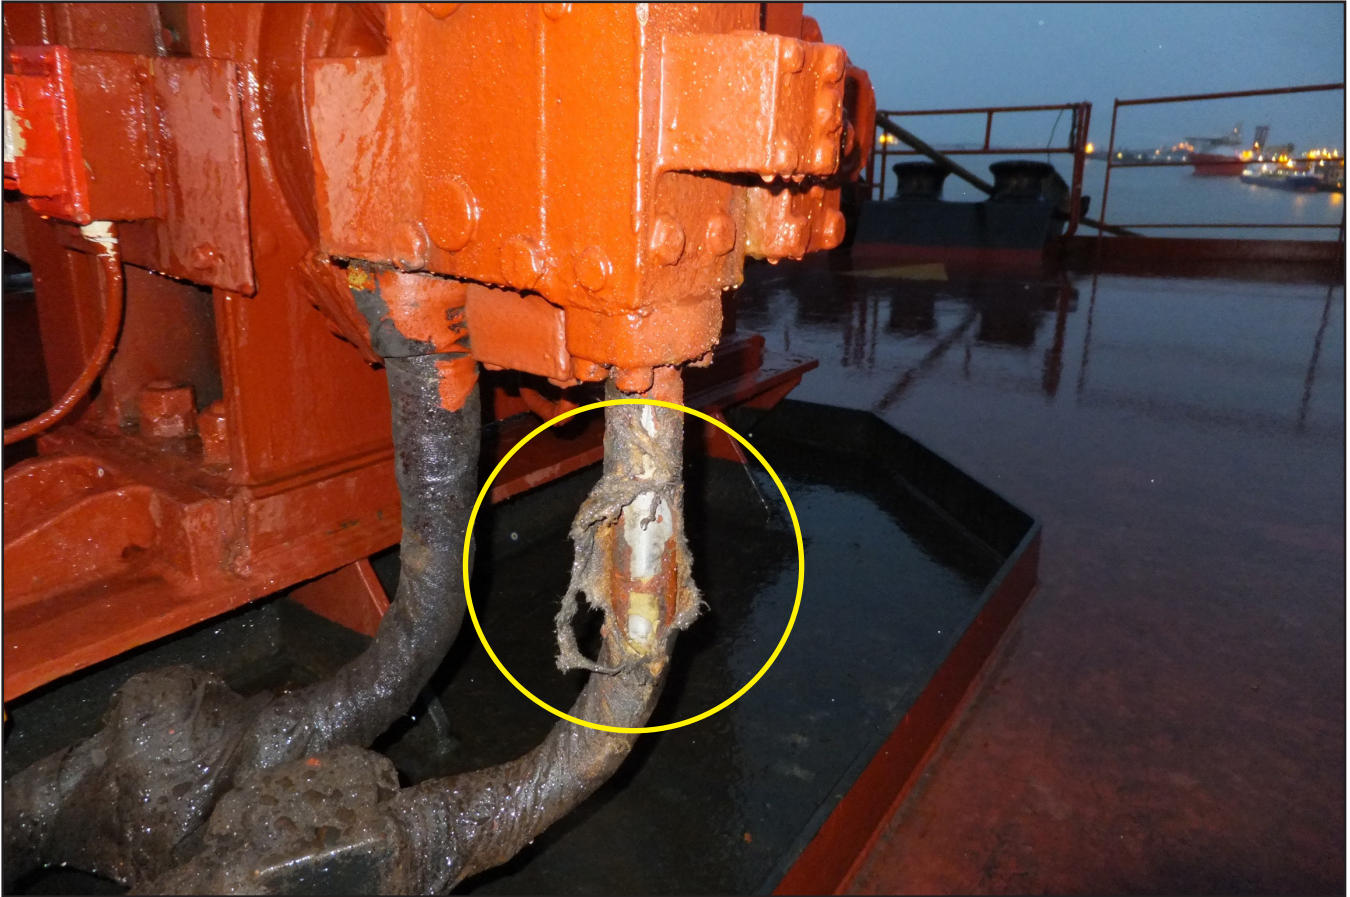
Figure 3: Chaffing marks on hydraulic pipe of starboard winch

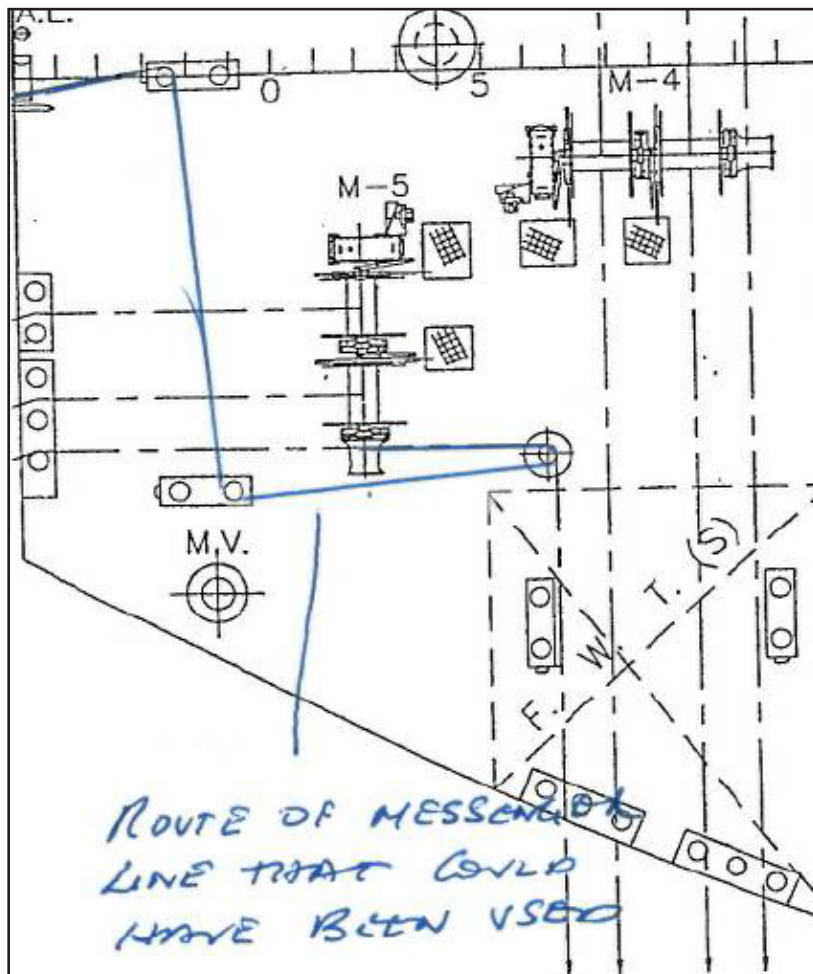
Figure 4: Initial suggestion for an alternative method to take the towline

Shortly after the accident, *Wah Shan's* master in consultation with marine surveyors acting on behalf of the ship owner produced a sketch showing what he considered to be a better alternative method of heaving in a tow wire (**Figure 4**). The designated person ashore (DPA) from Sincere Navigation carried out an investigation on board after the accident and produced a different plan showing the method that he thought to be 'correct' (**Figure 5**). The forward mooring and towing arrangements were more simply arranged and are shown in (**Figure 6**).

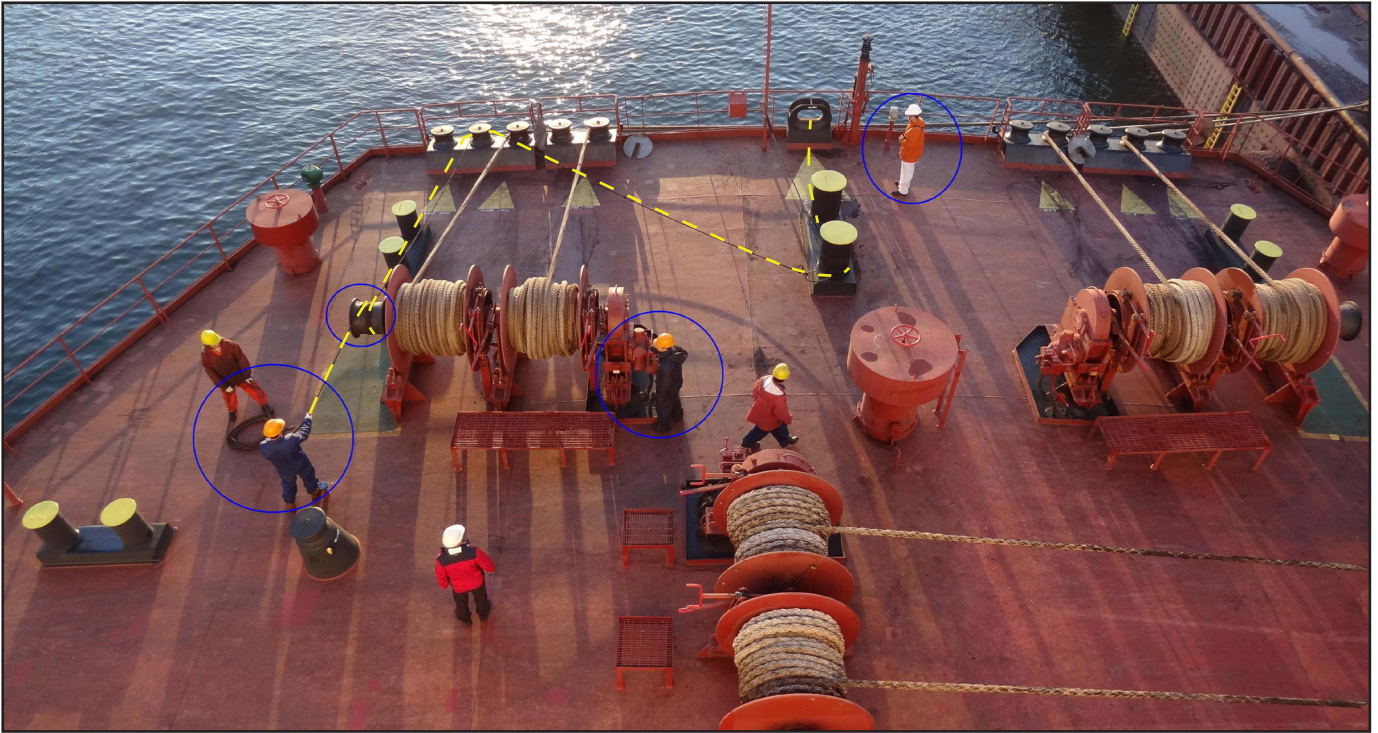
Figure 5: DPA's suggestion for the 'correct' method to take the towline

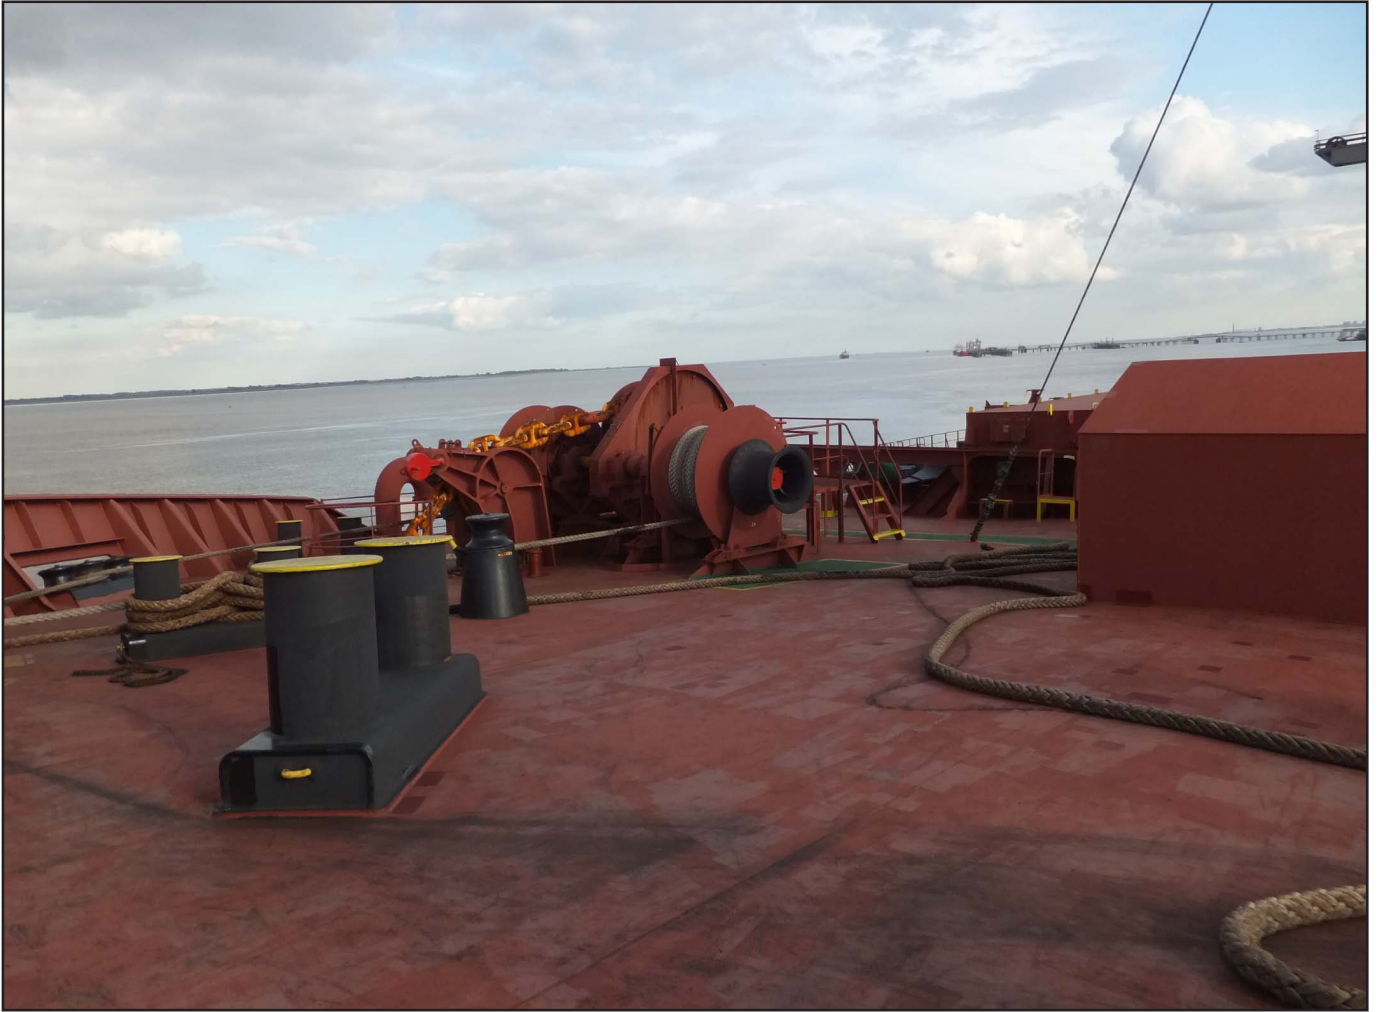
Figure 6: Forward mooring arrangement on *Wah Shan*

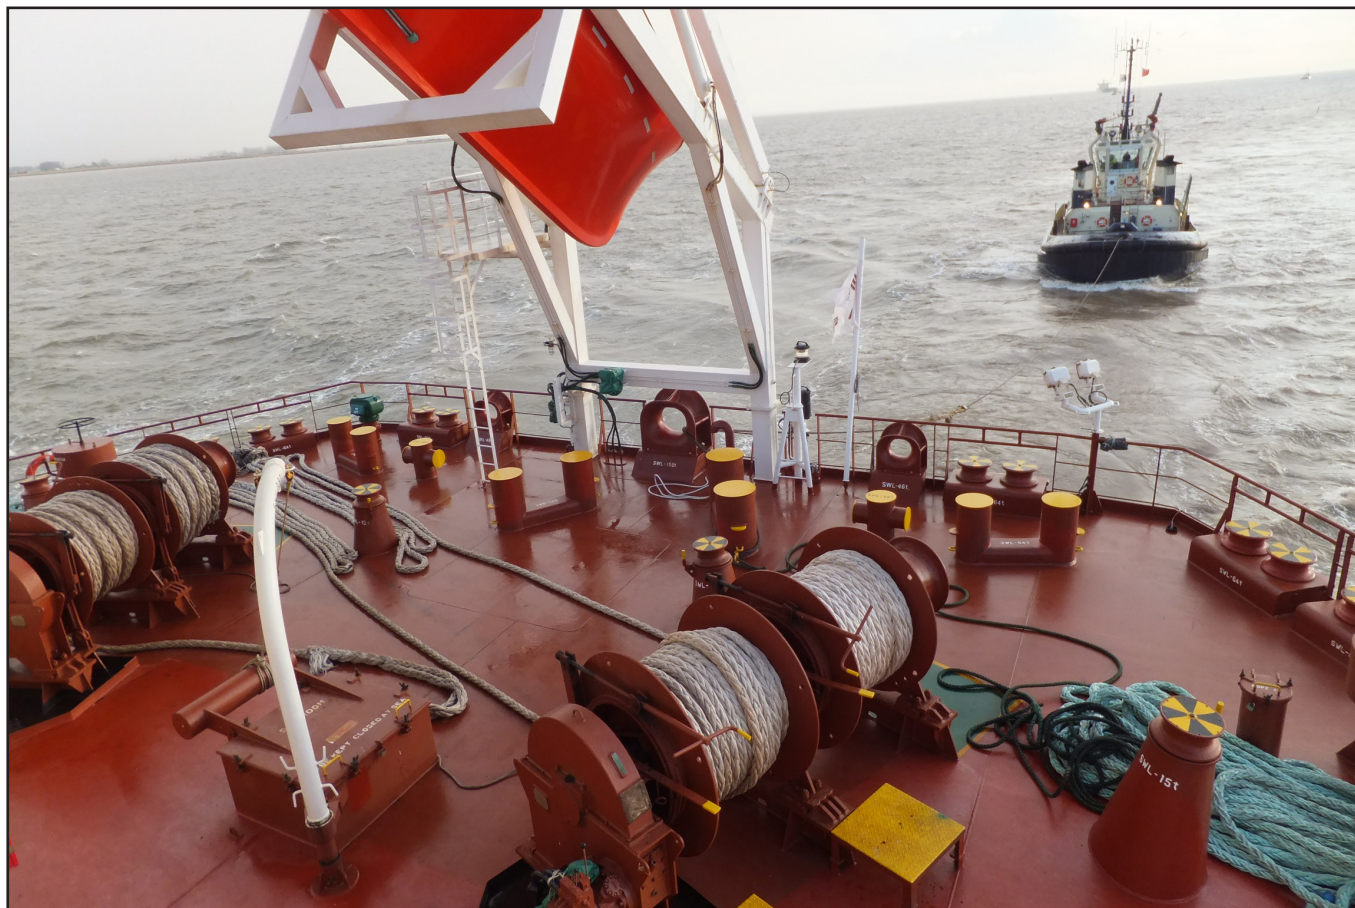
MAIB inspectors went on board a randomly selected bulk carrier arriving at Immingham to study the process used to secure a tug aft. The selected vessel was a Panamax⁷ size bulk carrier and the tug *Alma* was in attendance. The mooring equipment on this vessel was well positioned, making it readily apparent how a messenger line should be led from the centreline fairlead to the warping drum. The entire operation, beginning with sending a heaving line to the tug and ending with the eye of the towing pennant on the bitts, took less than 5 minutes. The mooring equipment on the bulk carrier's aft deck is shown in (**Figure 7**).

Figure 7: Aft mooring deck on a bulk carrier visited by MAIB
