Report on the investigation of
the foundering of the small passenger ferry

Vixen

in Ardlui Marina, Loch Lomond

on 19 September 2012

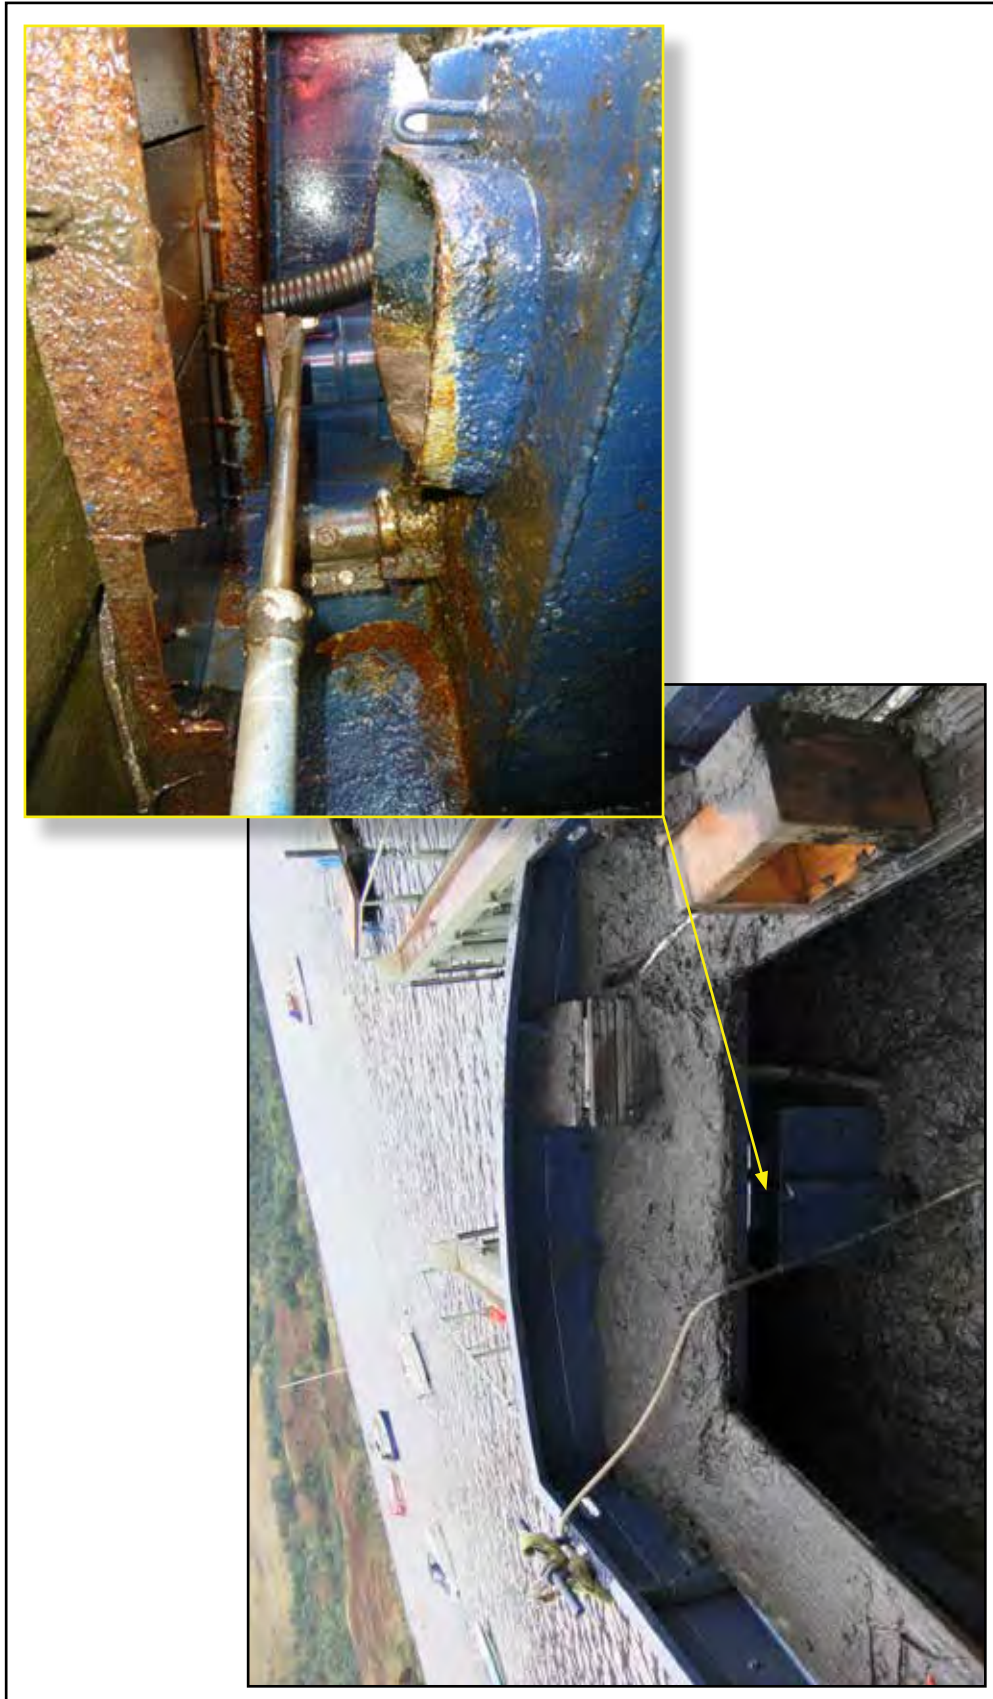
Figure 9: The weed hatch

Beneath the bench seat at *Vixen's* stern was a weed hatch that provided access to the rudder and propeller (**Figure 9**). This allowed weed and other items obstructing the propeller to be removed without having to take the boat out of the water. The weed hatch coaming was around 330mm above the water line when the vessel was berthed with no passengers or crew on board (**Figure 10**).

The weed hatch opening measured 255mm by 170mm. The hatch cover was found on the deck in the aft part of the boat after the boat was salvaged. Both of the hatch cover's hinges had completely corroded away and there was no evidence of a locking or securing device on the side opposite to the hinges (**Figure 11**). The inner surface of the hatch cover did not have any sealing material fitted to make it watertight when closed over the weed hatch coaming.

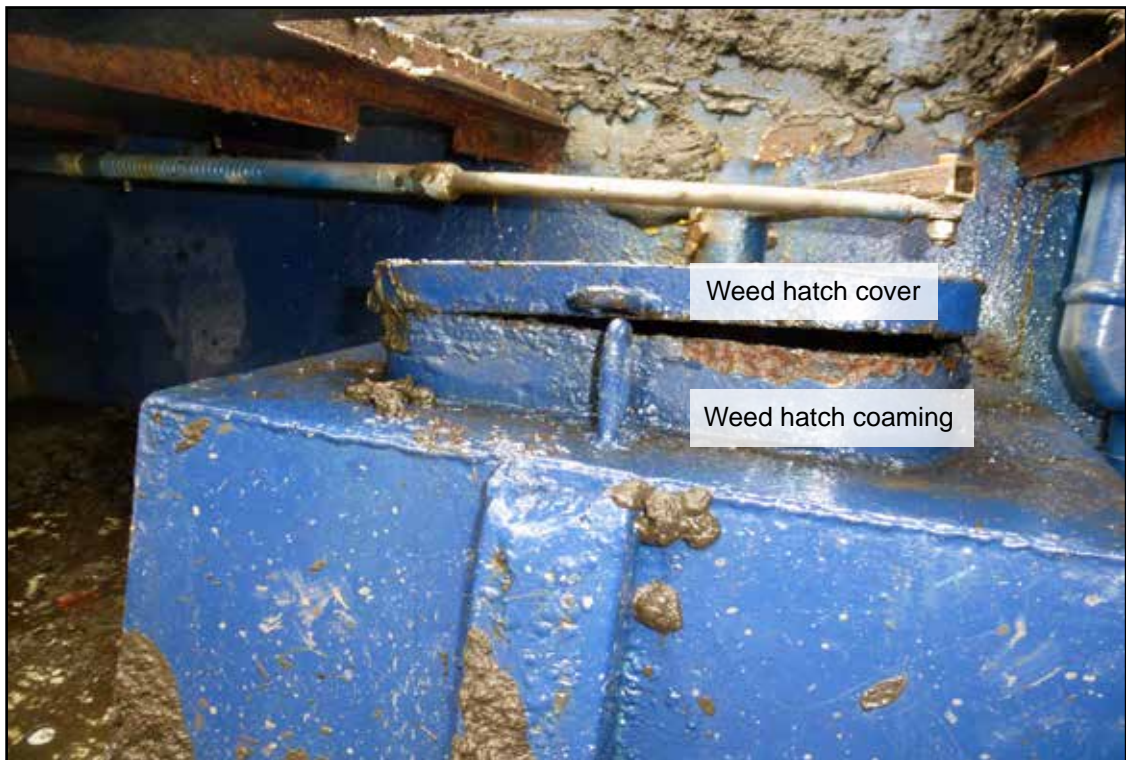
Figure 11: The weed hatch cover

The build-up of rust, both on the hatch coming and on the hatch lid, prevented the hatch cover from fitting over the coaming properly (**Figure 11**). Witness marks found in the paintwork suggested that, prior to the accident, the hatch cover might have rested on top of the coaming. It was also possible, but less likely, that the hatch cover had lain on the deck for an unknown period of time before the accident.

During the accident, a witness reported seeing water “*flowing like a waterfall*” at the centre part of the stern between the deck and the bench seating. The weed hatch cover was in extremely poor condition: there was no sealing gasket, the hinges had severely corroded, and there was no evidence that the closing mechanism had been secured. Even if it had been jammed onto the coaming, the weed hatch cover would have done little to prevent water ingress. In the absence of any other significant hull defects in the after part of the vessel, the witness's observation was almost certainly that of water flooding through the weed hatch at *Vixen*'s stern.

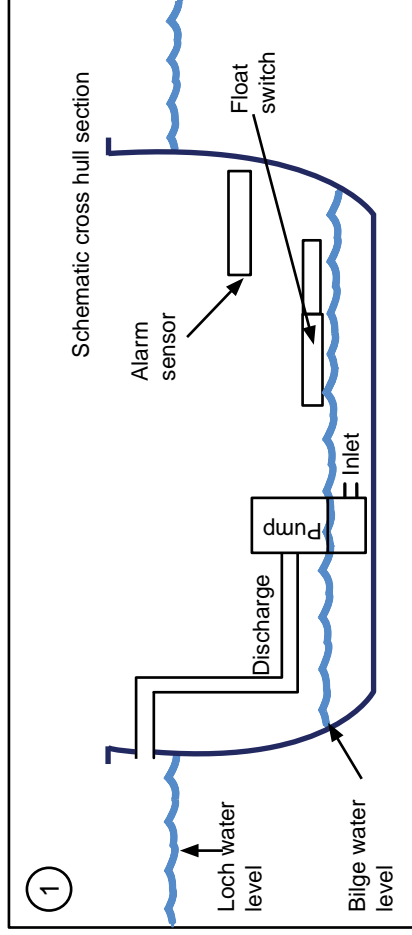
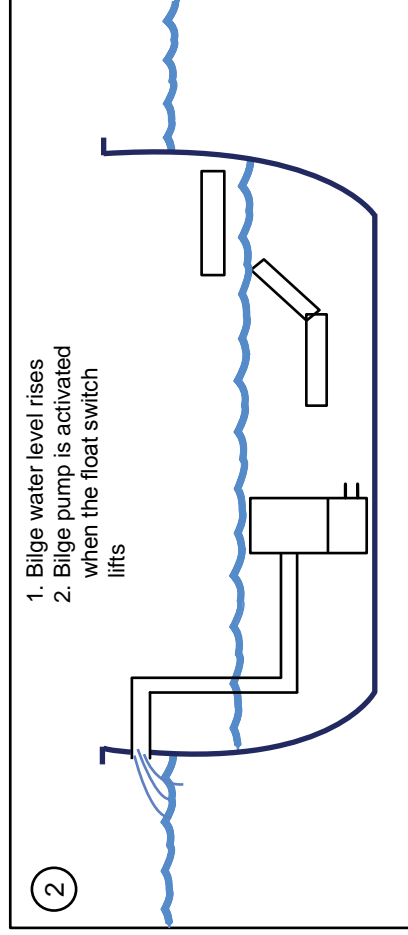
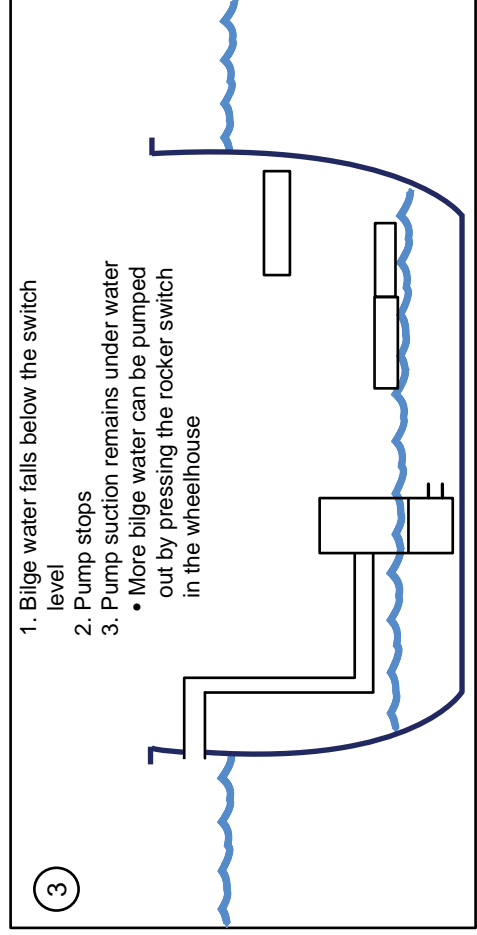
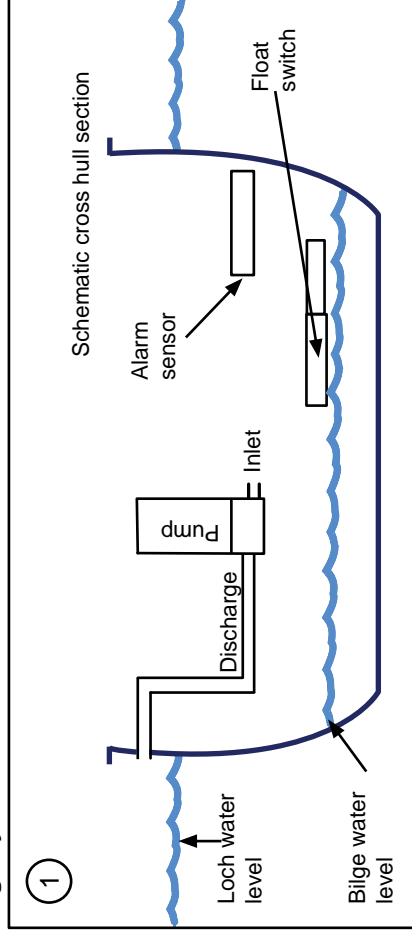
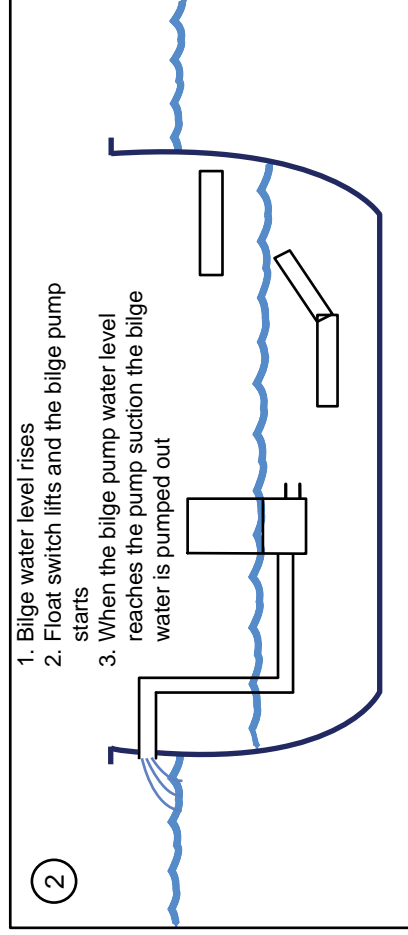
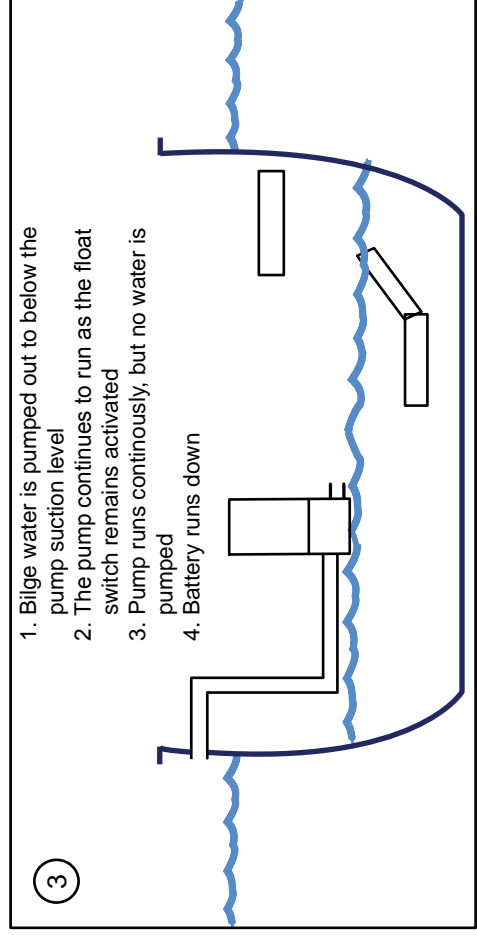
Figure 13: Schematic diagram of Vixen's bilge system as fitted and as found following the salvage

The pump had been raised deliberately from its original position, probably in order to reduce the risk of clogging the pump with debris and sludge that collected in the bilge¹. The bilge pump suction was found to be higher than the float switch. Consequently, once the water level rose sufficiently to activate the float switch, the bilge pump would run continuously; it would never be possible for the pump

The overall effect of raising the bilge pump increased the volume of water that remained in the bilge after the pump had lost suction.

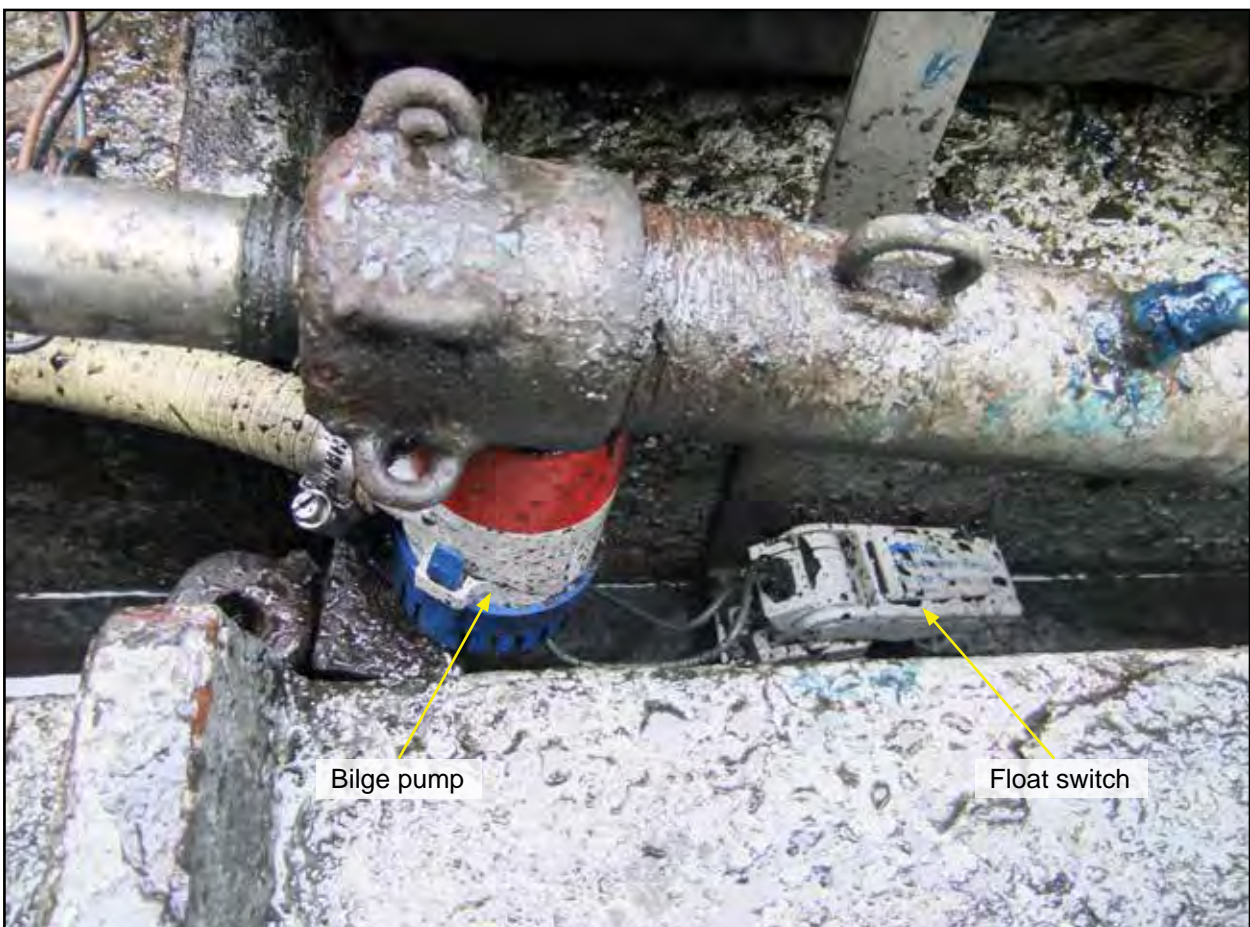
Figure 15: Bilge pump as found post-salvage

After *Vixen* had been salvaged, its bilge pump was found firmly wedged against the propeller shaft stuffing box by a metal block (**Figure 15**). The float switch and pump were tested once the mud, which had gathered after the sinking, had been removed. The float was found to move freely. Power was temporarily restored to the circuit and both the pump and float switch were found to operate normally.

to reduce the level of water below the float switch in order to turn itself off. In this condition, the pump could run continuously, discharging the battery as soon as the main engine was shut down. However, there was sufficient charge in the battery to start the engine on the morning of the accident.

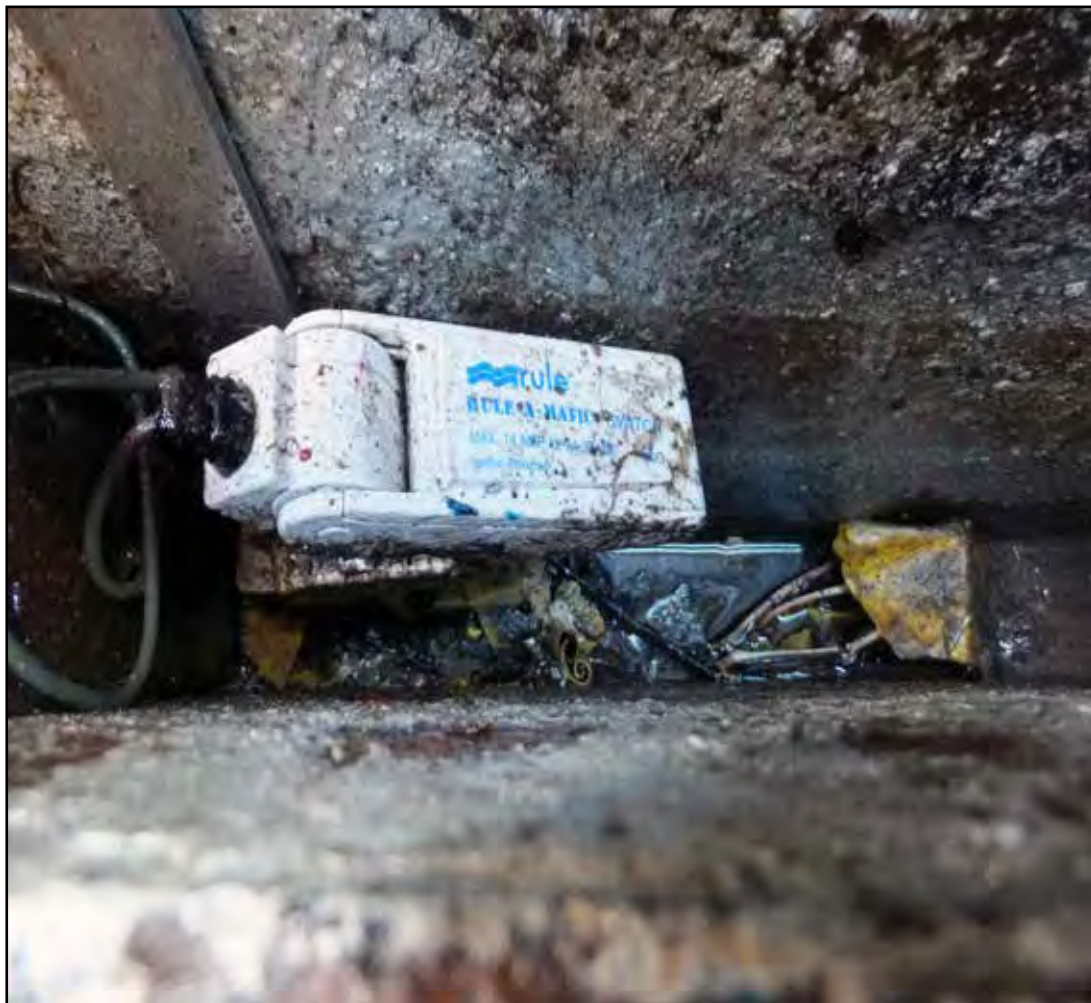
Figure 16: Vixen's bilge and float switch

The float switch was positioned close to the side of the keel. If it was held down, either due to the debris that was found in the bilge (**Figure 16**) jamming the float, or deliberately, the system would not have worked automatically and would not have discharged the battery. However, the pump could still have been turned on by operating the rocker switch in the wheelhouse. The main skipper routinely operated the bilge pump by using the rocker switch. However, the person acting as skipper on the day of the accident, and the groundsman, reported only occasionally using the rocker switch to operate the bilge pump. Heavy rainfall on the 16th and 17th September may therefore have resulted in an increased amount of water laying in the bilge.

Debris (that was not attributable to the effects of the sinking) was found in *Vixen*'s bilge, and it was evident that the area was not routinely or effectively cleaned. The bilge pump had been raised at some point since it was fitted, probably to prevent it becoming clogged with debris, which had made the automatic operating mode redundant. With the pump above the float switch, it would start to operate as soon as there was enough water in the bilge to activate the float switch, but would never be able to reduce the water level sufficiently to reset the switch. In this situation, the pump would have run continuously and the battery would quickly have been discharged. The engine was reported to have started satisfactorily on both the day before, and the day of the accident, without the battery needing to be charged. The bilge pump was tested after the vessel was recovered, and found to work correctly. It is therefore concluded that the float switch must have been wedged in the 'off' position in some way. Although the float was found to be free to move after the mud and detritus from the sinking had been cleaned away, it was considered most likely that during operation the float switch had been jammed by some of the debris found in the bilge. There was little clearance between the float and the keel structure, and not much force would have been needed to stop the float from lifting

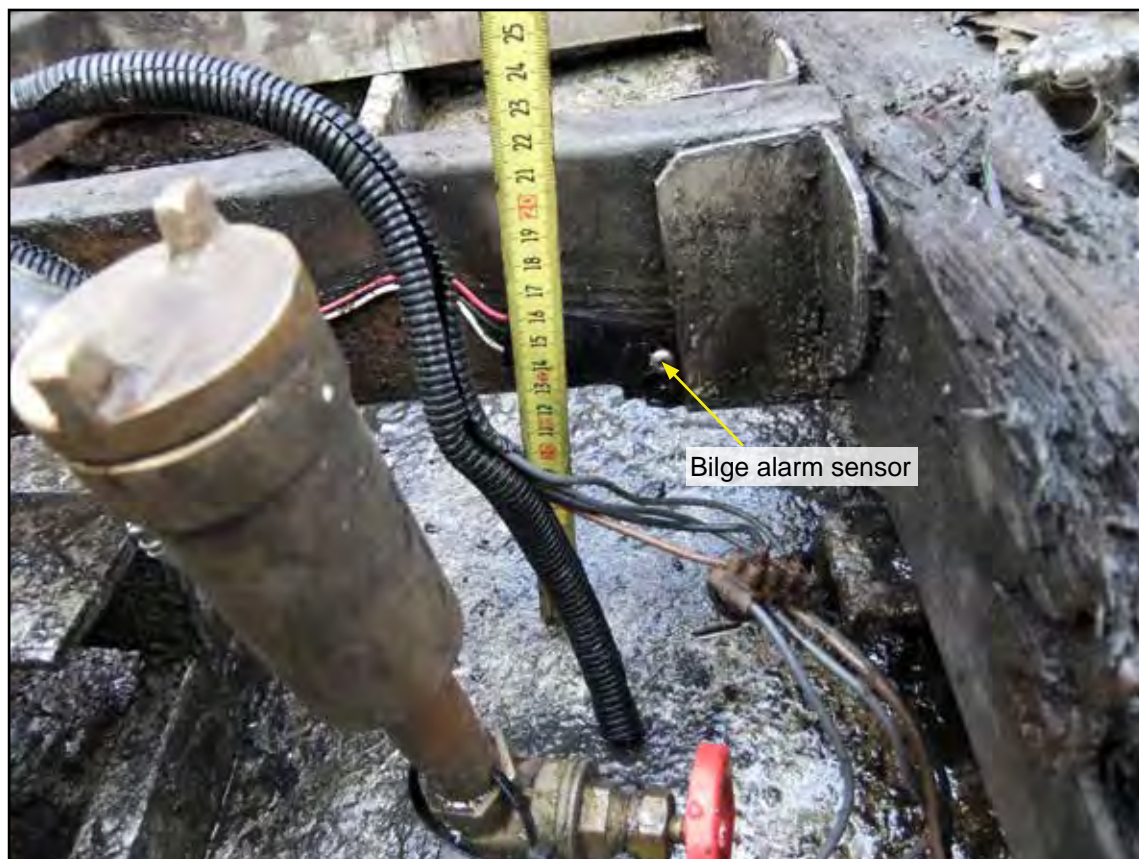
Figure 17: Bilge alarm sensor

A new bilge alarm system was fitted to *Vixen* in March 2010. The alarm was activated by a sensor fitted in the bilge (**Figure 17**). The bilge alarm was powered from the main battery and was activated by a switch in the wheelhouse (**Figure 14**). The alarm system was also protected by an in-line fuse.

The inspection of *Vixen* carried out after the salvage found that the main bilge alarm switch was in the 'off' position and the system's in-line fuse was missing. The bilge alarm system was subsequently tested; a new fuse was fitted and the system was turned on, the alarm both sounded and a warning lamp lit.

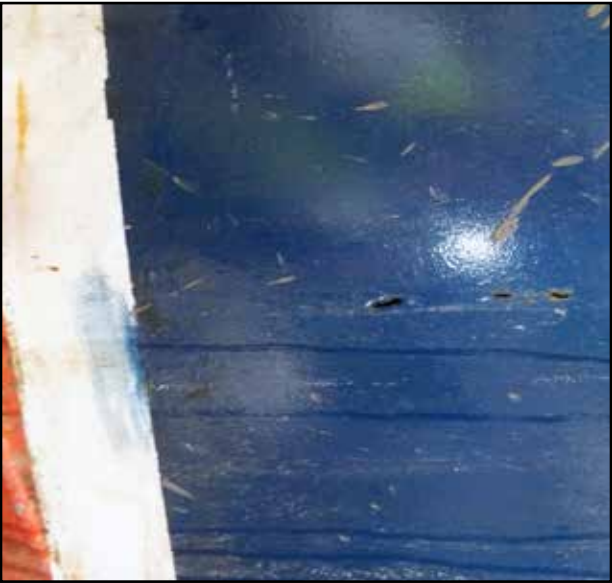
Figure 18a: Hull penetrations above the waterline

- There were several small penetrations in the hull plating above the waterline (**Figure 18a**).
- The steel at the gunwale top had corroded away completely in some areas (**Figure 18b**).
- The weld between the main seawater inlet fitting and the hull was not watertight (**Figure 18c**).
- The electrical connectors fitted in the bilge were not sealed against water ingress and were unsuitable for use in a wet environment (**Figure 18d**).

The owners did maintain *Vixen's* engine and some other areas of the boat, such as the decking, but they did not consider any further assessment of *Vixen's* hull and its fittings to be necessary. In addition to the defective weed hatch, hull penetrations above the waterline, the corroded bulwark top, and a leaking weld around the cooling water inlet were all indications that further repairs to *Vixen's* hull were required.

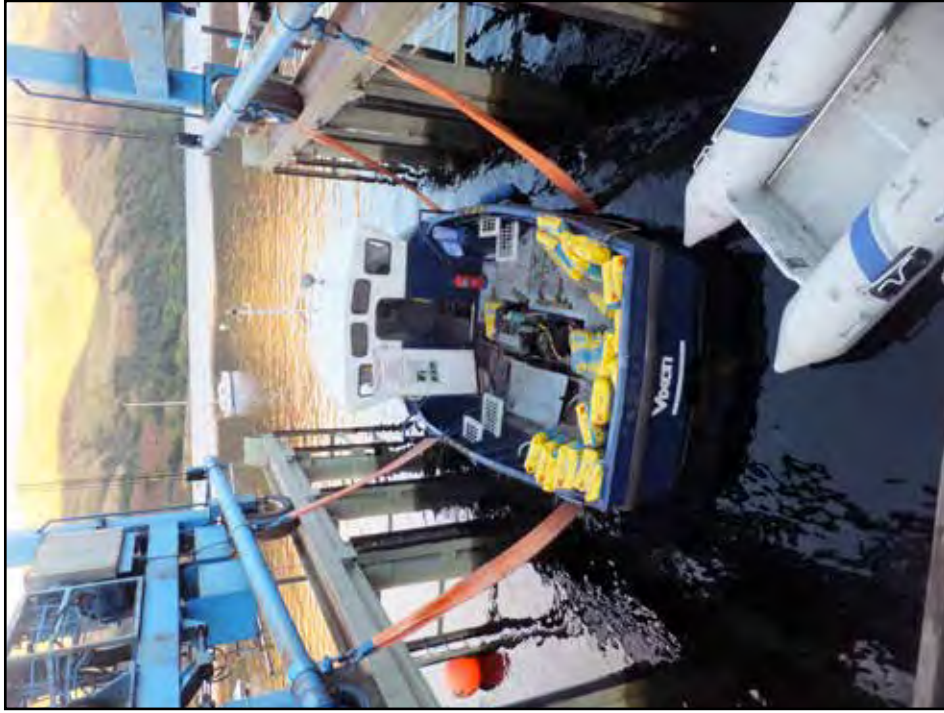
Figure 19a: Loading simulation

Vixen was refloated and ballast weights were added to establish *Vixen's* effective freeboard (the distance from the top of the weed hatch coaming to the waterline) in different conditions (**Figure 19a**).

The simulation of *Vixen*'s loading condition at the time of the accident showed that the combination of the six passengers all sitting at the stern, their rucksacks, and accumulated water in the bilge, reduced the effective freeboard significantly.

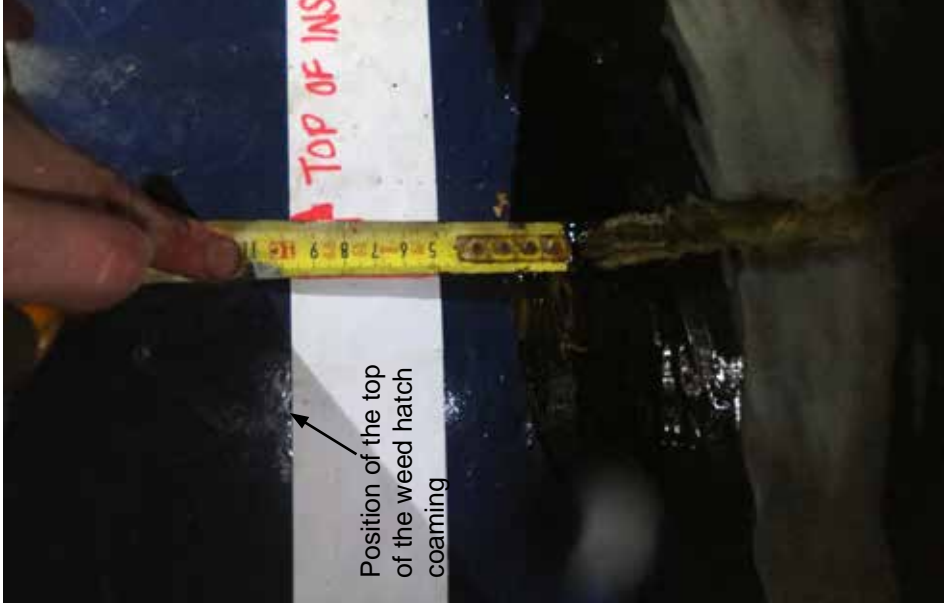
Figure 19c: Loading condition 3

| Condition | Passenger and crew loads | Rucksacks | Bilge conditions | Effective freeboard (waterline to top of weed hatch coaming) |
|---|---|---|--|--|
| Loaded 3 | 6 passengers 1 crew | 6 | Bilge full to bilge alarm activation level | 98mm (Figure 19c) |

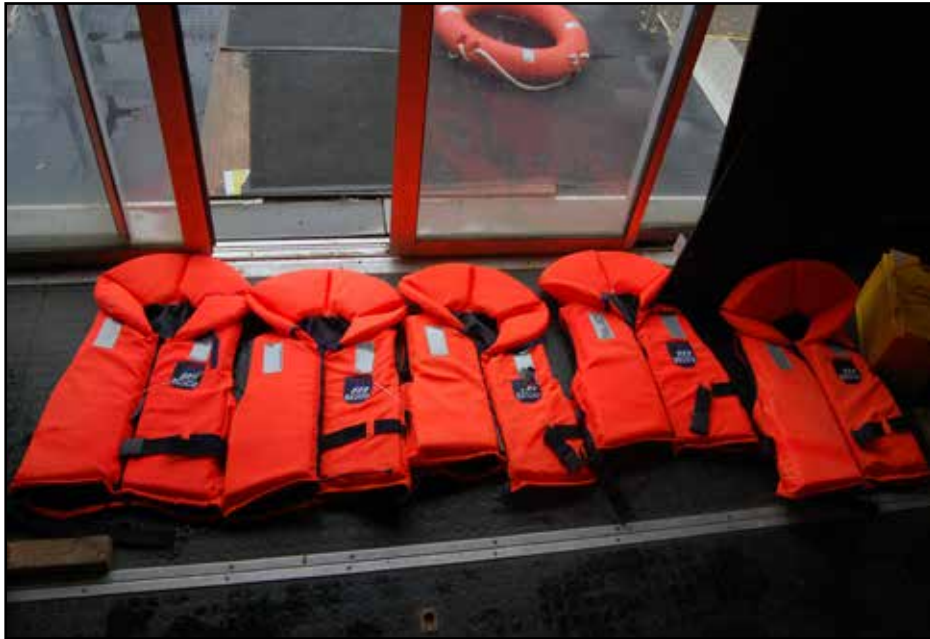
Figure 20a: Lifejackets worn by passengers

Five 100 N² lifejackets (**Figure 20a**) were located inside the port side of *Vixen's* wheelhouse, inside plastic bags. Six other buoyancy aids of various sizes (**Figure 20b**) were found on board *Vixen* after the accident. Of these, two 100 N buoyancy lifejackets were found on the port side of the wheelhouse; three 45 N buoyancy aids were found tied to a horizontal line secured on the starboard side of the wheelhouse (**Figure 20c**) and one child's 45 N buoyancy aid was found at the forward end of the wheelhouse.
