Report on the investigation of
the capsized and foundering of the fishing vessel

Sarah Jayne (BM 249)

6nm east of Berry Head, Brixham

11 September 2012

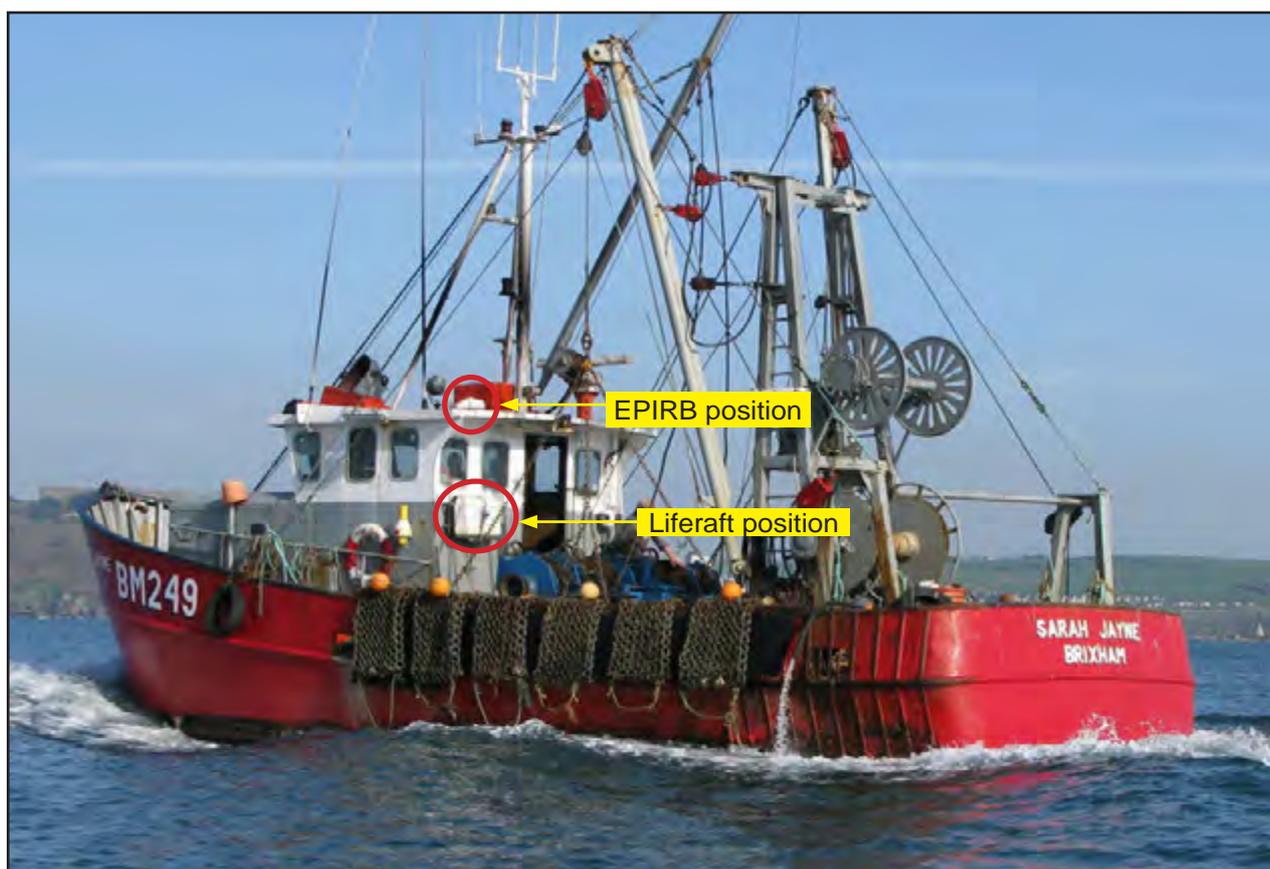
Figure 7: *Sarah Jayne* (liferaft and EPIRB positions)

The liferaft failed to surface and inflate, probably as a result of its being obstructed by the wheelhouse roof overhang when it was released from its stowed position on the aft external bulkhead. Although a definitive reason for an EPIRB transmission not being received following the accident cannot be determined, the carriage of an EPIRB remains an important safety precaution for fishing vessels.

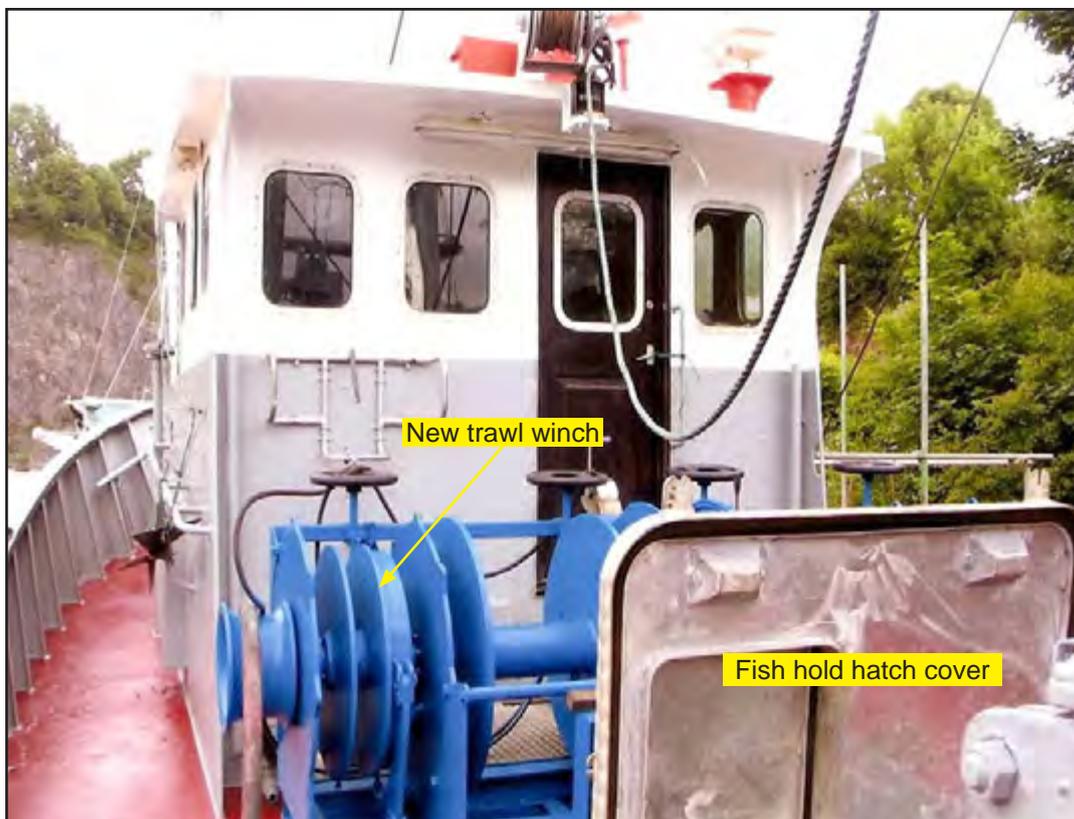
Figure 12: Sarah Jayne's new trawl winch and fish hold hatch cover in 2006

- Replacement of the original Gardner 8L3B engine (dry weight 3.2te) with a new Cummins NTA 855-M engine (dry weight 1.45te).
- Replacement of the original trawl winch (weight unknown) in 2006 with a North Sea Winch GF-80 (**Figure 12**).
- Installation of a small net drum (estimated weight 0.25te), approximately 3m above the main deck.

It is unknown if the owner had manually corrected the SIB to account for these alterations as the SIB was lost with the vessel. However, he had sought advice from a consultant naval architect in May 2005 prior to fitting the additional net drum. After some preliminary calculations, it was concluded that the net drum could be fitted but that it would reduce the vessel's stability. No further calculations or amendments to the SIB were requested.
