Report on the investigations of the flooding and foundering
of the fishing vessel

Audacious

the flooding and foundering of the fishing vessel

Chloe T

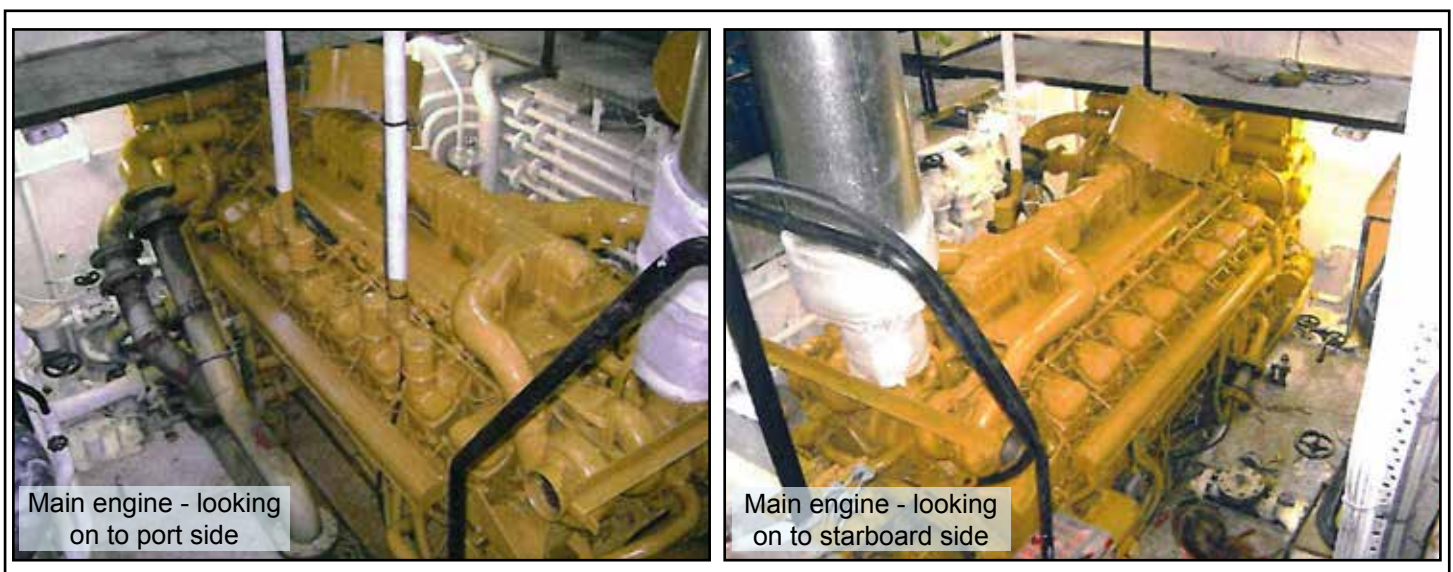
Figure 2: Engine room

The engineer entered the engine room at about 1525 to investigate. He saw that water had entered the compartment and was almost level with the top of the main engine (**Figure 2**). He immediately started a bilge pump, rated at 25 tonnes per hour, to pump out floodwater from the compartment.

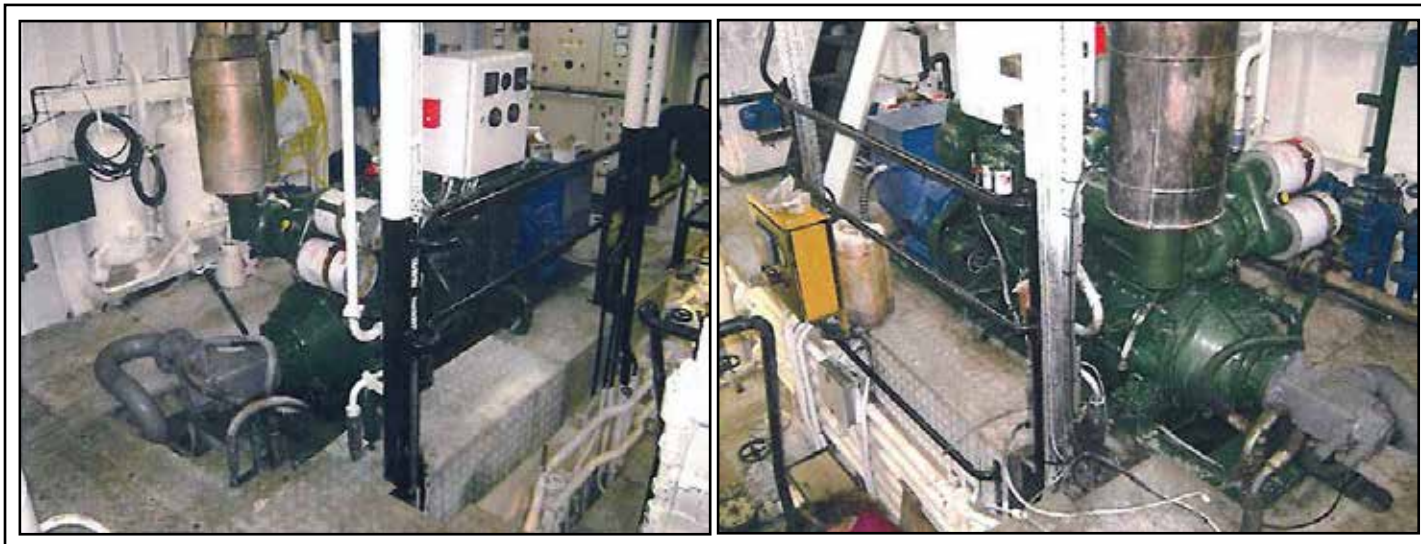
Figure 3: Engine room showing auxiliary engines

Water began to spray from the flywheel onto the turbocharger and intercooler; the resultant steam began to fill the machinery space and the main engine stopped. The auxiliary engines (**Figure 3**), which provided power to the bilge pump, were still above the water level and continued to operate.

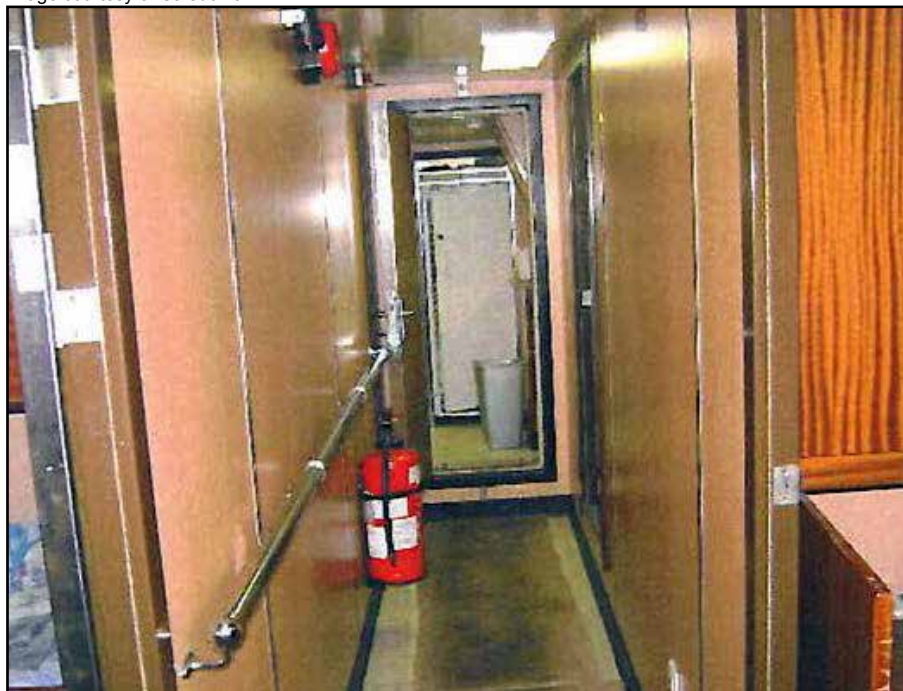
Figure 4: Accommodation alleyway

To gain a better understanding of the situation, the skipper decided to proceed to the engine room himself, via the internal accommodation. As the skipper opened the engine room door he met the engineer emerging through steam and smoke. The engineer told the skipper that the flooding was out of control and that they should evacuate immediately. The skipper asked if the sea inlet valves had been closed, and was advised that they were still open as they were more than a metre under water and were inaccessible.

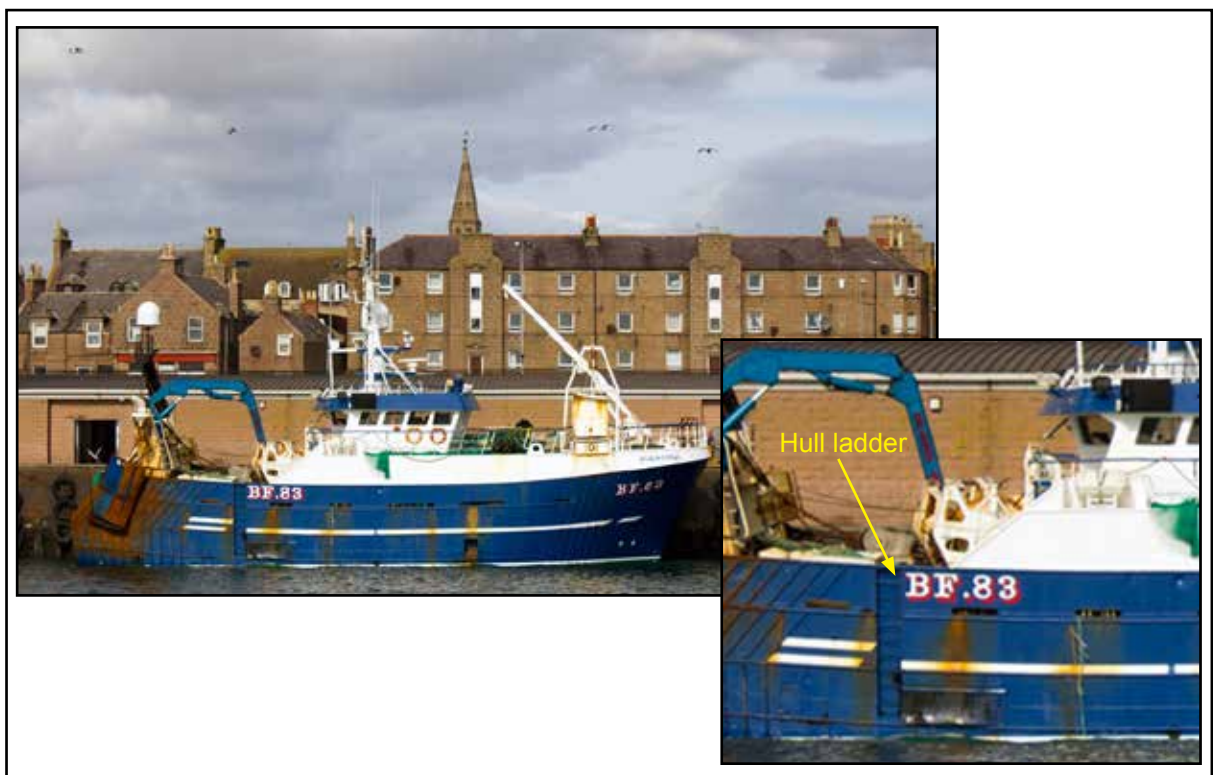
Figure 5: Starboard side hull ladder

The crew launched both liferafts, but the painter of the port liferaft was inadvertently released during the launch process and the raft drifted away from the vessel before it could be secured. The remaining liferaft was made fast to the starboard hull ladder (**Figure 5**), from where the crew boarded it.

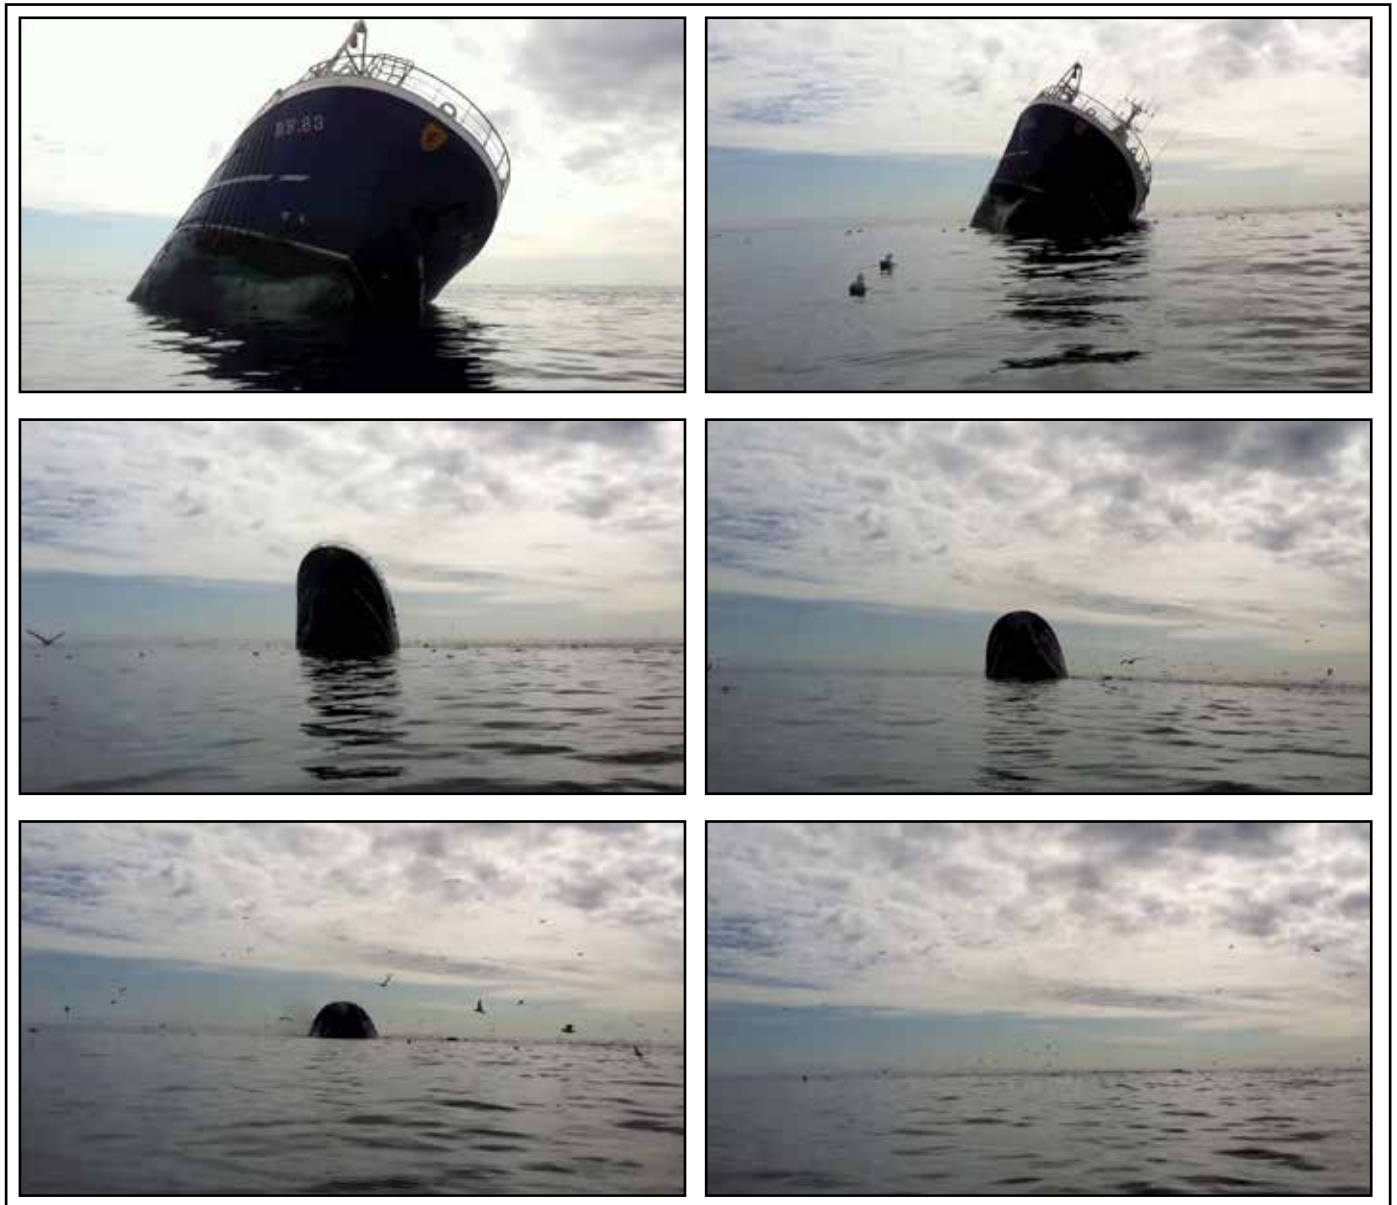
Figure 6: *Audacious* sinking sequence

At about 1545 the skipper passed the EPIRB and several trawl sensors into the liferaft and then joined the rest of the crew in the liferaft. The painter was cut and the liferaft drifted away from the vessel; the crew photographed *Audacious* as she settled in the water (**Figure 6**) until she sank at 1554.

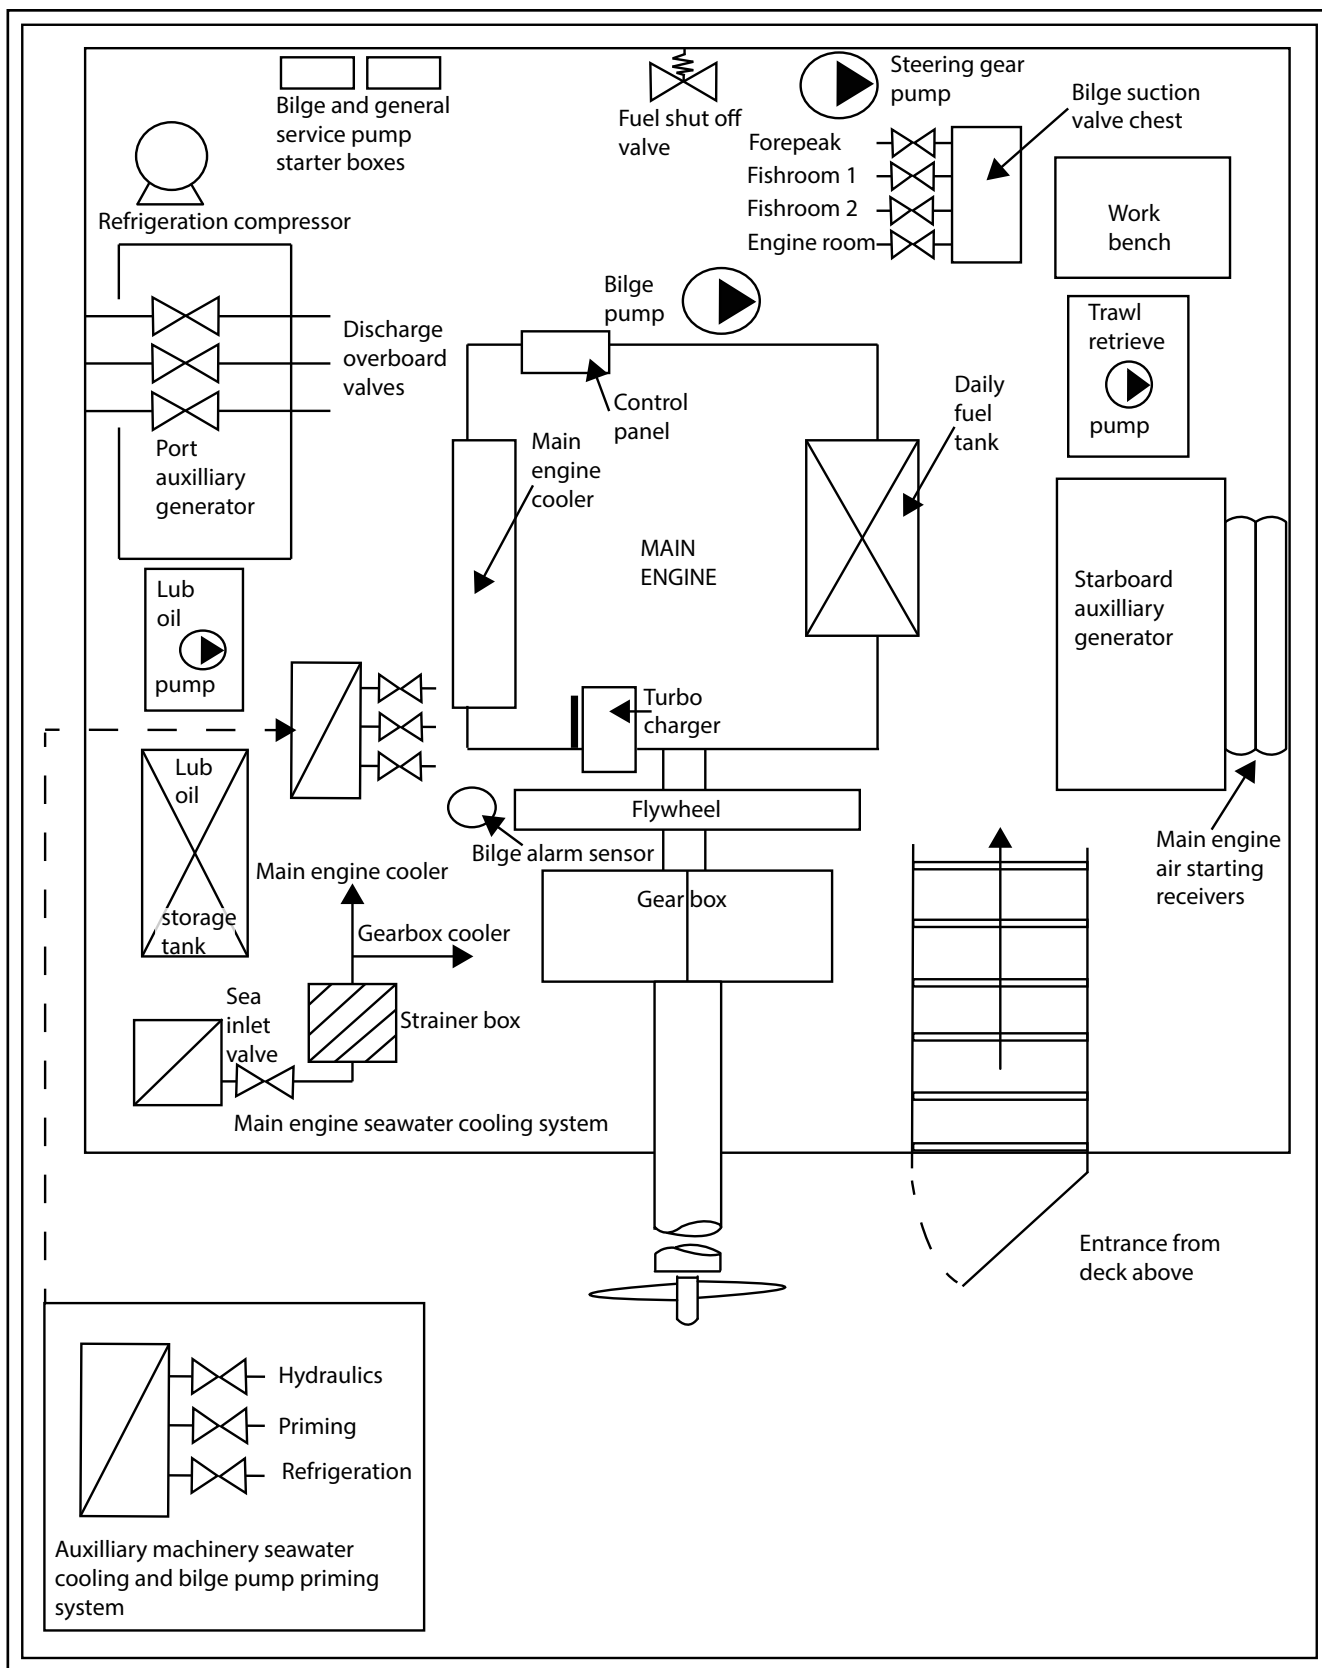
Figure 9: *Chloe T*'s engine room layout - schematic diagram based on crew recollections

The engineer/deckhand moved past the valves controlling the seawater inlets for the auxiliary machinery systems to the port-aft corner of the engine room where the main engine seawater cooling inlet valve and strainer were situated. While there were small access holes the valve handle and strainer were beneath the engine room floor plates. Many of the surrounding floor plates were screwed down, and the engineer/deckhand attempted to lift these in order to gain better access to the pipework and valve handle.

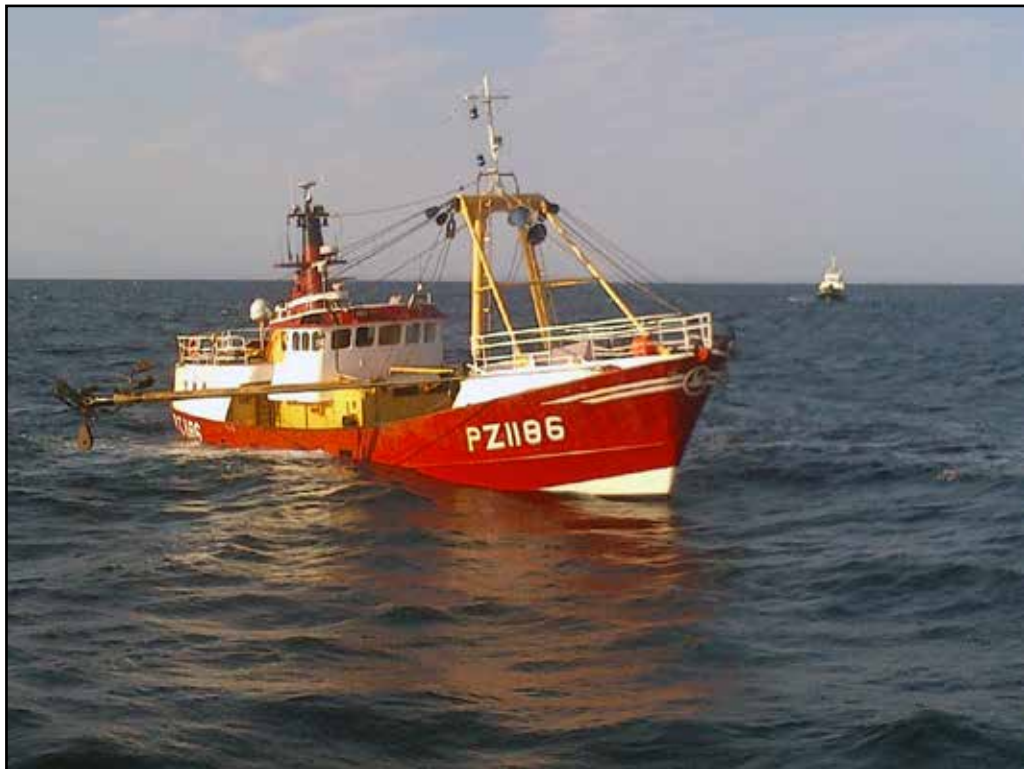
Figure 11: *Chloe T* (picture taken at 1757)

The skipper of *Lady Maureen*, another vessel operated by Langdon and Philip, volunteered to board *Chloe T* and attempt to rig a salvage pump. He was advised against boarding in case the vessel suddenly capsized, and no further attempts to salvage the vessel were made. *Chloe T* sank at 2226 (**Figures 11-14**).
