Report on the investigation of the collision between

Alexander Tvardovskiy

UKD Bluefin and ***Wilson Hawk***

1 August 2012

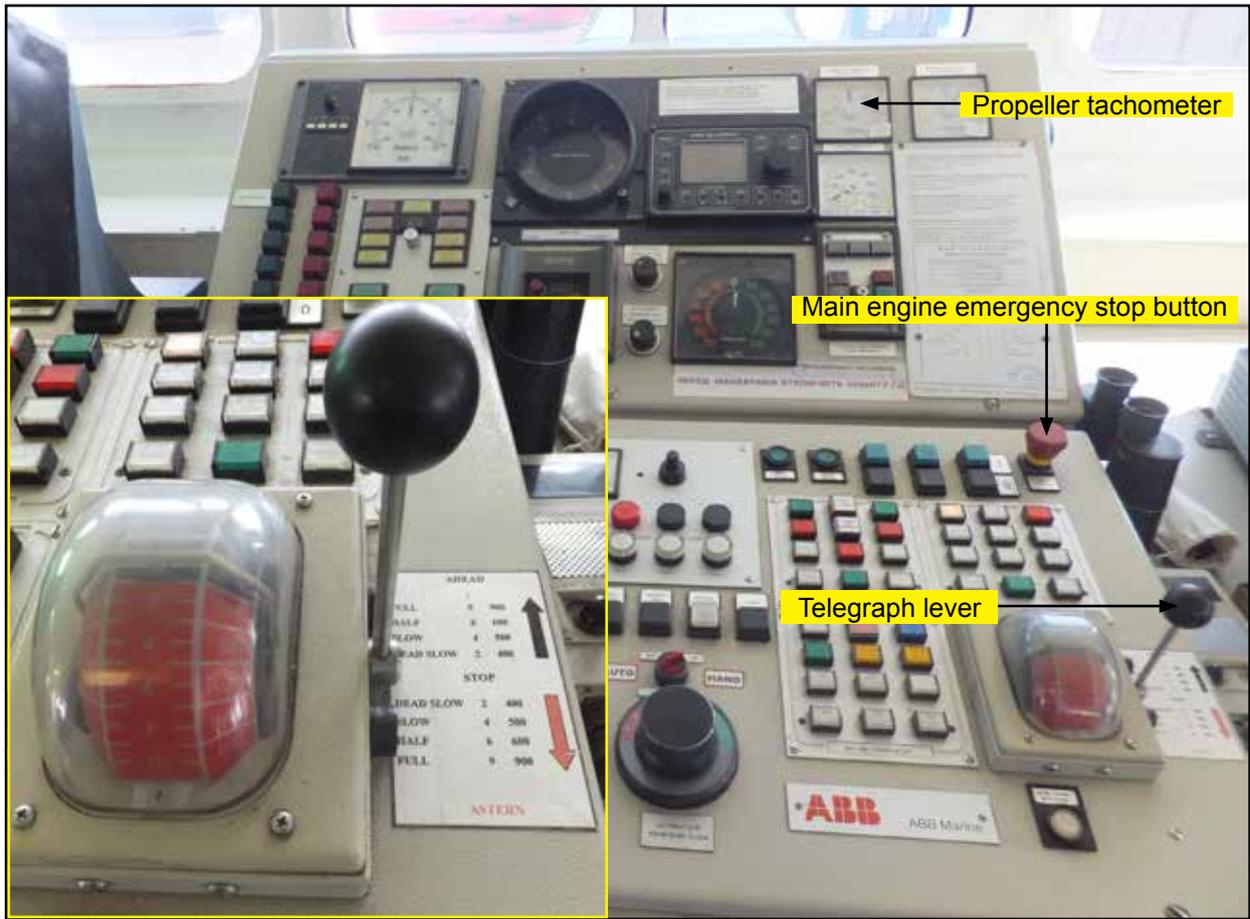
Figure 4: Bridge propulsion control panel

The interval between the order being given for 'dead slow astern' and the collision was at least 2 minutes. During this time, neither the chief officer nor the master looked at the propeller indicator on the bridge console (**Figure 4**) or observed the propeller wash (**Figure 6**). Consequently, they did not realise that the propeller was still rotating astern until after the collision. Ensuring that bridge teams are well briefed and that propulsion indicators are monitored when a vessel is manoeuvring in a confined area are key elements of bridge teamwork and resource management that are emphasised in the Bridge Procedures Guide. On this occasion, in common with the circumstances of the collision involving *Grand Rodisi* (**Paragraph 1.15.3**), effective teamwork and adequate support to the pilot was lacking.

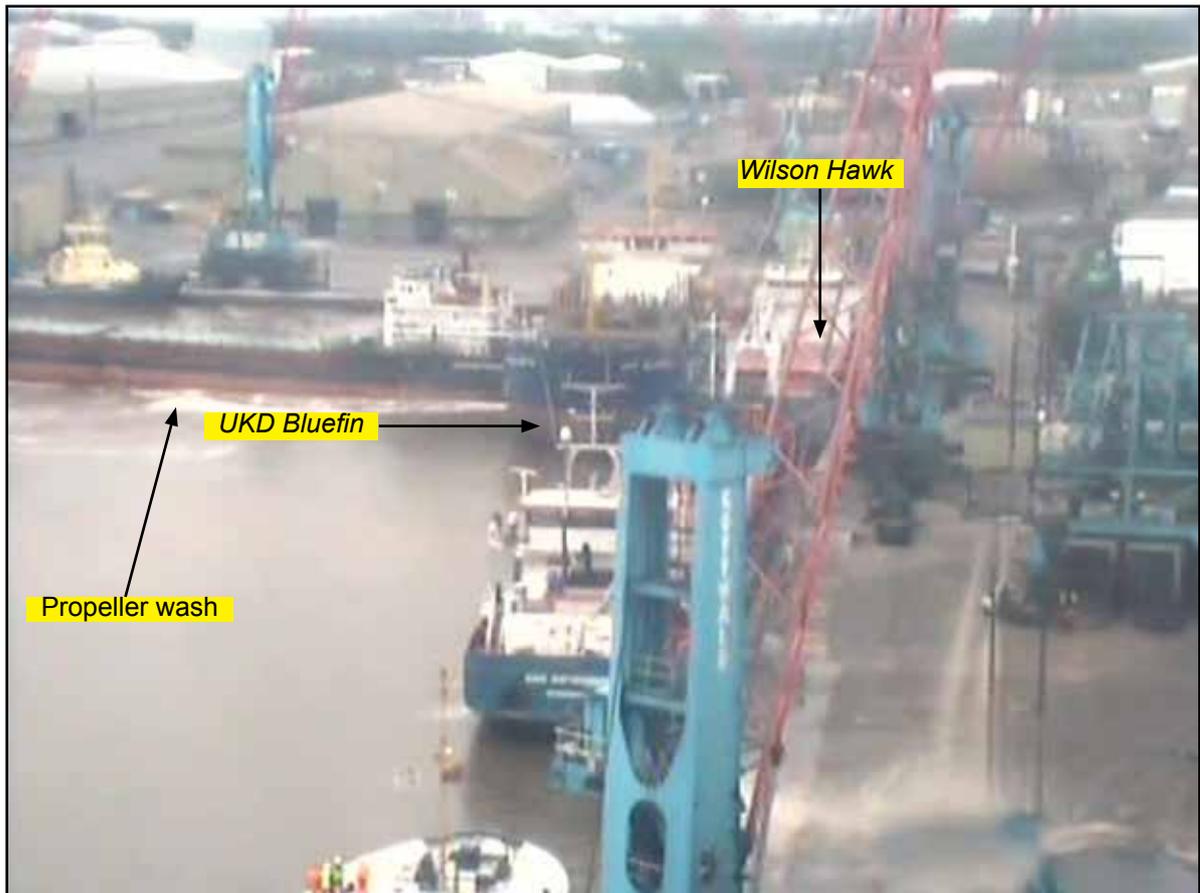
Figure 6: Port CCTV 1337 hrs: *Alexander Tvardovskiy* collision with *UKD Bluefin*

Twenty seconds later, at about 1337, *Alexander Tvardovskiy*'s starboard quarter struck *UKD Bluefin*'s starboard side, amidships (**Figure 6**). The pilot ordered the main engine to be stopped, so the master put the bridge telegraph lever to 'stop' and the chief officer again repeated the order over the intercom.

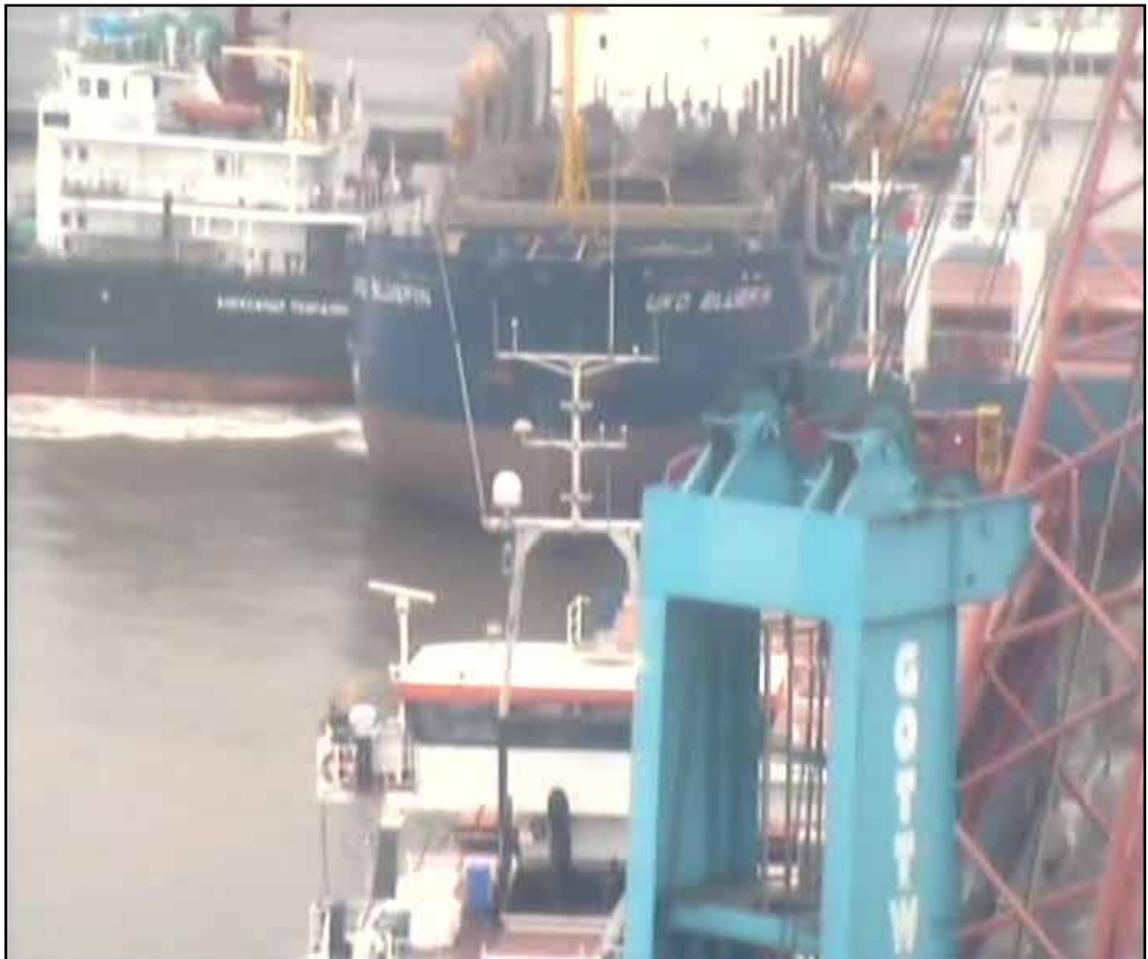
Figure 7: Port CCTV: *Alexander Tvardovskiy* collision with *UKD Bluefin* and *Wilson Hawk*

About 1 minute after the collision, *Alexander Tvardovskiy*'s engine was taken out of gear. By that time she had pushed *UKD Bluefin* against *Wilson Hawk* (**Figure 7**). *Alexander Tvardovskiy* was then manoeuvred ahead and the vessel placed back alongside berth 2 without further incident.

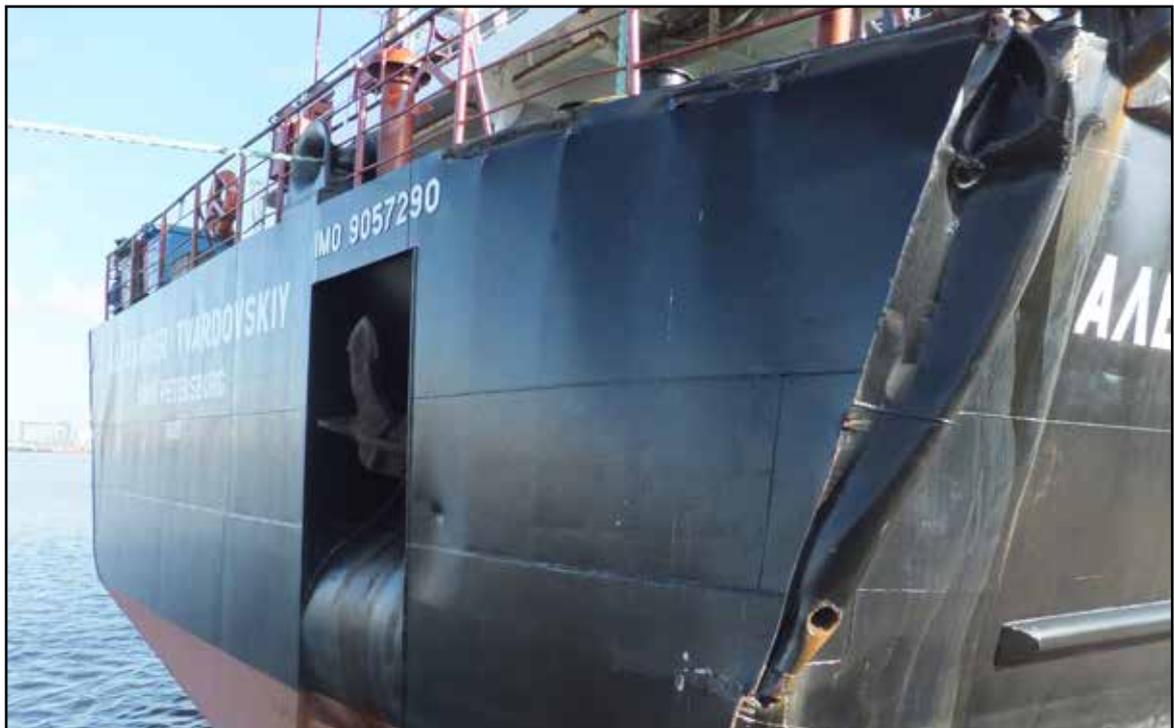
Figure 8: *Alexander Tvardovskiy* damage to starboard quarter

Alexander Tvardovskiy sustained significant deformation to her starboard quarter, a penetration to the aft peak tank, and buckling of her poop deck (**Figures 8 and 9**).

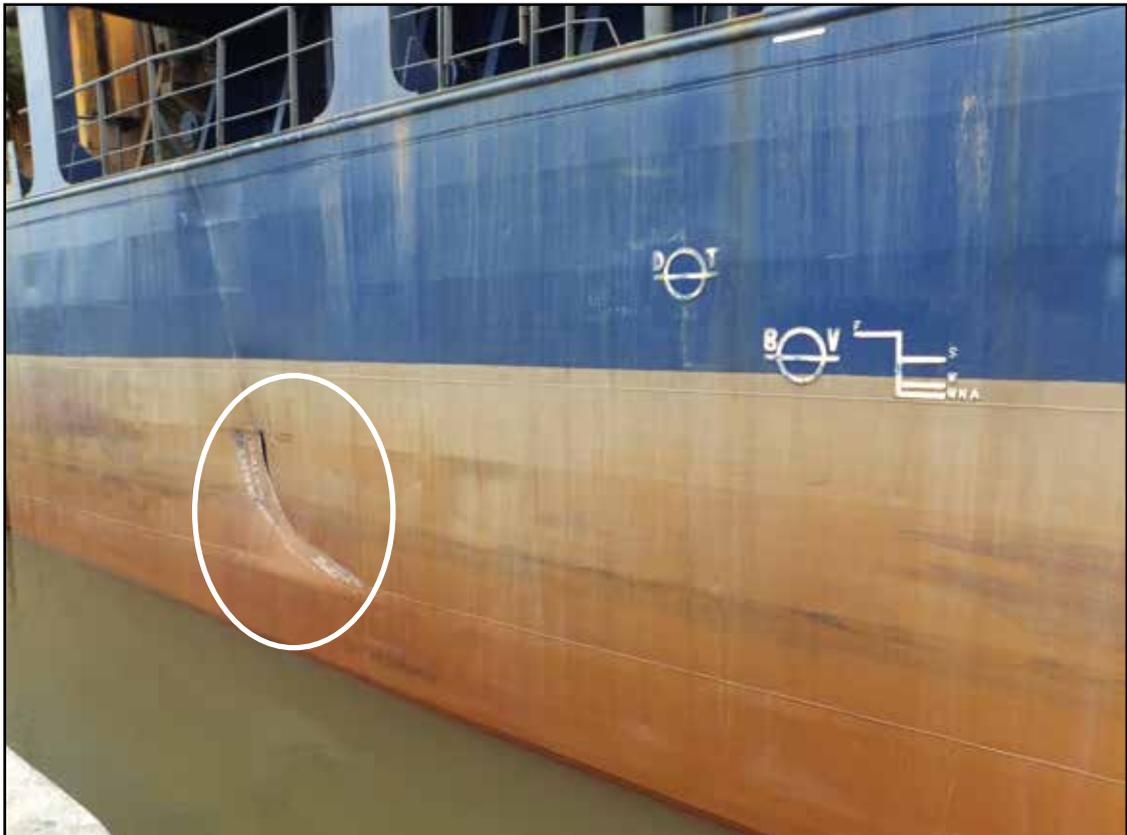
Figure 10: *UKD Bluefin* damage to starboard shell plate

UKD Bluefin suffered a 2m penetration of her starboard void space and internal frame damage (**Figures 10 and 11**). The vessel's fixed dredging equipment was also damaged. Repairs to the vessel took 16 days in dry dock to complete, and cost about £180,000.

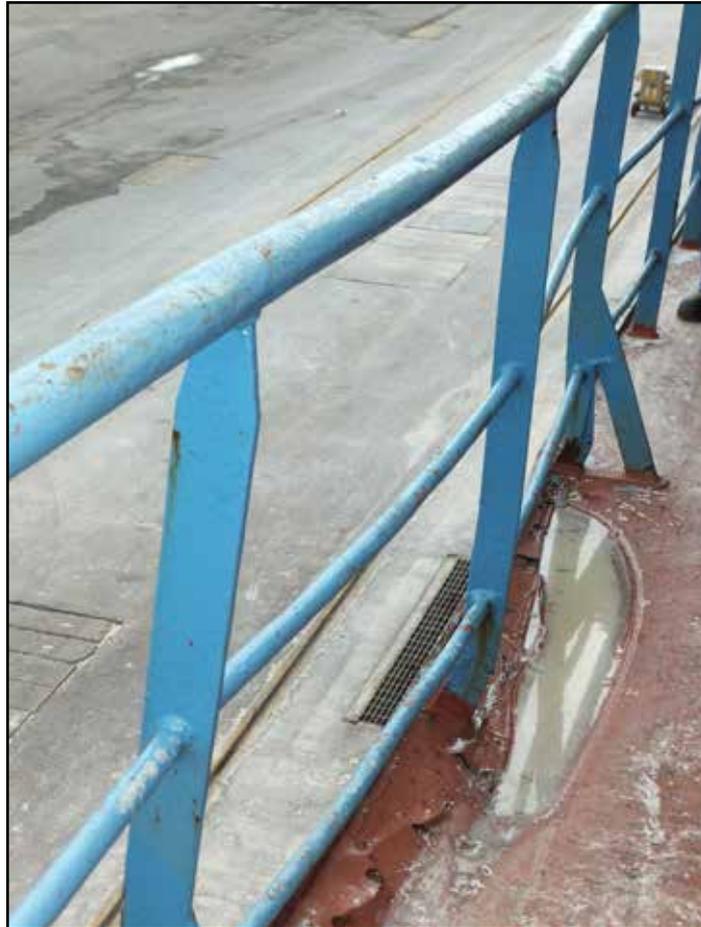
Figure 12: *Wilson Hawk* damage to deck starboard side

Wilson Hawk's side plating was damaged in several areas (**Figures 12 and 13**), and the rescue boat also suffered damage.

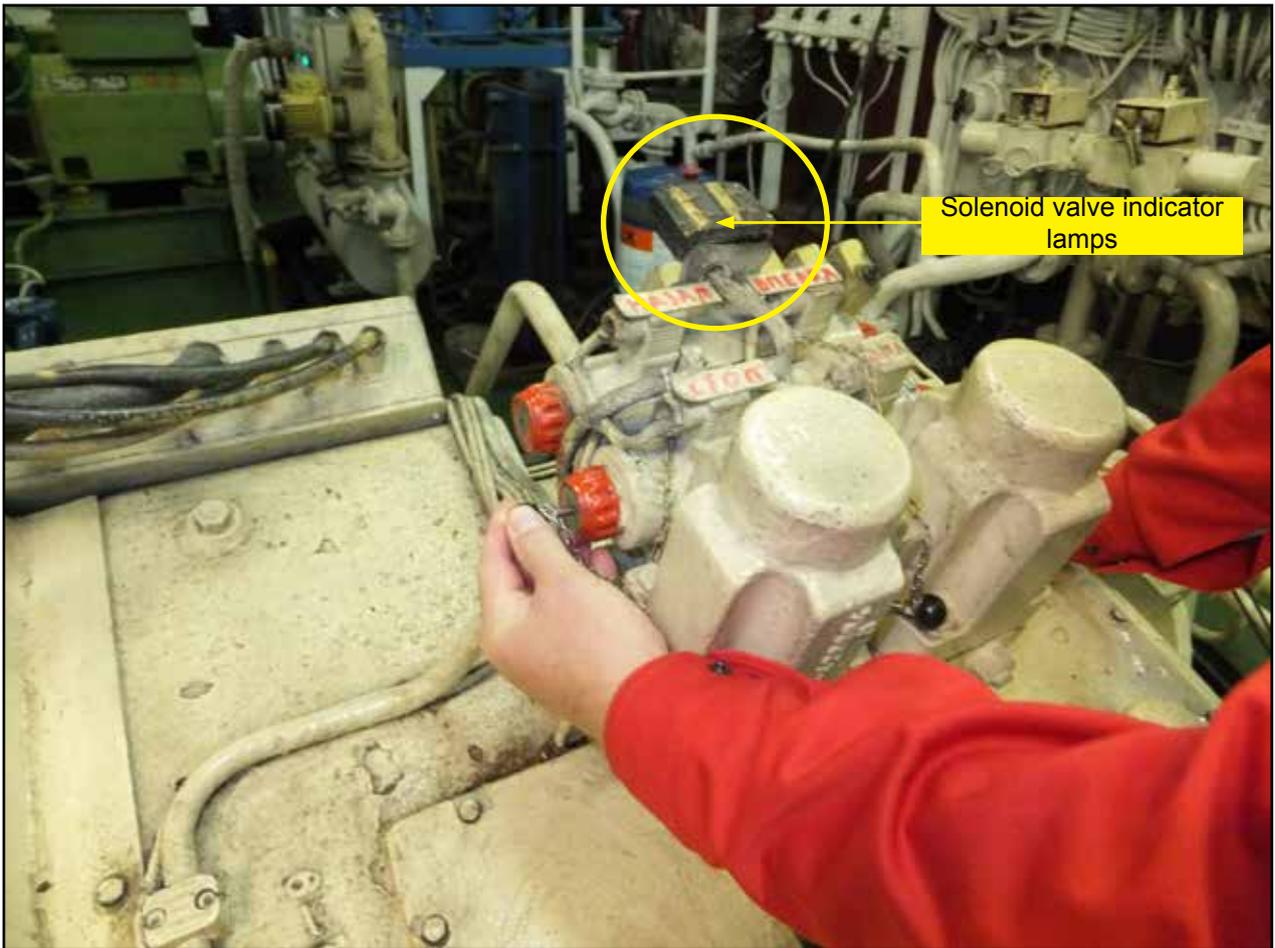
Figure 20: Gearbox solenoid valve block

For the departure, *Alexander Tvardovskiy's* propulsion was controlled manually using local controls on the main engine and the gearbox. Therefore, the failure to change the gearbox setting from 'astern' to 'ahead' could only have resulted from the incorrect operation of gearbox solenoid valves. However, because this error was not detected by the crew in the engine room or by the bridge team, the resulting action taken to avoid colliding with *UKD Bluefin* only exacerbated the situation.

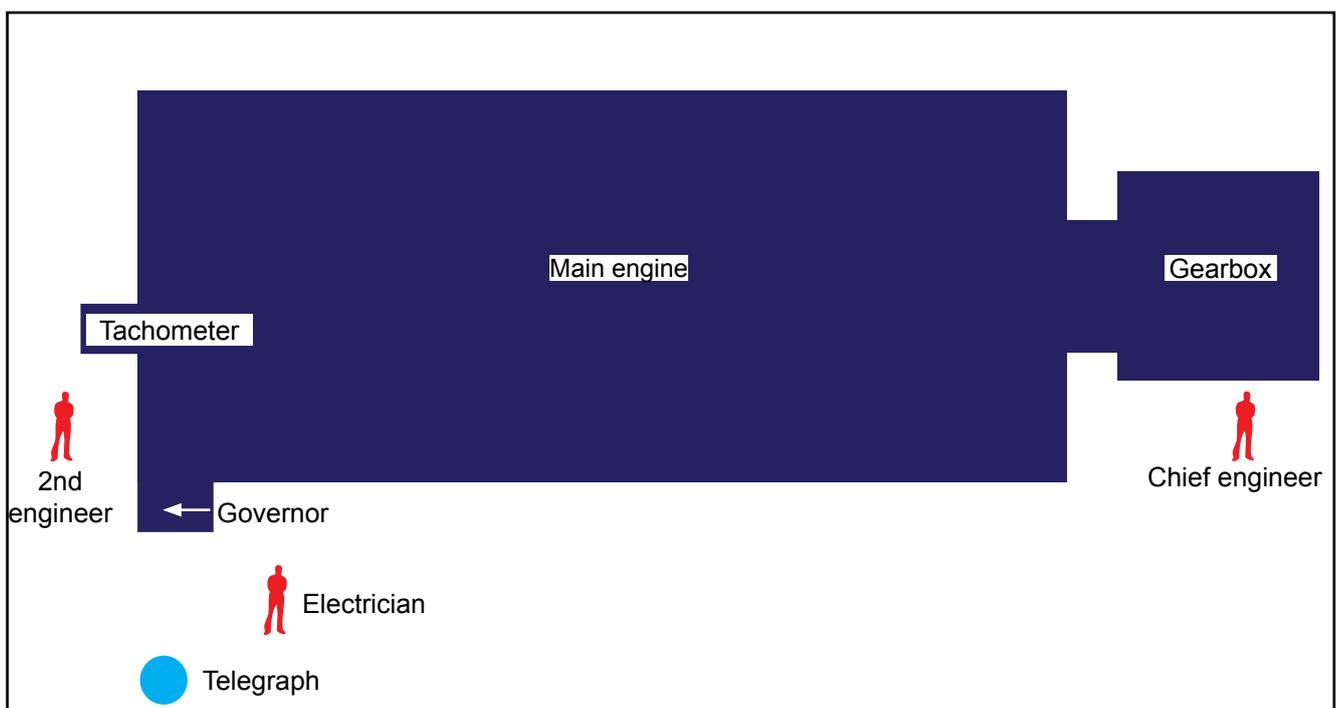
Figure 23: Positions of engineers

On 1 August 2012, the manual control of the propulsion system was undertaken by the chief engineer, the second engineer and the electrician (**Figure 23**). The electrician operated the engine room telegraph repeater indicator pointer (**Figure 24**) to confirm receipt of bridge orders, the chief engineer operated the solenoid control valves on top of the gearbox for the clutch and ahead or astern gears (**Figure 20**), and the second engineer operated the control wheel on the main engine governor to control the engine speed (**Figures 19 and 25**).

The second engineer was able to see the engine room telegraph repeater. The chief engineer standing by the gearbox control solenoids was too far from the engine room telegraph repeater to read it, so the electrician passed the orders to him. Due to the noise of running machinery in the engine room, the electrician relayed the orders by pointing forward with his hands and arms to indicate 'ahead' or by pointing aft to indicate 'astern'.
