TIMBERLAND

Man overboard
North Sea
25 November 2012

SUMMARY

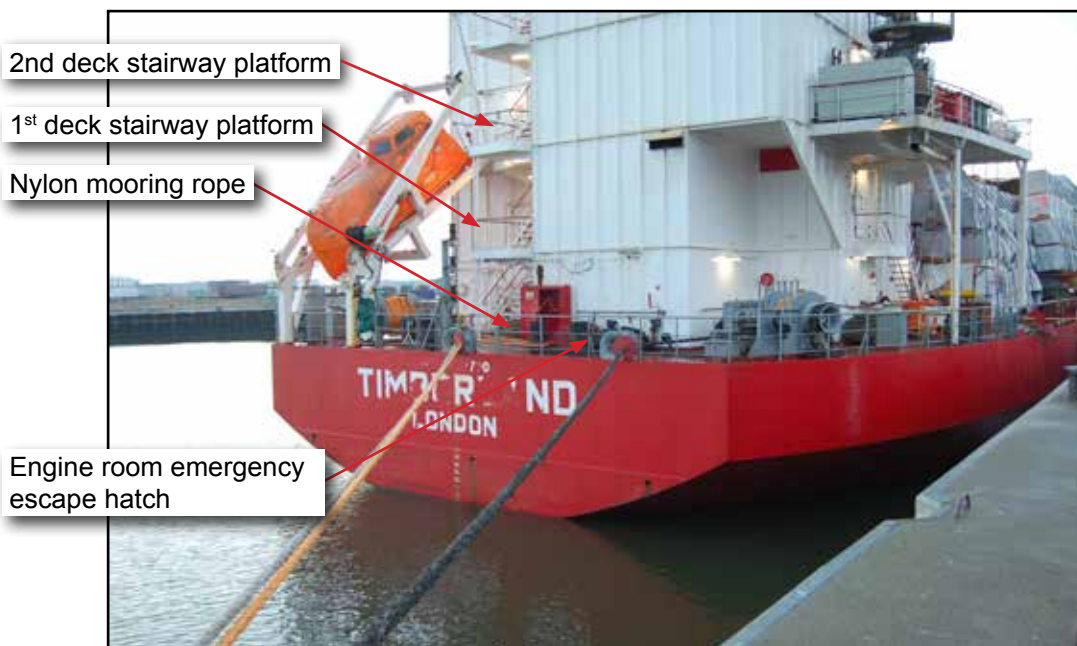
Figure 1: Aft mooring deck

The two crew members had proceeded onto the aft mooring deck (**Figure 1**) to secure a coiled mooring rope that had loosened in its stowed position.

They were struck by a large wave, which washed them overboard, causing their respective lifelines, which were secured to the vessel, to part.

The management company, Imperial Ship Management AB, has since taken action to ensure that all mooring ropes which are not secured on drums are stowed underdeck on board all vessels within its fleet. Additionally, it has introduced detailed instructions and guidance in its safety management system manual with regard to sending crew on deck in heavy weather. Consequently, the MAIB has made no recommendations.

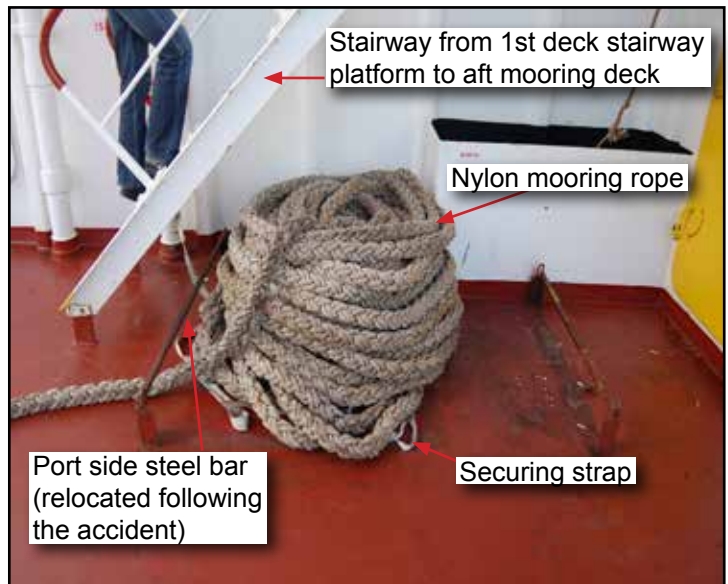
Figure 2: Nylon mooring rope stowage

The master proceeded to the 2nd deck external stairway platform to visually check both the nylon mooring rope, located under the external stairway leading from the 1st deck to the aft mooring deck (**Figure 2**), and the polypropylene mooring rope located adjacent to the engine room emergency escape hatch. Both ropes were loose in their stowage. The master's main concern was that if the nylon rope was washed overboard it would sink, and potentially foul the vessel's propeller. He therefore decided that action needed to be taken to re-secure the rope.

Following the accident, it was found that the port side steel bar holding the nylon mooring rope in position had broken free from the deck, causing the rope to loosen.

The port side steel bar holding the nylon mooring rope pallet in position broke free from the deck due to weld failure. The structure as manufactured had lacked strength, and its exposed position and apparent lack of maintenance rendered it liable to corrosion from the effects of weather and shipped seawater.

- Following the accident, verified that mooring ropes that are not secured on drums are stowed underdeck on board all vessels within its fleet.
- Subsequently enhanced its safety management system manual instructions for preparing for heavy weather, particularly to the effect that all loose deck equipment is to be secured and all additional mooring ropes not secured on drums are to be stowed in an assigned container or underdeck.
