Report on the investigation of
the foundering of the fishing vessel

Purbeck Isle

9 miles south of Portland Bill, England

on 17 May 2012

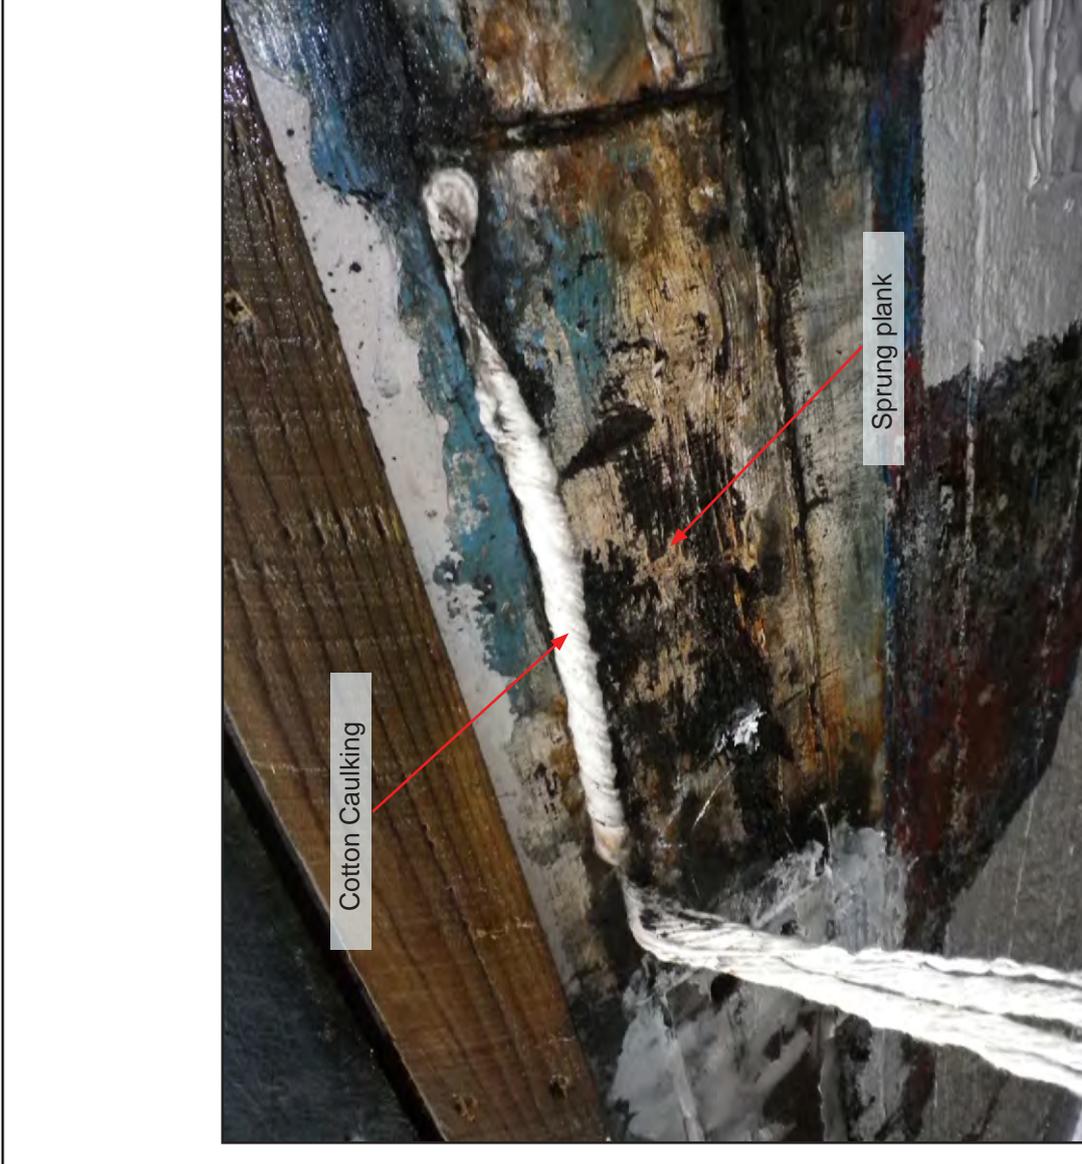
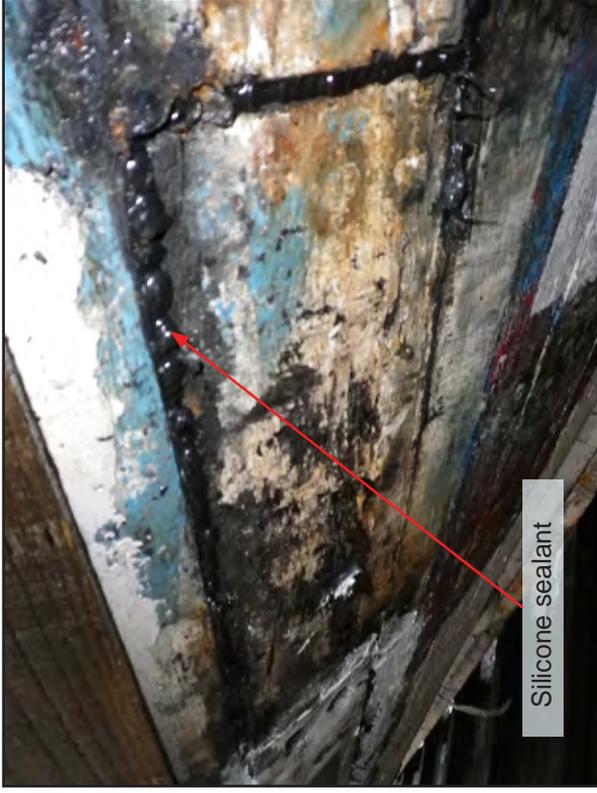
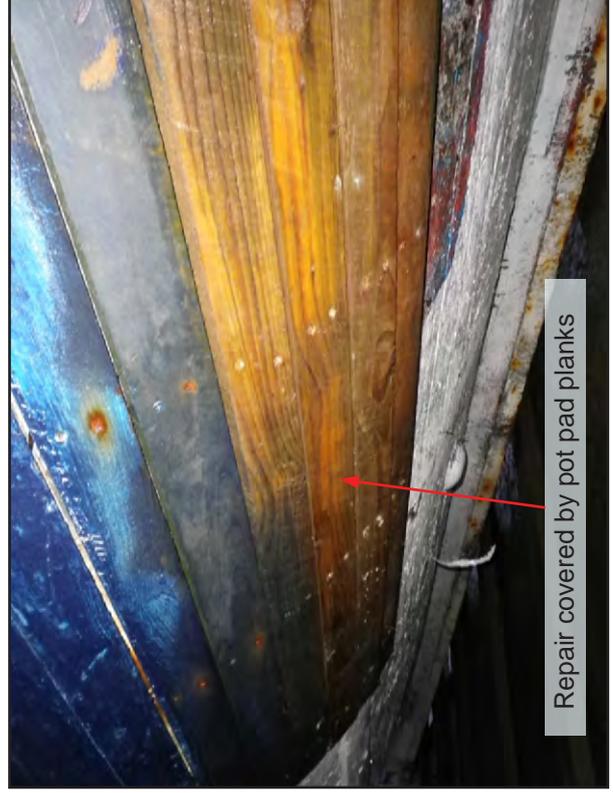
Figure 10: Repair carried out following flooding incident on 3 January 2011

When David McFarlane took over the operation of *Purbeck Isle* in 2010 a short section of damaged hull planking behind the pot pad was cut away and replaced. On 3 January 2011, the repair failed at sea when this short length of plank sprung, causing the vessel to flood. *Purbeck Isle* was taken out of the water and the plank was re-fastened and its seams were re-caulked and stopped with a silicon-based marine sealant (**Figure 10**).

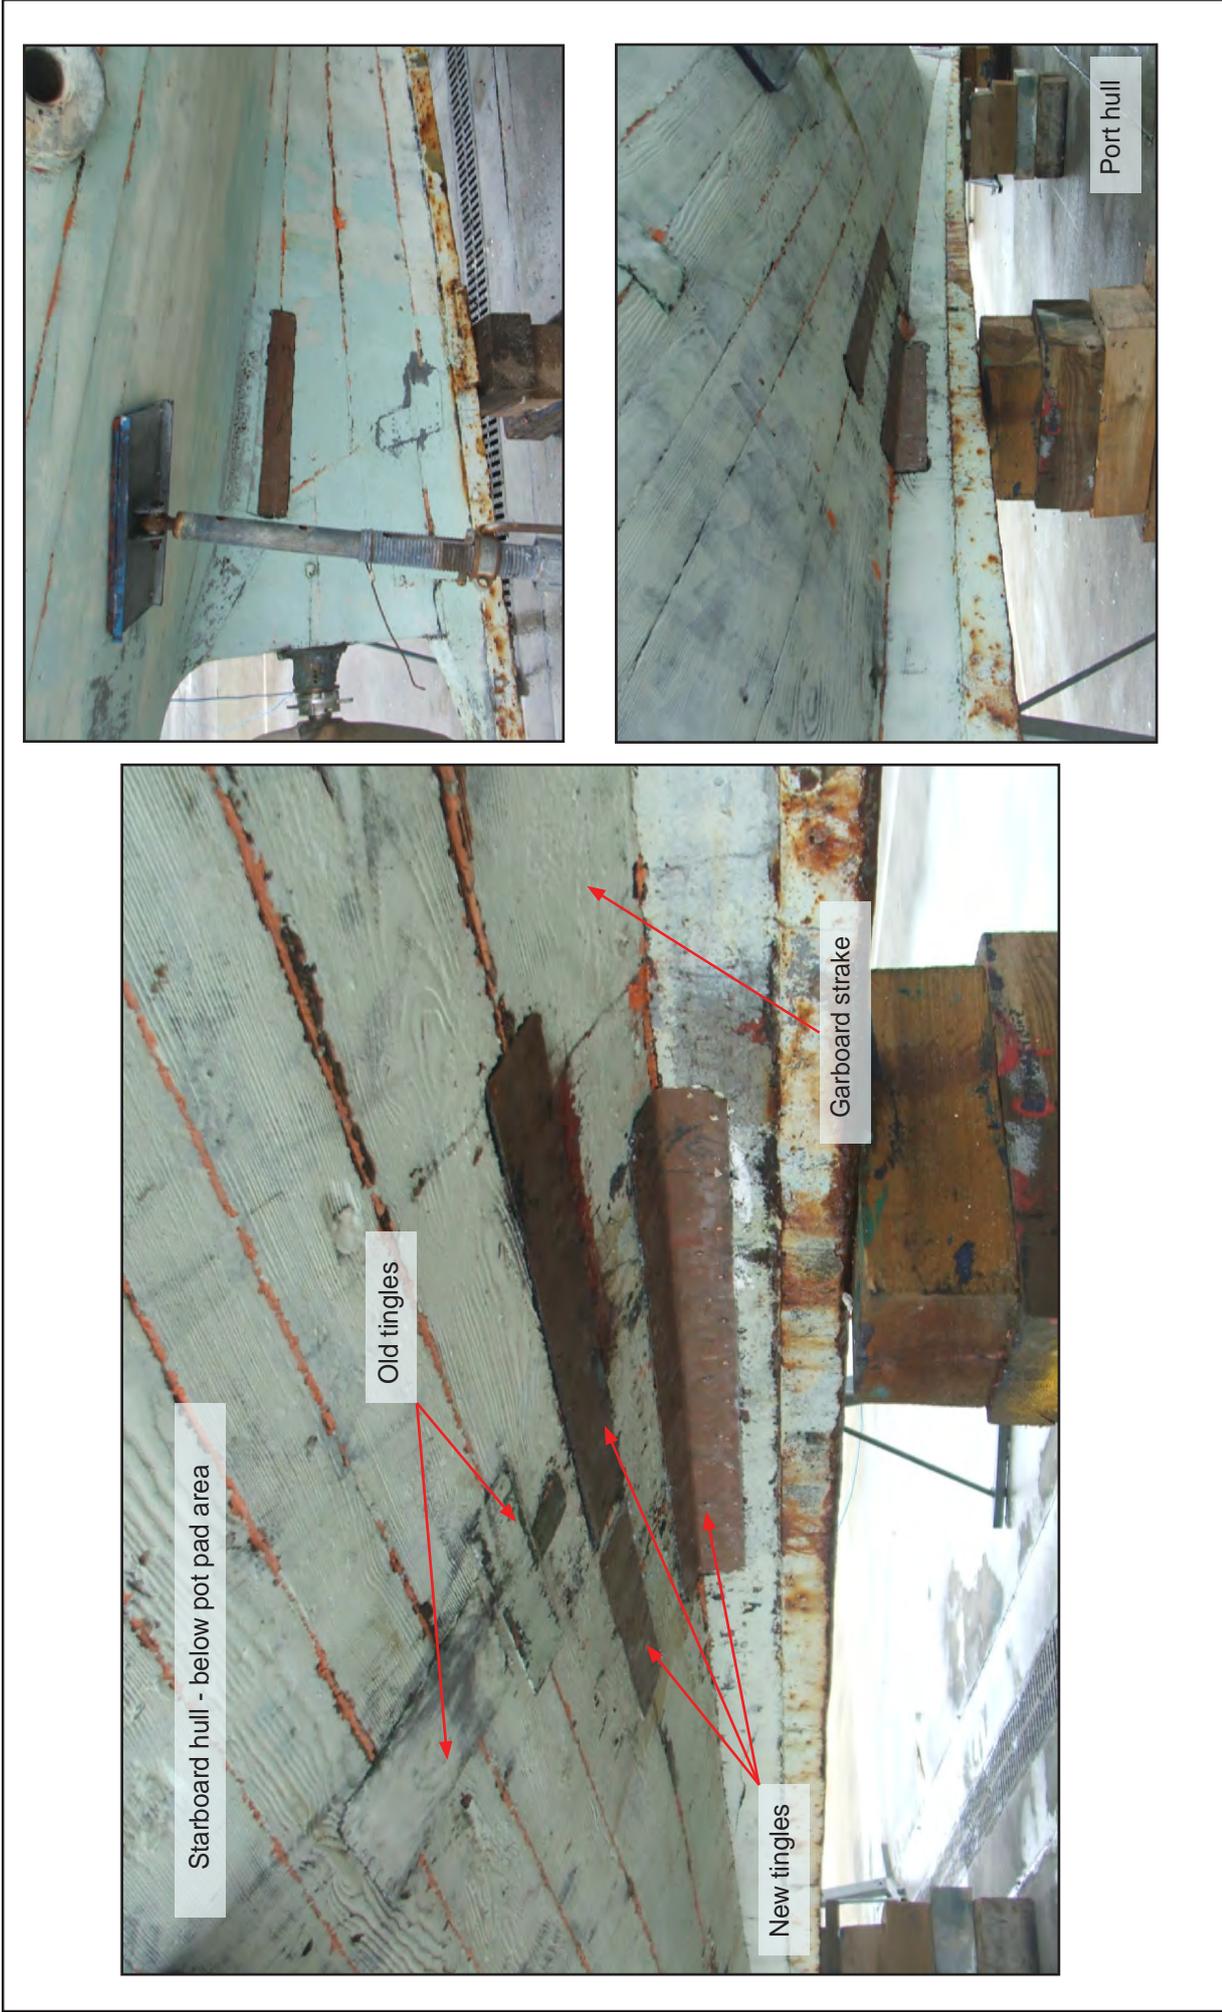
Figure 11: Hull condition in October 2011

It was noted during the maintenance period that some small areas of planking, mainly behind the pot pad, had been attacked by gribble worm¹⁰. It was also evident from the photographs taken at the time that a significant number of tingles¹¹ (**Figure 11**) had been fitted over the exterior seams between the hull planking. Many of these were fitted below the pot pad and around the garboard¹² strakes. Several of the old tingles, which had been removed by the previous contractor, were renewed.

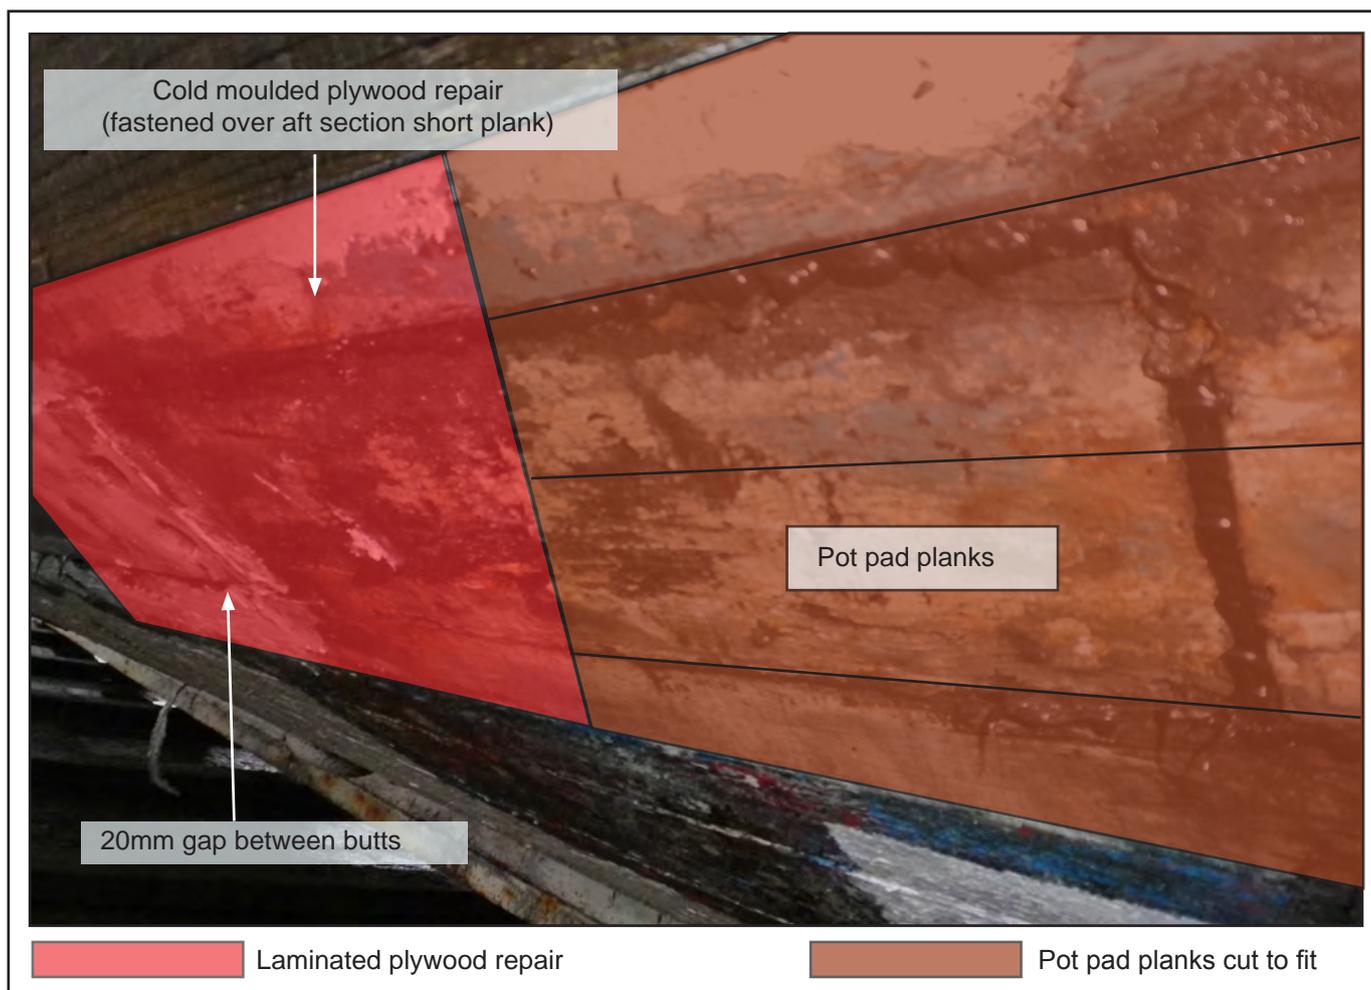
Figure 12: Temporary repair to short section plank behind pot pad

The boatyard recommended that the affected planks be removed and replaced with a new one of adequate length. As this would have taken 2 days to do, the skipper instructed the boatyard to carry out a temporary repair. As instructed, the boatyard sealed the gap between the planks by fastening 6 layers of 4mm thick plywood board over the affected area (**Figure 12**). The plywood boards were laminated and cold moulded in situ. The plywood repair spanned three planks vertically and a strong back was fitted internally to add further strength. In order to do this a section of the pot pad had to be cut away. The boatyard's invoice (**Annex A**) listed the work it had carried out and included a recommendation to remove the temporary repair and fit a new plank at a later date.

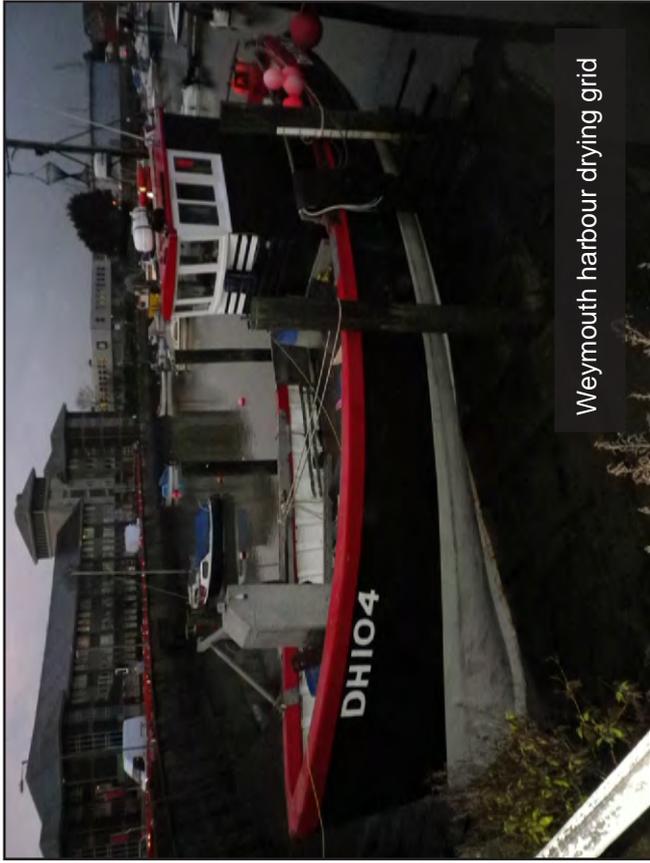
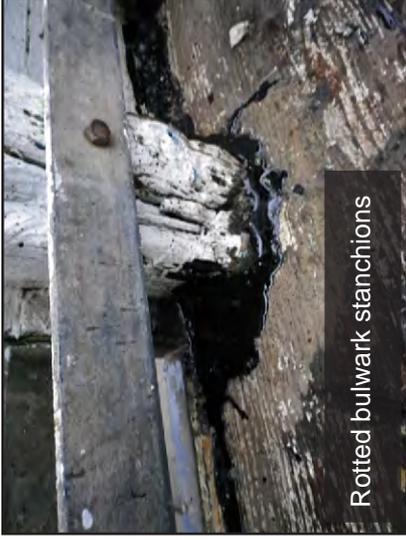
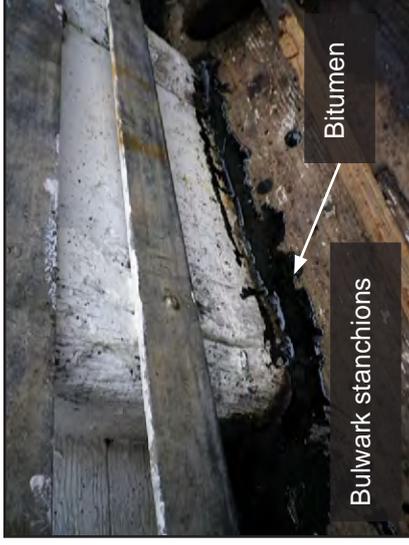
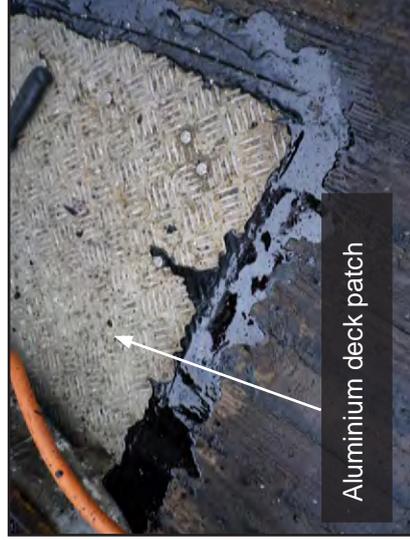
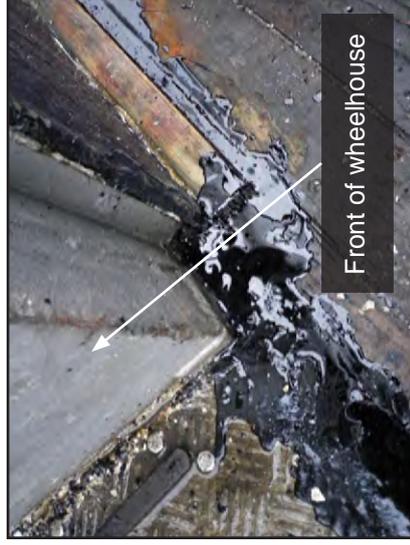
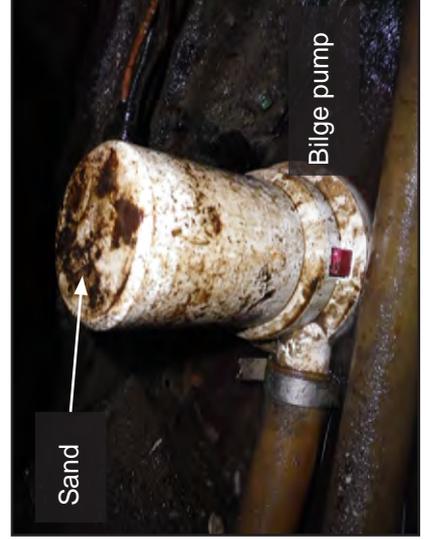
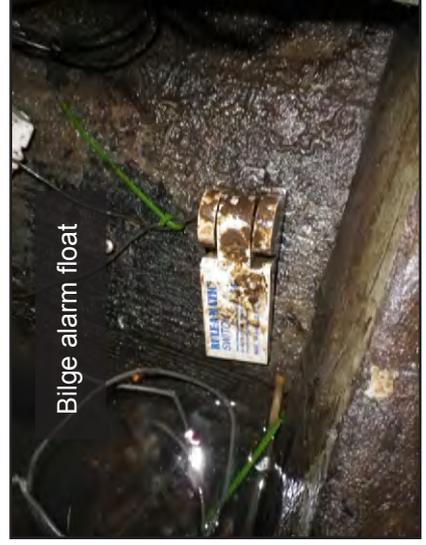
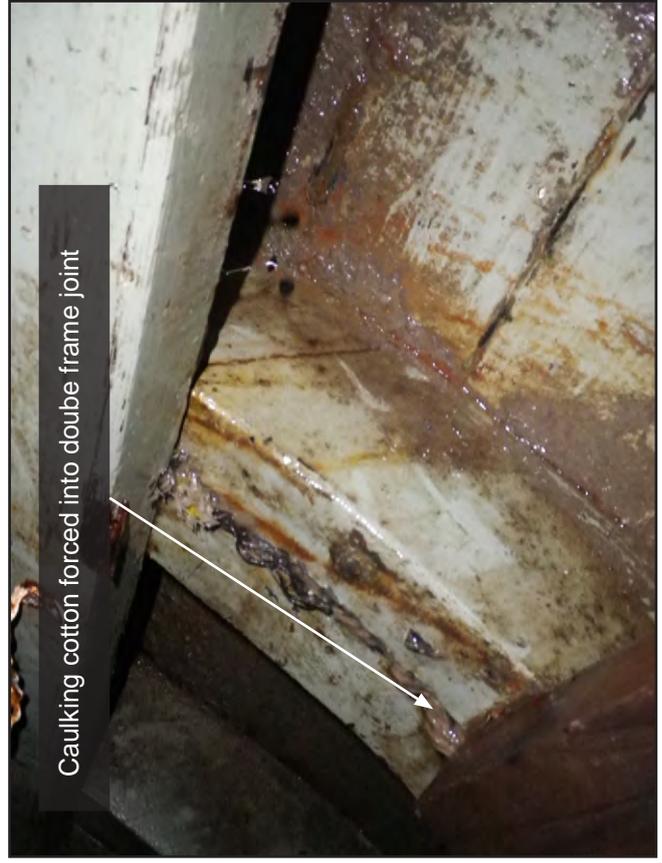
Figure 14: Photographs taken during MCA inspection in January 2011

Although there was no mention of the vessel's deck in the report, the photographs taken by the surveyor during his inspection gave an indication of its overall condition and showed the extent of the skipper's attempts to make it watertight.

Large amounts of bitumen had been poured around the outer edges of the deck adjacent to the heavily rotted bulwark stanchions and around the forward end of the wheelhouse (**Figure 14**).

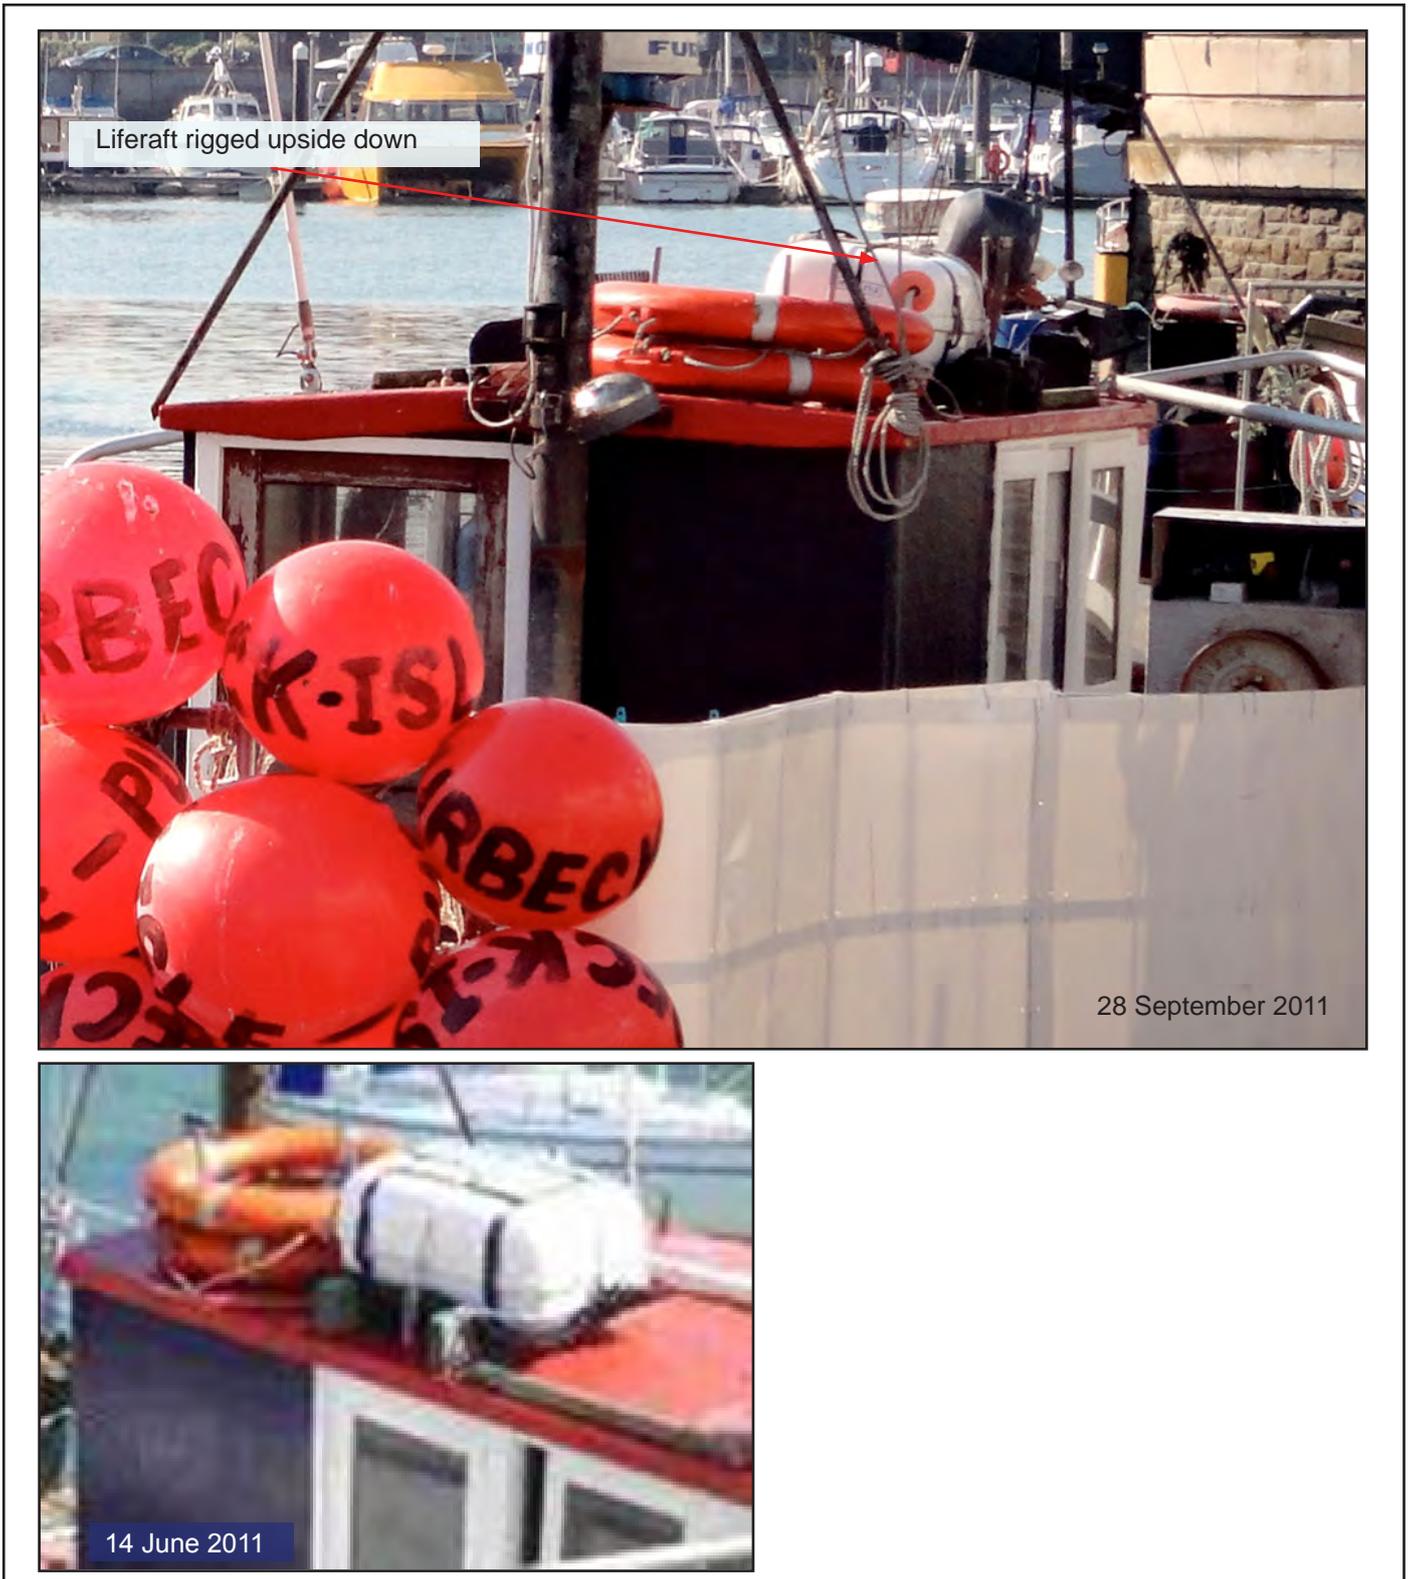
Figure 19: Liferaft lashed on wheelhouse roof

Photographs (**Figure 19**) taken of *Purbeck Isle* up to and including 7 months before the accident clearly show the liferaft secured upside down in its cradle on the wheelhouse roof.

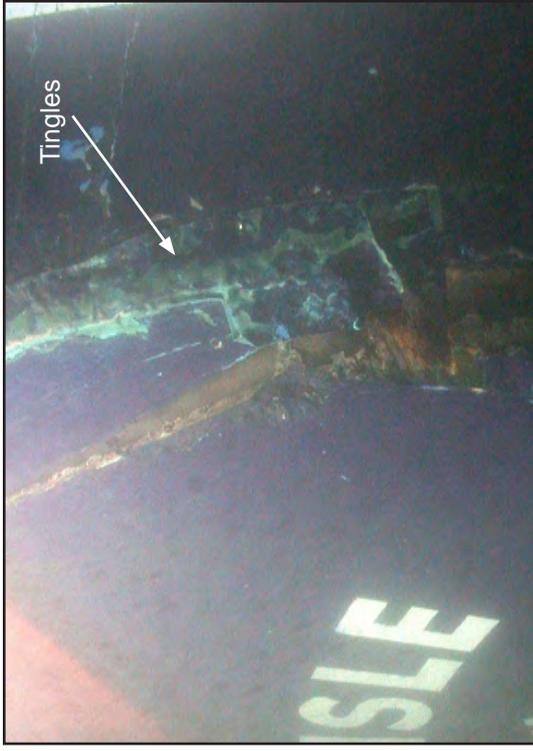
Figure 22: ROV footage showing damage to transom

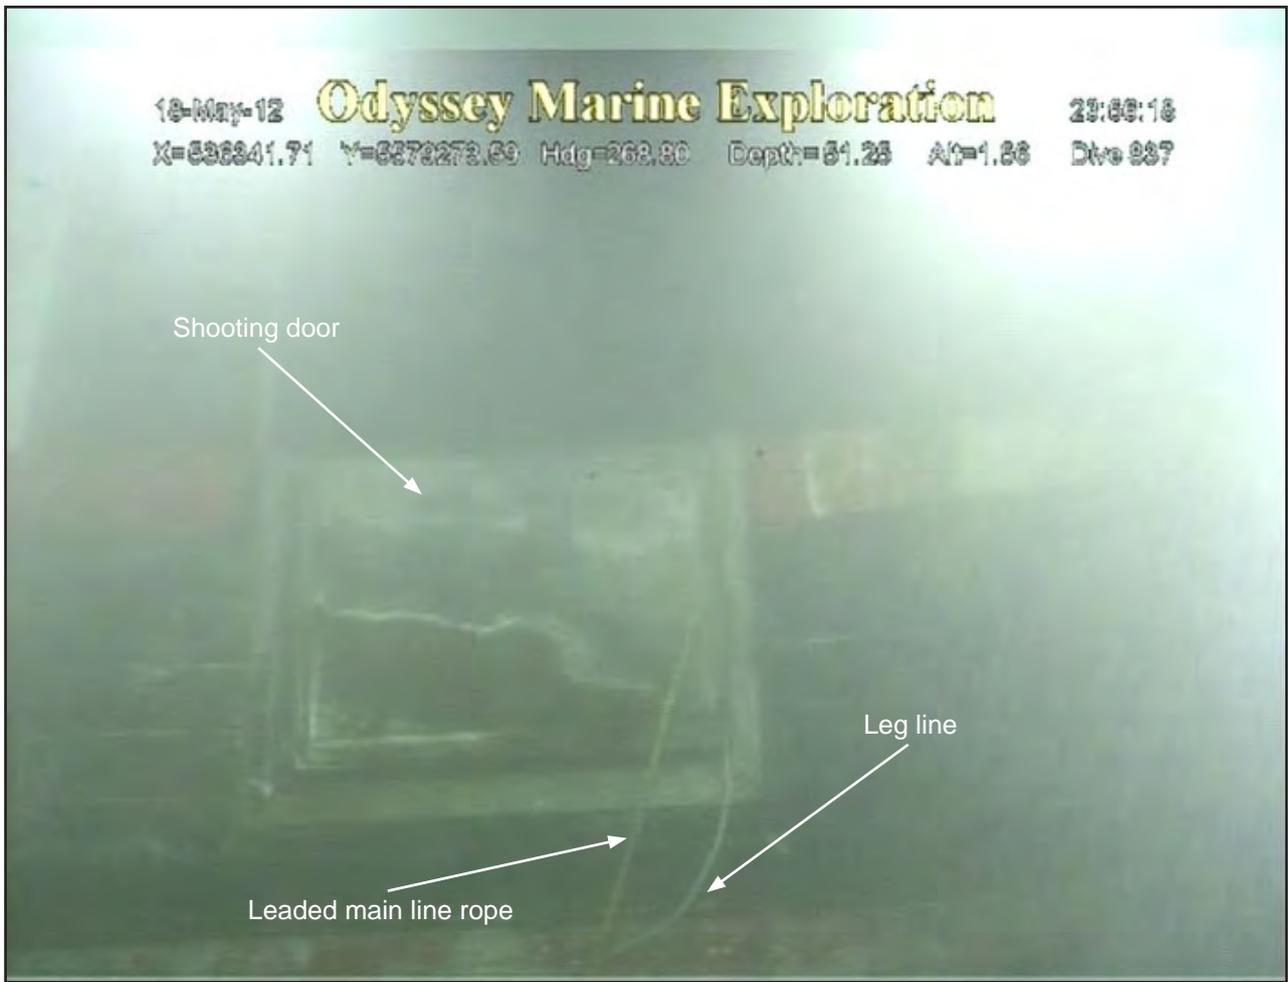
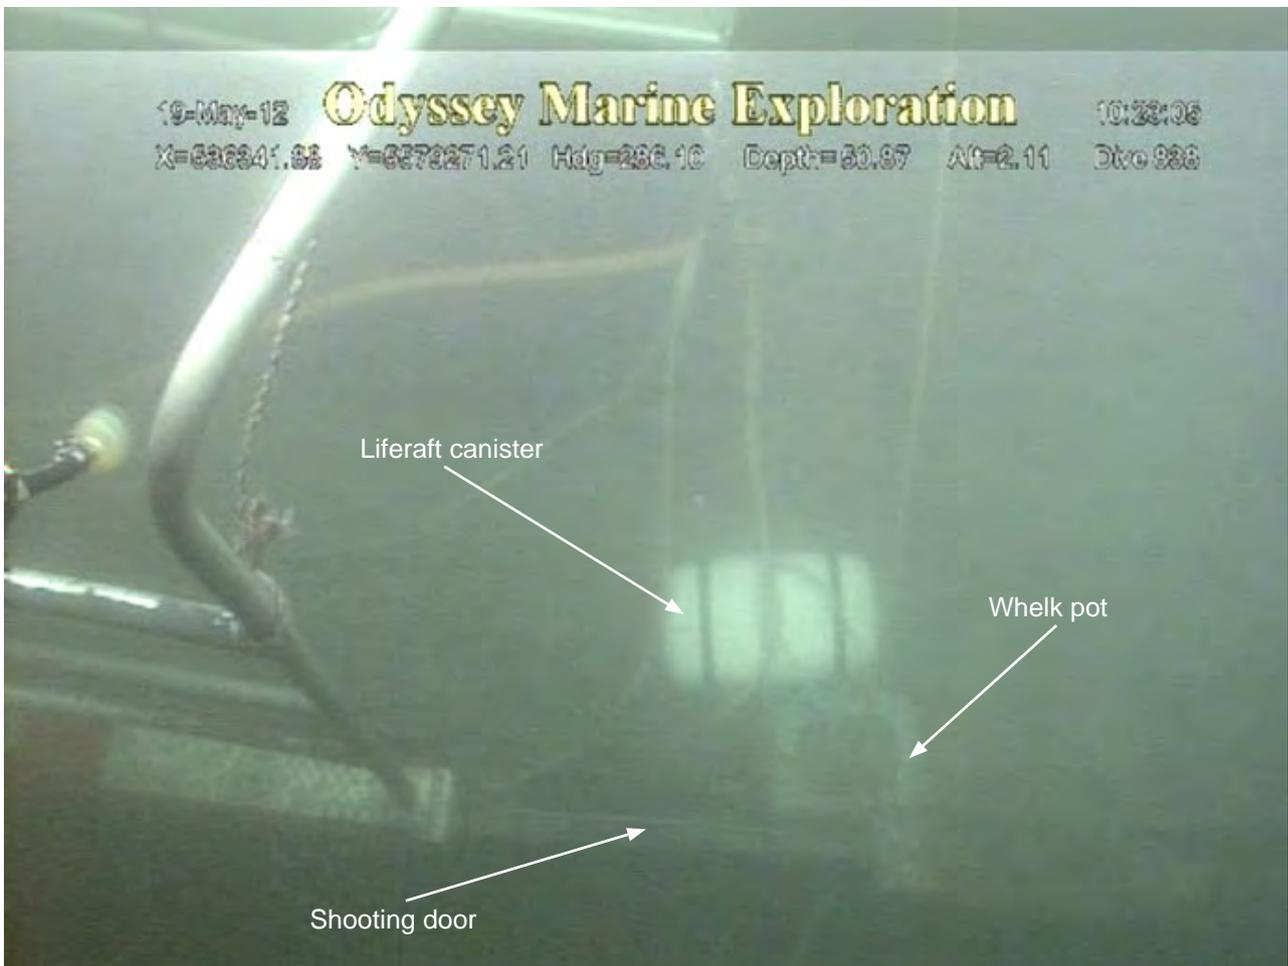
Figure 23: ROV footage showing the shooting door closed and the liferaft on deck

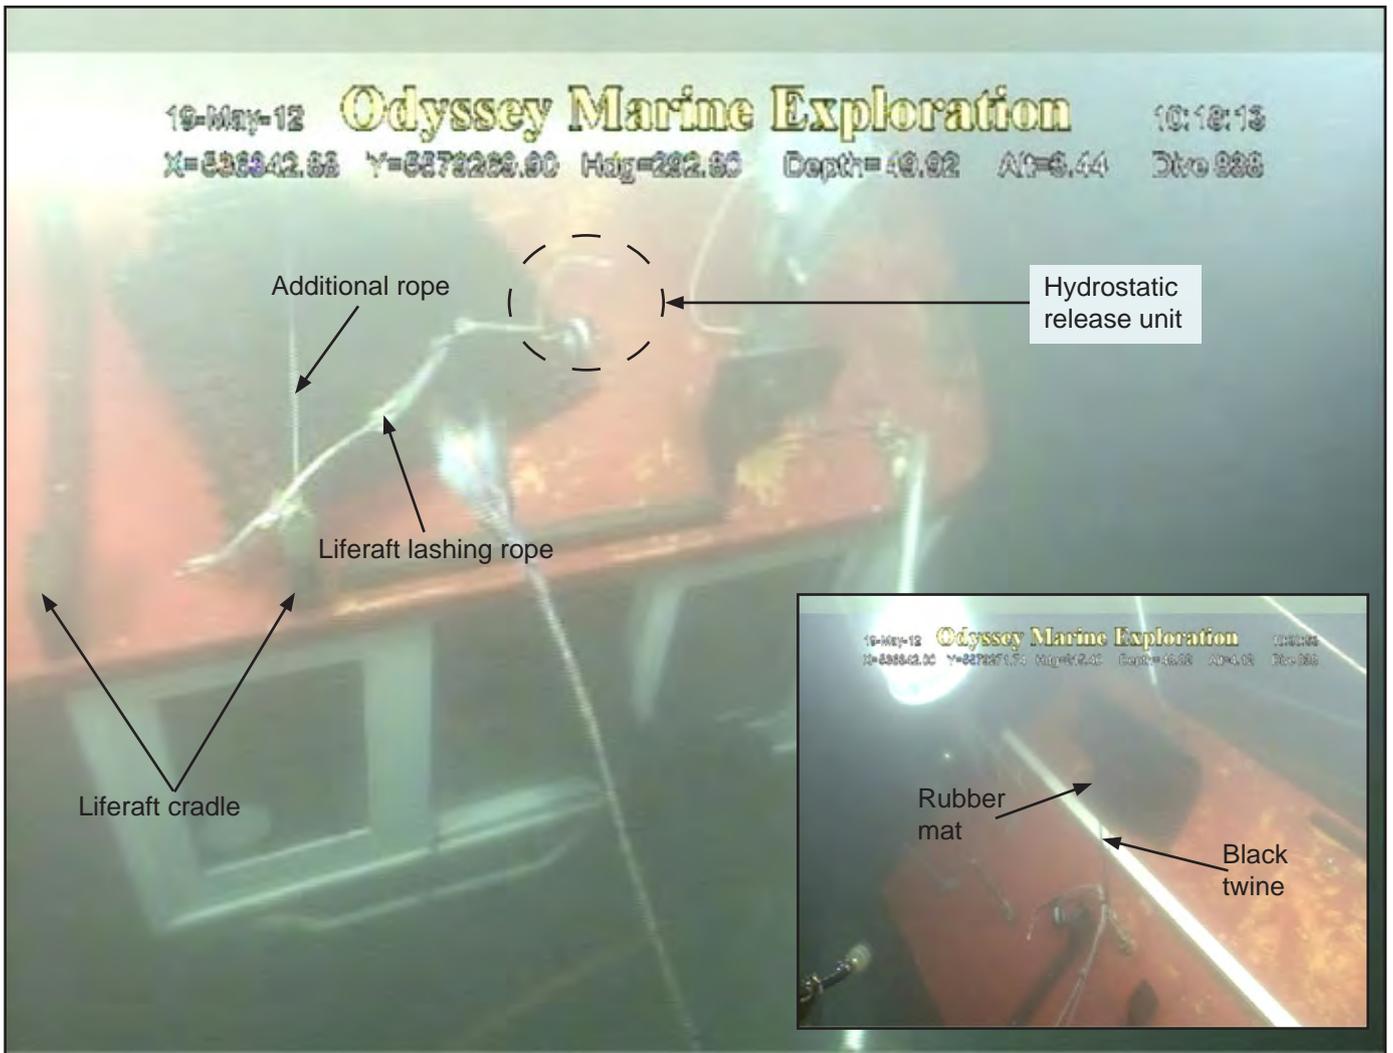
Figure 27: ROV footage showing the liferaft cradle and hydrostatic release unit

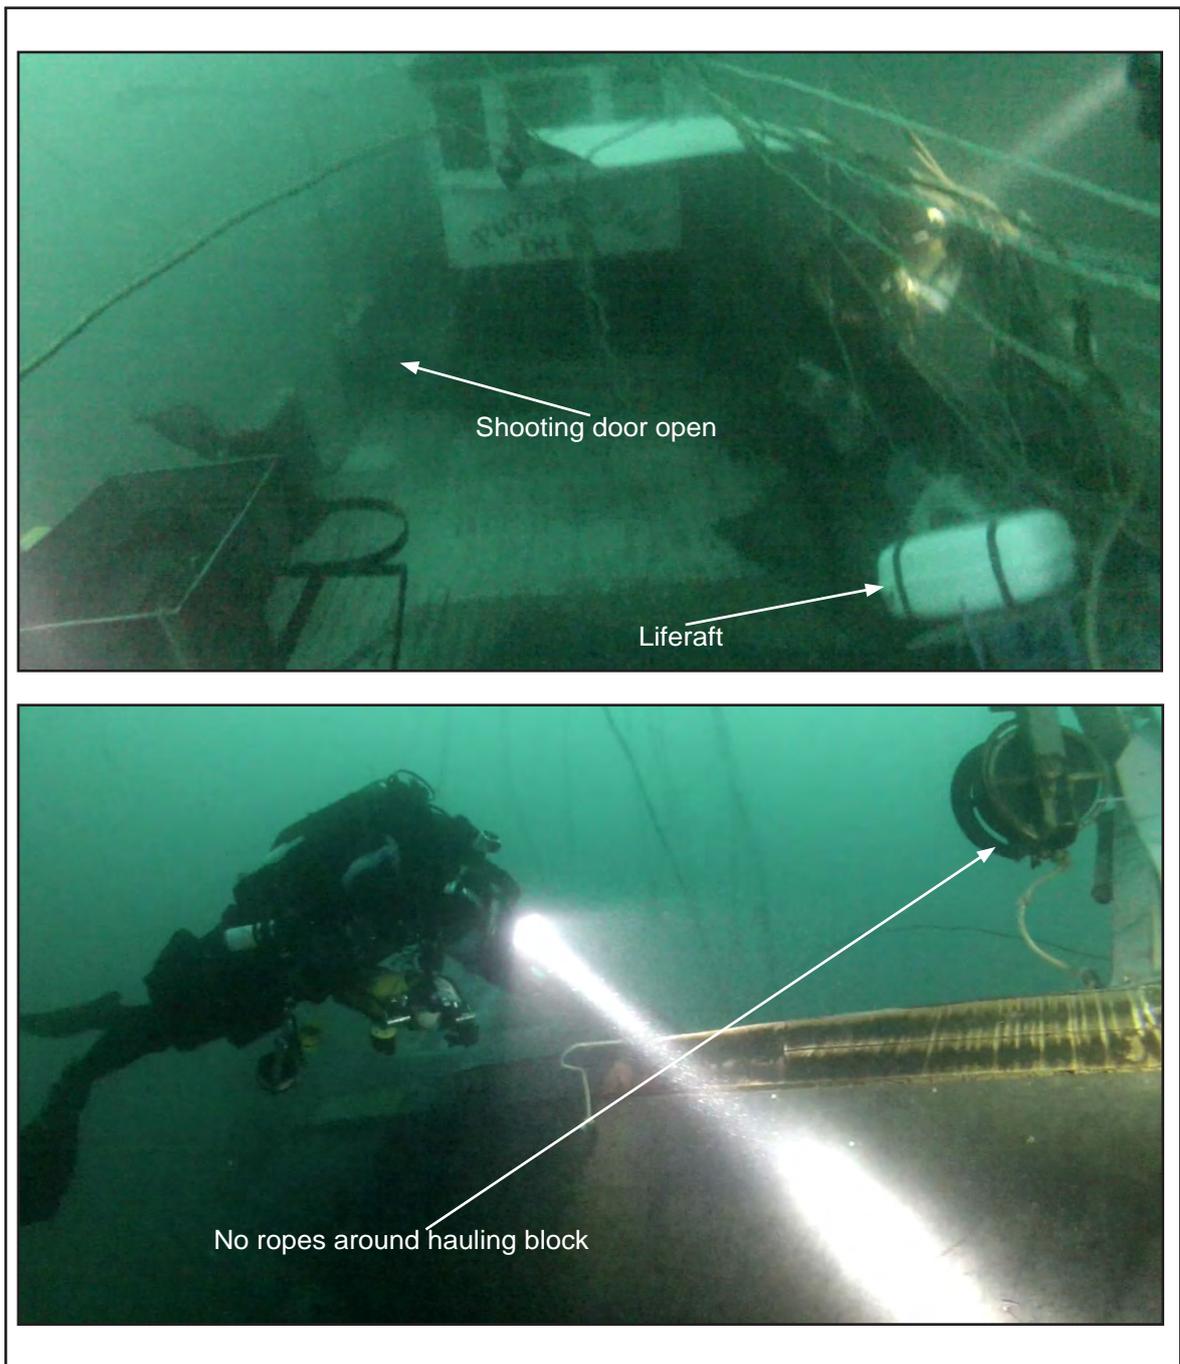
- There were no ropes on the hauling block (**Figure 28**).
- Bags of whelks were stacked on the port side of the deck outside the wheelhouse (**Figure 29**).
- Bags of whelks were lying in a row on the port side bench inside the wheelhouse (**Figure 29**).
- Bags of whelks and ropes were stowed in the machinery compartment (**Figure 29**).

Figure 28: Dive one footage showing the deck forward of the wheelhouse

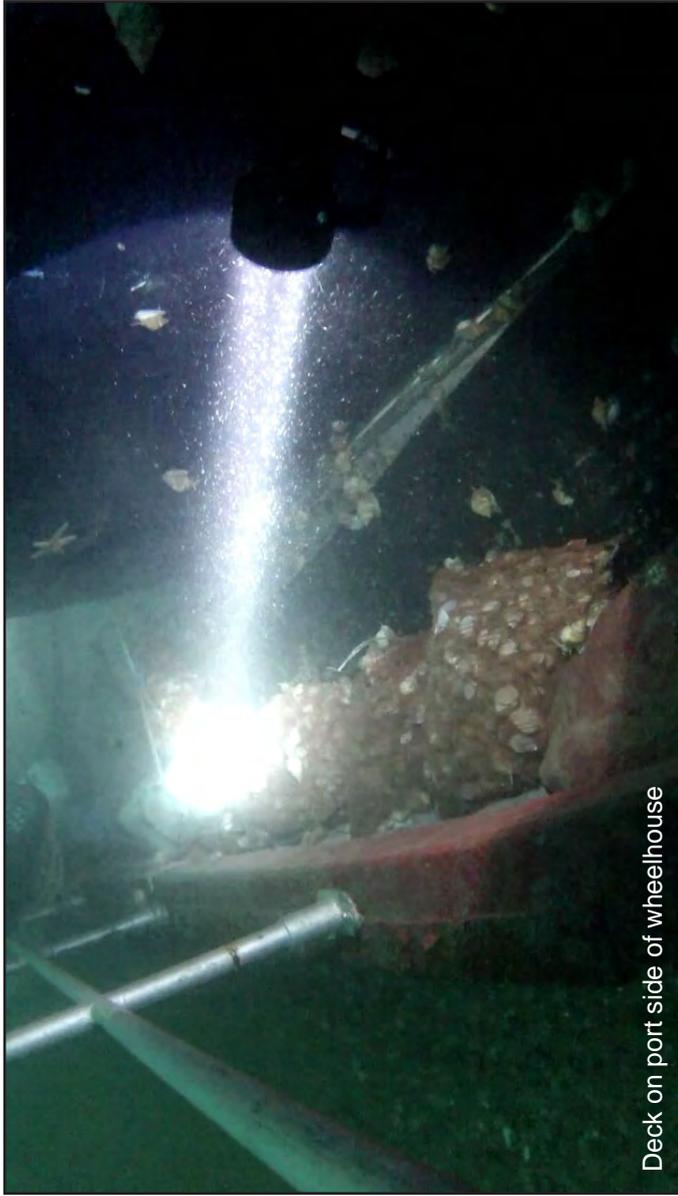
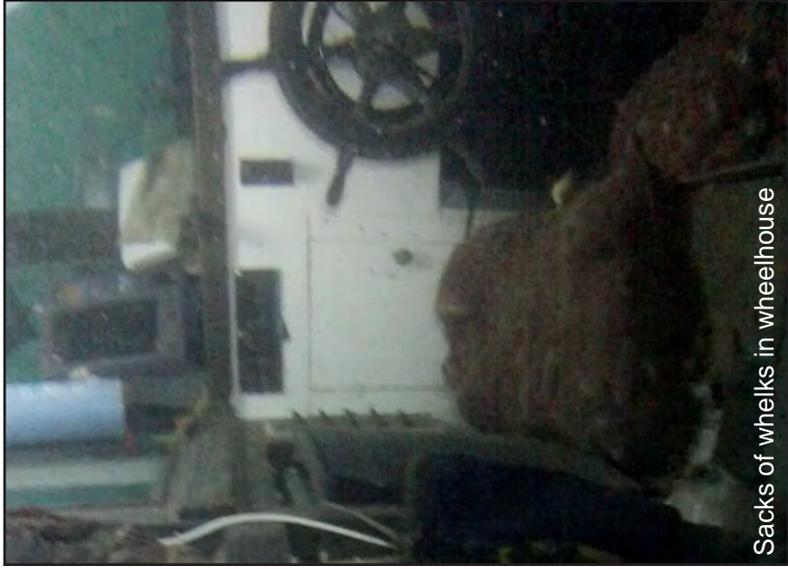
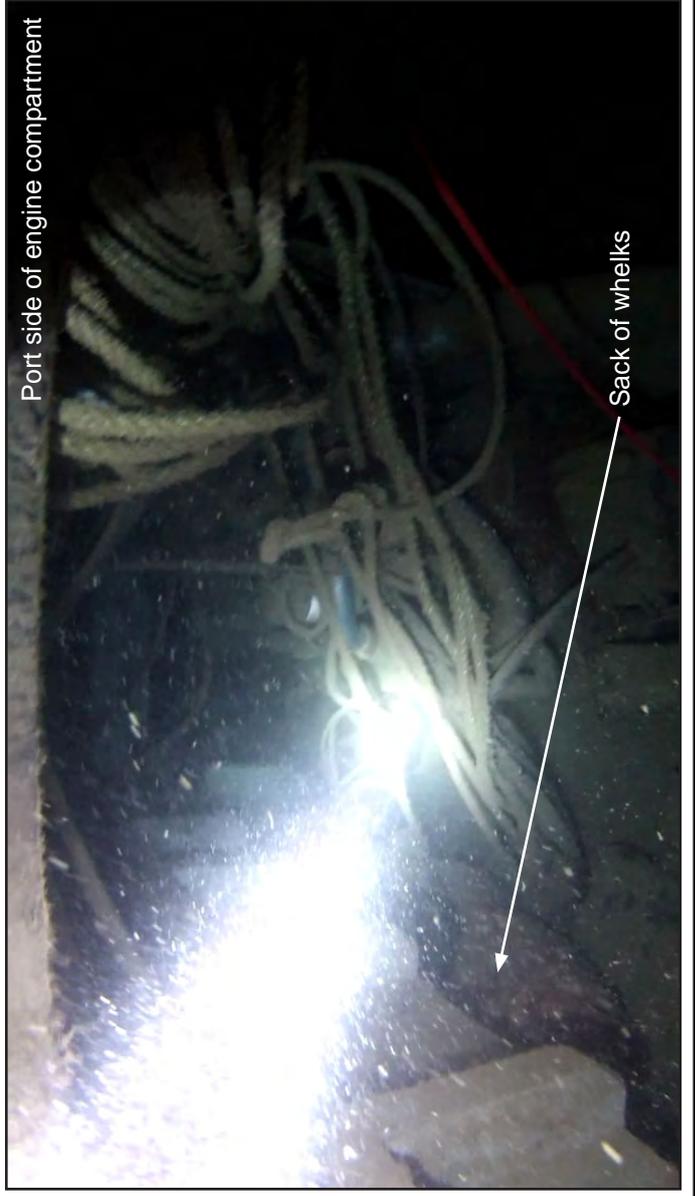
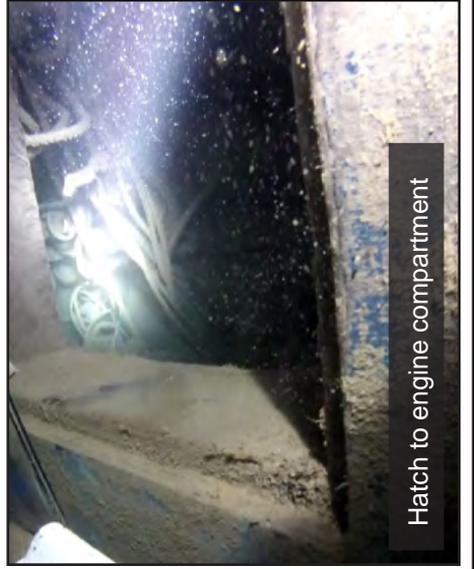
Figure 29: Dive one footage showing sacks of whelks on deck, in the wheelhouse and below deck

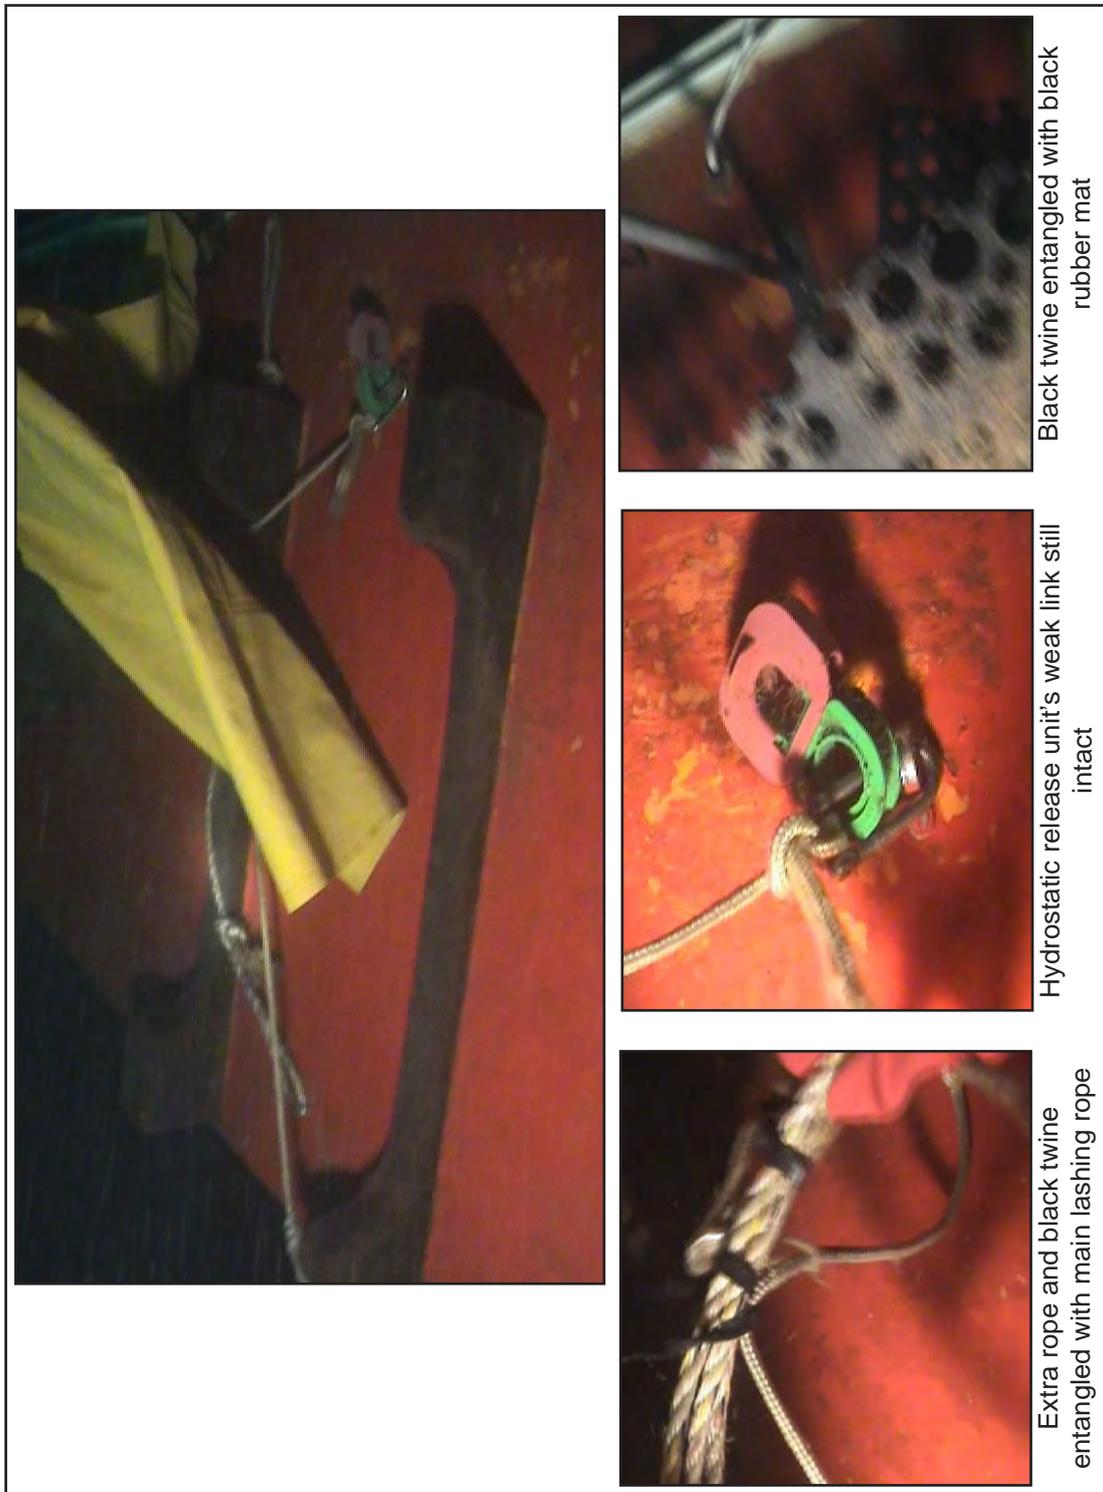
The second dive was carried out on 30 June 2012 at the request of *Purbeck Isle's* registered owner. The aim of the dive was to recover the liferaft. The divers discovered that *Purbeck Isle* had moved several hundred metres along the seabed, she had suffered damage, and the liferaft was no longer on board and was not found. The video footage taken of the dive provided a clear view of the HRU (**Figure 30**), which showed that the weak link had not been broken.

Figure 30: Dive two footage showing hydrostatic release unit with weak link still intact

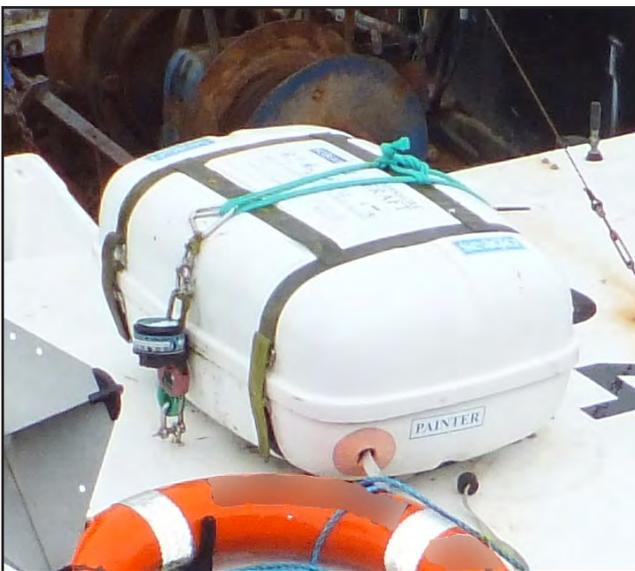
Liferaft rigged to float free but painter line is not attached to the weak link

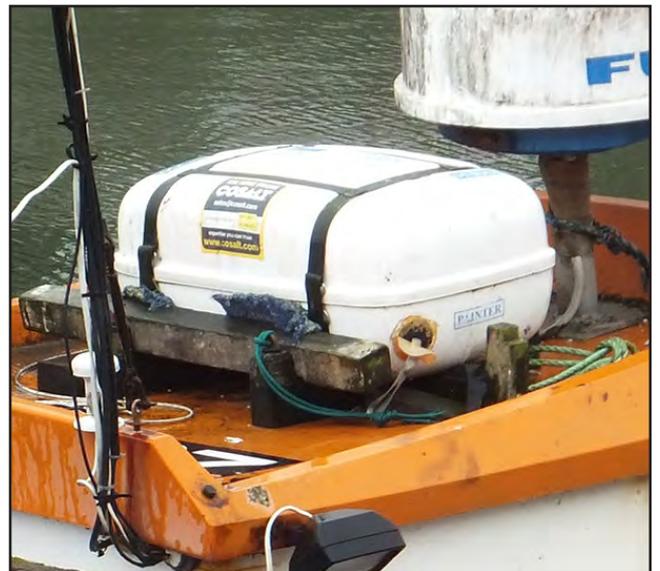
Liferaft rigged to float free but painter line is not attached to a HRU and raft does not fit in cradle

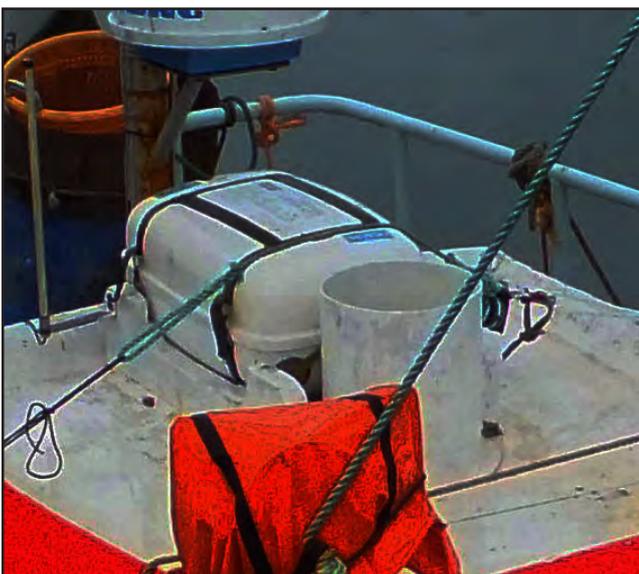
Liferaft rigged to float free and painter line is attached to weak link. Liferaft does not fit in cradle
