Report on the investigation of
the foundering of the fishing vessel

Purbeck Isle

9 miles south of Portland Bill, England

on 17 May 2012

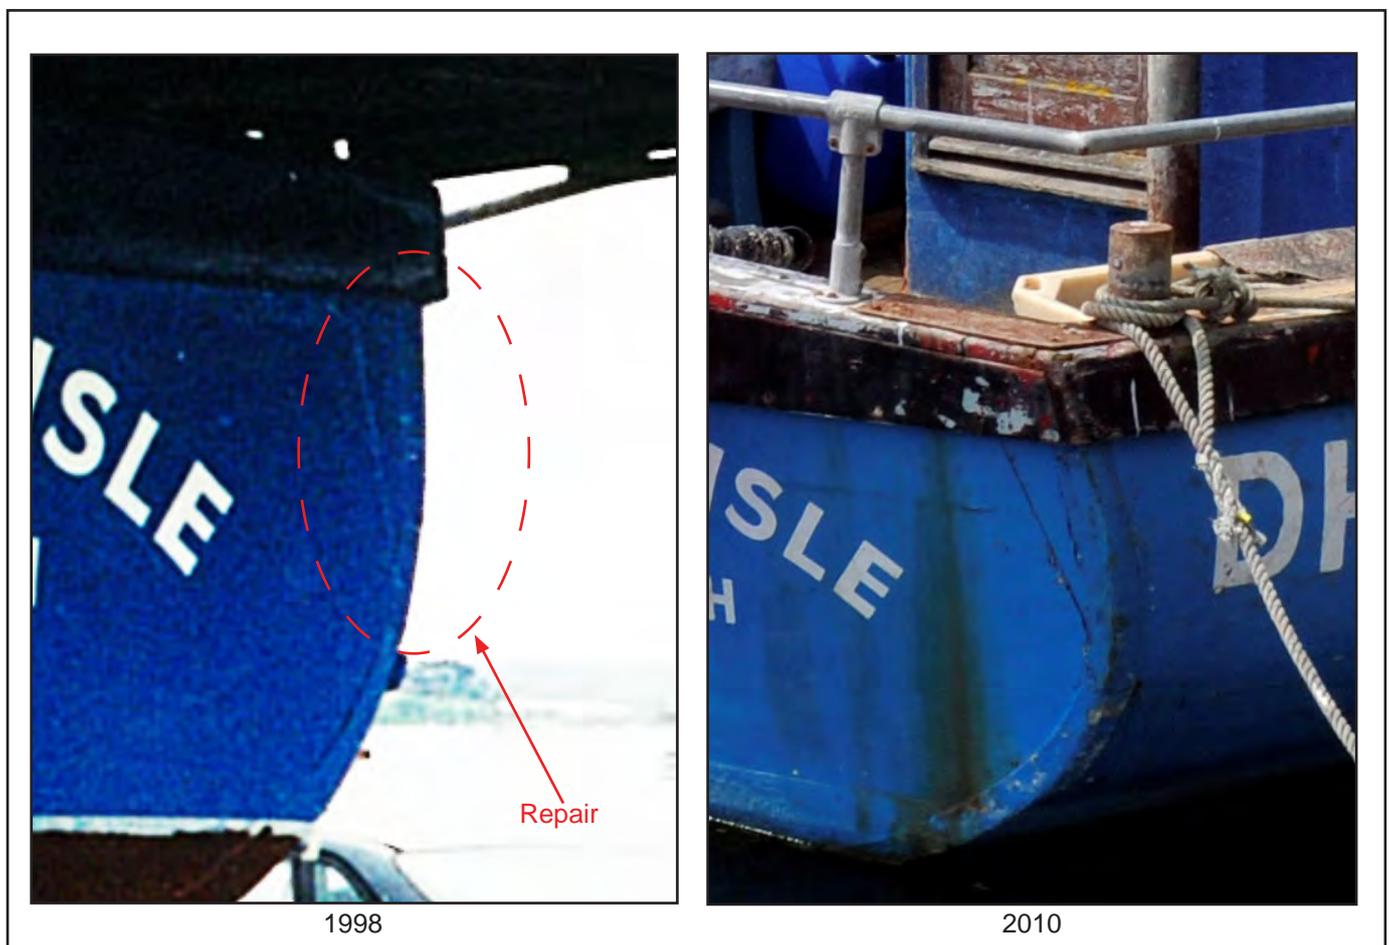
Figure 32: Photographs of previous transom repair

It was immediately apparent from the photographs provided that a repair had been carried out to the vessel's transom several years earlier (**Figure 32**). A section of planking on the upper starboard side of the transom had been cut away and replaced with a patch. In addition, it was evident that the seams between the hull strakes and the transom planks had been covered by tangles for many years.

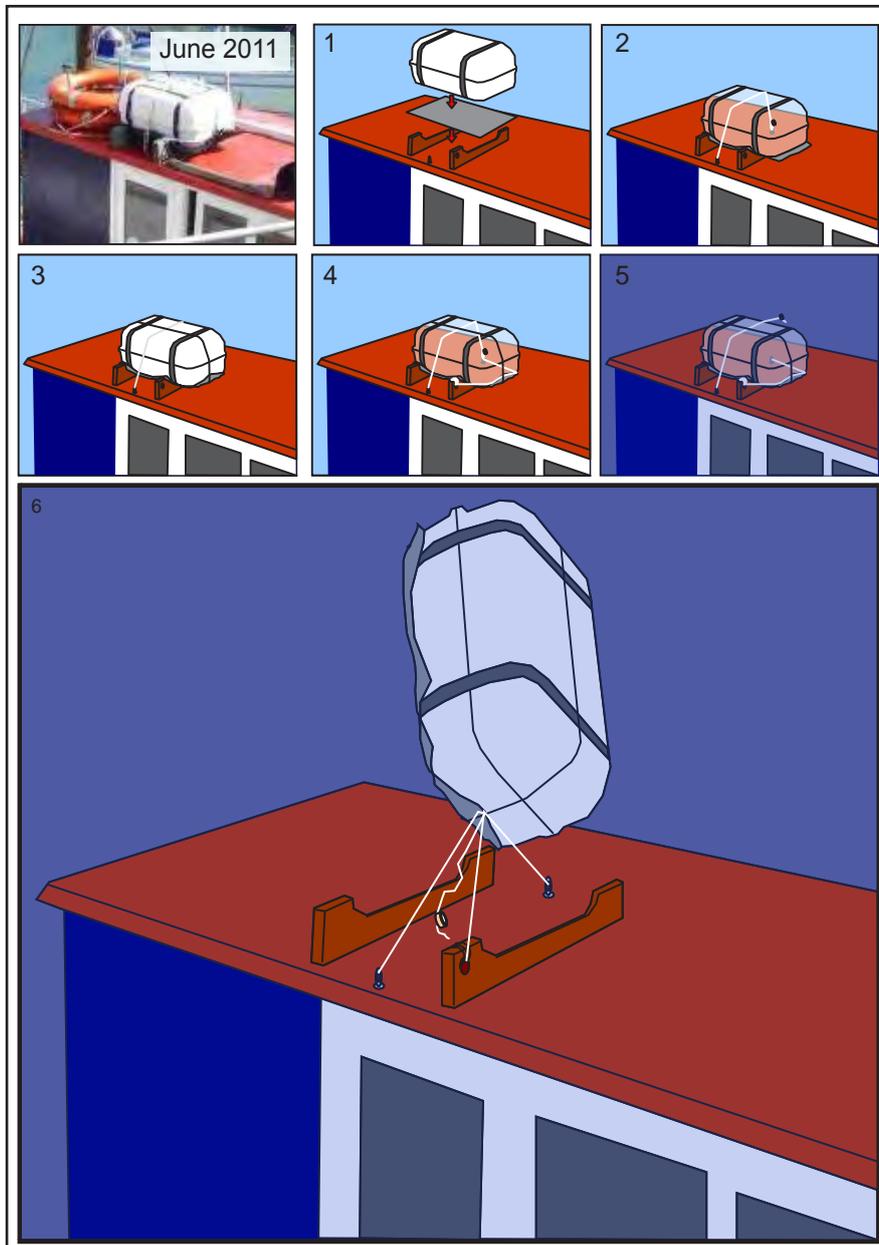
Figure 33: Likely sequence of events leading to failure of the liferaft float free

1. The liferaft was laid upside down on top of a rubber mat in its wooden cradle.
2. The liferaft's main securing rope was lashed to a steel eyelet screwed in the wheelhouse roof at one end, and directly to the strong eye of the HRU on the other.
3. Black twine was wound around the rubber mat and the liferaft canister.
4. An additional length of rope, secured to the outboard side of the forward cradle bracket, had been fed around the front of the liferaft canister and tied to the shackle that secured the HRU to the wheelhouse roof.

5. As *Purbeck Isle* sank, the hydrostatic release mechanism activated and released the liferaft canister.
6. Due to the additional lashings being intertwined with the main securing rope, the liferaft was prevented from floating free and sank to the seabed with the vessel.
7. Over time, the liferaft probably worked free in the underwater currents, and was released. However, as the canister was likely to be full of water by this time, it had become negatively buoyant and sank to the deck.
