Fire on board the fishing vessel **ONWARD**

**60nm off the north coast of Scotland
resulting in the loss of the vessel
11 April 2012**

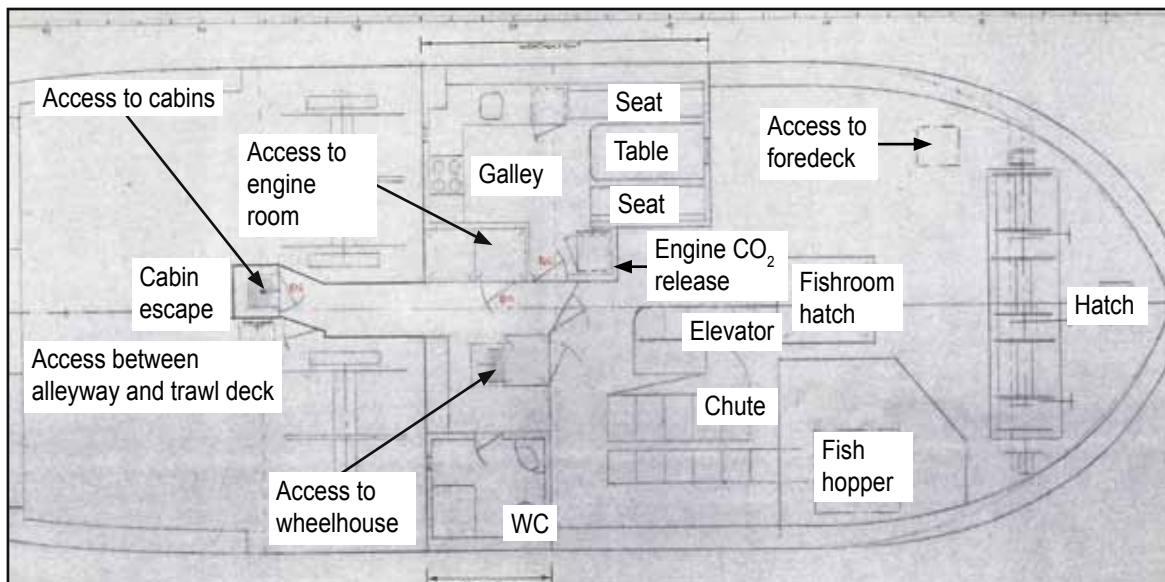
Figure 2: General arrangement (Accommodation deck)

Access to the engine room was via a door sited next to the galley door on the port side of the main alleyway (**Figures 2 and 4**). The compartment's bulkheads, deckhead and access door had a fire insulation rating of B15¹. The engine room access door was kept closed when the vessel was at sea, but it did not provide a tight seal. The engine room had a single exhaust fan leading to a vent to port of the wheelhouse (**Figure 5**). A closed circuit television (CCTV) system enabled the engine room and trawl deck to be monitored from the wheelhouse.

of the smoke was assisted by the air flow through the vessel resulting from the foredeck hatch, the galley porthole and door, and the wheelhouse hatch all being left open. As soon as the engine room door burned through, the fire would have instantly intensified and thick black smoke would have quickly spread throughout the vessel.

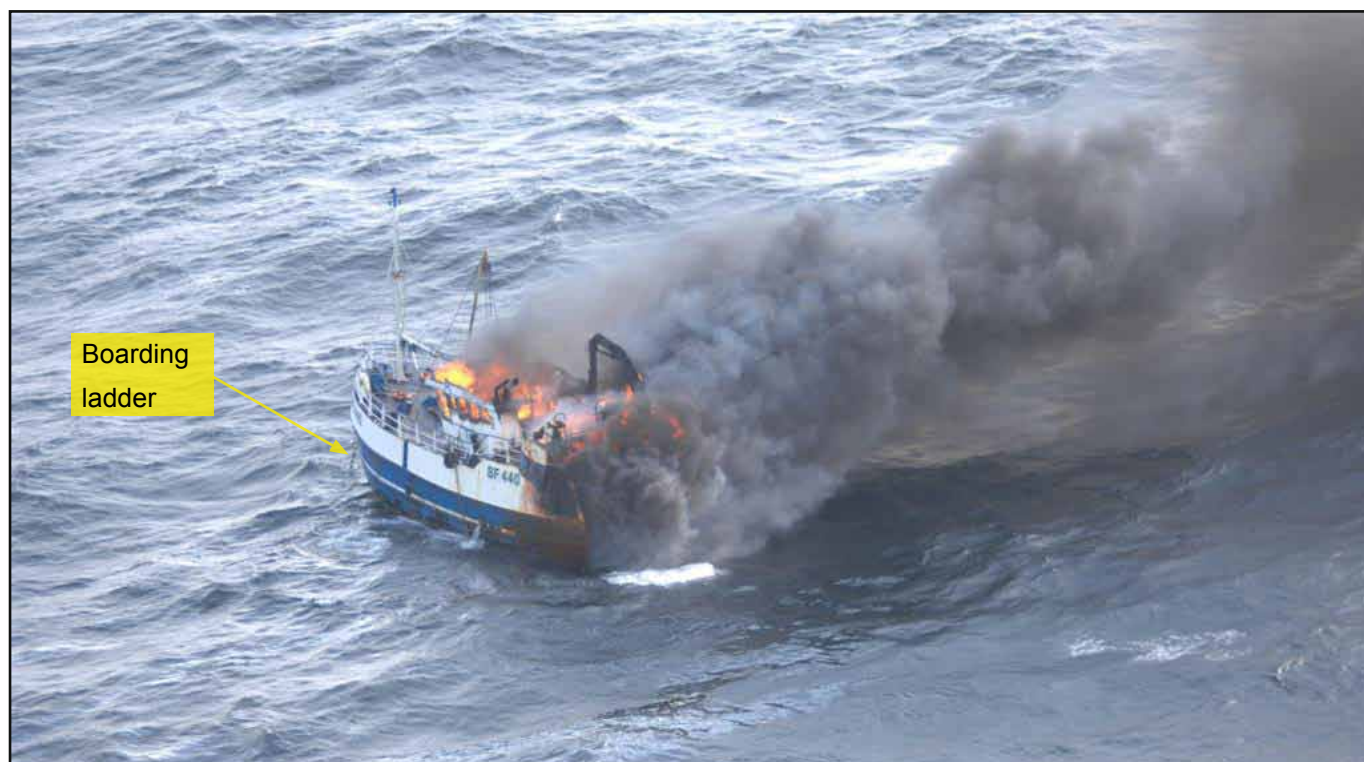
Figure 3: *Onward* on fire

In view of the intensity of the fire (**Figure 3**) and the vessel's wooden construction, *Onward* would have continued to burn until foundering. The proximity of the underwater obstruction discovered in June 2012 to the vessel's last known position, and the positions of the EPIRB on 12 April 2012 (**Figure 1**), suggests that the obstruction could be the wreck of *Onward*.

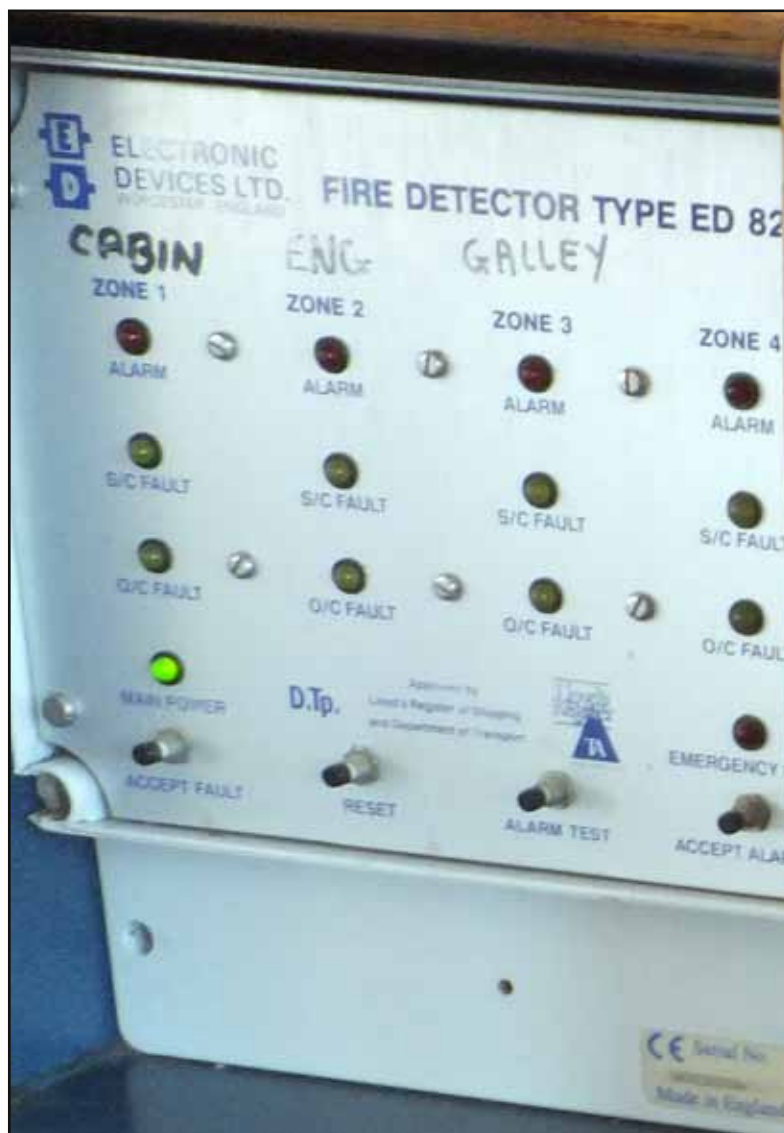
Figure 6: Fire detection system control panel (*Ocean Challenge*)

The first indication that a fire had broken out was when the skipper smelled smoke in the wheelhouse that had come up from the deck below. Given that both smoke and heat sensors were fitted in the engine room, galley, alleyway and the cabins, and that no alarms were heard by the skipper in the wheelhouse or by the rest of the crew when they were in their cabins, it can be concluded that the fire detection system was either unserviceable or was not switched on.

Although the fire detection system fitted on board *Onward* met the design and performance standards required by LR, it was not tested regularly. Indeed, it is possible that the system had not been thoroughly tested since the vessel's last survey in 2009. In such circumstances, the probability of some of the system's sensors not functioning as intended, particularly those in high-risk spaces such as engine rooms, which were continuously exposed to high levels of heat, dirt and vibration, was increased considerably. It is possible that system faults were indicated on the control panel in the wheelhouse, but they had either not been noticed or their significance had not been recognised by any of the crew.
