Fire on board the fishing vessel **ONWARD**

**60nm off the north coast of Scotland
resulting in the loss of the vessel
11 April 2012**

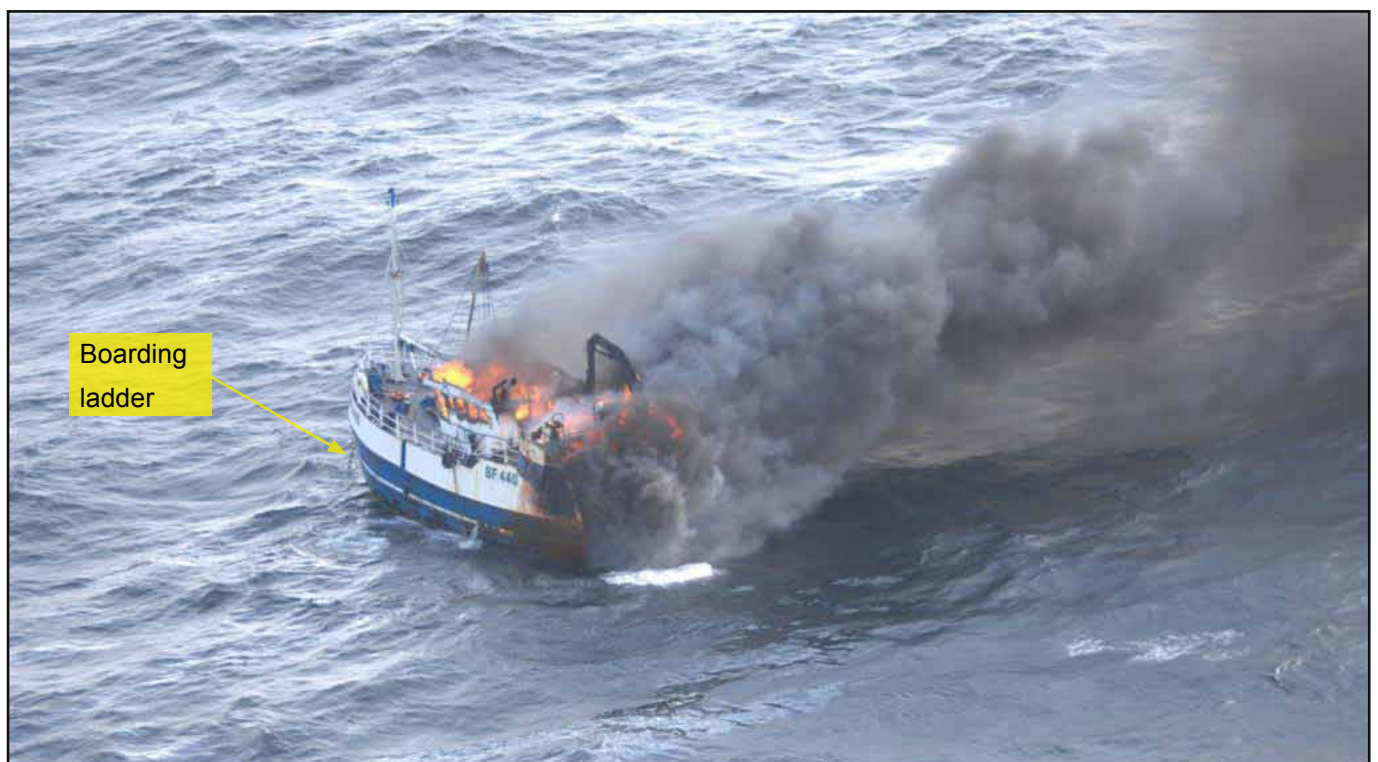
Figure 3: *Onward* on fire

In view of the intensity of the fire (**Figure 3**) and the vessel's wooden construction, *Onward* would have continued to burn until foundering. The proximity of the underwater obstruction discovered in June 2012 to the vessel's last known position, and the positions of the EPIRB on 12 April 2012 (**Figure 1**), suggests that the obstruction could be the wreck of *Onward*.

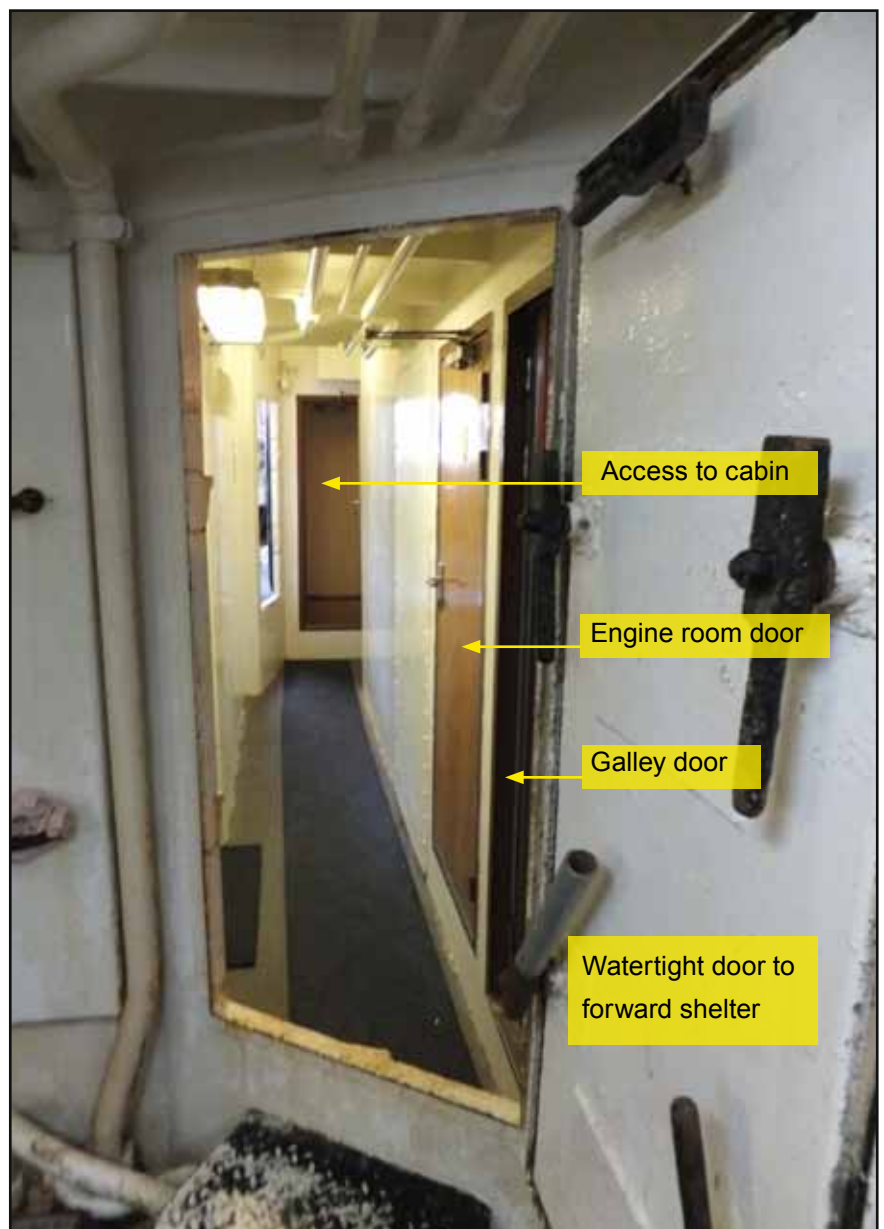
Figure 4: Access to the engine room via a door sited on the port side of the main alleyway (*Ocean Challenge*)

Access to the engine room was via a door sited next to the galley door on the port side of the main alleyway (Figures 2 and 4). The compartment's bulkheads, deckhead and access door had a fire insulation rating of B15¹. The engine room access door was kept closed when the vessel was at sea, but it did not provide a tight seal. The engine room had a single exhaust fan leading to a vent to port of the wheelhouse (Figure 5). A closed circuit television (CCTV) system enabled the engine room and trawl deck to be monitored from the wheelhouse.

Once an oil-based fire was established in the engine room, large quantities of black smoke would have escaped into the alleyway through the gaps between the engine room door and its frame. It is highly likely that the rapid development and spread

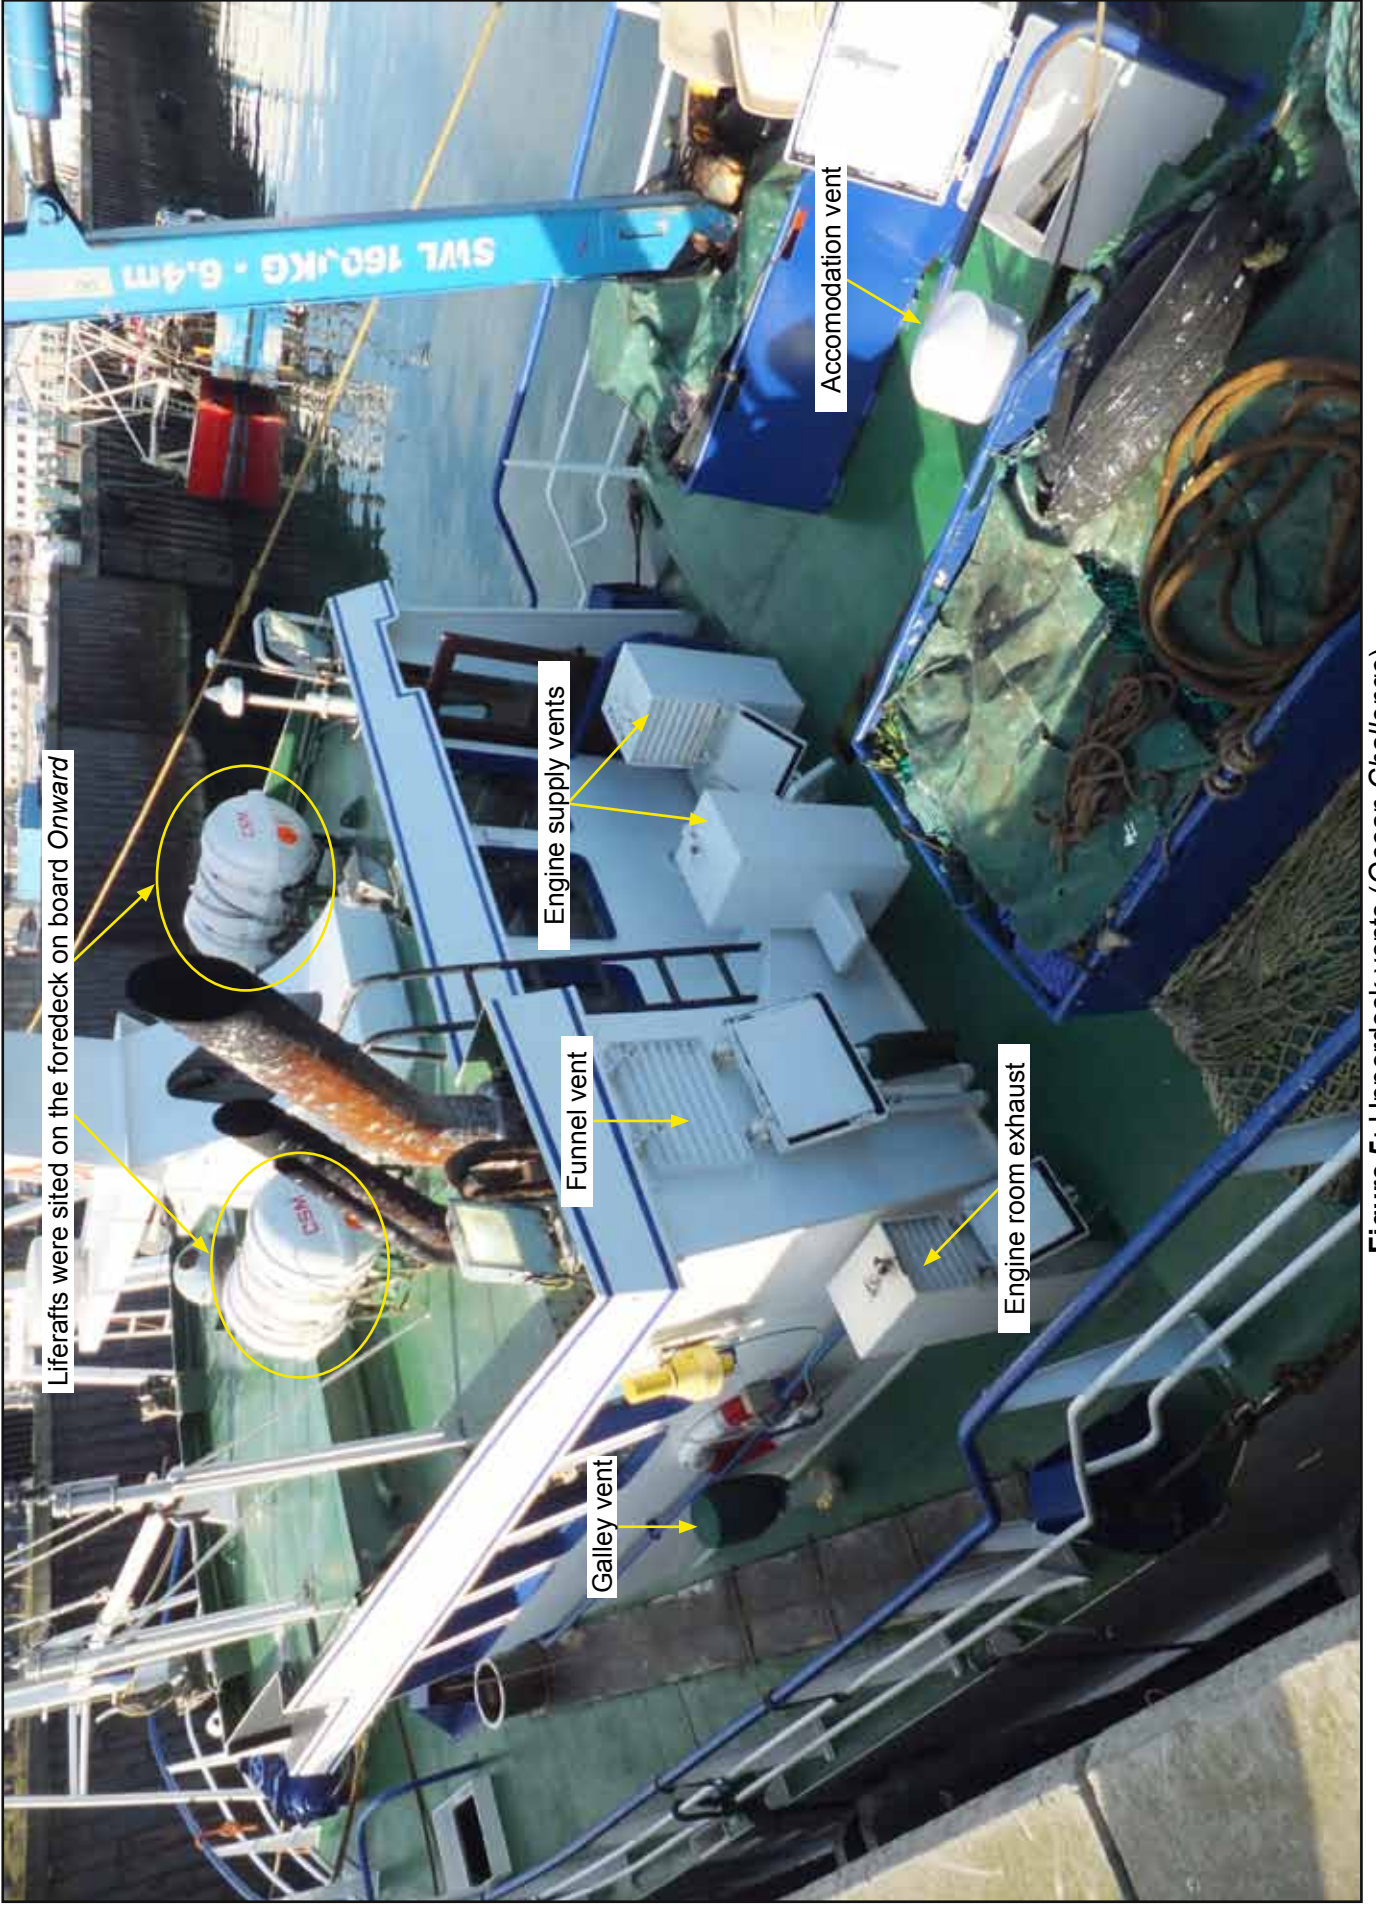
Figure 5: Upperdeck vents (Ocean Challenge)

- The closing of the vents on the upper deck was uncoordinated and incomplete.

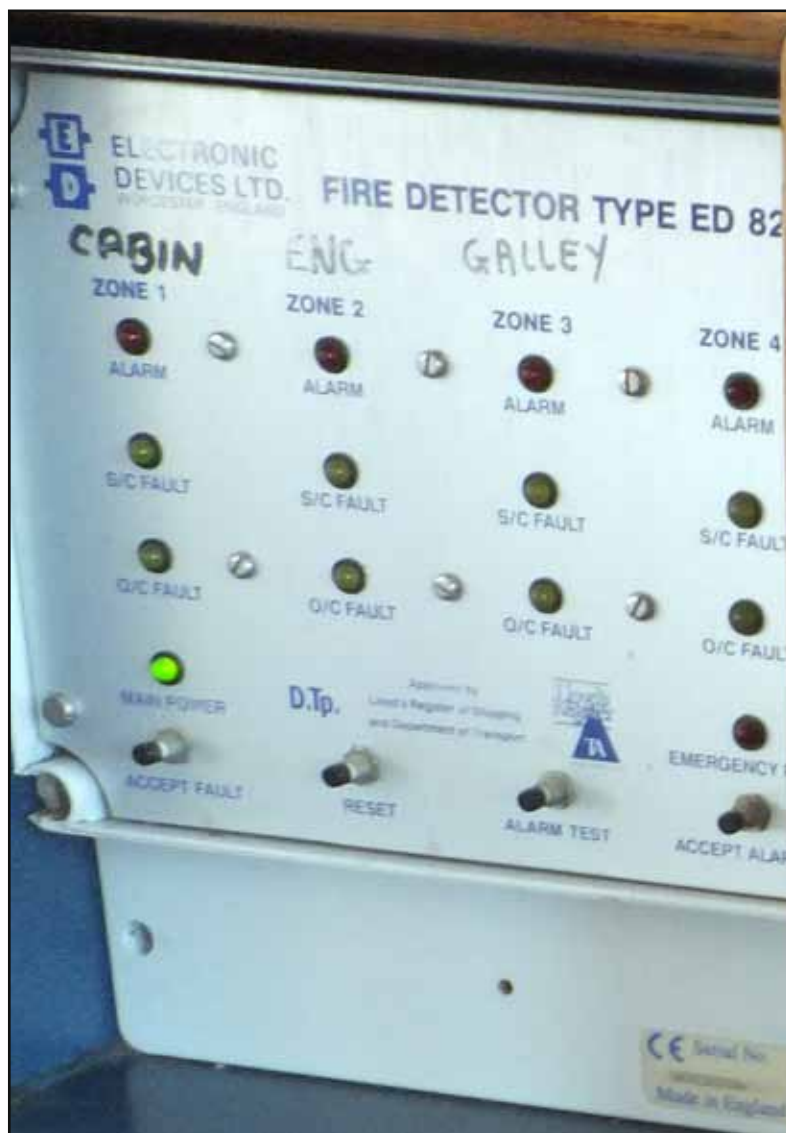
Figure 6: Fire detection system control panel (*Ocean Challenge*)

Although the fire detection system fitted on board *Onward* met the design and performance standards required by LR, it was not tested regularly. Indeed, it is possible that the system had not been thoroughly tested since the vessel's last survey in 2009. In such circumstances, the probability of some of the system's sensors not functioning as intended, particularly those in high-risk spaces such as engine rooms, which were continuously exposed to high levels of heat, dirt and vibration, was increased considerably. It is possible that system faults were indicated on the control panel in the wheelhouse, but they had either not been noticed or their significance had not been recognised by any of the crew.

- The absence of any testing or maintenance on the fire detection system, or the recognition or understanding of any faults that were probably displayed visually on its control panel.
- The lack of any emergency drills.
- Leaving doors, hatches and portholes open when at sea. The galley door was a fire door and therefore should have been closed when not in use, particularly when all the crew except the skipper were in their beds.
- The lack of knowledge regarding the uses of the various vents on the upper deck and the key vents to be closed in the event of a fire in the engine room.
- The re-wiring of the galley hob in order to leave a heat ring permanently on.
- Leaving the wheelhouse unattended when on passage.

- 2012/150
- Ensure that the crews on board any vessels it may own in the future are fully prepared to effectively deal with emergency situations, taking into account, inter alia:
- The requirement to conduct periodic emergency drills and the importance of emergency drills to a vessel's safety.
 - The need for all early warning devices such as fire detection systems and bilge alarms to be properly maintained and tested, and that crews fully understand their operation.
 - The need for crews to have a good knowledge of all onboard safety-related systems and equipment, and that routine safety precautions such as the closing of fire doors are taken at all times.
