Fire on board the fishing vessel **ONWARD**

**60nm off the north coast of Scotland
resulting in the loss of the vessel
11 April 2012**

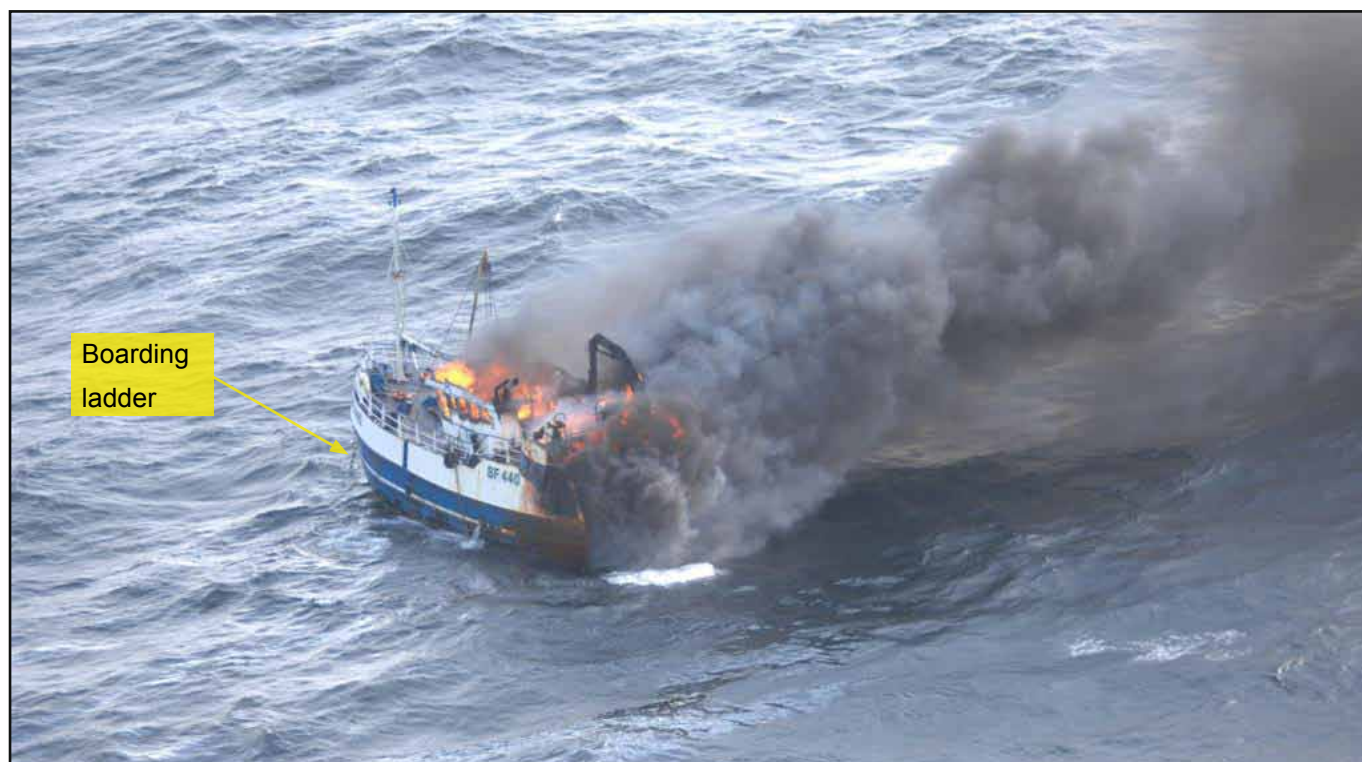
Figure 3: *Onward* on fire

In view of the intensity of the fire (**Figure 3**) and the vessel's wooden construction, *Onward* would have continued to burn until foundering. The proximity of the underwater obstruction discovered in June 2012 to the vessel's last known position, and the positions of the EPIRB on 12 April 2012 (**Figure 1**), suggests that the obstruction could be the wreck of *Onward*.
