Saga Sapphire

## SYNOPSIS

At 1020 on 29 March 2012, two crewmen fell 22m into the water from *Saga Sapphire's* No 5 lifeboat while the ship was secured port side alongside in Southampton. They sustained minor injuries.

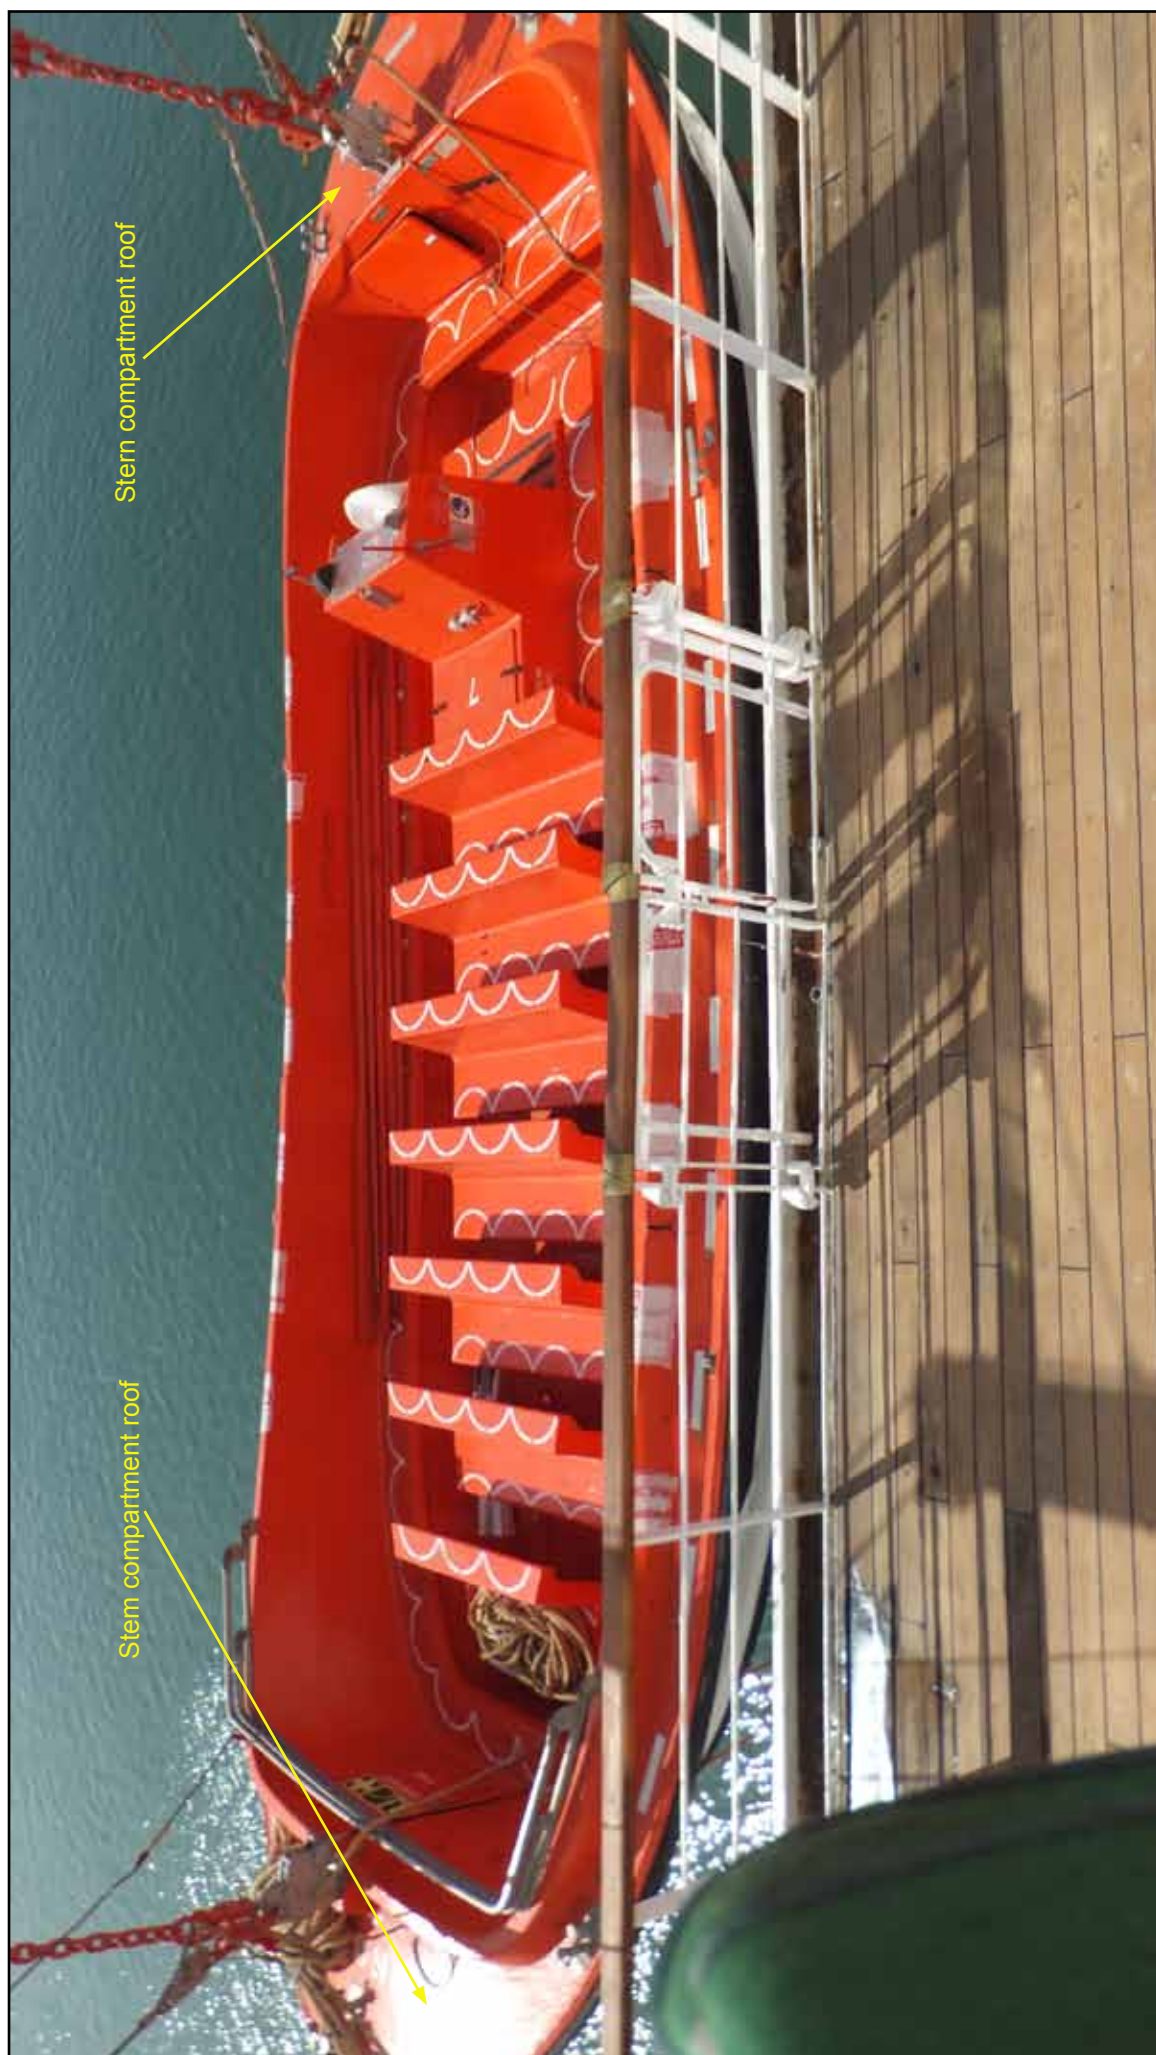
**Figure 4:** Open lifeboat - access to bowing tackles

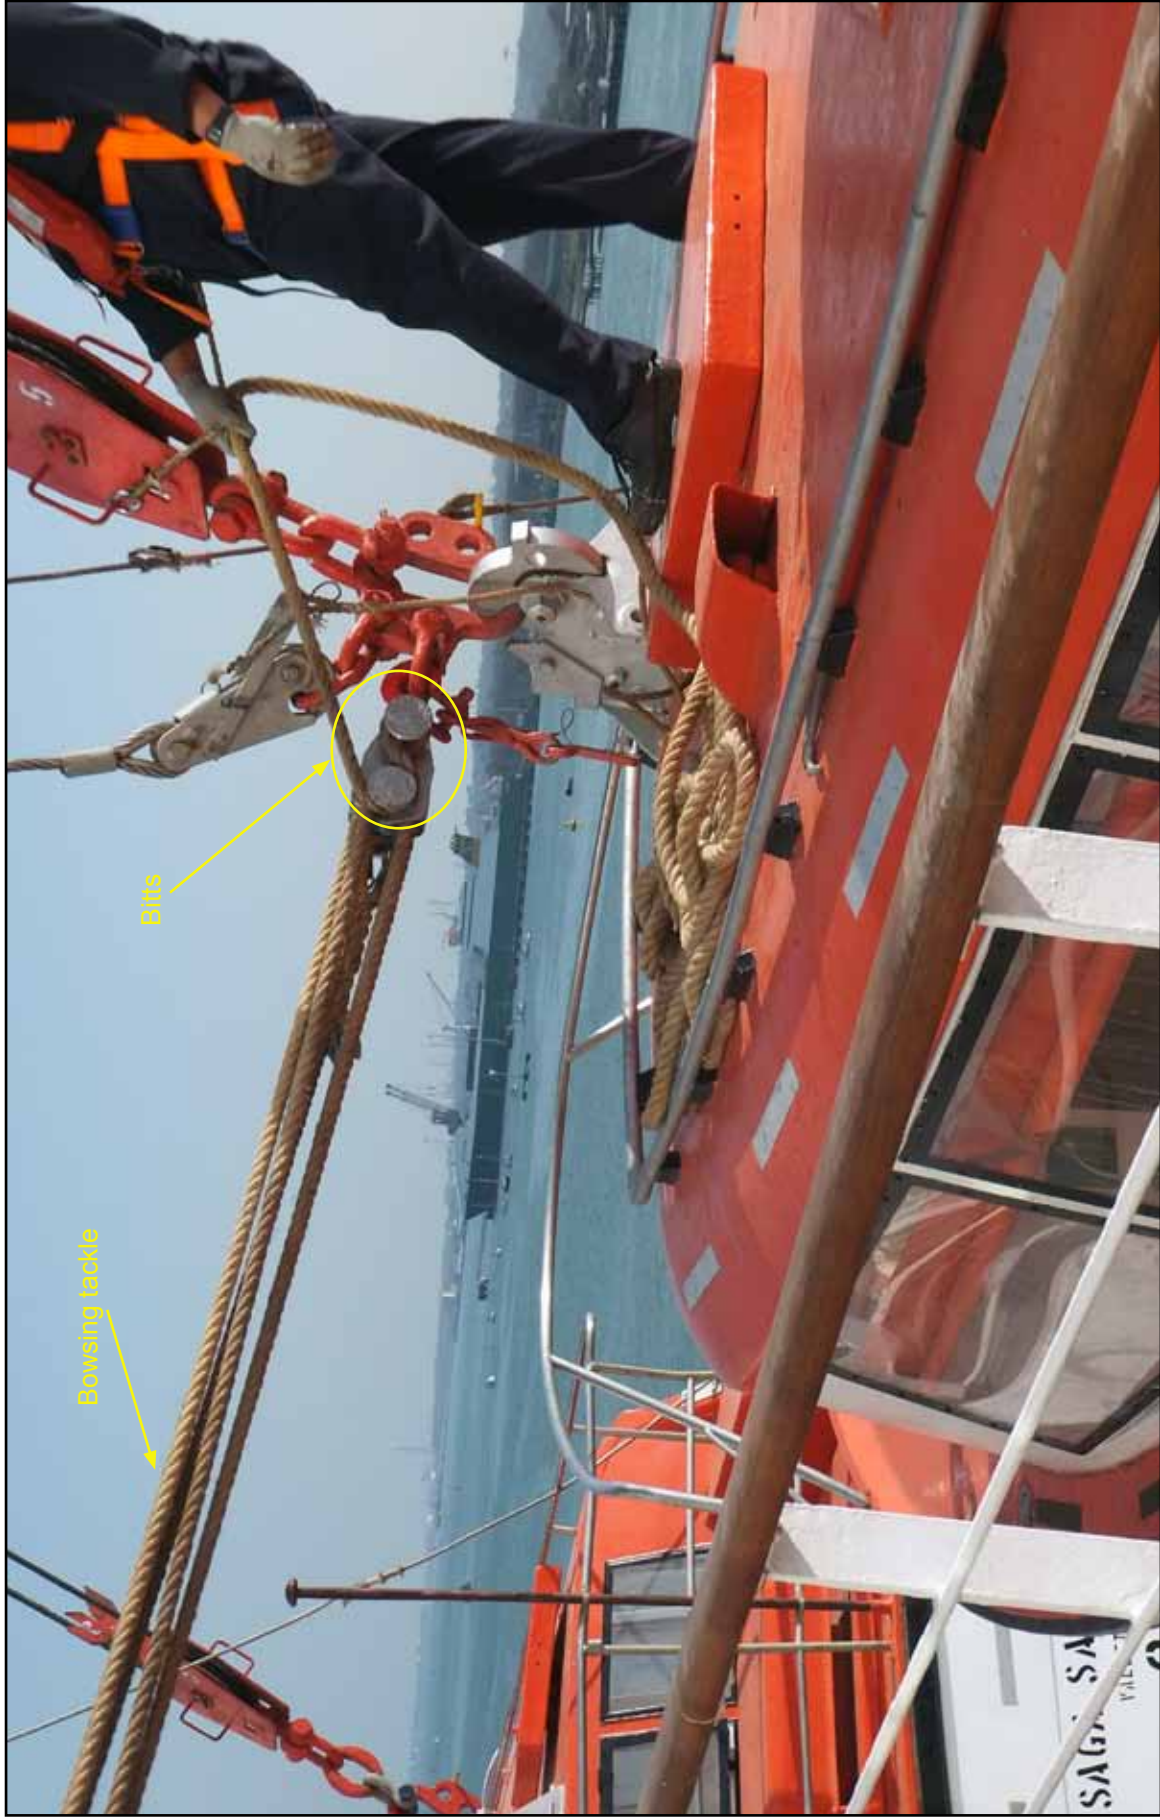
**Figure 5:** Bowing tackles secured to bitts

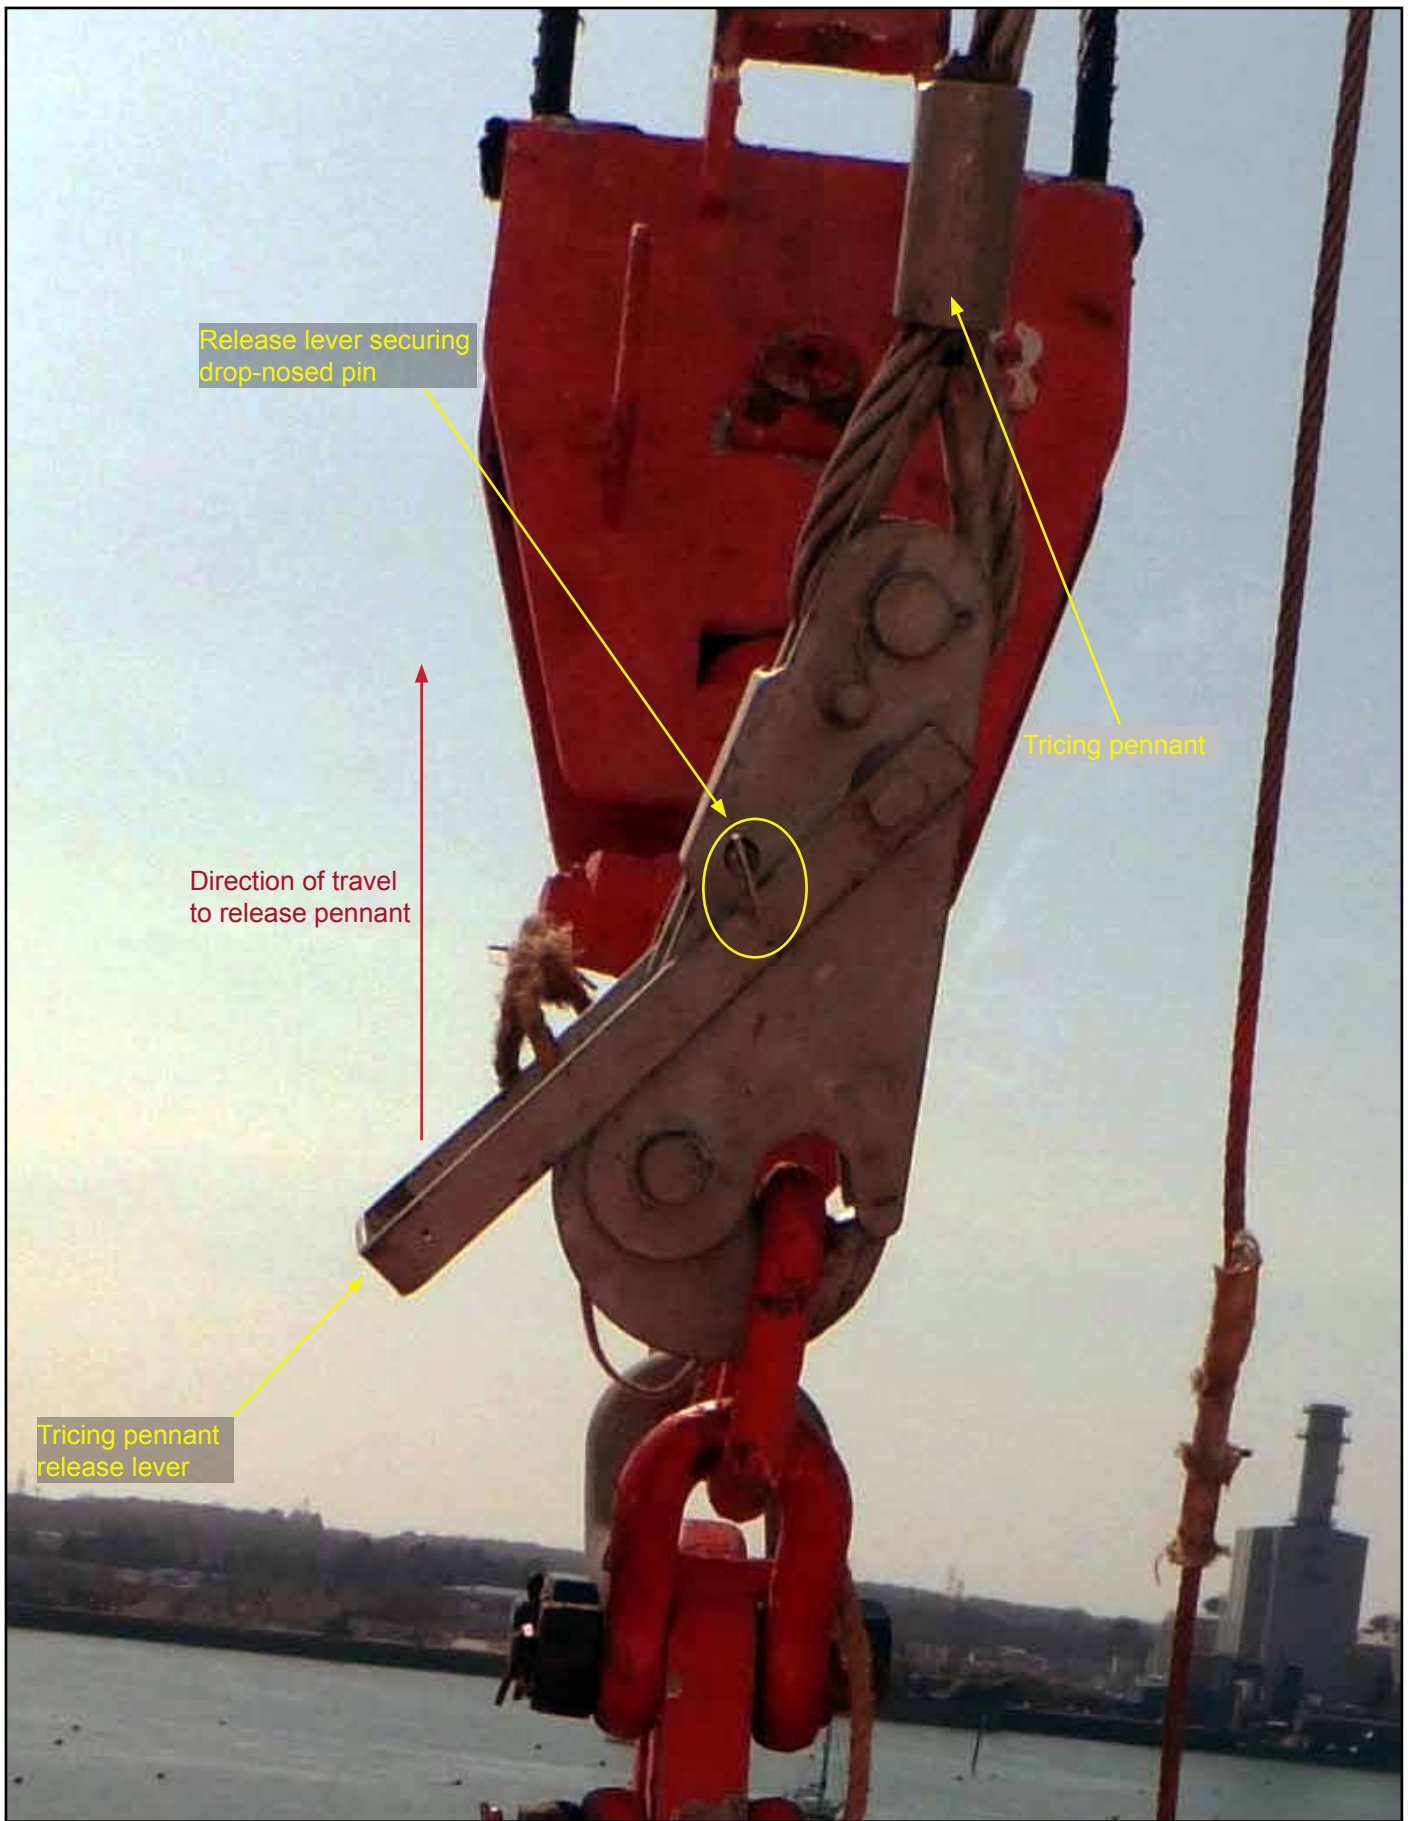
**Figure 6:** Tricing pennant release lever and securing drop-nosed pin

The process of having a single crewman to secure and hold the bowsing tackle rope and, at the same time, remove the drop-nosed pin securing the tricing pennant release lever, and then operate the tricing pennant release lever, risks overloading the crewman. The dimensions of the bitts allowed for two figure-of-eight turns of the bowsing rope around them. In most circumstances, this was likely to be sufficient to maintain the necessary tension to keep the lifeboat firmly alongside if the tail rope is held. However, if the crewman stepped out of line with the bitts, there was a significant risk of the rope slipping off the bitts and releasing, causing the lifeboat to swing away from the ship's side.

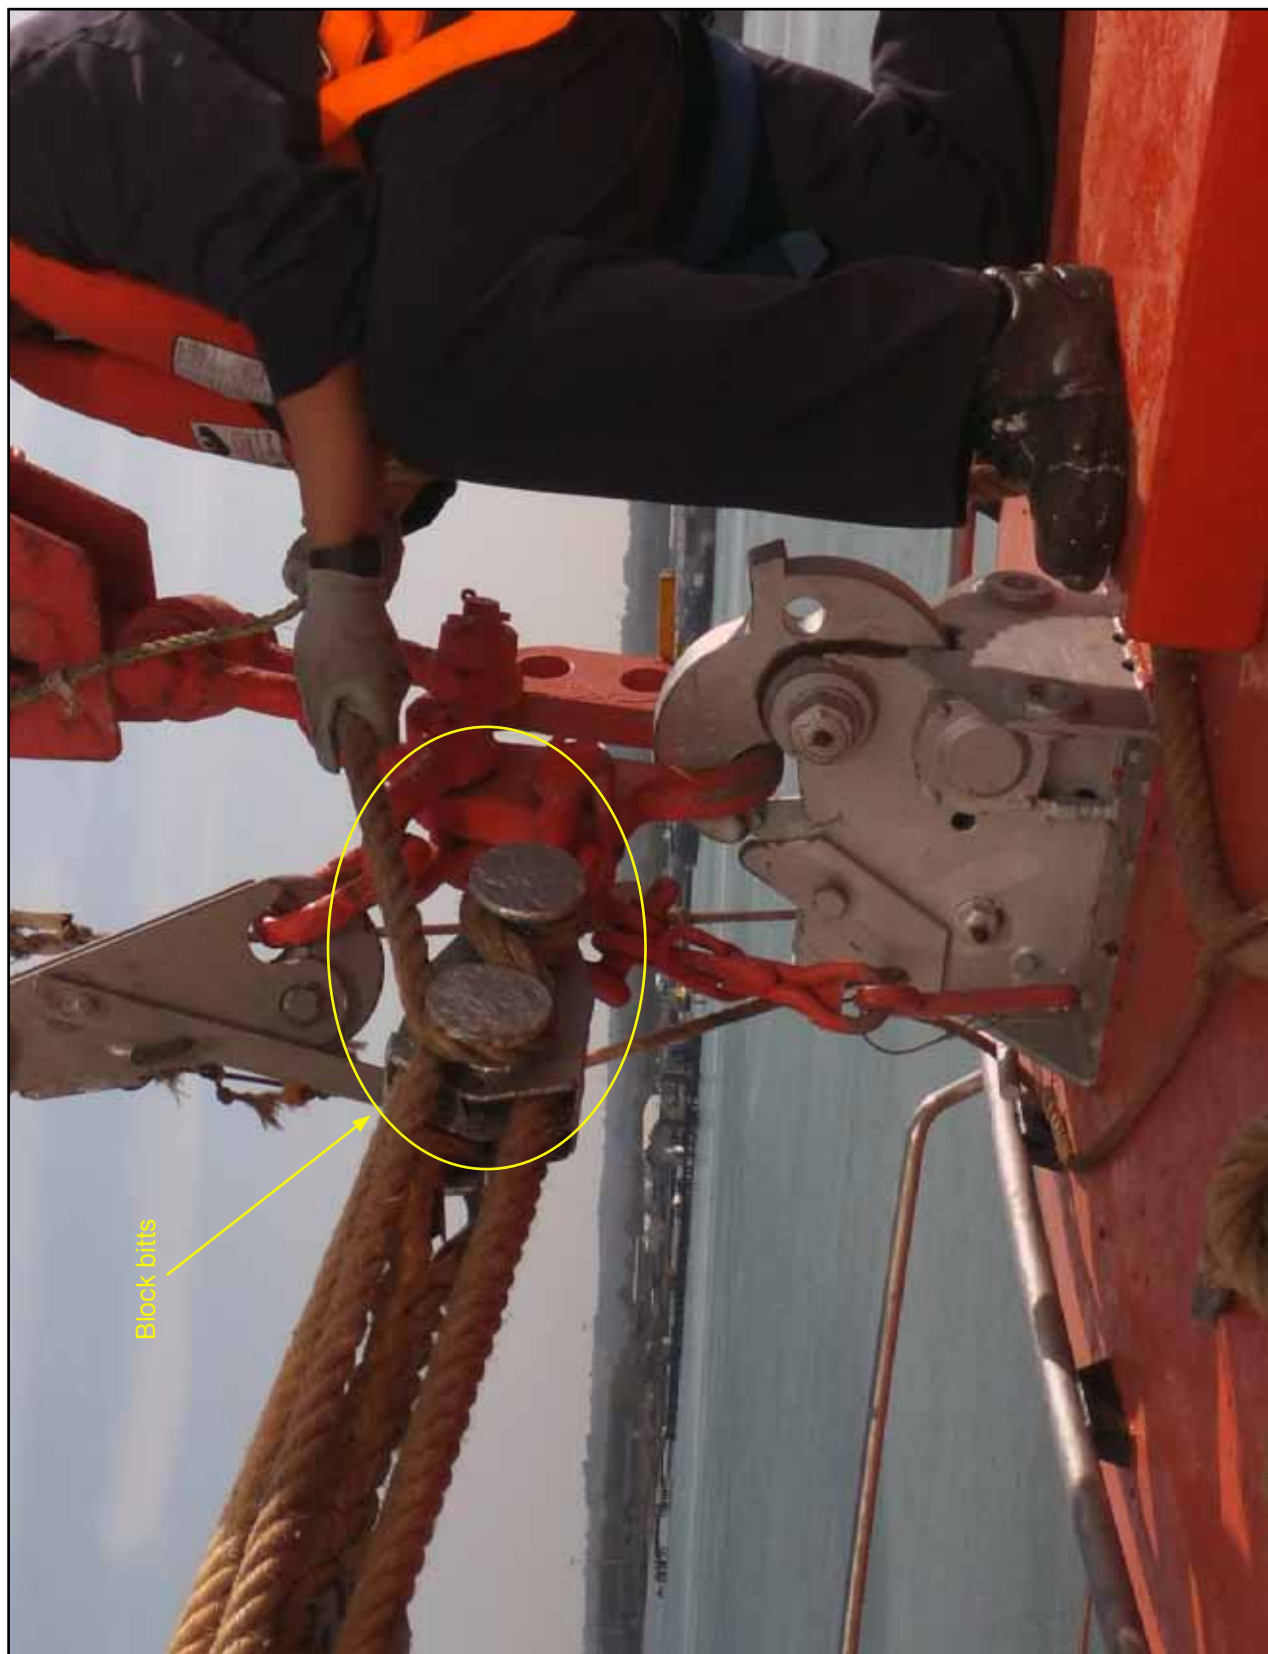
**Figure 7:** Bowsing tackle rope on the block bitts

Freely running ropes and blocks are essential for the efficient and safe operation of the bowsing arrangement so that the system can be properly controlled. The use of the oversized ropes, first identified during refit in Palermo, compromised that safety. This was recognised by the master, who instructed them to be changed. However, insufficient priority was given to this. The management of the rope changes was inadequate and there was no involvement of the ship's safety management team, whose responsibility it was. No one was clearly nominated to take control of the changes and there was no process in place to confirm they had been completed. The dangers manifested themselves when the first cook was only able to put one figure-of-eight turn around the forward bowsing block bitts on No 5 tender. It was this which allowed the rope to come easily off the bitts and initiate the accident.

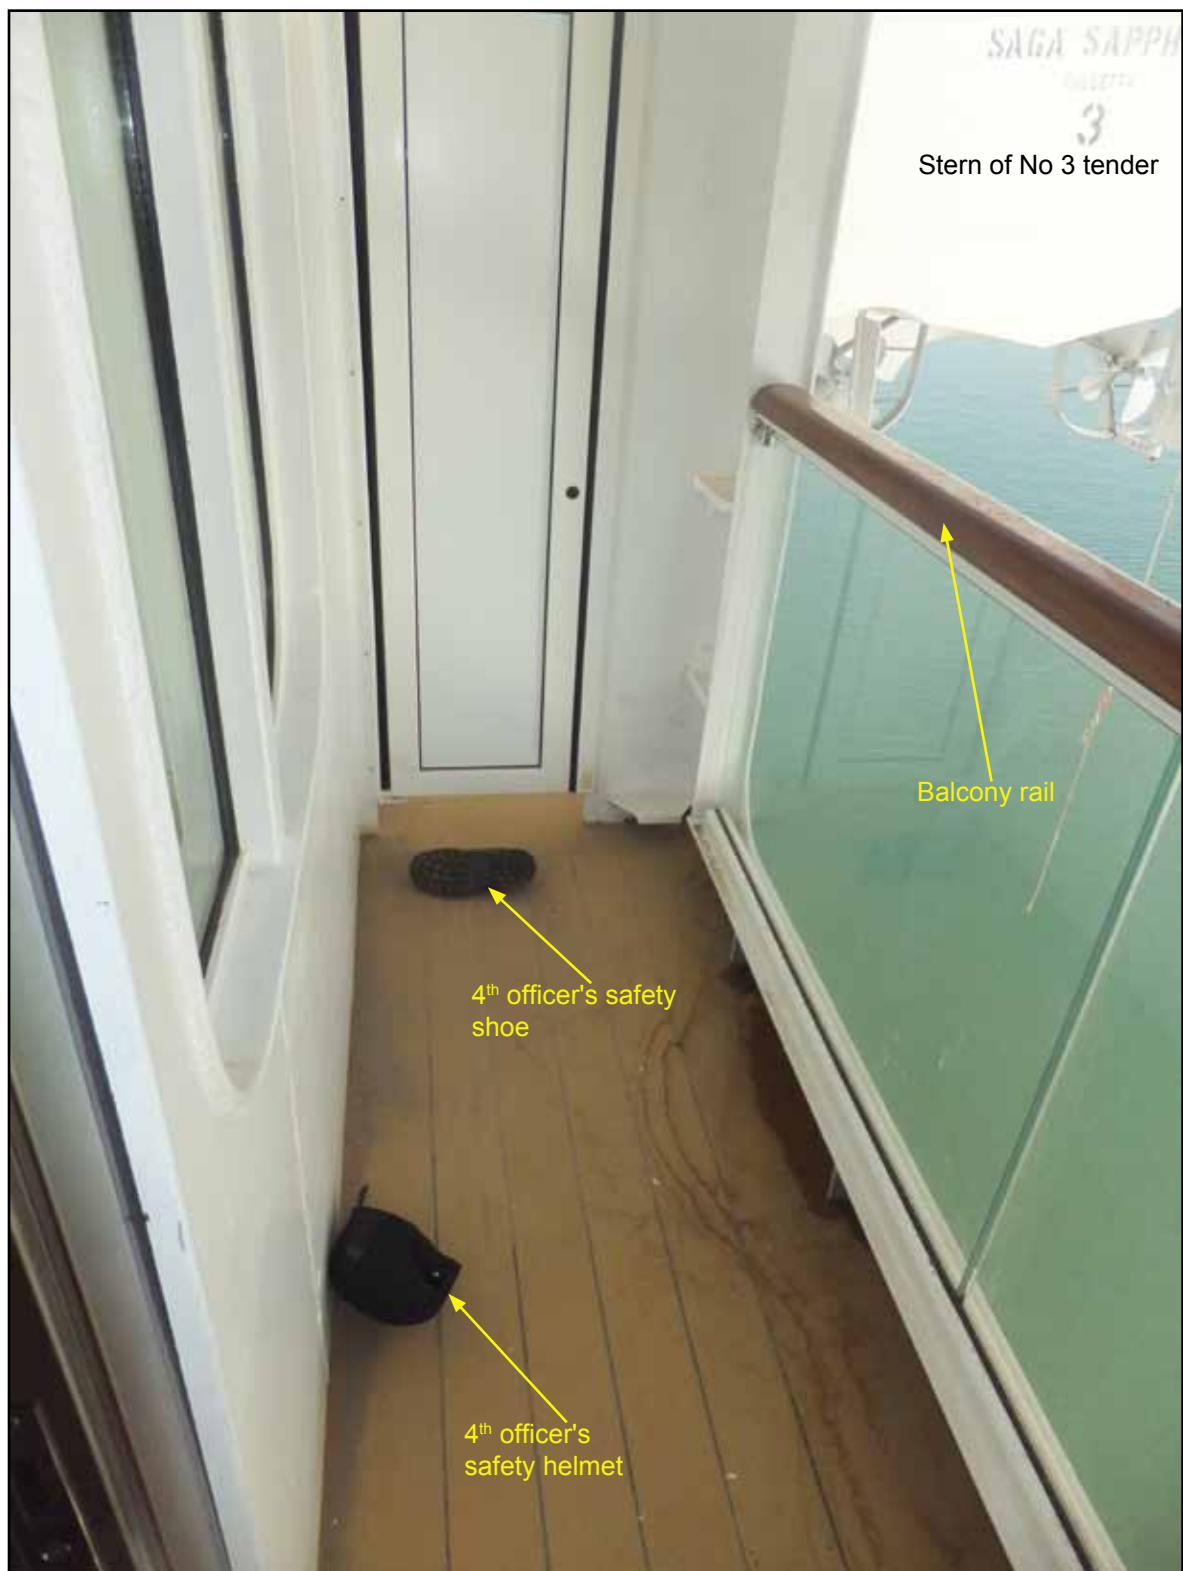
The fourth officer's and first cook's attempts to prevent themselves from falling over the tender's port side were unsuccessful. The fourth officer fell first and made contact with the balcony rail of cabin 8036 (**Figure 8**), one deck below the tender's position. His safety helmet and right safety shoe landed on the balcony deck and he then fell about 22m into the water. As his lifejacket auto-inflated, the fourth officer surfaced just as the first cook entered the water. As the latter surfaced, the fourth officer swam towards him to check his condition and to provide reassurance that they would be rescued. At the same time, a lifejacket and two lifebuoys were thrown into the water and each man managed to grasp one of the lifebuoys.

**Figure 8:** Balcony rail of cabin 8036

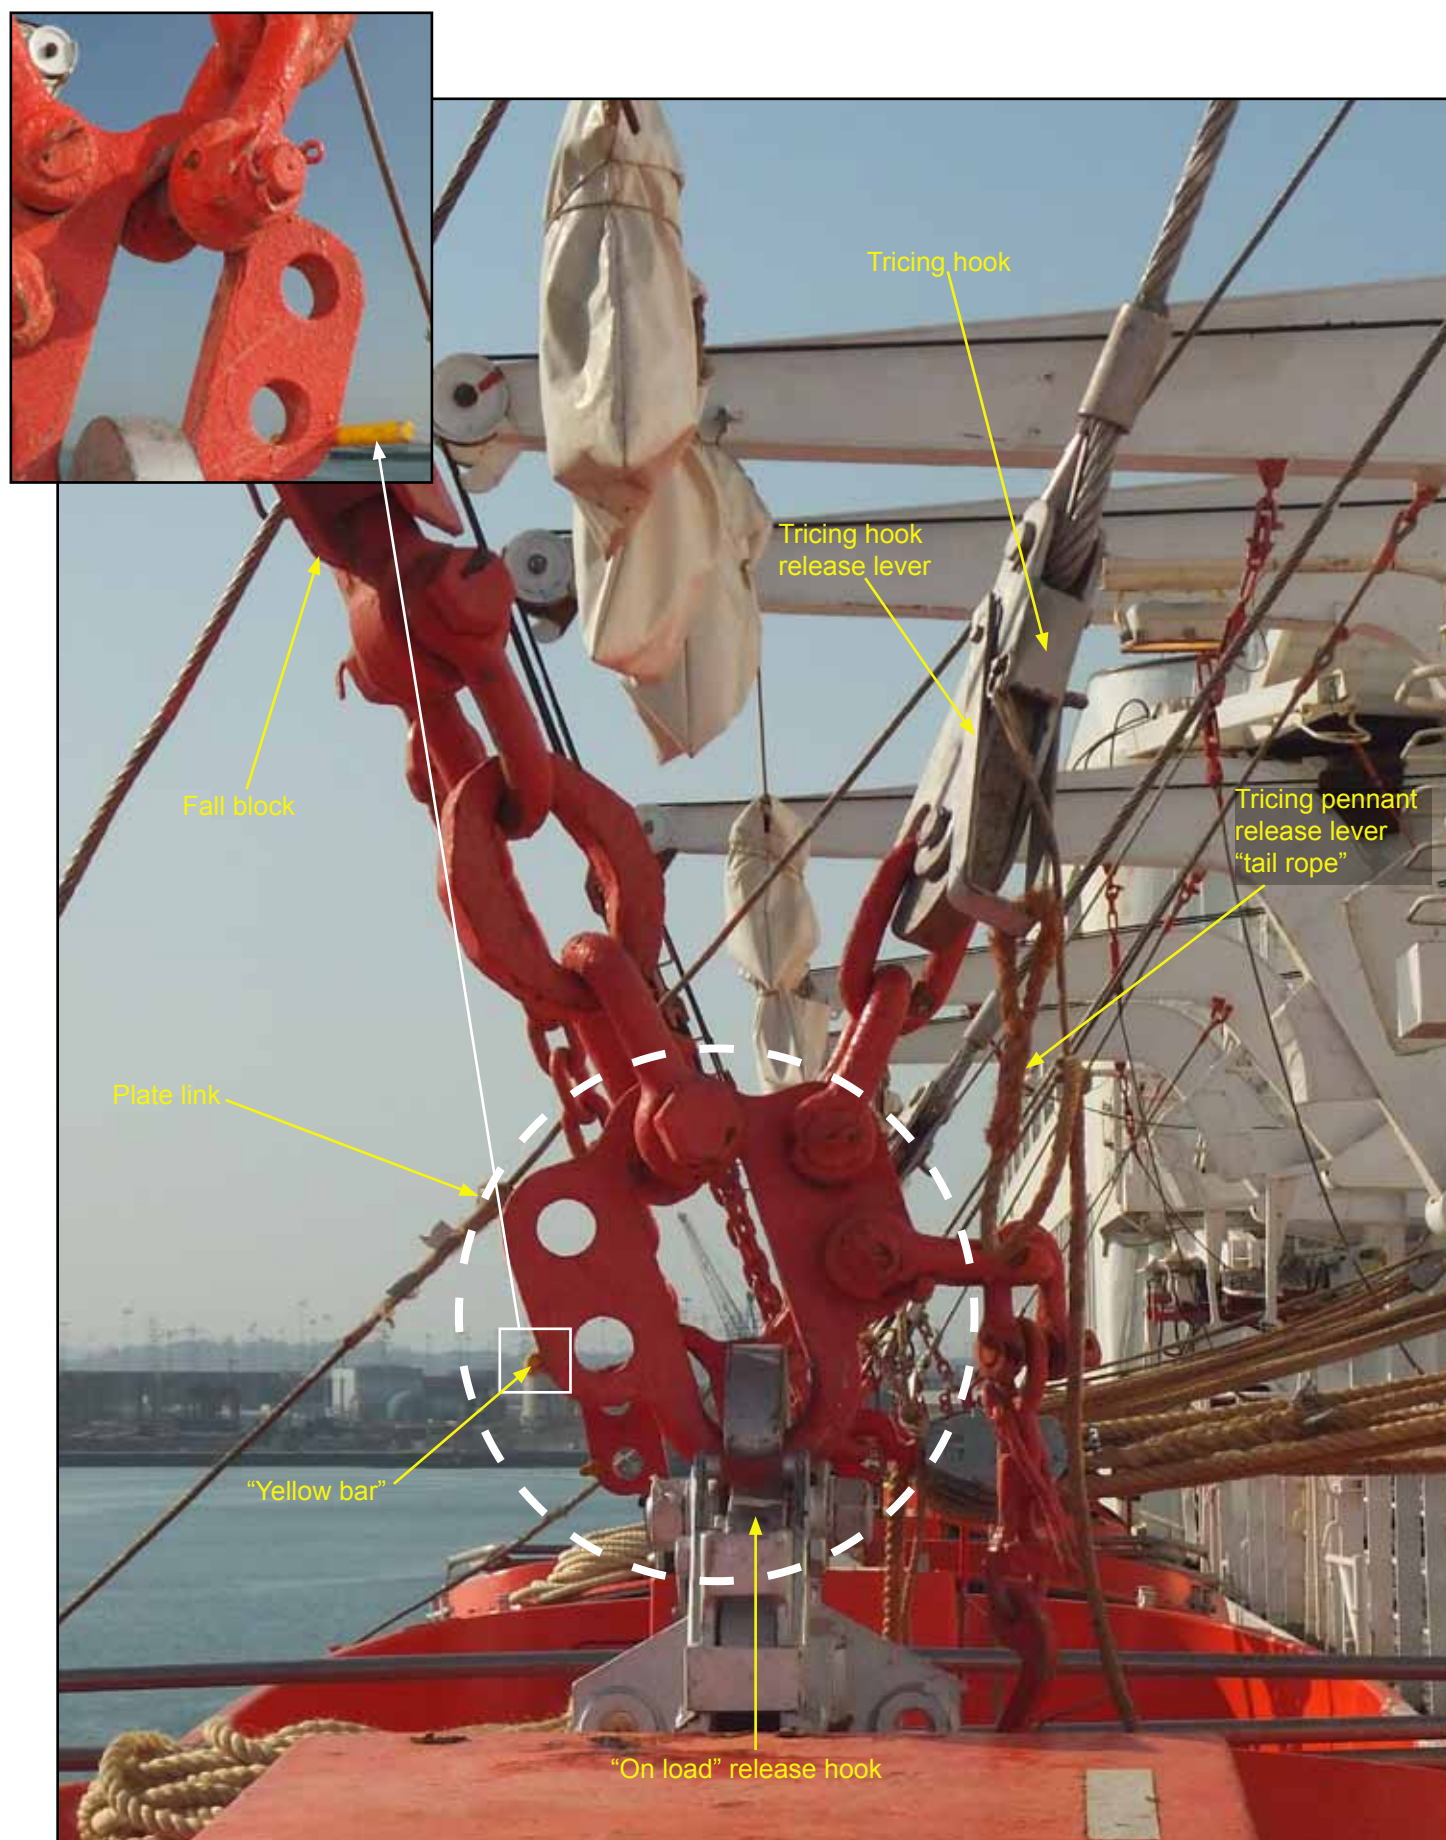
**Figure 14:** Tricing hook, plate link and "yellow bar" arrangement

The interim procedure to use the existing bowsing block arrangement, but securing the tail rope to the "yellow bar" which has been welded to the plate link of the boats, is potentially unsafe. The bars were added after the blocks entered service. There is no record of them being load-tested and they may well be unfit for the purpose for which they are now being used. If this securing method is to continue, the bar's SWL requirement should be identified and it should be appropriately load-tested and approved.

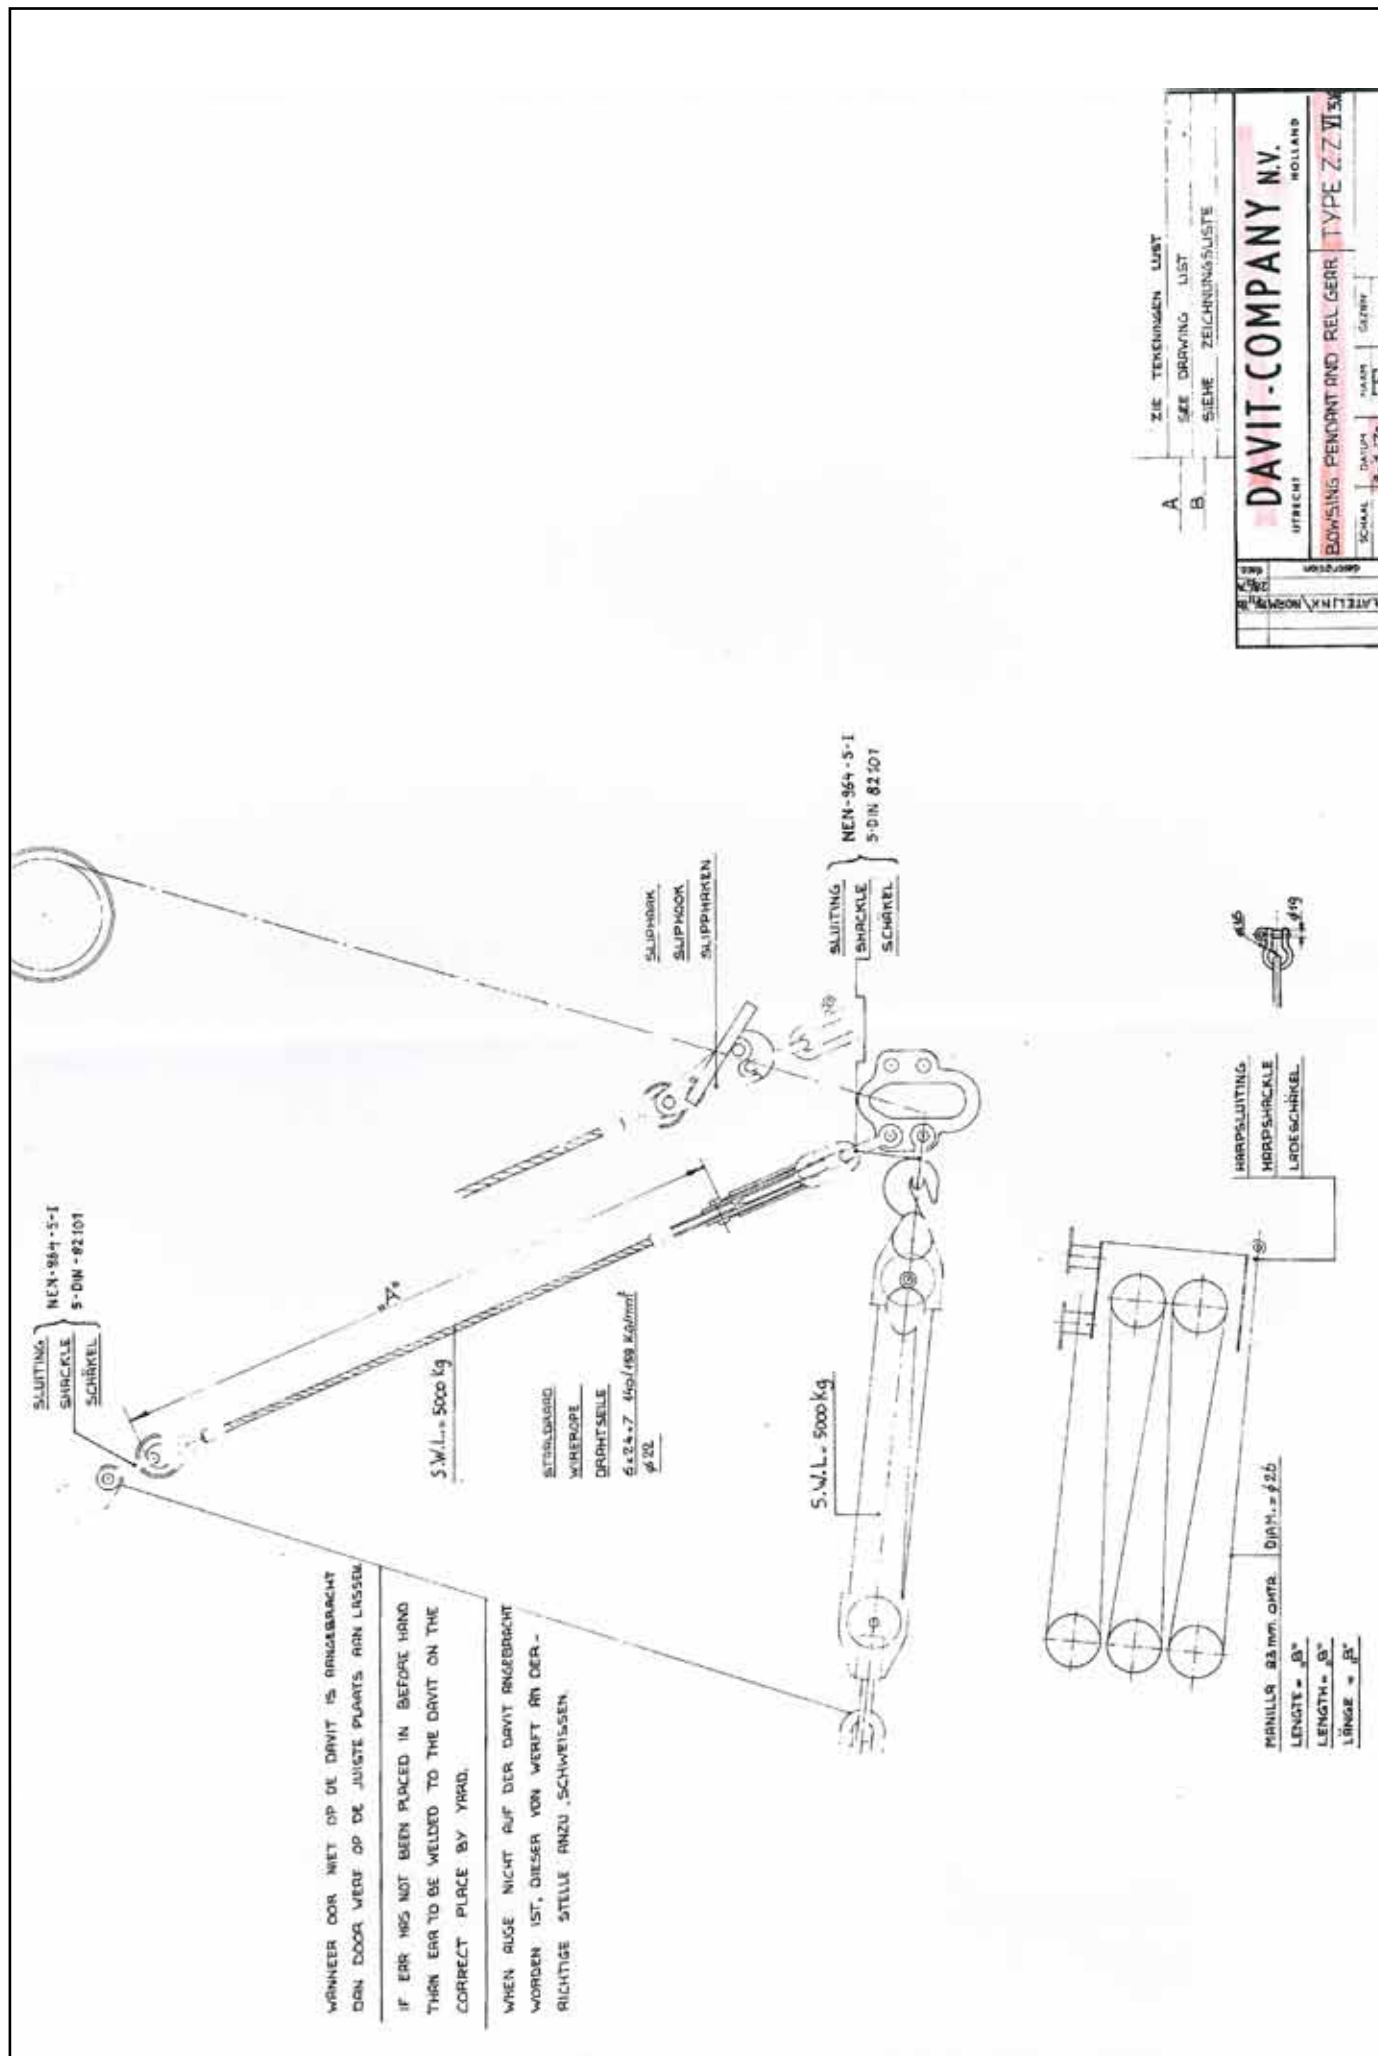
The original design drawing for the bowsing gyn-tackle arrangement, which includes the tricing pennant, is shown at **Figure 15**. It was designed for a SWL of 5000kg (49kN) and a mechanical advantage of five. During the investigation it was found that the forward bowsing tackle used on No 5 tender was fitted with a 34mm diameter manila rope instead of the designed 26mm diameter manila rope. Only 4 of the 20 bowsing tackle ropes complied with the design dimensional criteria; all of the others exceeded 26mm to varying degrees.

**Figure 15:** Davit - Company N.V. design drawing C.3570 dated 9 January 1970 - Type Z.Z.V1 Bowsing tackle and tricing pennant arrangement

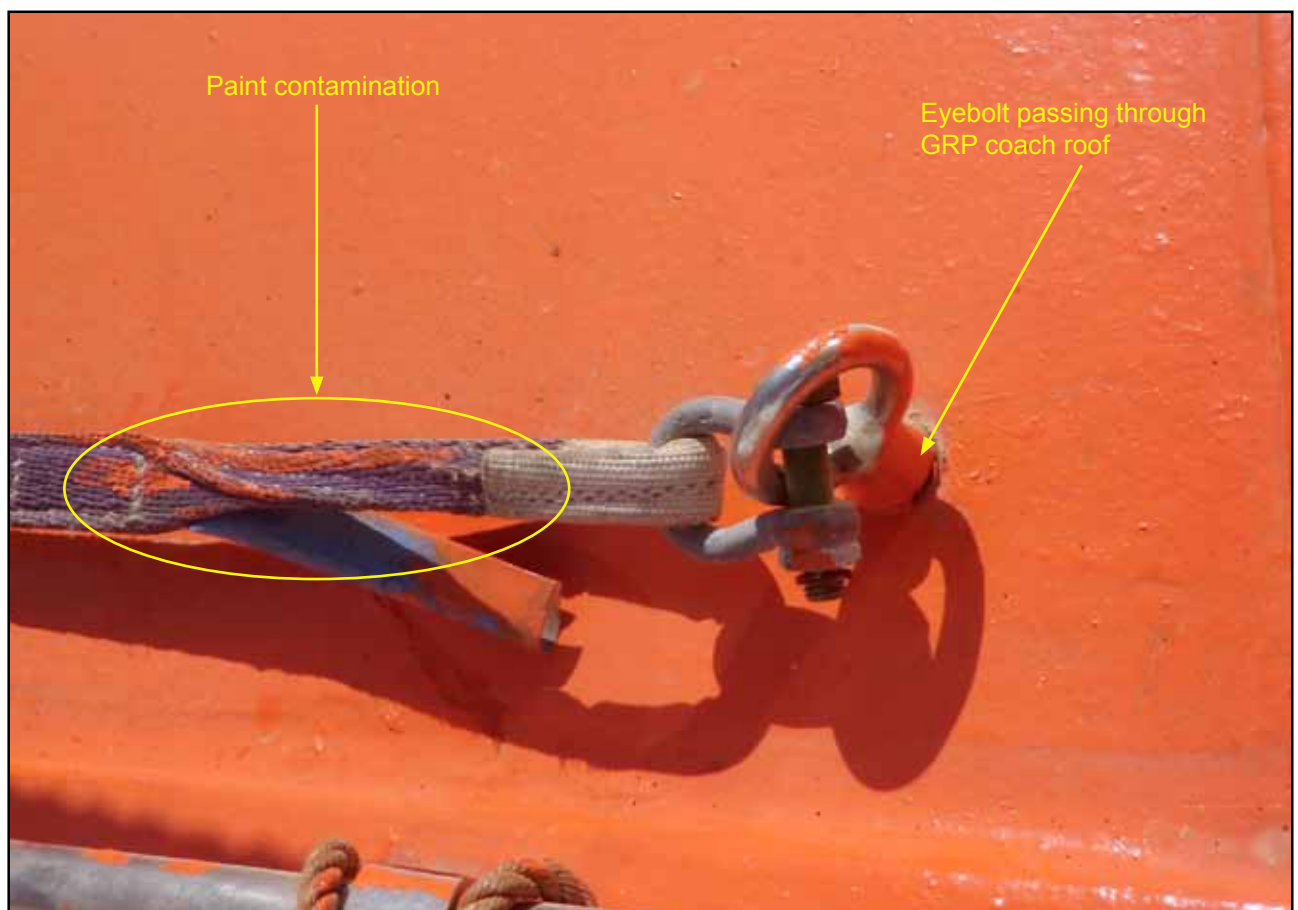
**Figure 22:** *Saga Ruby's* tender jackline securing arrangement and jackline paint contamination

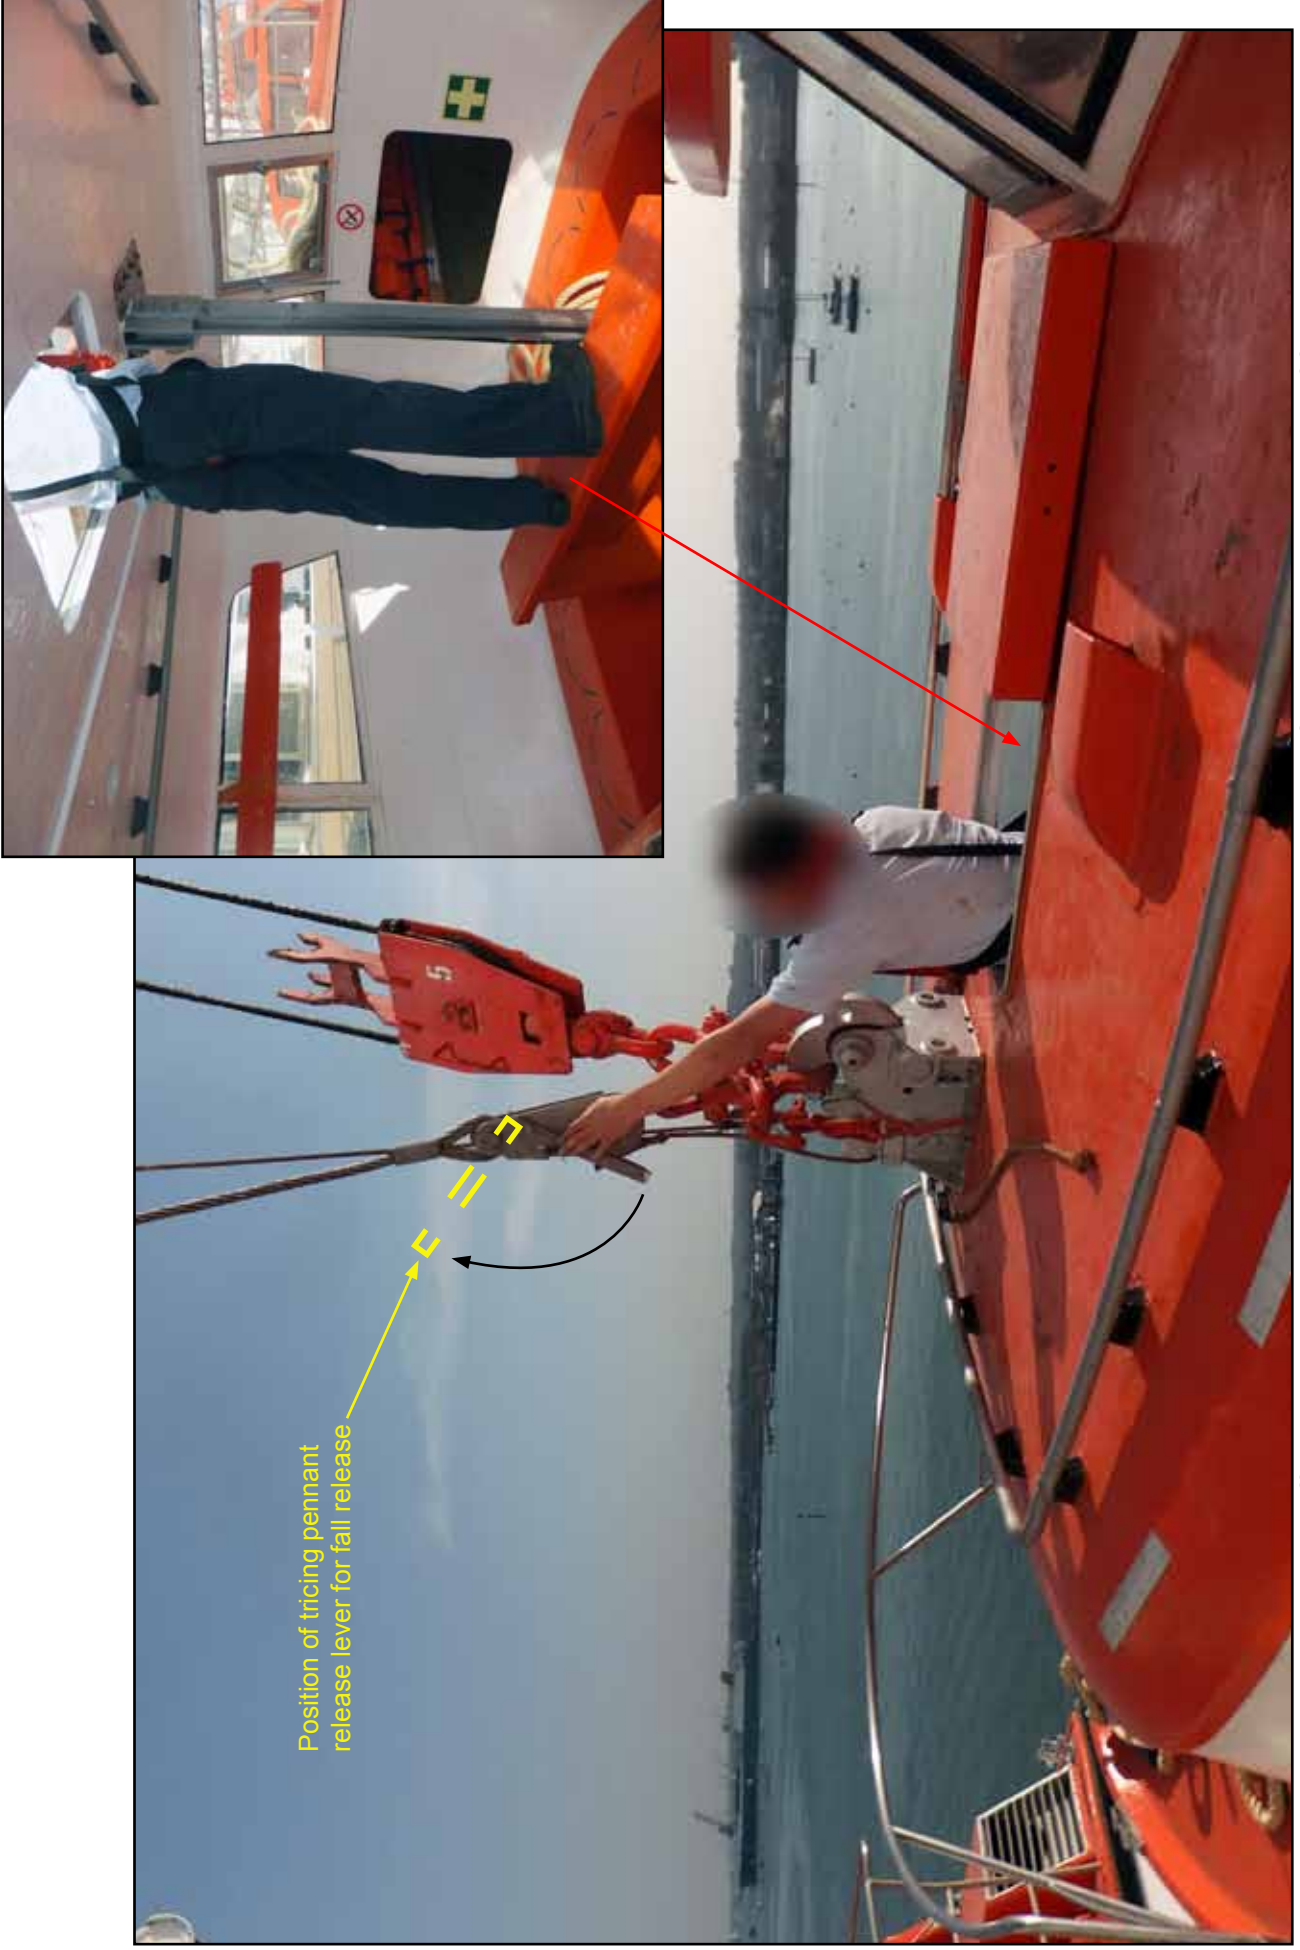
The same issue was also observed when the lifeboat crew attempted to operate the tricing pennant hook release lever from within the open lifeboat, while standing on the forward bench seat. Again, because of crew height limitations, in most cases it was not possible to do so safely.

**Figure 23:** 1.9m tall officer attempting to reach the tricing pennant release lever from the tender's coach roof forward hatch
