MV *SPRING BOK* and MV *GAS ARCTIC* Collision 6nm south of Dungeness, UK 24 March 2012

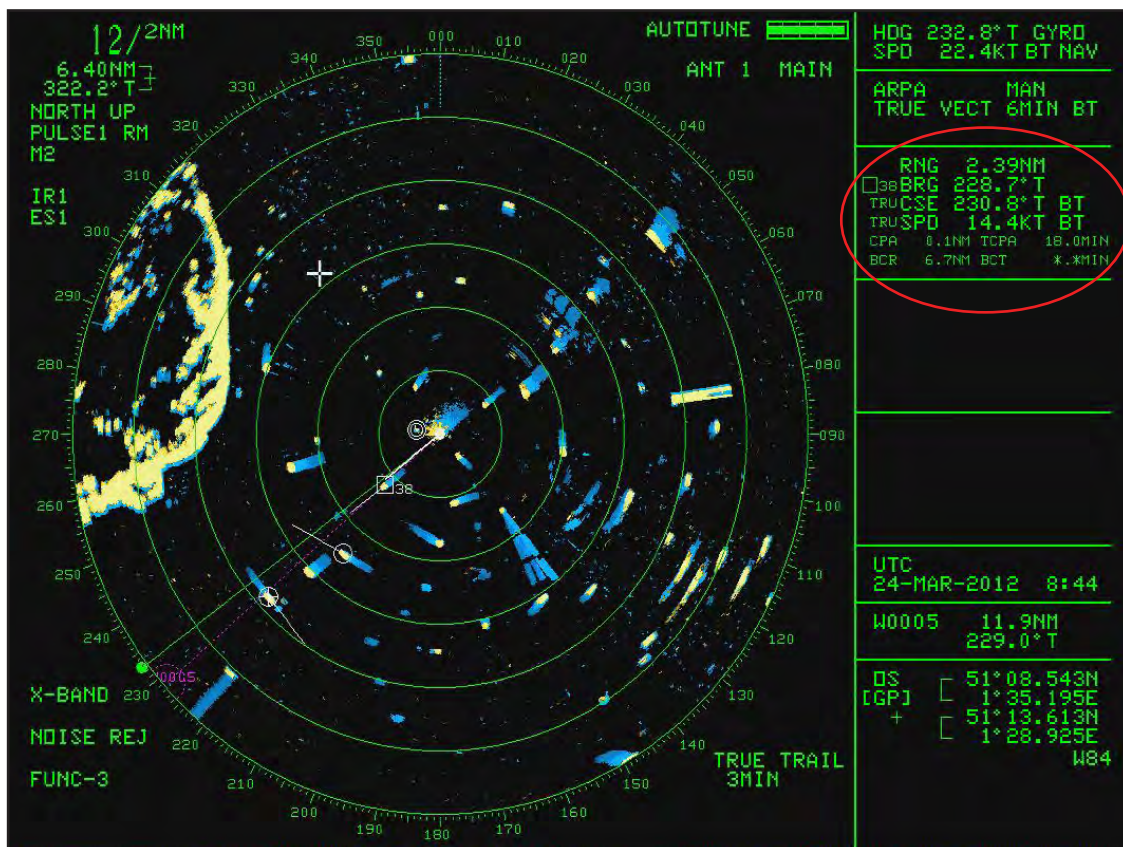
Figure 4: 0844 X-Band radar display showing data selected for one target

At 0810 the master reported the vessel's details to Dover coastguard on entry to the mandatory reporting area for vessels using the Dover TSS. The visibility then reduced and a lookout was posted. At 0844, as the vessel was approaching Dover, the master called the coastguard on VHF radio to report that visibility was 200 metres, the vessel's speed was 22.4 knots and no fog signal was being sounded. There were numerous other vessels in the vicinity, and the master manually acquired one of the closest radar targets and displayed the target data on the radar set (Figure 4).

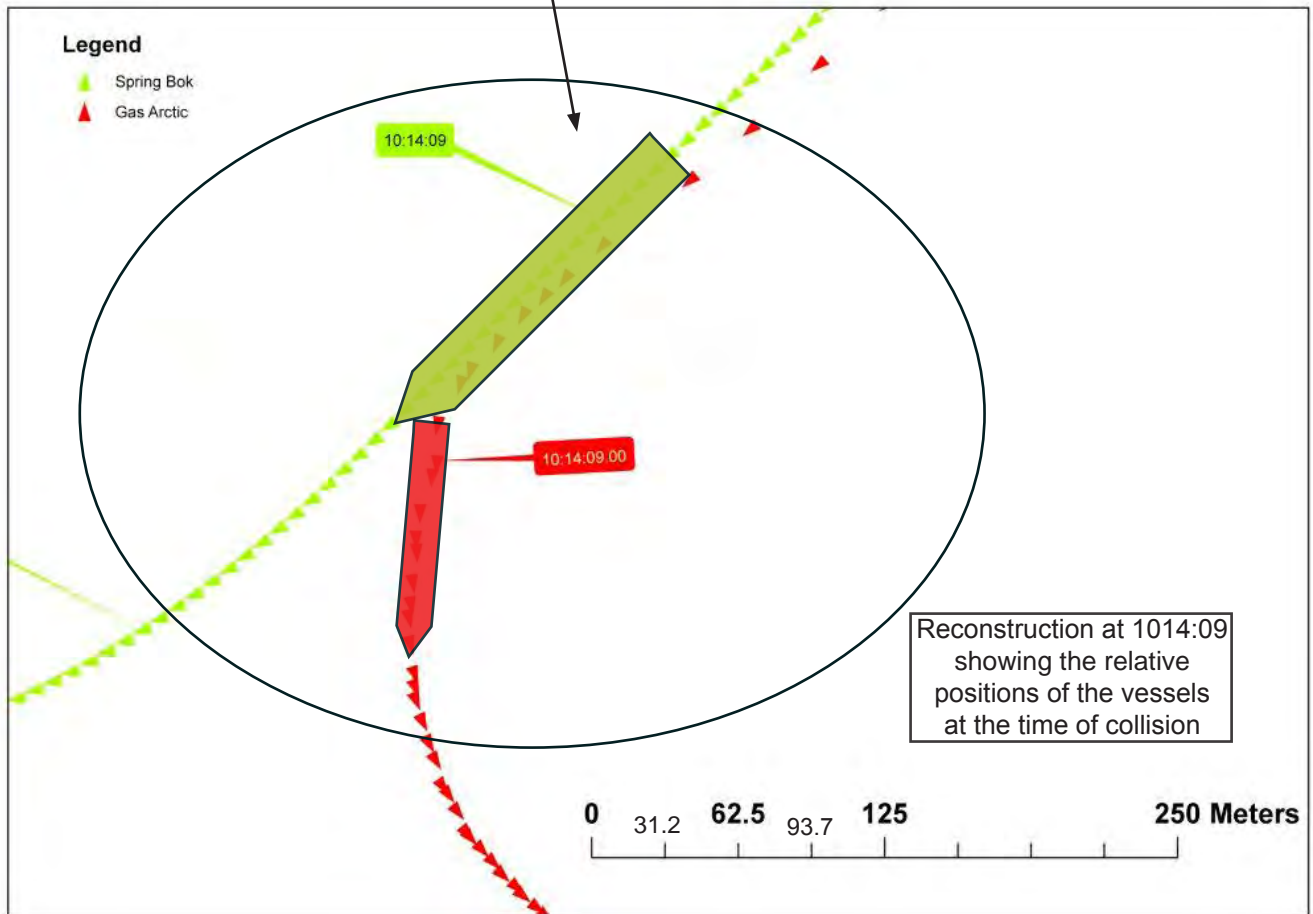
Figure 7: Reconstruction

The reconstruction of the ground tracks of *Spring Bok* and *Gas Arctic*, based on GPS information (**Figure 7**), confirms that *Spring Bok* was overtaking *Gas Arctic* and made no alteration of course before the collision.

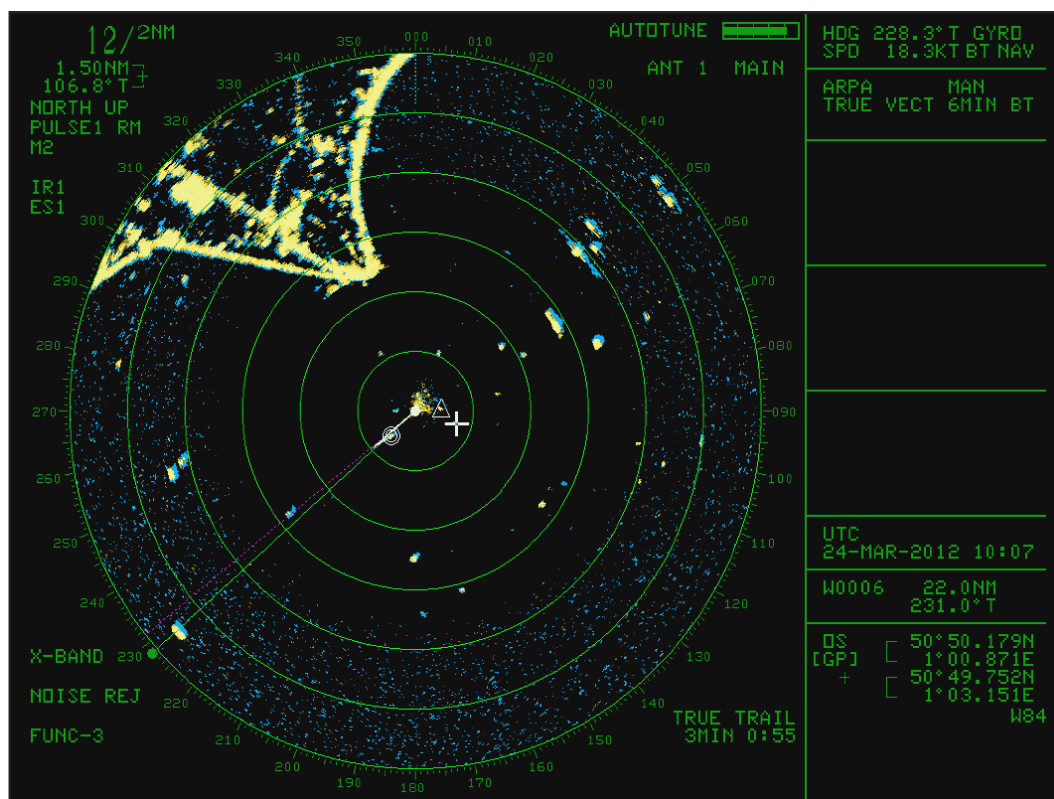
Figure 8: *Spring Bok* - ARPA radar display at 1007

The master selected true vectors and true trails for targets on the ARPA radar. This selection had the disadvantage of giving no relative information of a target, unless it was selected for display, which the master did not do. With *Gas Arctic* directly ahead, the radar heading line and *Spring Bok's* own vector might have combined to obscure the radar target's vector unless the heading line was occasionally switched off; and there is no evidence to suggest the master was doing this. Further, as *Spring Bok's* radar was on the 12 mile range scale, *Gas Arctic's* radar echo became less distinct as its range decreased (**Figure 8**).

The fact that the target data of *Gas Arctic* was not displayed meant that there was no stimulus to the master once the target had merged with the vessel's own heading line and vector as the likelihood of collision increased.
