## MV *SPRING BOK* and MV *GAS ARCTIC* Collision 6nm south of Dungeness, UK 24 March 2012

### SUMMARY

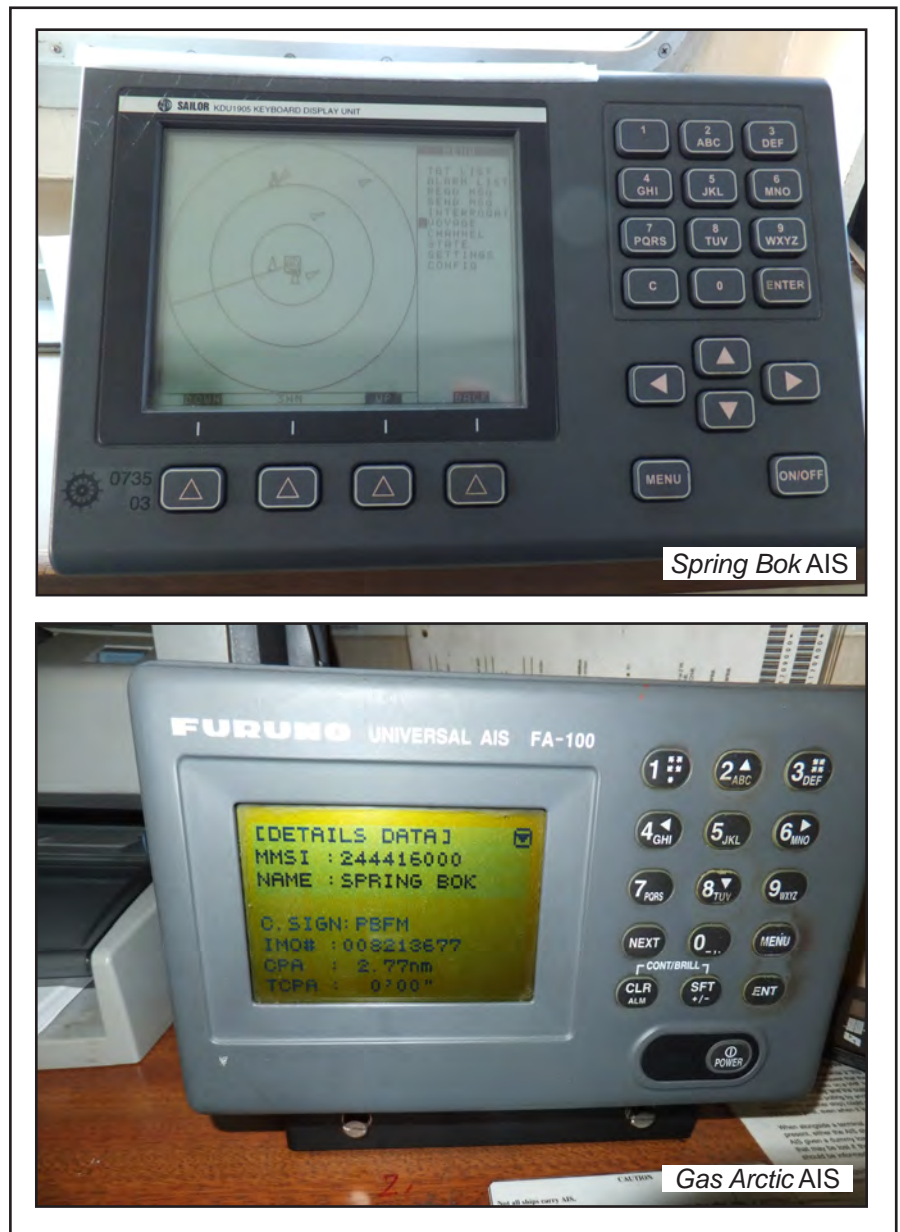
Figure 5: *Spring Bok* and *Gas Arctic's* AIS

*Bok. Gas Arctic's* AIS display had a feature which (Figure 5) allowed the 3/O to observe that the closest point of approach (CPA) of *Spring Bok* was 0.3nm.

At 1000 the 3/O again observed *Spring Bok* on AIS when she was about 3nm astern with a CPA of zero; he could not see the vessel visually at that time. He took no action to contact the other vessel because he expected it, as the overtaking vessel, to keep clear. He was also plotting the *Gas Arctic's* position onto the paper chart at frequent intervals during this period.

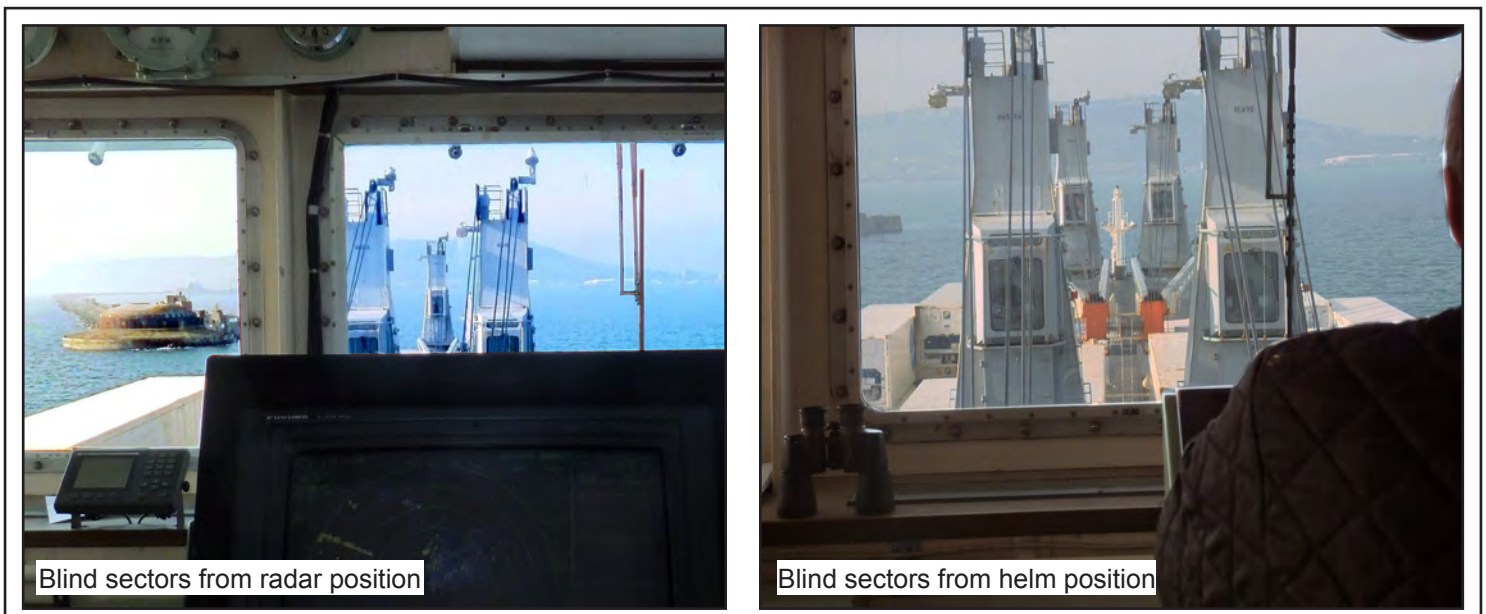
**Figure 9:** *Spring Bok* bridge showing blind sectors from radar and helm positions

to see *Gas Arctic* from that location due to a blind sector caused by a combination of the wheelhouse window frame and the cargo cranes (**Figure 9**), and he first became aware of her presence after she altered course to port and appeared to the left of the blind sector.

SOLAS<sup>8</sup> Chapter V, Regulation 22 sets maximum permissible blind sectors from the conning position on vessels built after 1 July 1998. Although these regulations do not apply to *Spring Bok* as she was built in 1984, the visibility from the bridge did comply with the new regulations.

On vessels with wheelhouse blind sectors, it is important that the OOW/lookout moves around the bridge frequently to ensure that a proper lookout is maintained at all times. This was not the case at the time of the collision as the master had stationed himself at the radar display, a not unreasonable course of action in restricted visibility, and the lookout that should have been available to back him up had been stood down.
