MV *SPRING BOK* and MV *GAS ARCTIC* Collision 6nm south of Dungeness, UK 24 March 2012

SUMMARY

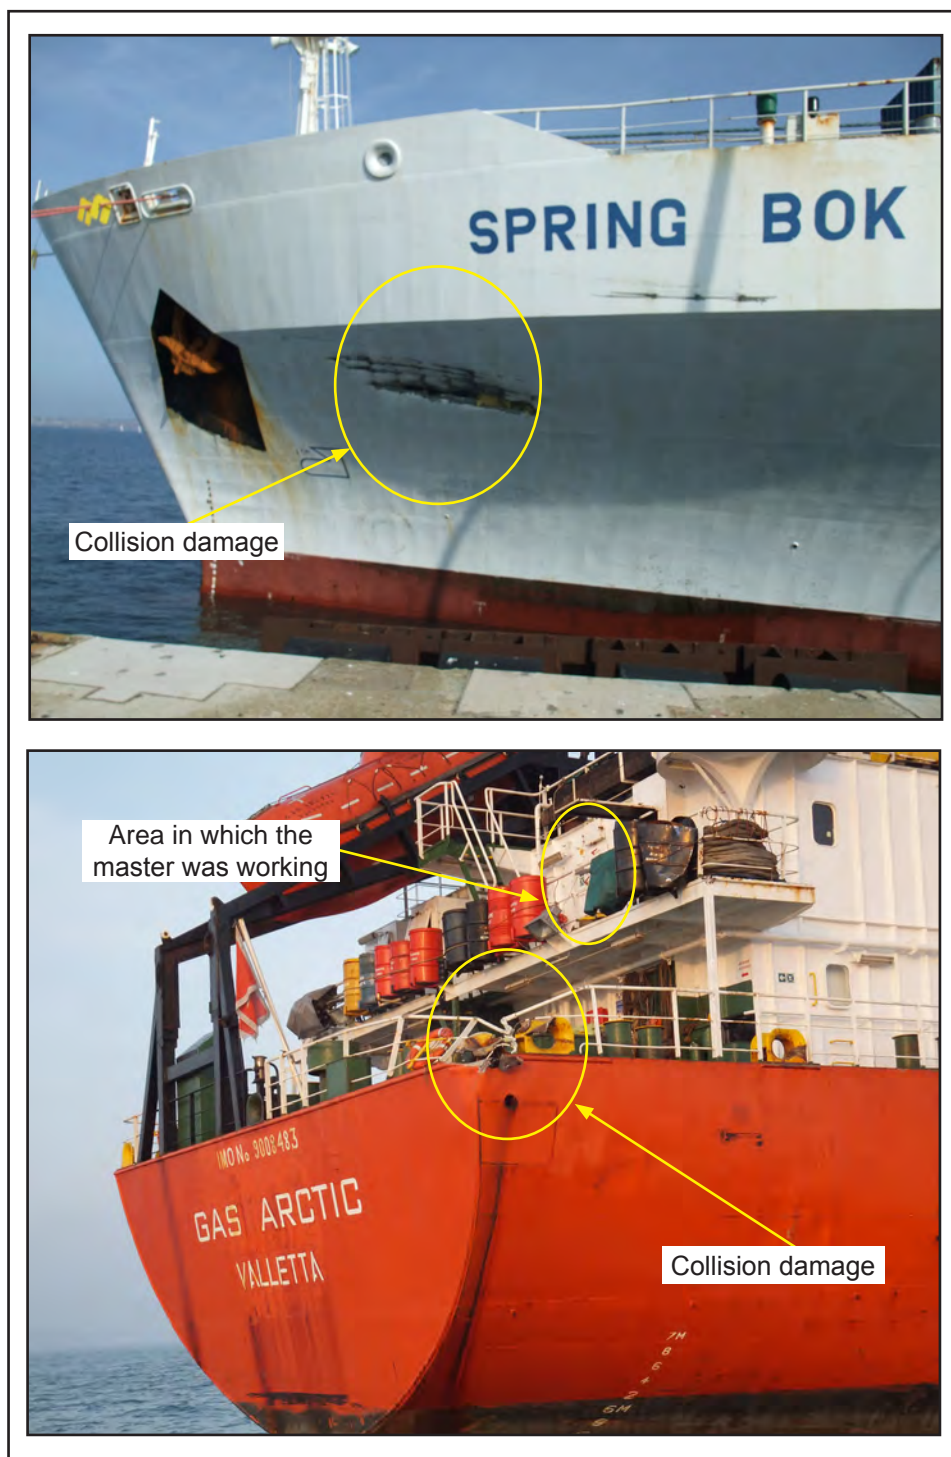
Figure 6: Damage to both vessels

The point of collision was between the port bow of *Spring Bok*, which had maintained her heading, and the starboard quarter of *Gas Arctic* (**Figure 6**).

Gas Arctic suffered a breach of her hull, shell indentation and damage to fairleads and railings on her starboard quarter. *Spring Bok* was holed on the port bow and her collision bulkhead was penetrated.

Spring Bok was detained pending repair of her steelwork, which was carried out in Portland. She was released from detention and resumed her passage to the Caribbean on 31 March.

Gas Arctic was given a condition of class⁶ and a single voyage dispensation to proceed to the nearest suitable repair port. She was subsequently dry docked and repaired in Poland, and resumed service on 21 April.
