Report on the investigation of the collision between

Seagate

Timor Stream

on 10 March 2012 at 0540 local time

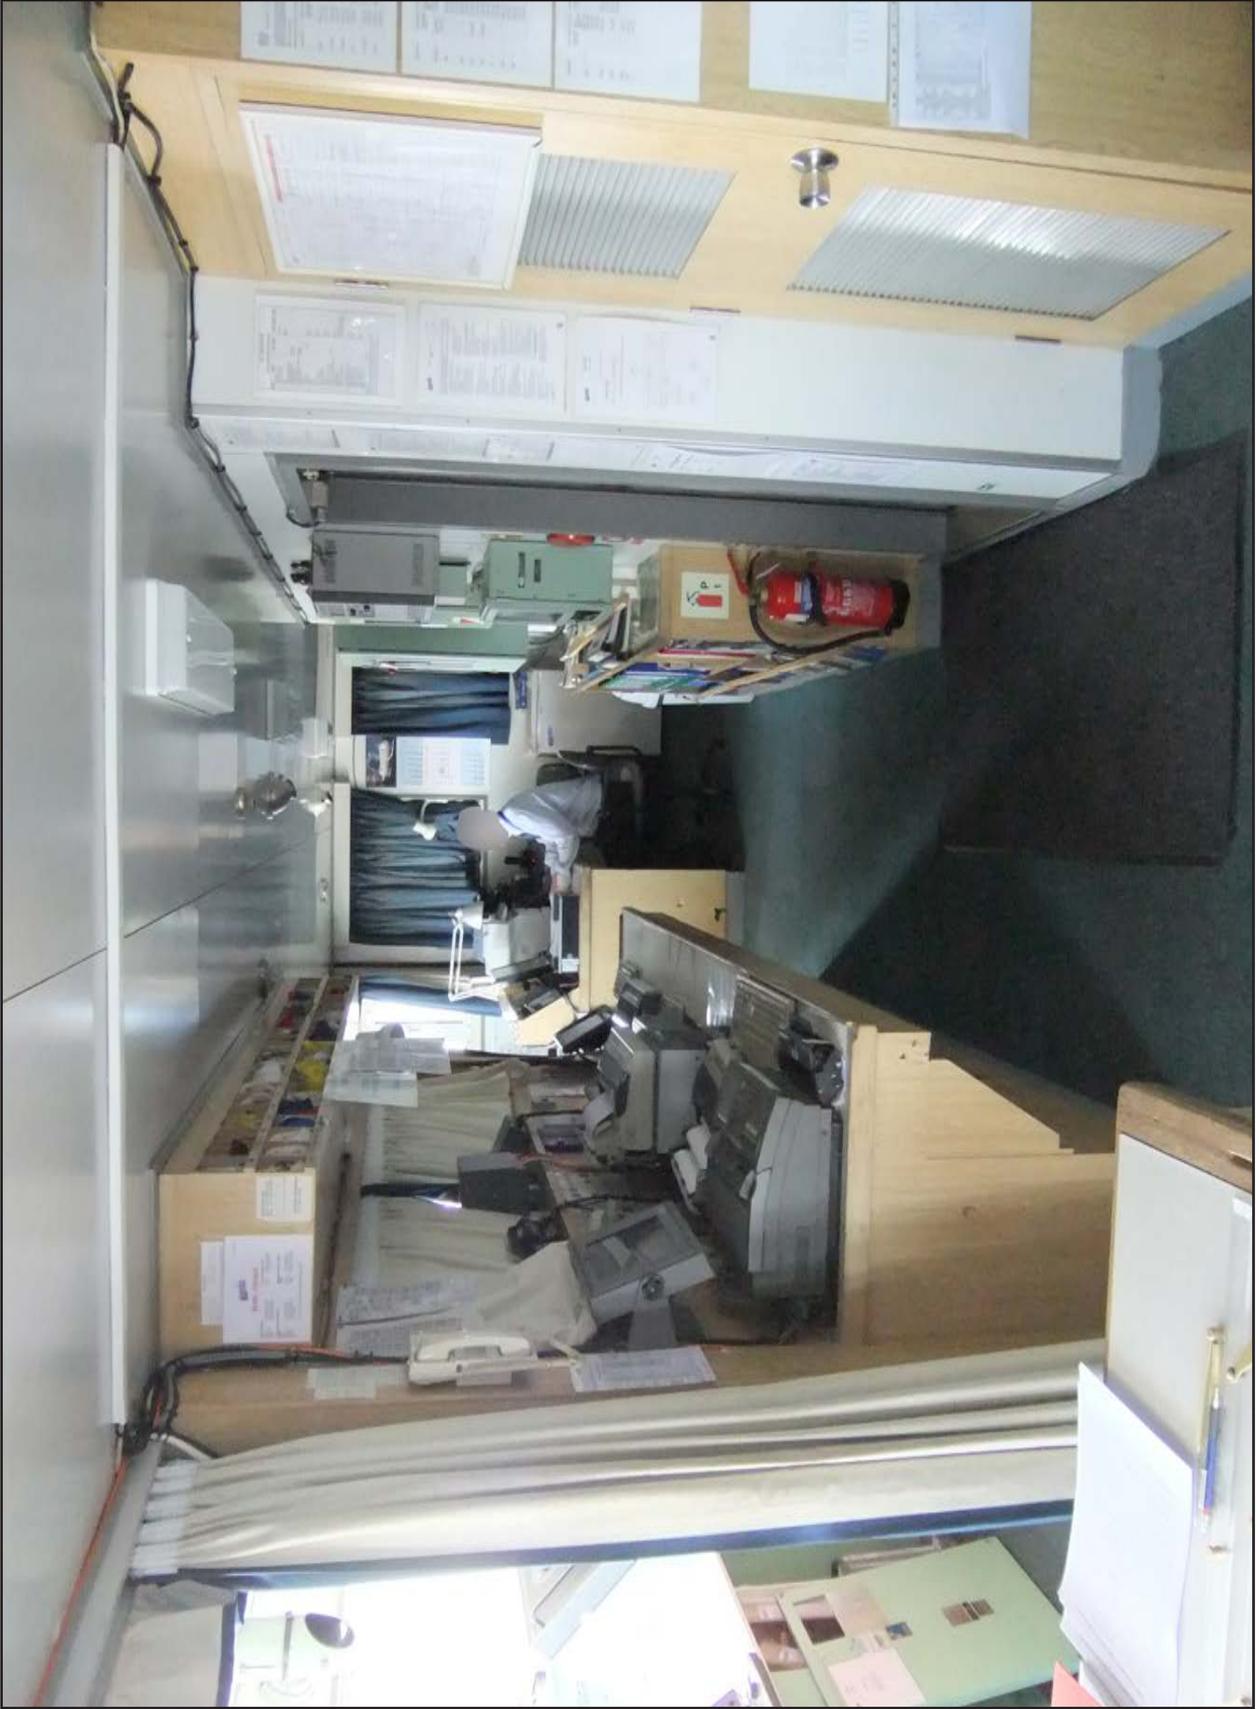
Figure 2: *Timor Stream* – desk on the starboard side of the bridge

At 0441, an hour before the collision, *Timor Stream's* master sent a departure email message from the computer located on the desk on the starboard side of the bridge. This would probably have taken him several minutes to complete. At that time, in the prevailing conditions, *Seagate* would probably have been detectable on *Timor Stream's* radar. At 0500, when the master plotted the ship's position on the chart, *Seagate* was 34° on *Timor Stream's* port bow at a range of 12nm. However, the master did not detect *Seagate* either visually or on his radar display. Similarly, he either did not notice, or took no action to correct, the incorrect heading information that was being transmitted from his vessel's AIS.

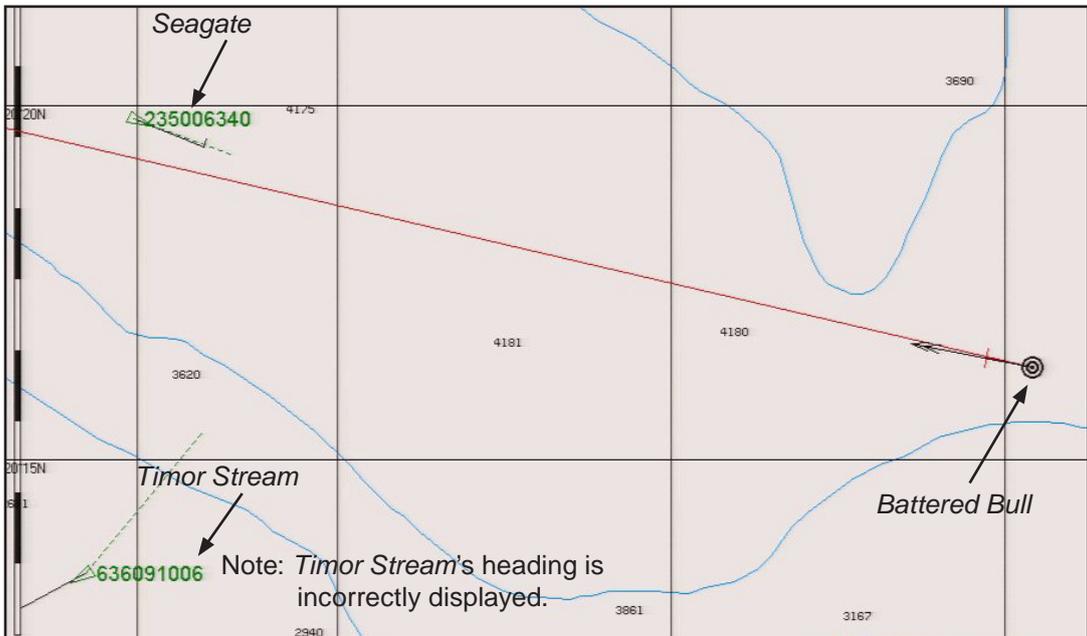
Figure 3: Battered Bull's ECS display at 0520

At 0520, the motor yacht *Battered Bull* was heading 326° at a speed of 12.5 knots at a range of 13nm from *Seagate*, on an almost reciprocal heading (**Figure 3**). *Timor Stream* was around 25° on *Battered Bull's* port bow crossing from port to starboard. *Battered Bull's* chief officer identified that *Seagate* and *Timor Stream* were 6.7nm apart and that action was required by *Seagate*, the give way vessel, to avoid a close quarters situation or collision.

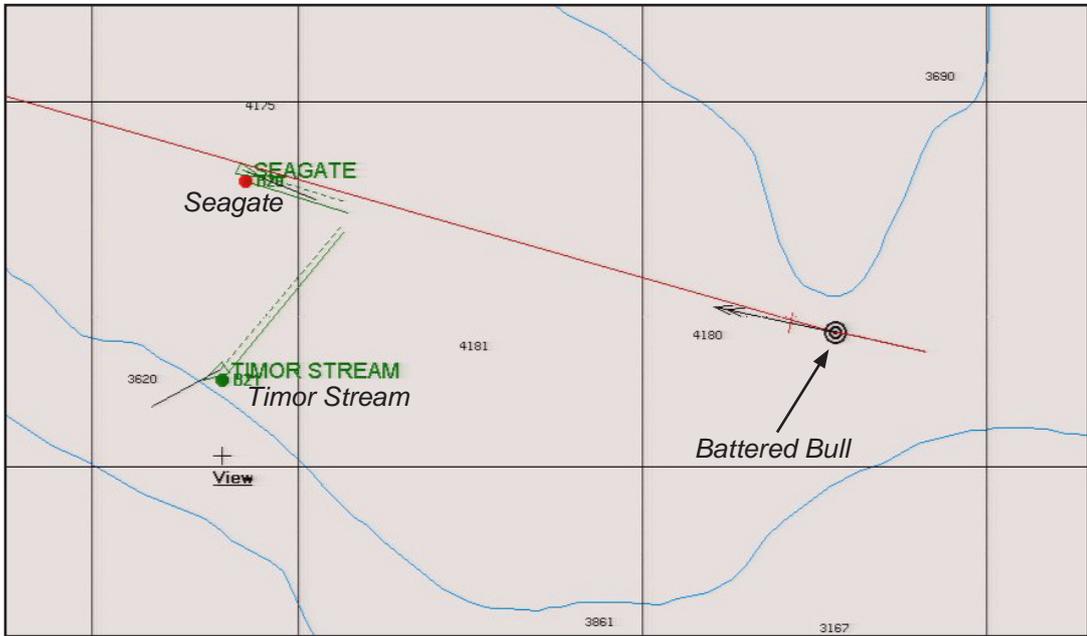
Figure 4: Battered Bull's ECS display at 0532

By 0532, *Seagate* and *Timor Stream* were 2.8nm from each other on a collision course (**Figure 4**); *Battered Bull* was 8.5nm from *Seagate*. *Battered Bull's* chief officer altered course 24° to port to avoid the developing situation with both *Seagate* and *Timor Stream* (**Figure 5**).

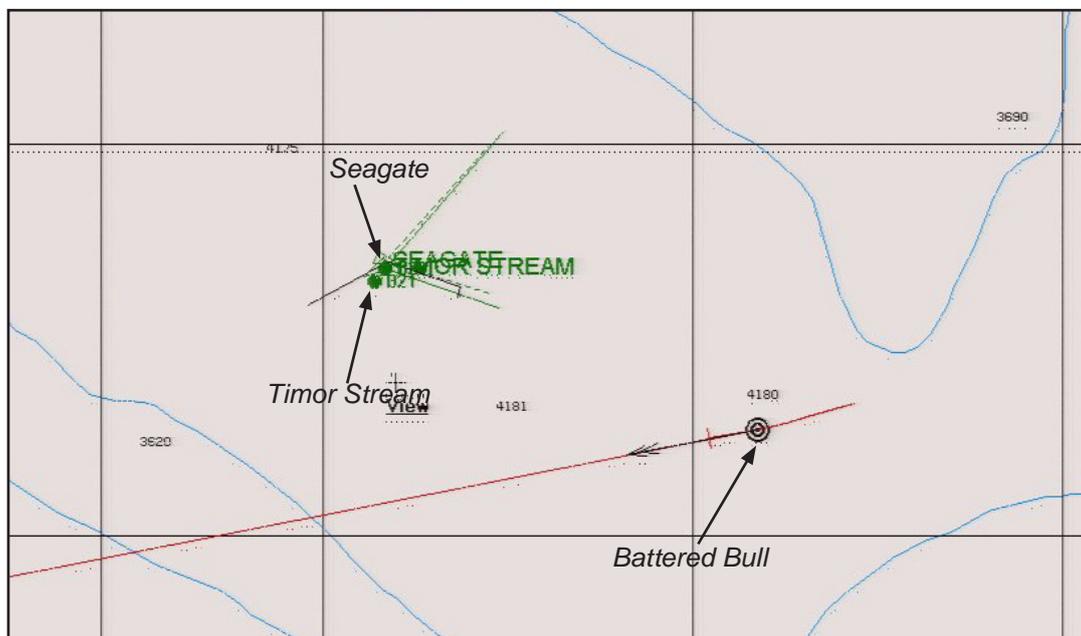
Figure 8: Battered Bull's ECS display at 0540:50

At 0540:50 the two vessels collided (**Figure 8**). *Timor Stream's* heading had not changed; *Seagate's* heading had altered by 7°. *Timor Stream's* bow hit the after part of *Seagate's* starboard side in the area of the accommodation block and engine room; the engine room started to flood and the electrical power system failed. *Seagate's* starboard liferaft was destroyed and its starboard lifeboat fell onto *Timor Stream's* damaged forecastle deck.

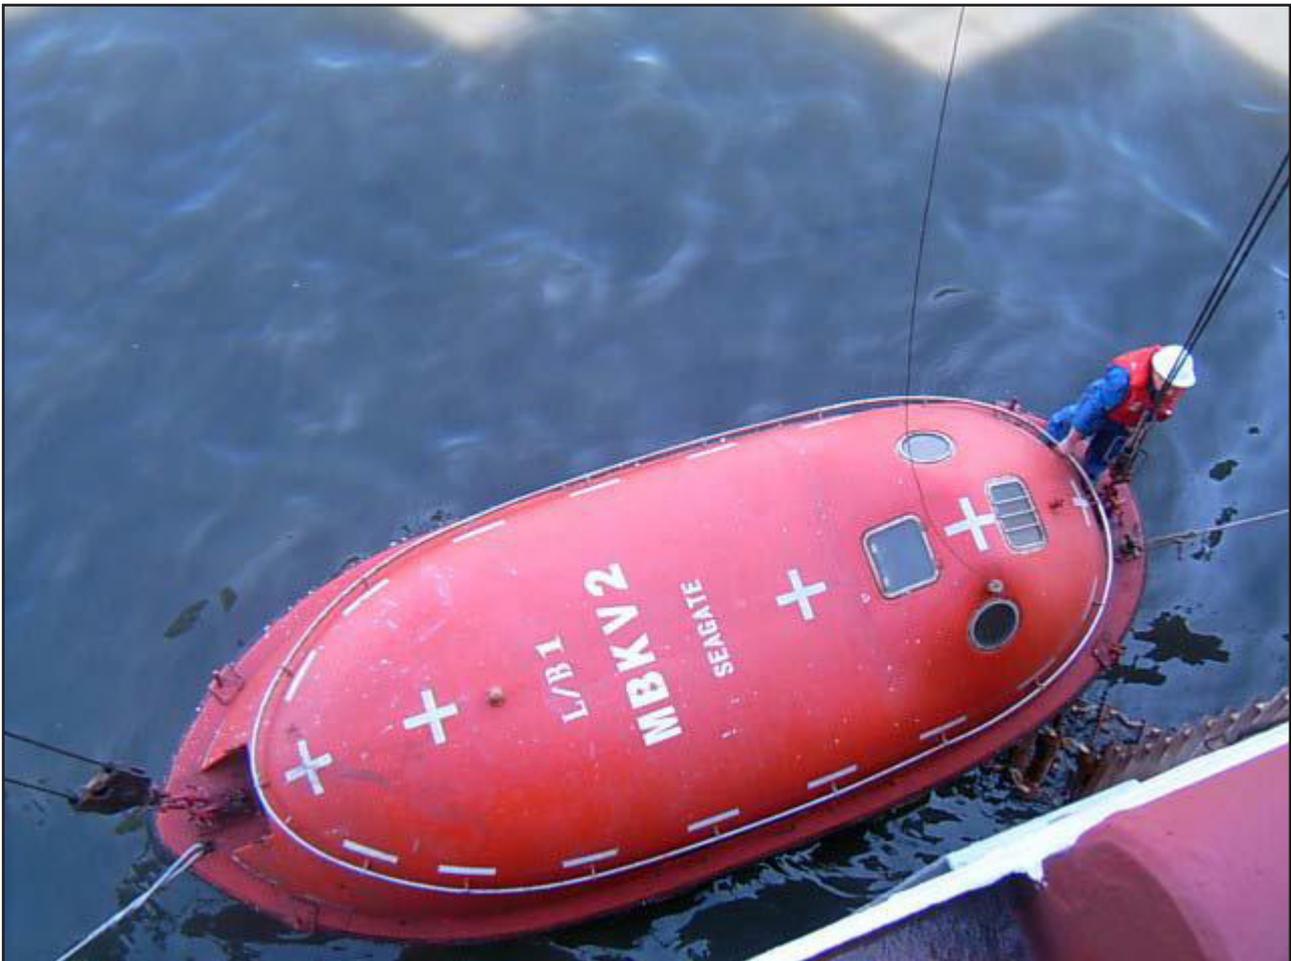
Figure 9: Pre-accident photograph showing *Seagate's* starboard lifeboat for illustration purposes

Also at around 0600, *Seagate's* master instructed the chief officer to prepare the port side lifeboat and liferaft for launching. The chief officer took a motorman, and told him to lower the lifeboat into the water. The chief officer, who was not wearing a lifejacket, then climbed onto the top of the lifeboat (**Figure 9**), went inside it and attempted to disengage the lifeboat's fall blocks from their release hooks. The chief officer was not familiar with the release mechanism and was unable to release the hooks.

At about 0630, *Seagate's* chief officer climbed onto the bow of the port lifeboat and attempted to disengage the lifeboat's release hooks manually. Shortly afterwards, at around 0635, he fell overboard from the lifeboat, landing in the sea between the lifeboat and the ship's side. *Seagate's* master used the VHF radio to broadcast that a man was overboard, and the chief engineer threw a lifebuoy into the sea close to the chief officer. The chief officer held onto the lifebuoy and the liferaft boarding ladder. *Battered Bull's* master manoeuvred his yacht (**Figure 10**) close to the chief officer and a manoverboard recovery net was rigged over the yacht's side (**Figure 11**). The chief officer swam, with the lifebuoy, to *Battered Bull* and their crewmen pulled him on board. The chief officer was covered in oil, exhausted and disorientated, but was uninjured.

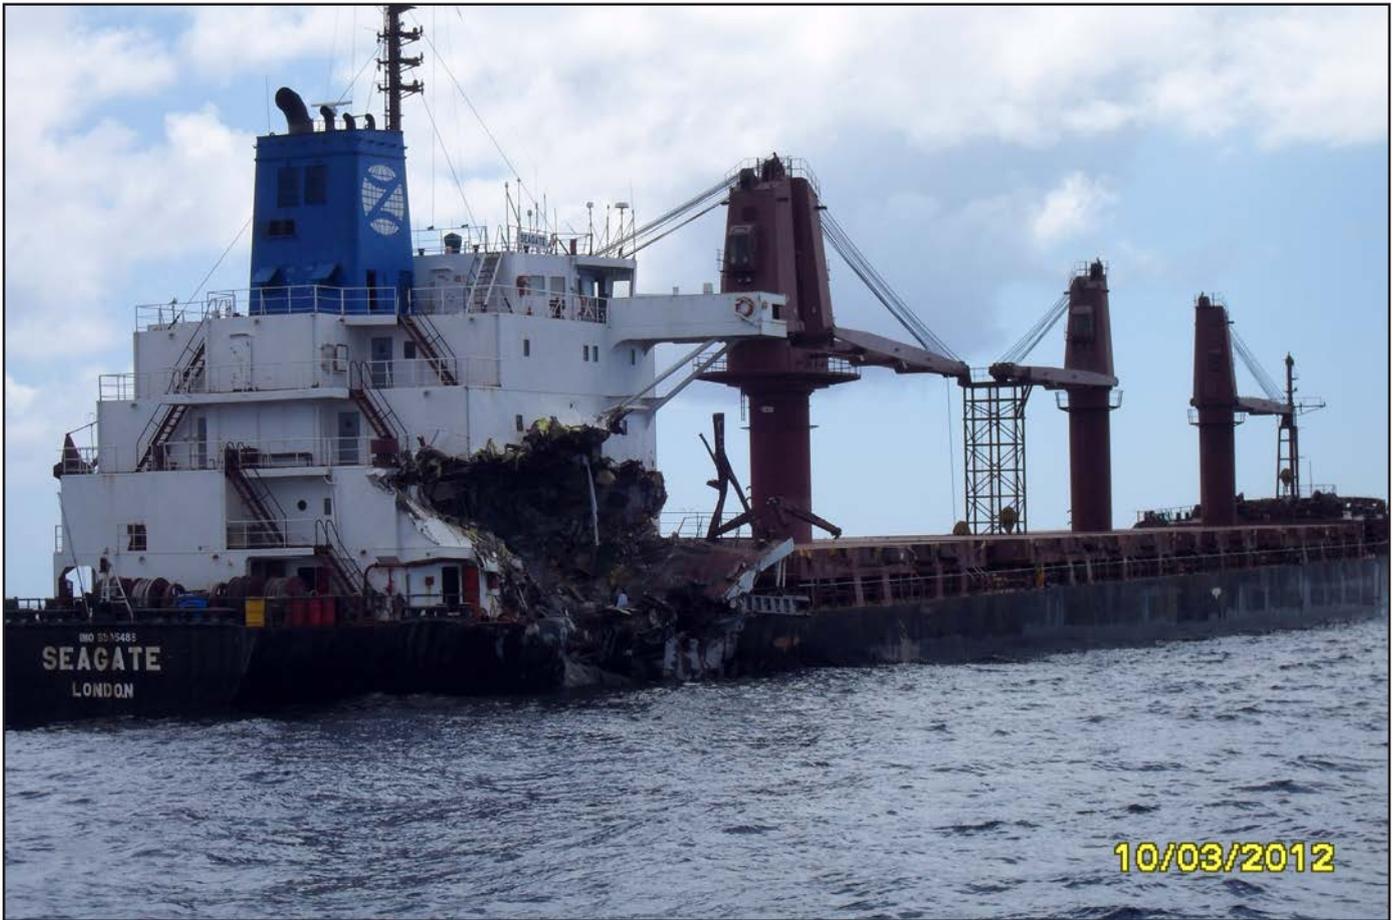
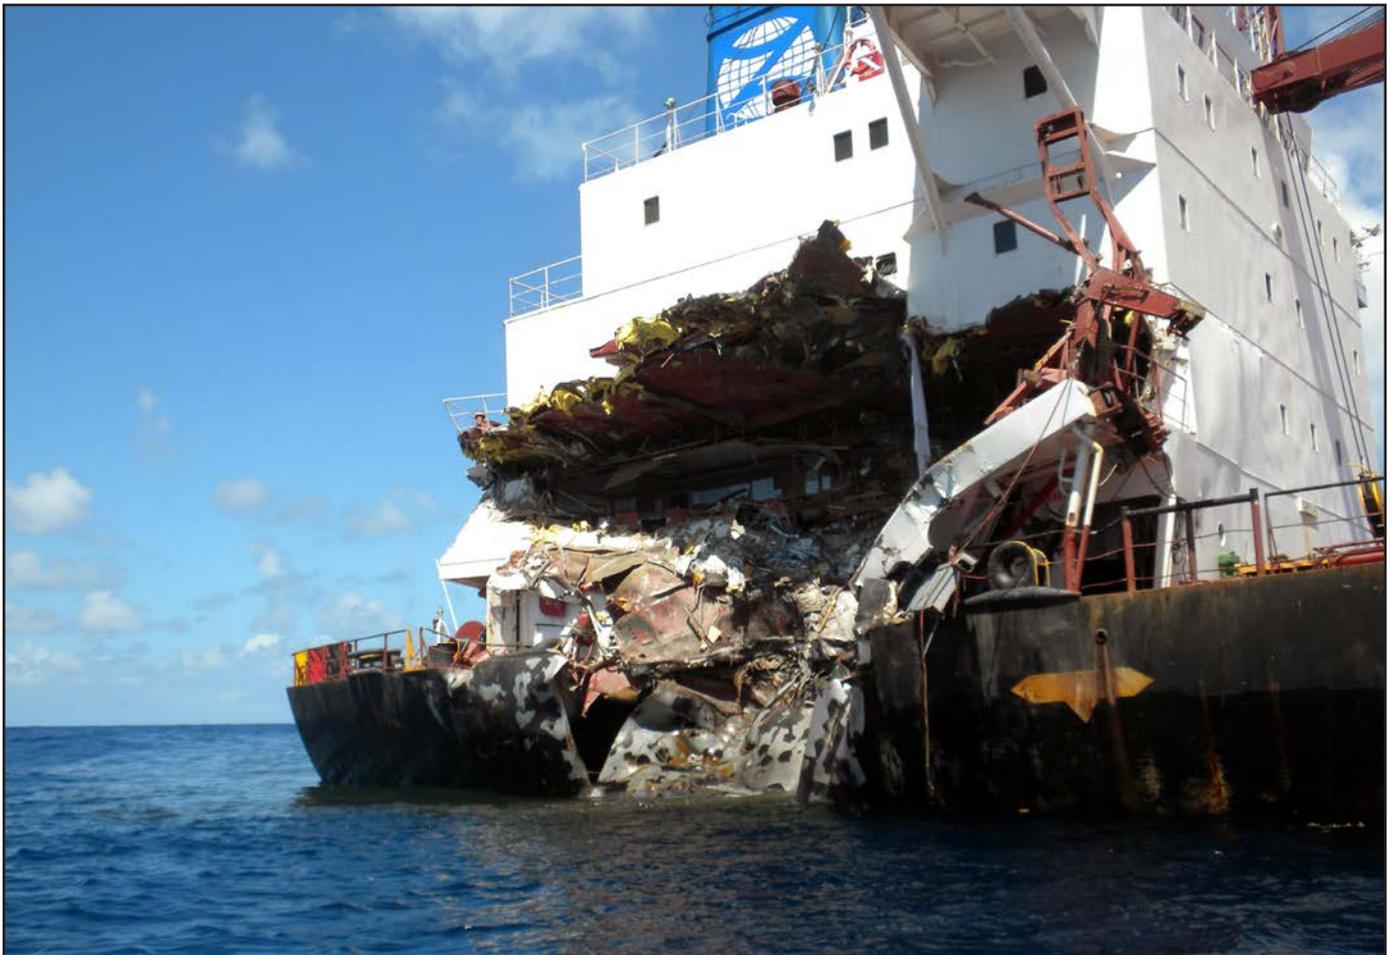
Seagate suffered extensive damage to the aft starboard side (**Figures 13a and b**). The engine room was holed above and below the waterline and flooded. Around 12500 litres of diesel oil and 5500 litres of lubricating oil spilled into the sea and flooded engine room from two damaged tanks. The accommodation on the starboard side was heavily damaged, including numerous cabins and the mess room. The starboard lifeboat and liferaft were destroyed. The cargo holds were undamaged and the vessel remained stable throughout the tow to Port-au-Prince.

Figure 13a: Seagate's starboard side – post-collision

Figure 13b: Seagate's starboard side – post-collision (close-up)

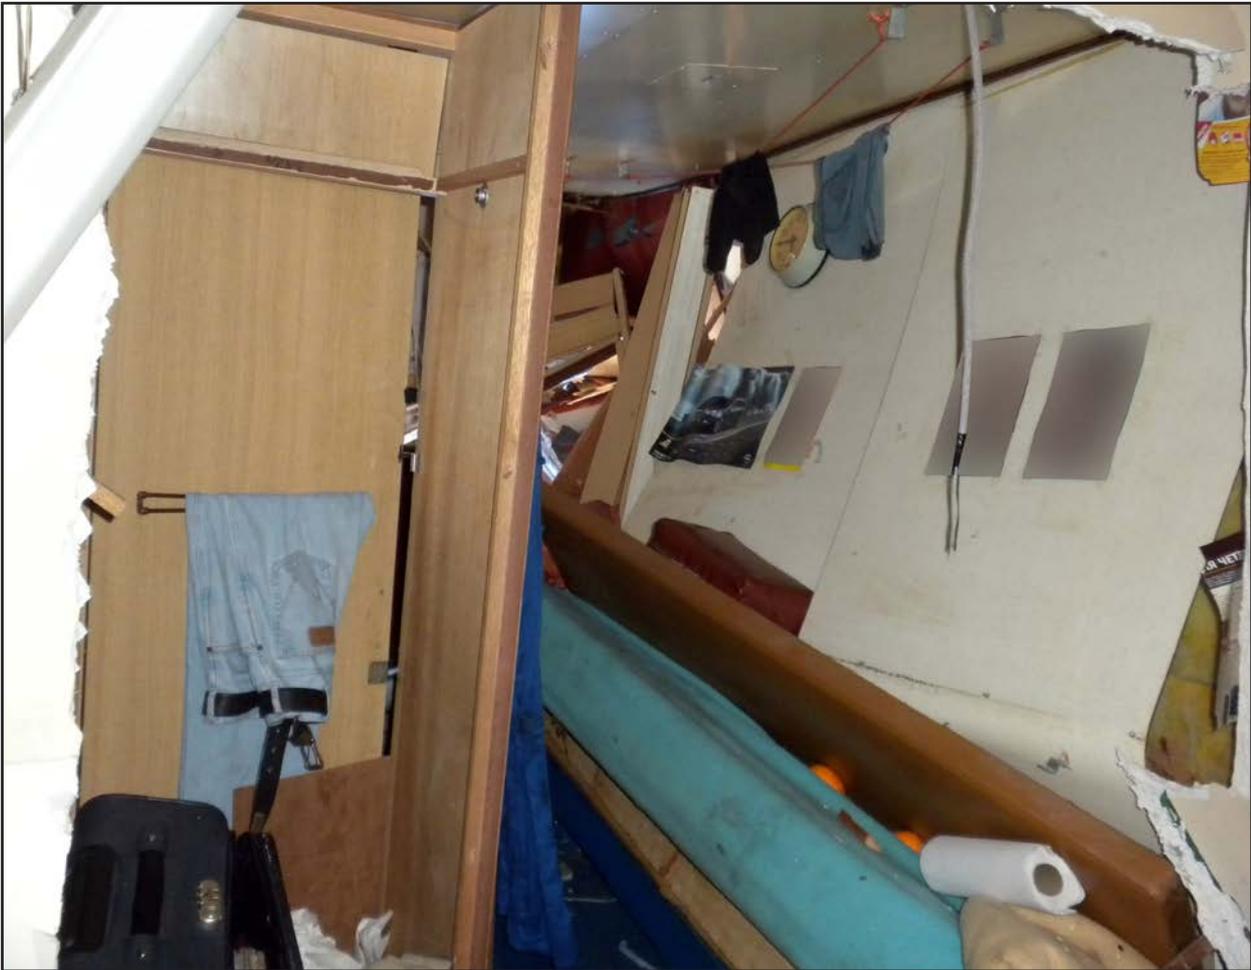
Although crew members were asleep in some of the heavily damaged cabins (**Figure 14**), there were no injuries either in the collision or subsequent abandonment.

Figure 14: Crew cabin on board Seagate – post-collision

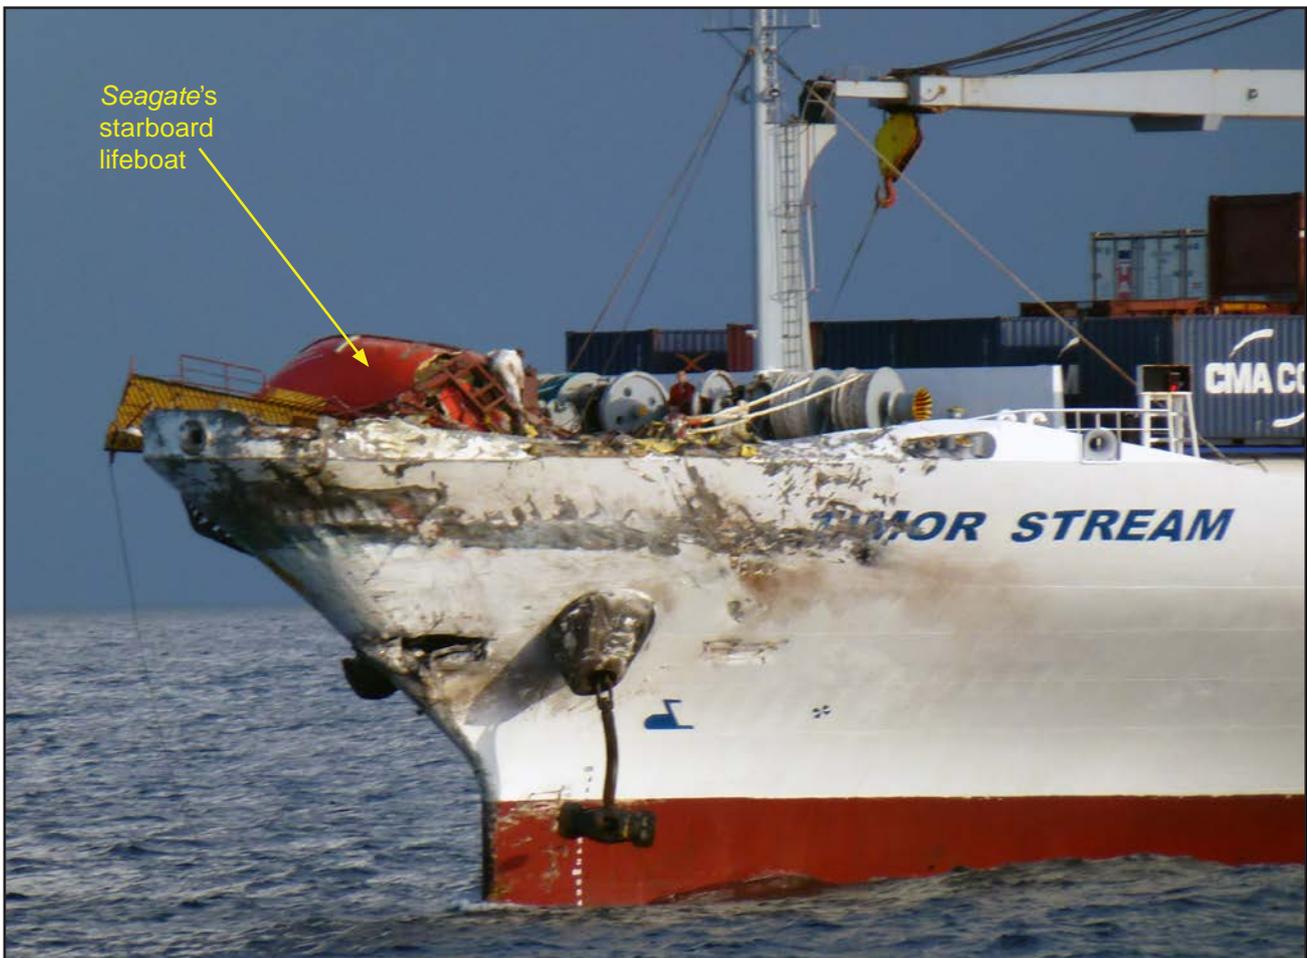
Timor Stream sustained major damage to its bow section (**Figure 15**); however, the collision bulkhead was not breached. The bulbous bow was damaged and the lower forepeak tank was holed. The shell plating to the upper fore peak tank was also holed above the waterline. Both anchors were badly damaged and were unusable. The forecastle deck, mooring equipment, bulwarks and mooring line fairleads were also severely damaged. There were no injuries and there was no pollution.

Figure 15: *Timor Stream's* bow section – post-collision

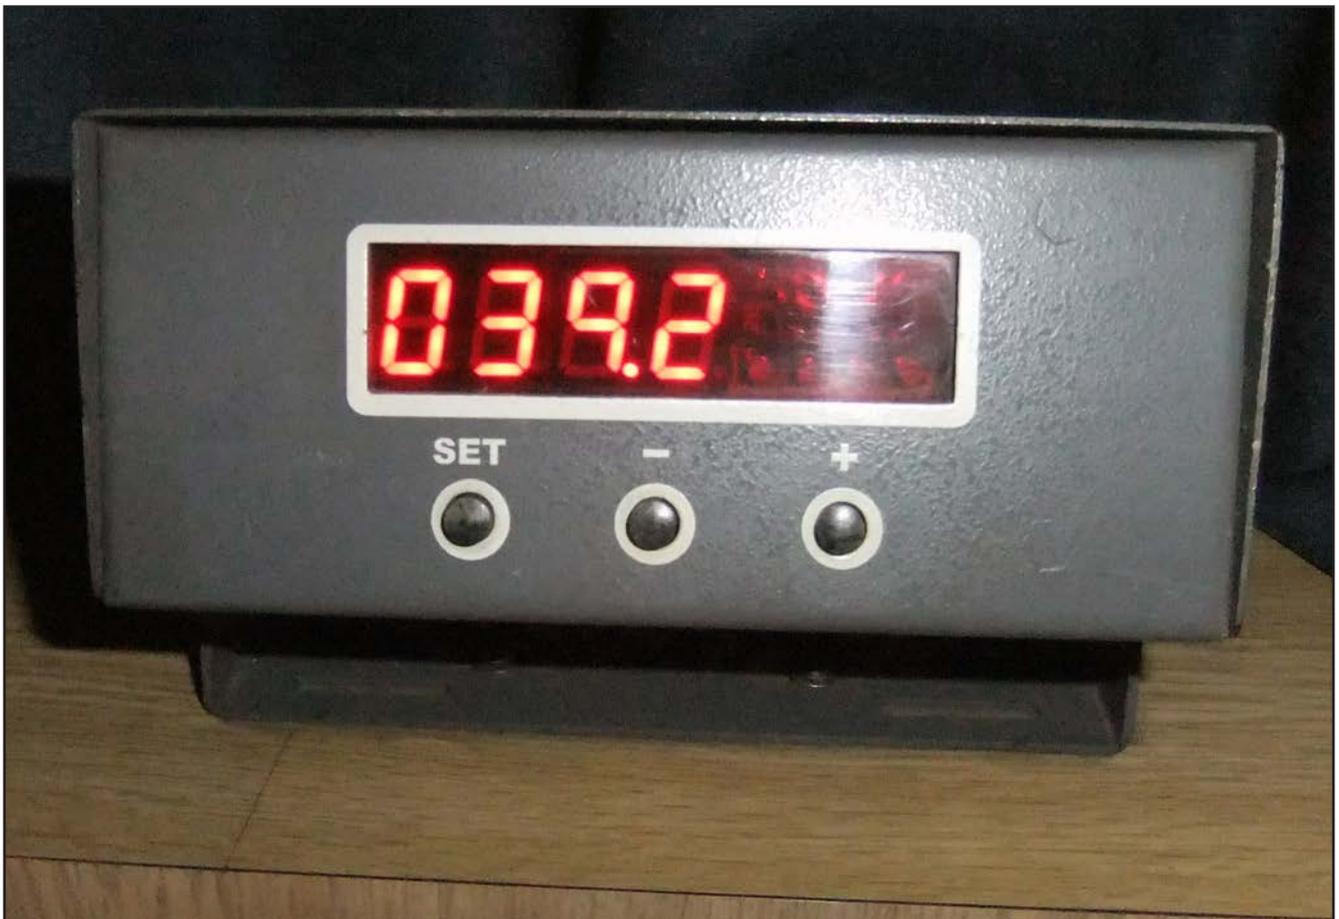
Figure 22: *Timor Stream's* gyro interface repeater

At the time of the accident, the AIS data transmitted from *Timor Stream* showed that the vessel's heading was around 160° different to its actual heading. This data was recorded on *Timor Stream's* VDR and on *Battered Bull's* electronic chart system. *Timor Stream's* AIS data was received from the gyro compass via the gyro interface repeater (**Figure 22**). Following the accident it was established that the error introduced into the AIS was variable.

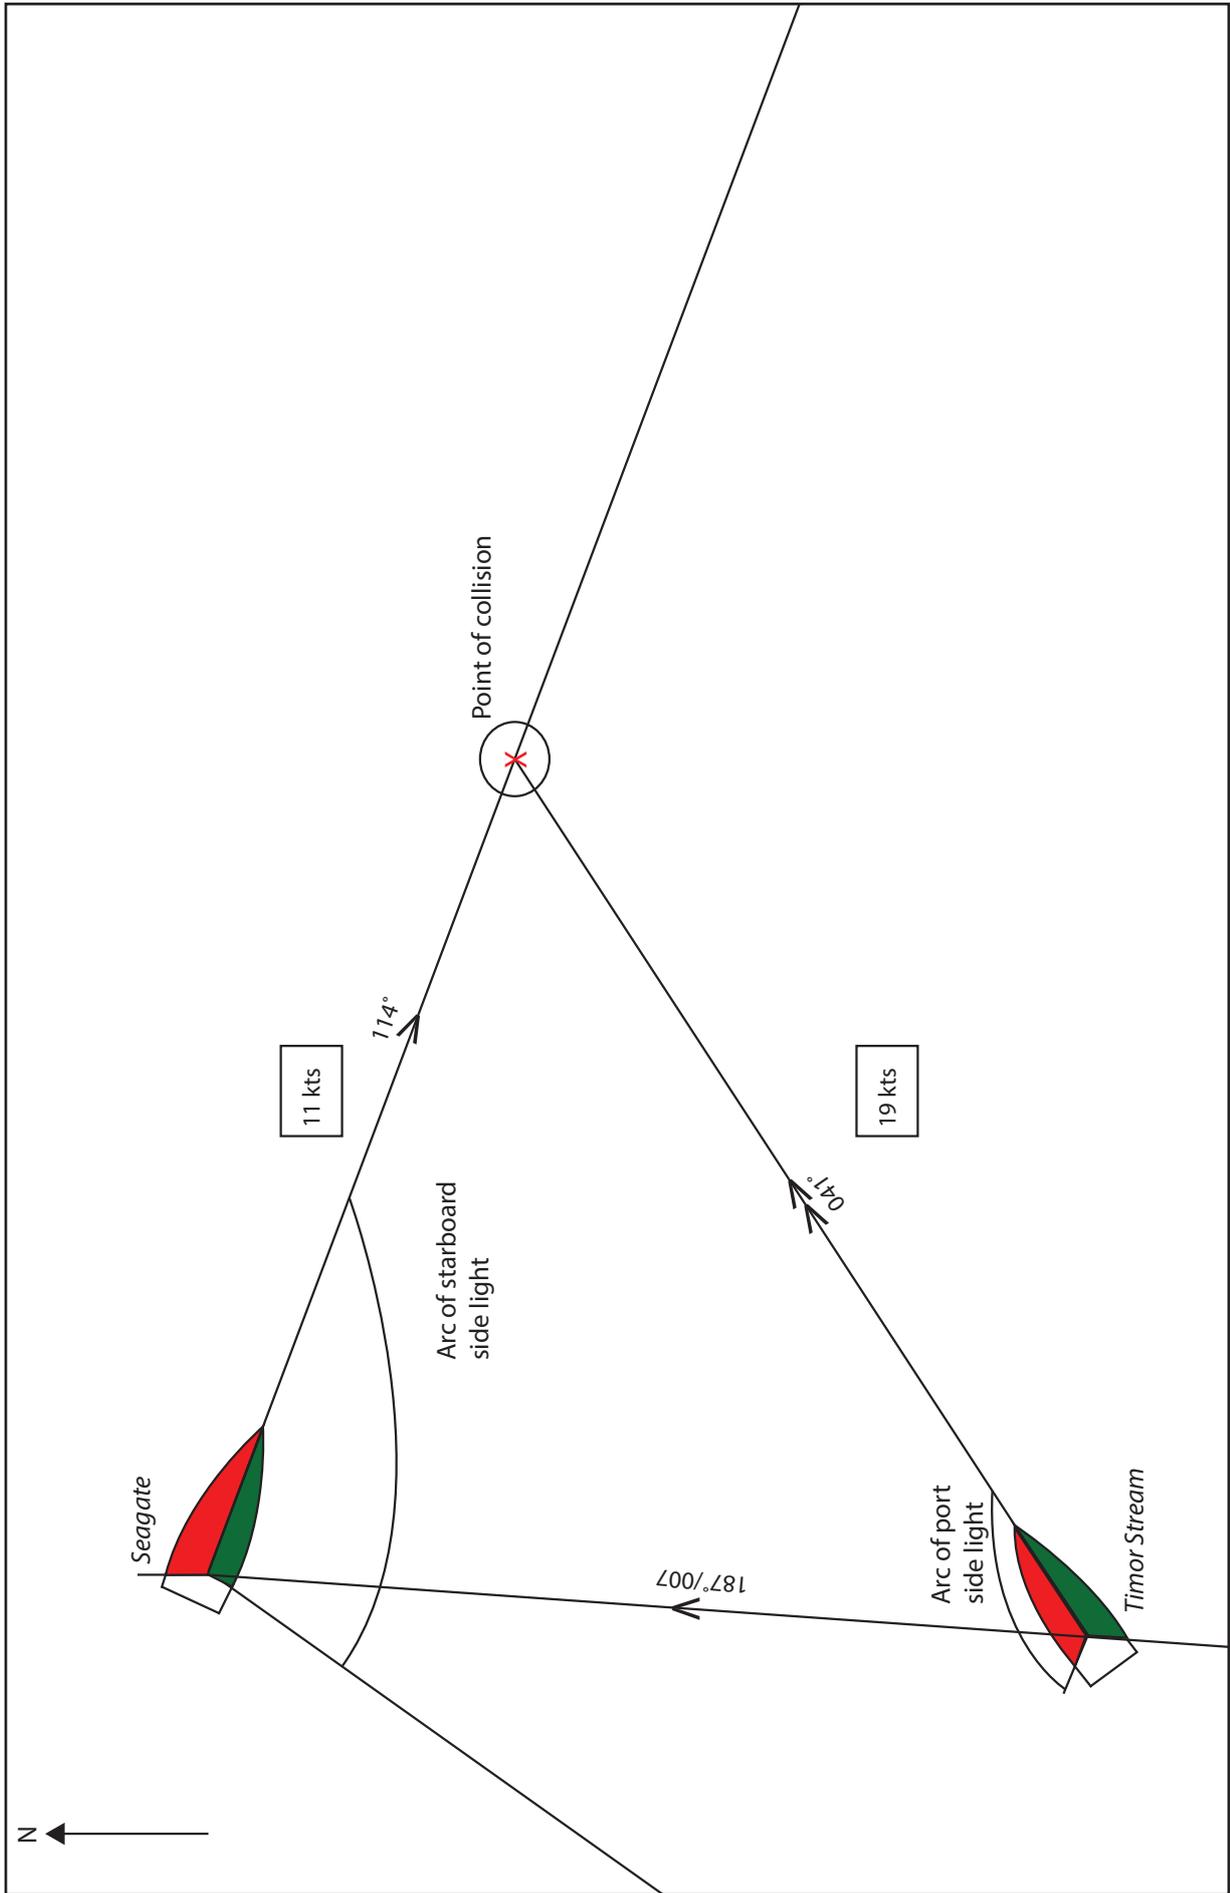
Figure 25: Collision analysis

Seagate's chief officer believed that *Timor Steam* was on a heading of around 090°, at a speed capable of overtaking *Seagate* so that it would pass his vessel with a CPA of 3 or 4 cables. *Battered Bull's* ECS data showed that, for the 40 minutes before the collision, *Timor Stream* was on a constant heading of 041° at a speed of 19.5 knots. *Timor Stream* was on a steady compass bearing of 187° from *Seagate*, 17° forward of *Seagate's* starboard beam (**Figure 25**).

his radar's ARPA, he should have identified that his estimate of *Timor Stream's* heading differed by about 50° from its actual heading; he should also have realised that *Seagate* was in a crossing situation rather than an overtaking one.

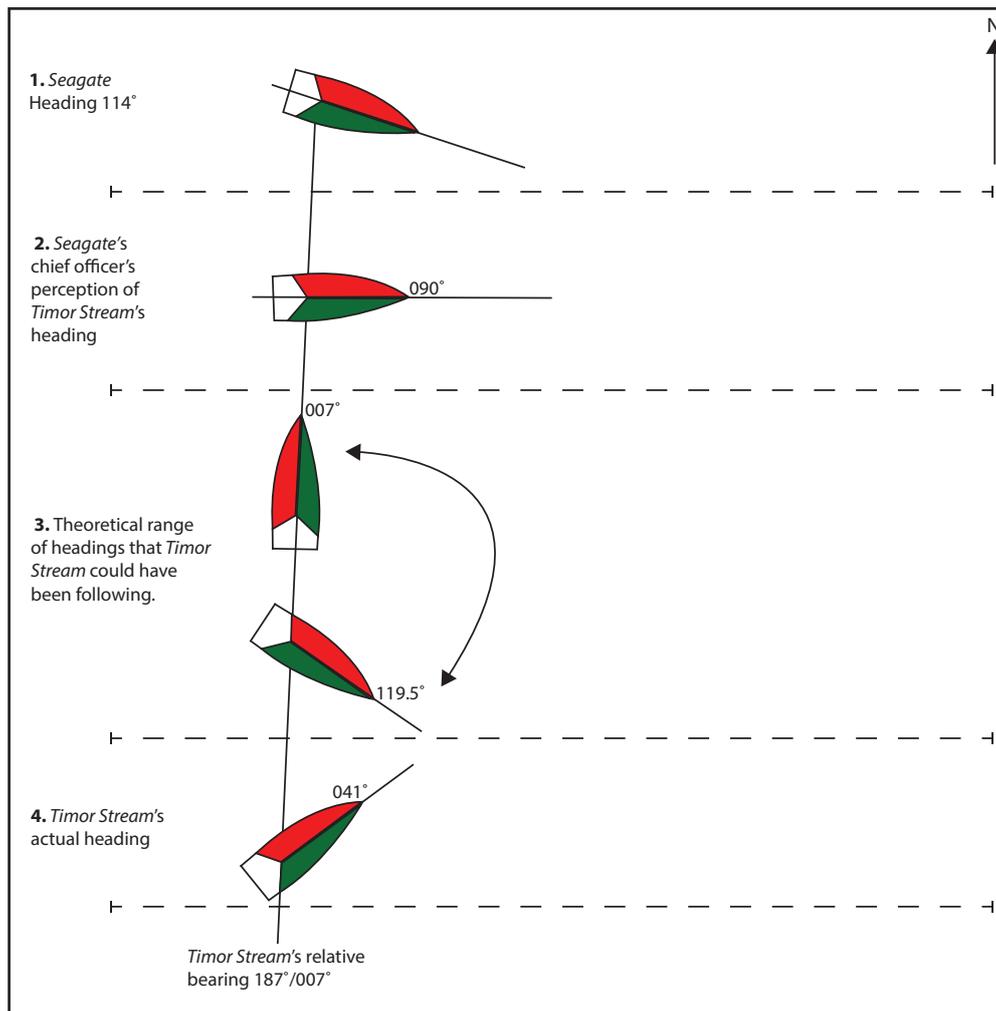
Figure 26: Analysis of the potential range of headings being followed by *Timor Stream* based on viewing its navigation lights alone

Timor Stream displayed the appropriate navigation lights for a ship of its size when underway. Its two masthead lights and port-side light could have, in theory, shown *Seagate's* chief officer that *Timor Stream's* heading was between 007° and 119.5° (**Figure 26**). Had the chief officer established *Timor Stream's* actual heading using
