Report on the investigation of
a fatal manoverboard from the fishing vessel

Zenith (B 470)

29 miles south-east of Kilkeel

on 29 January 2012

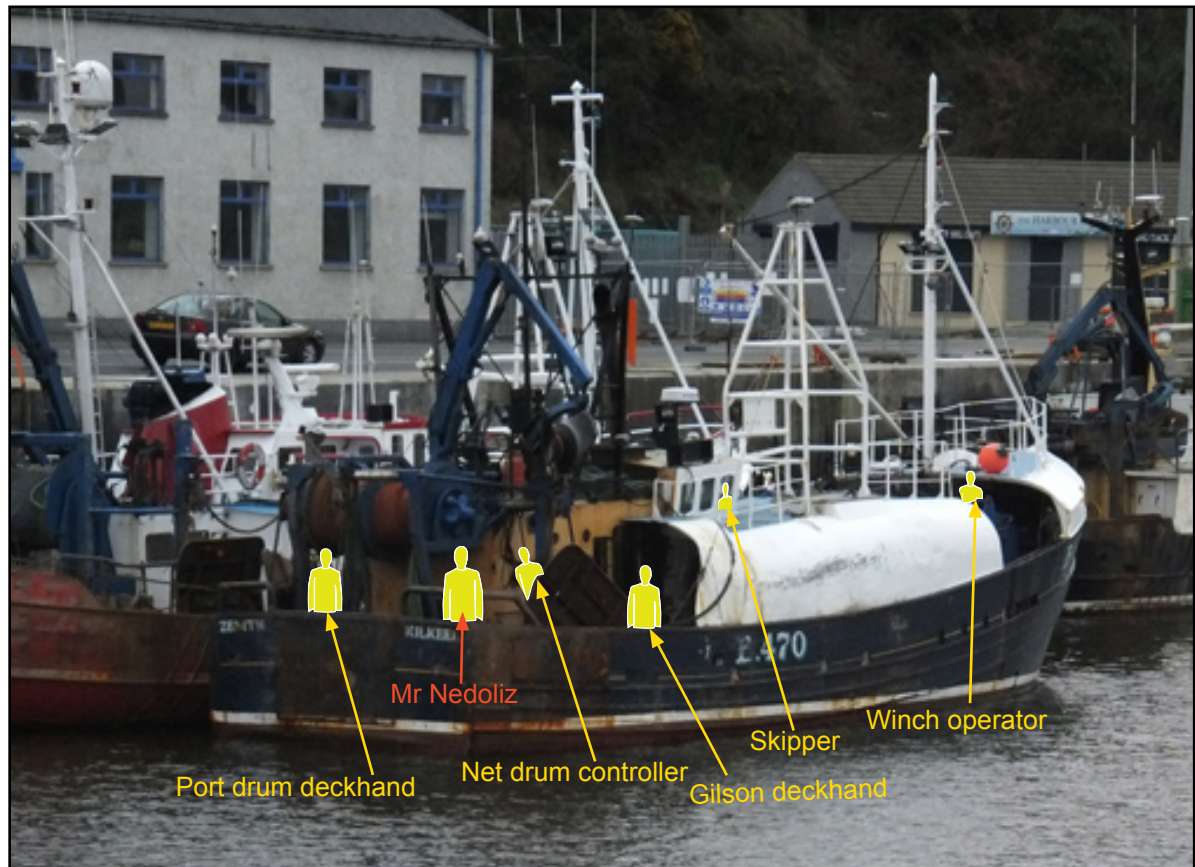
Figure 2: Location of crew before the accident

Zenith's crewmen were in the positions indicated in **Figure 2**. The skipper was in the wheelhouse, a deckhand controlled the trawl winch forward, another prepared the gilson hook on the starboard side deck for recovering the cod end, a third controlled the net drum from the aft starboard side deck, while the two remaining crewmen were stationed on the aft deck to disconnect bridles from behind the trawl doors and attach them to the net drums using the pennants.

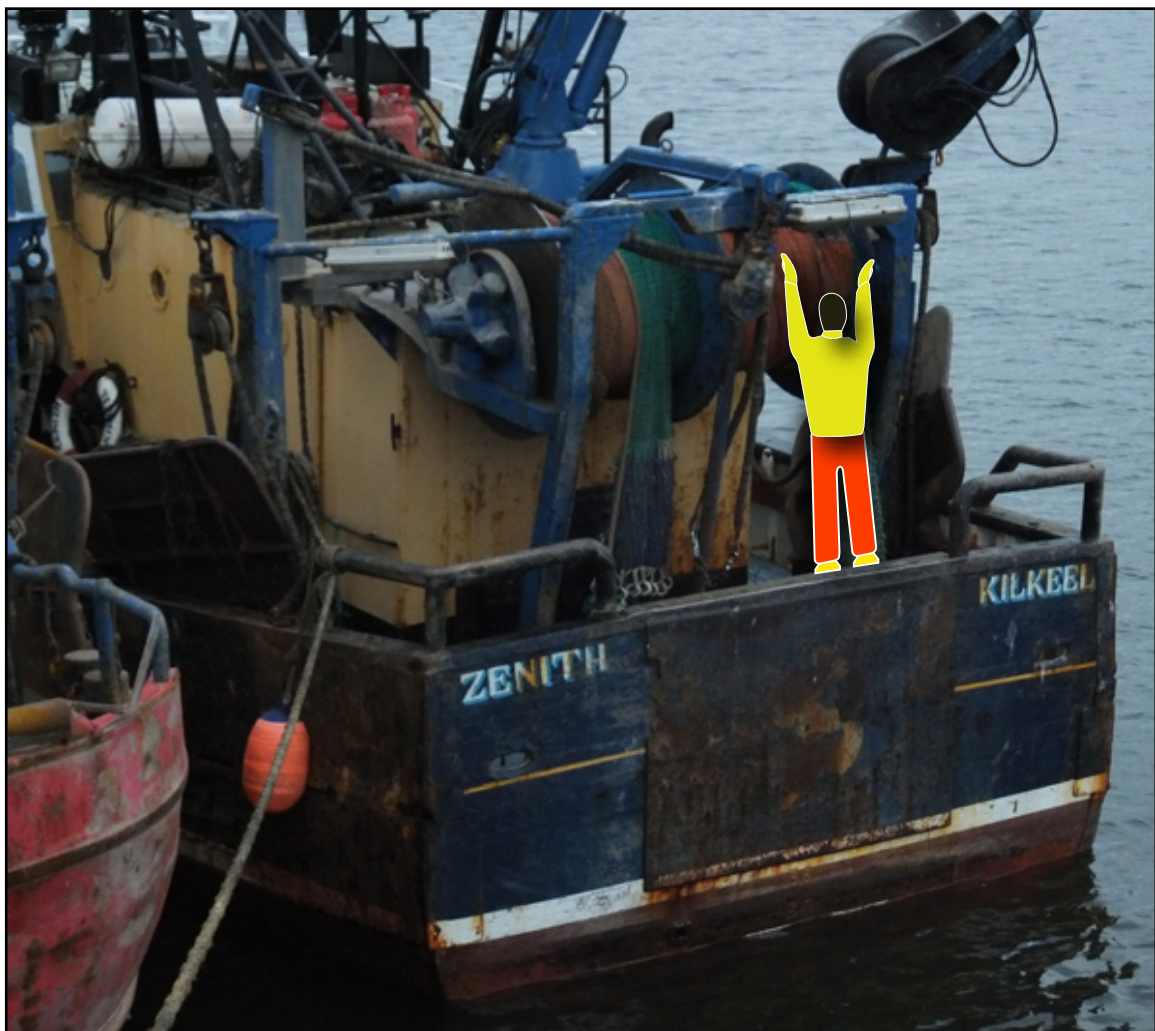
Figure 3: Position of casualty at time of being swept overboard

Once the bridles were transferred onto the net drums, the net drum controller proceeded to wind them onto the drum barrels. On the starboard side, Nikolai Nedoliz stood up onto the transom bulwark top rail, with his back towards the sea, and commenced pushing the bridles apart from that position (**Figure 3**). A large wave, of greater height than had thus far been encountered that day, was seen rising astern by both the net drum operator and the crewman on the port side drum. They shouted forcefully to Mr Nedoliz several times to get down from the top rail. However, Mr Nedoliz looked uncomprehendingly at his colleagues and remained in position. The wave swamped the vessel's stern and carried Mr Nedoliz from the top rail and into the sea.

The practice of working from the top rail was clearly unsafe, and it was only a matter of time before it led to an accident. Falling from the rail into the sea or onto the deck was not the only danger this task presented; the act of manually pushing bridle wires and net wings apart as they wound on to the net drum could also have resulted in being dragged into the revolving drums.

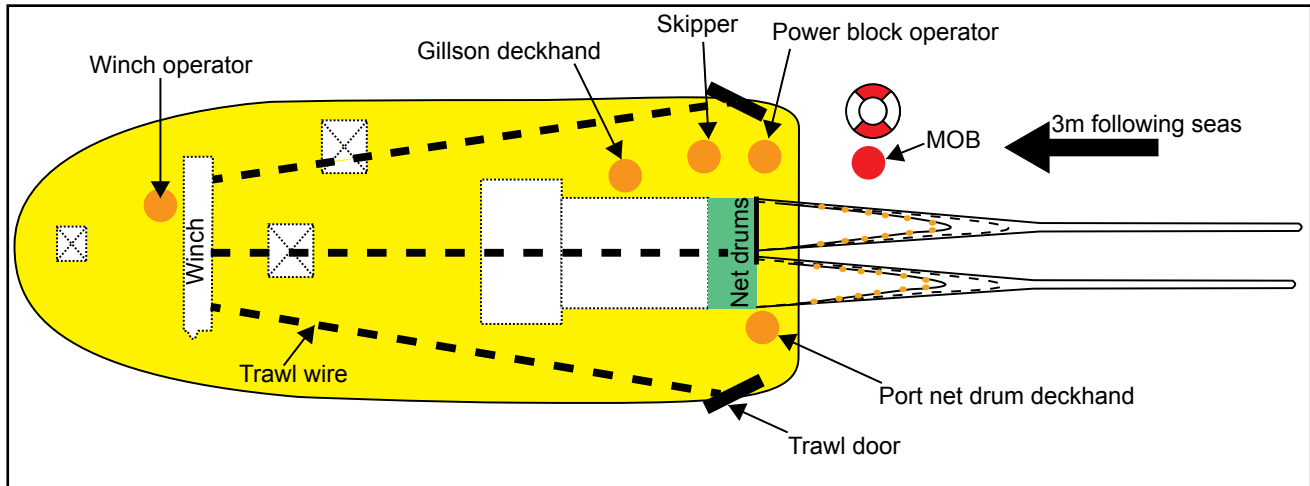
Figure 4: Diagrammatic representation of crew positions and MOB relative to vessel, nets etc

and he appeared to be swimming weakly in a position between the life-ring and the starboard net floats (**Figure 4**). As the life-ring had no lanyard attached, the men shouted to their colleague to swim to the net floats in the hope that once he had a hold of them they could simply wind the net onto the drum and retrieve him back on board. However, Mr Nedoliz appeared unable to swim the short distance to the nets and they were soon driven beyond his reach by the following seas.

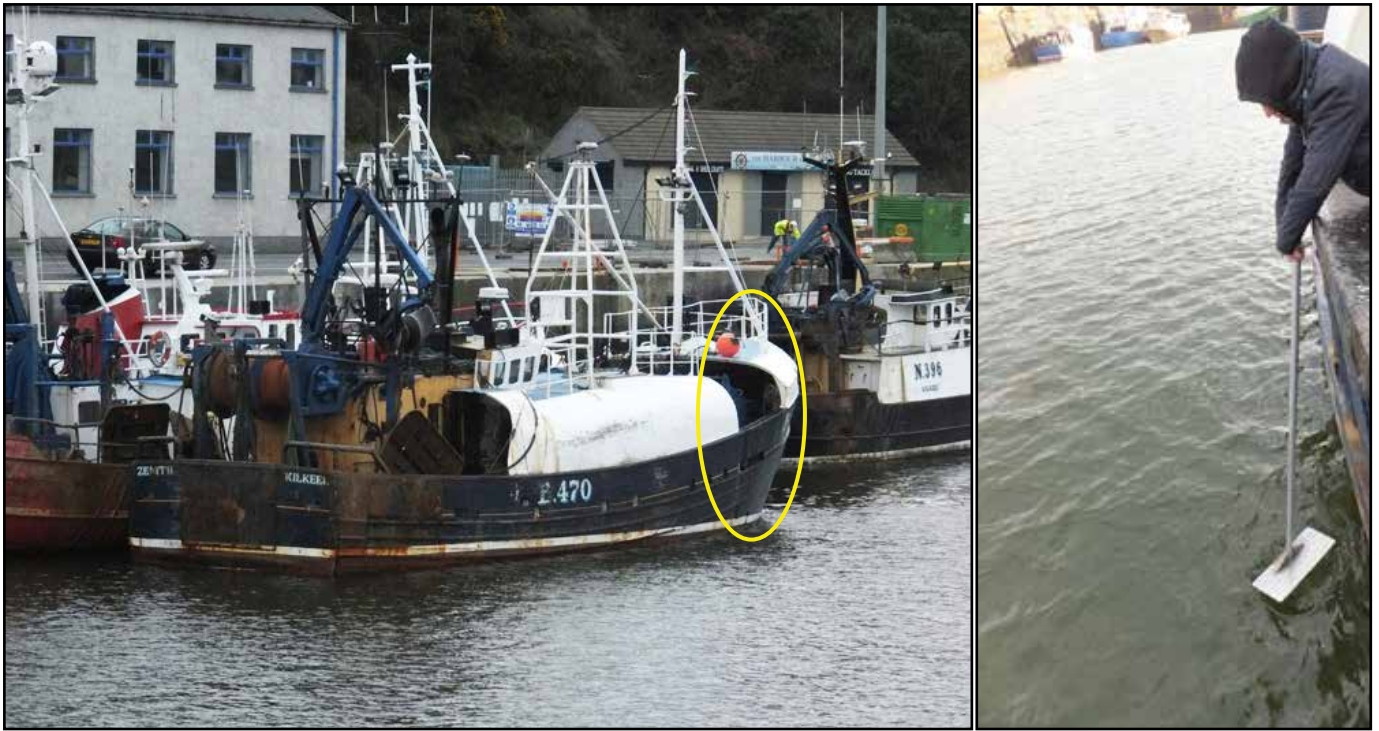
Figure 5: Showing the position where the casualty was taken alongside and the implement used to attempt to retain him alongside

- The life-ring thrown to Mr Nedoliz was missing a lanyard, so would not have enabled him to have been pulled back alongside had he been able to reach it.
- The vessel was not equipped with a boat hook or any other means of holding an incapacitated casualty alongside.
- There was no plan for the recovery of either a conscious or an incapacitated casualty from the water.
- The vessel had been equipped with *Lalizas* MOB retrieval equipment some 8 years earlier, but the skipper or crew were not aware the equipment was on board.

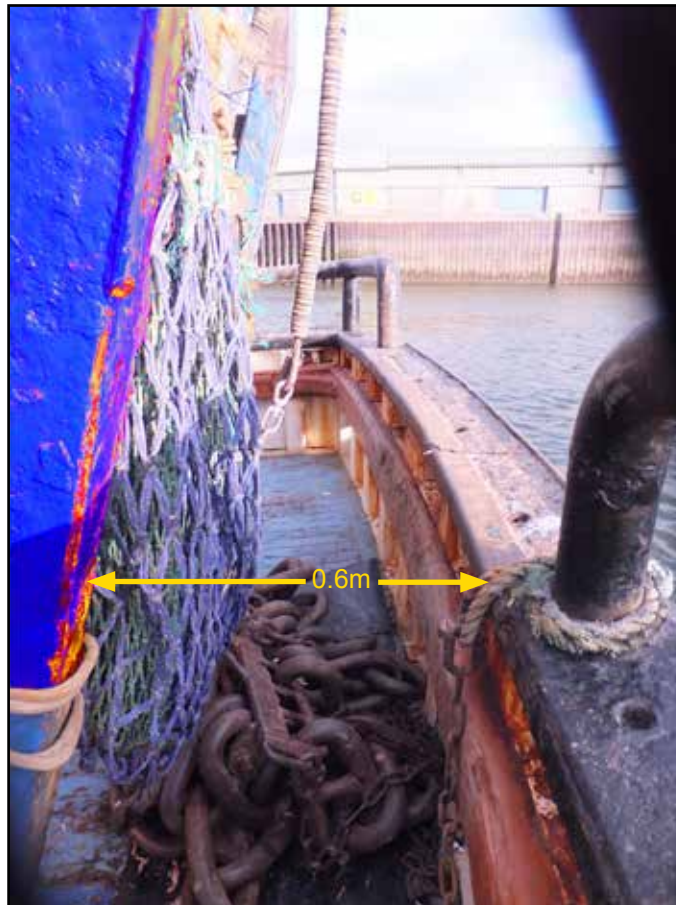
Figure 6: Showing distance between net drum supporting legs and transom = 0.6m

In 1996, two of her current owners acquired the vessel, renamed her *Antares*, and converted her to twin-rig stern trawling. This major conversion included replacing the seine net winch with a much heavier trawl winch, the construction of outrigger type trawl gallows, and the installation of a double net drum. Due to the reduced area of the aft deck resulting from the 1987 deckhouse extension, there was no room to place the net drum on the aft deck, so it was suspended from the aft side of the deckhouse above head level. This left about 0.6m between the net drum's supporting legs and the transom bulwark (**Figure 6**). The owners did not inform the MCA of this major modification, as required by The Fishing Vessels (Safety Provisions) Rules 1975, and they did not have the vessel's stability re-assessed.

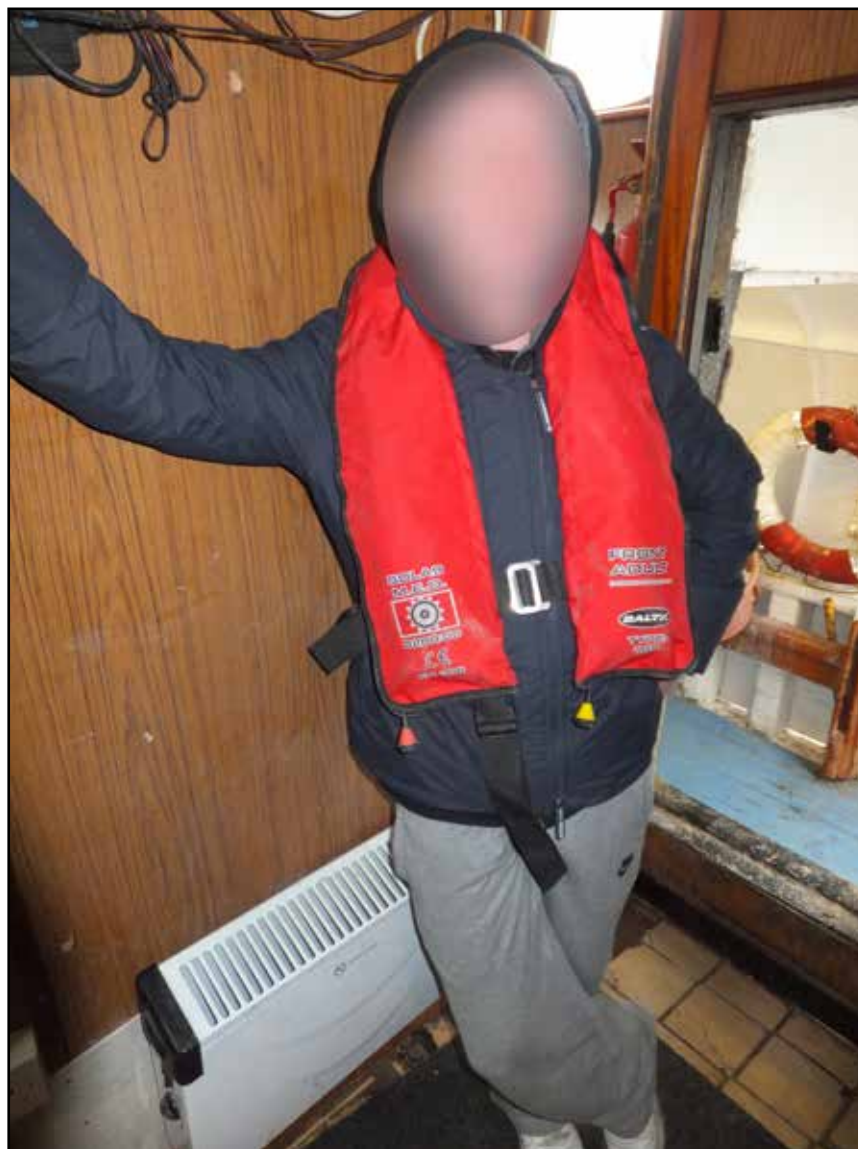
Figure 8: Inflatable lifejackets which were available onboard *Zenith*

Zenith's owners did provide her crew with readily available constant wear inflatable lifejackets (**Figure 8**), but these were seldom worn by her crew and were not worn by Mr Nedoliz.

6. *Zenith's* owners made inflatable lifejackets readily available, but crew members were not obliged to wear them. [2.9]
7. Until the wearing of PFDs becomes a legal requirement, the owners of *Zenith* should set their own standards and insist on the wearing of PFDs or safety harnesses on external decks where there is a risk of falling or being carried overboard. [2.9]

In the absence of such a legal requirement, the owners of *Zenith* and all other fishing vessels should set their own standards, and insist on the wearing of PFDs, or safety harnesses and lanyards, on external decks where there is a risk of falling or being carried overboard.
