Report on the investigation of
the loss of a crewman from the fishing vessel

***St Amant* (BA 101)**

off the coast of north-west Wales

on 13 January 2012

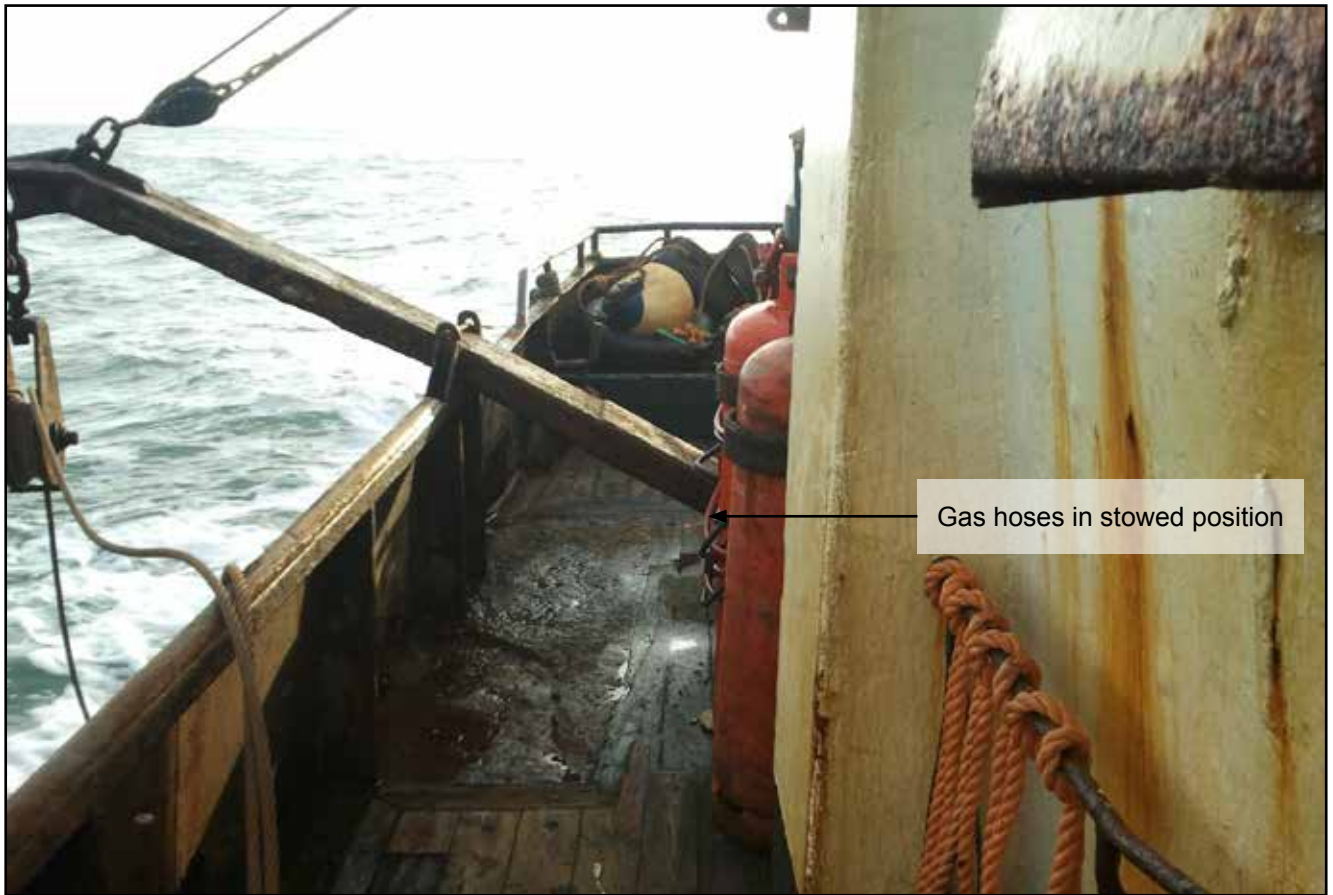
Figure 4a: Starboard outrigger in the deployed position looking aft, soon after the accident

Gas hoses in stowed position

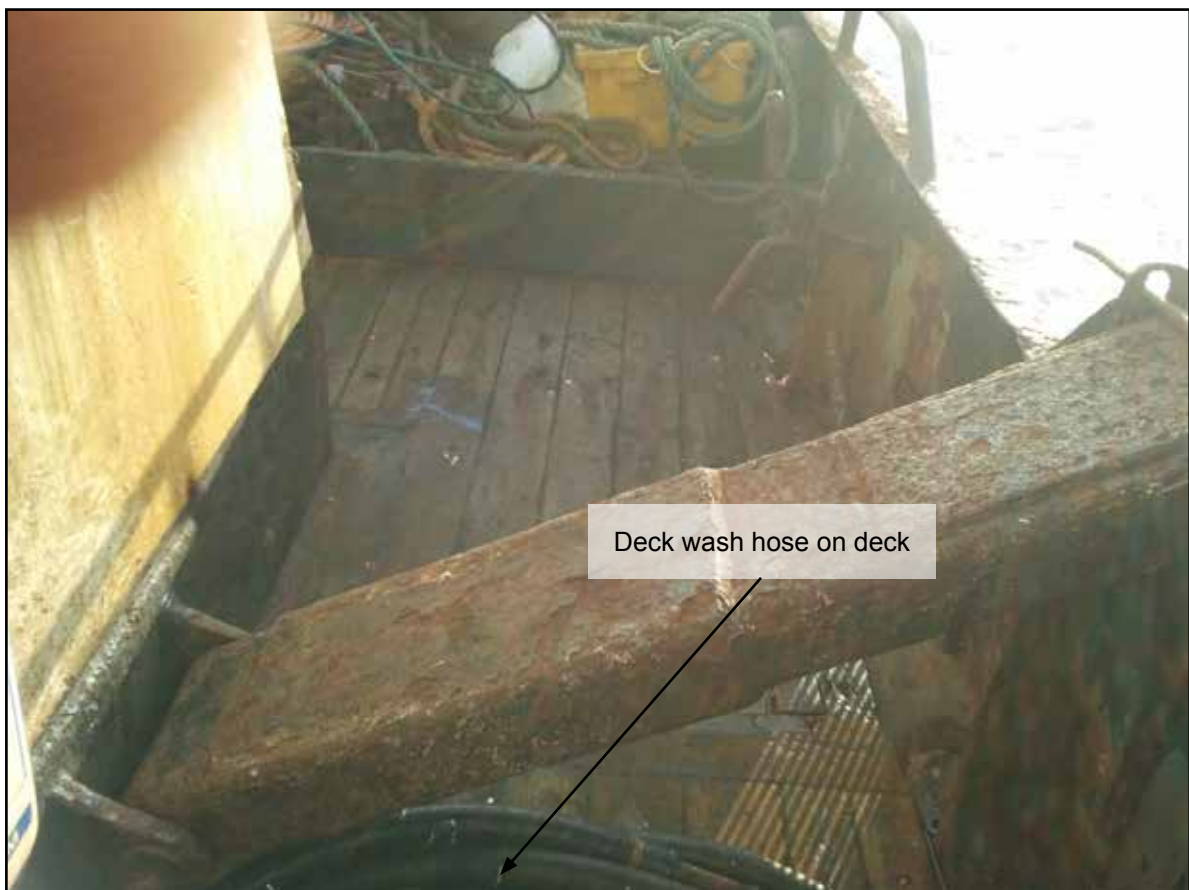
Figure 4b: Port outrigger in the deployed position looking aft, soon after the accident

Deck wash hose on deck

As *St Amant* was on passage at the time of the accident, the dredging gear was stowed on deck (**Figure 9**). Various items of equipment were also on deck, including a spare dredge and the deck wash hose on the port side deck area, that created trip hazards in the passageway outboard of the superstructure (**Figure 10**). It was also evident during the investigation that gas hoses for the vessel’s welding and burning equipment would trail across the deck if not stowed carefully (**Figure 4a**). Several ropes were kept in the aft stowage area, any one of which could have fallen onto the deck causing a trip hazard (**Figure 4b** and **Figure 10**).

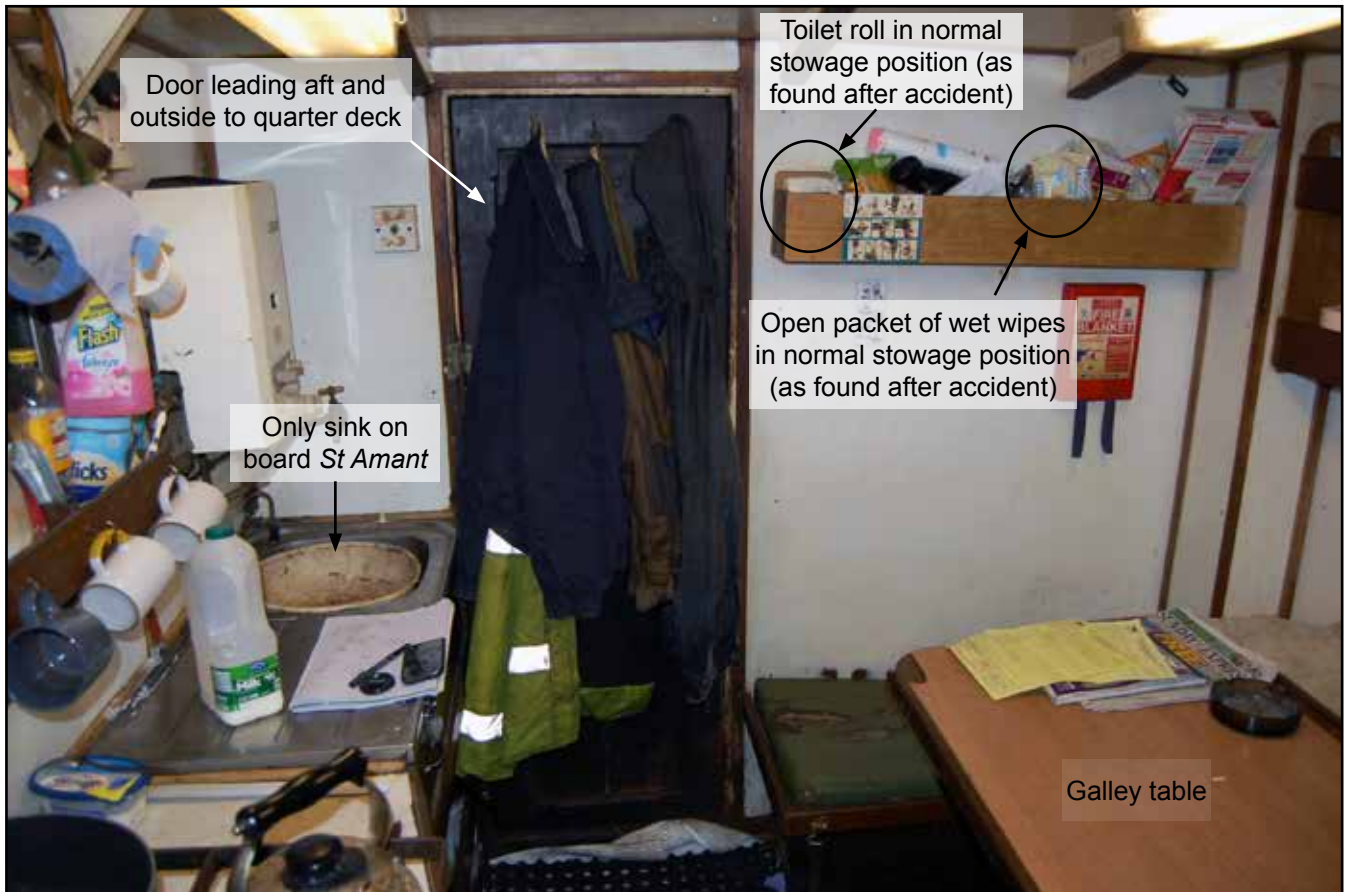
Figure 5a: Galley/mess area on *St Amant* looking aft

At about 0145, the mate left the wheelhouse to make a cup of tea. There was no one in the galley/mess, and the aft door leading out onto the quarter deck (**Figure 5a**) was closed; he assumed that all the crew were resting down below.

A toilet roll and a packet of wet wipes were normally stowed on the shelf by the galley/mess door. These were in their normal position when Steven was discovered missing (**Figure 5a**).

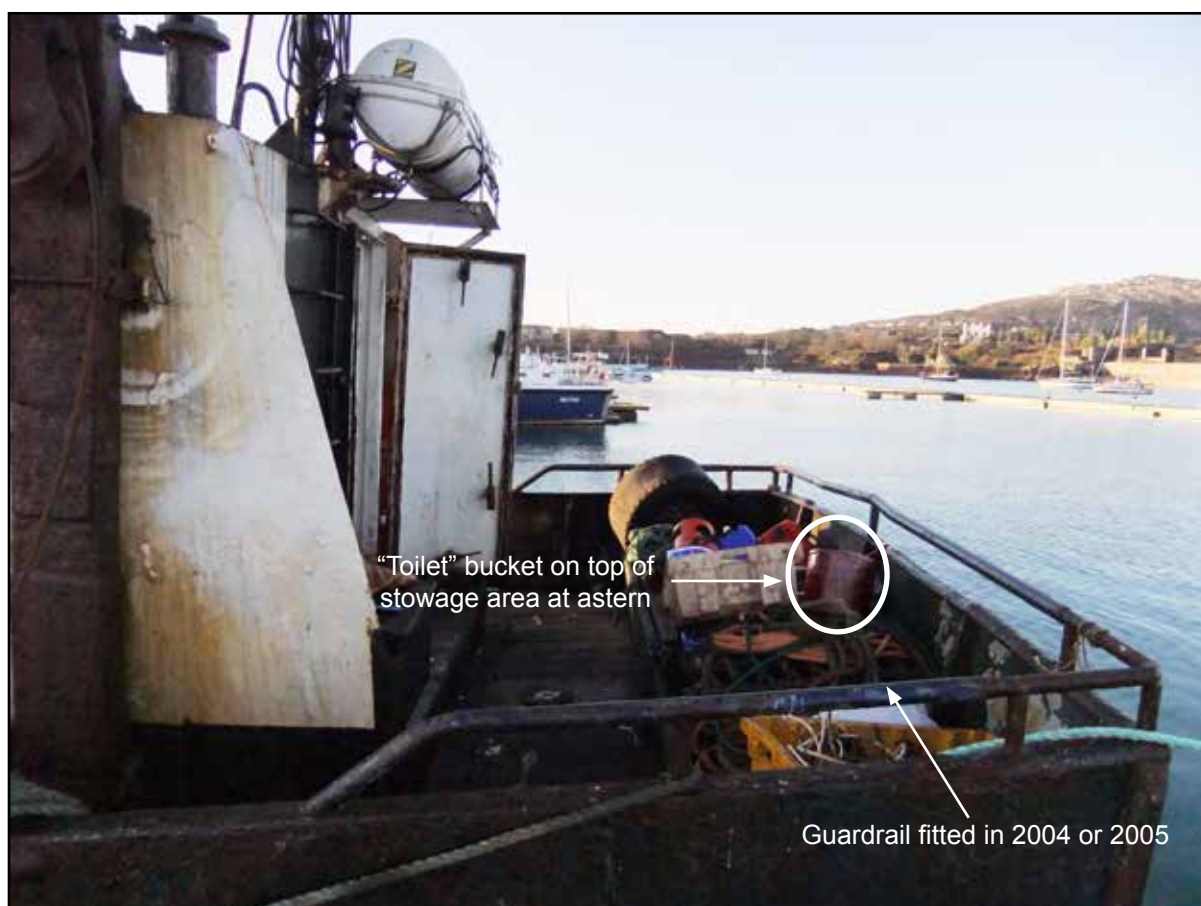
A basic chemical toilet, incorporating a bucket with an attached toilet seat, was reported to have been previously kept in the fish hold. However, at the time of the accident, the crew either relieved themselves overboard or into an ordinary bucket which was kept on top of the storage area at the stern (**Figure 11**). If the bucket was required, the accepted procedure on board was to use it on the open deck at the stern. However, if the weather was poor, crewmen would take the bucket down into the fish hold, where the catch of scallops and fresh provisions were stored, to provide more shelter. Steven was reported to have preferred to use the bucket. Others opted to sit over the side, partially supporting themselves on the outrigger (**Figures 12a and b**). The bucket was in its normal position when Steven was discovered missing.

Figure 11: "Toilet" bucket at storage area at the stern

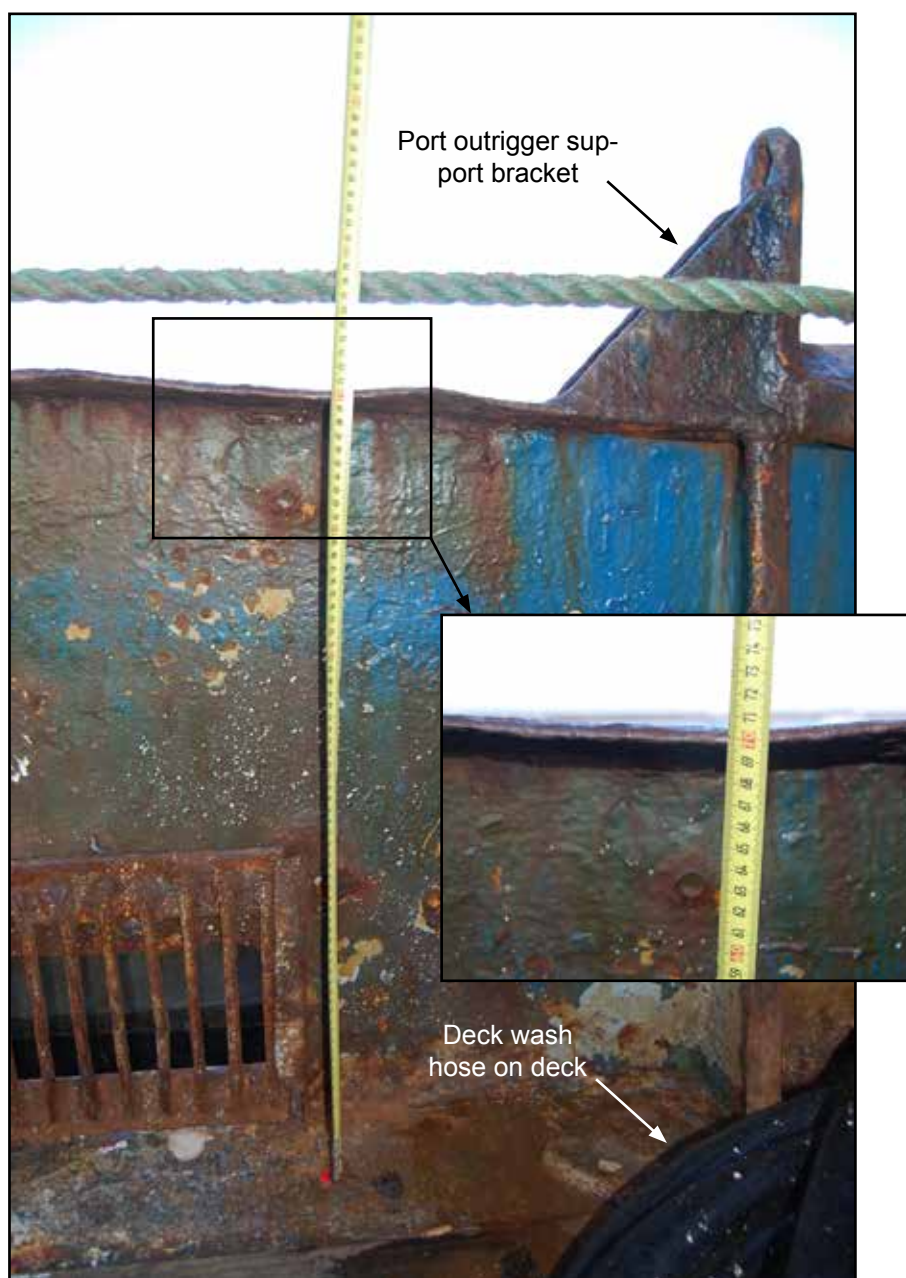
The repair work specification following the fire in 1984 included the renewal of approximately 12m of bulwarks on either side to provide 736mm high bulwarks; no reference to guard wires was included in this specification. At the time of this accident, there was no provision for guard wires on board *St Amant*. At their lowest point, aft of the outrigger support brackets, the bulwarks were 700mm high (**Figure 14**). Forward of the outriggers, the bulwarks were 770mm high, increasing to 840mm in the forward part of the working deck, just aft of the whaleback.

Figure 14: Lowest point of bulwarks, aft of outrigger

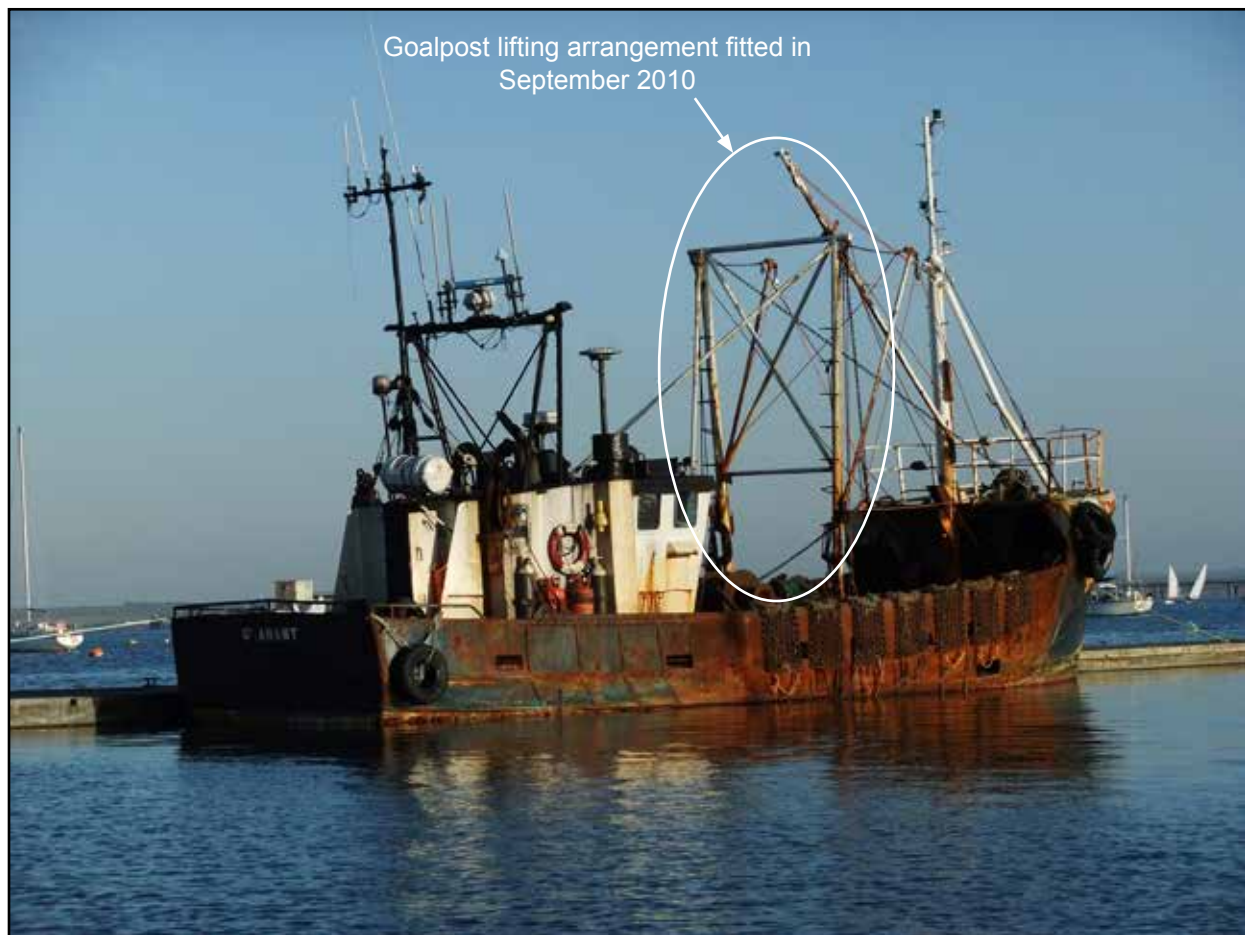
In early September 2010, the MCA became aware of modifications being made to *St Amant*'s lifting equipment: a new ‘goalpost’ type arrangement for the dredging gear was being fitted (**Figure 16b**) to replace the previous single lifting pole (**Figure 16a**). The MCA wrote to the skipper requesting that details of the modification be forwarded for approval.

During an MCA inspection on 29 September 2010, an action code 16 deficiency (requiring rectification within 14 days) was raised for details of these modifications to be forwarded to the Marine Office. There was no record on the CM files or SIAS (**Annex J**) of this deficiency being followed up.

Figure 16b: Lifting arrangement on *St Amant* after modification in 2010
