## Manoverboard during cargo operations **DETTE G**

**Queen Elizabeth Dock, Hull  
16 January 2012**

### SUMMARY

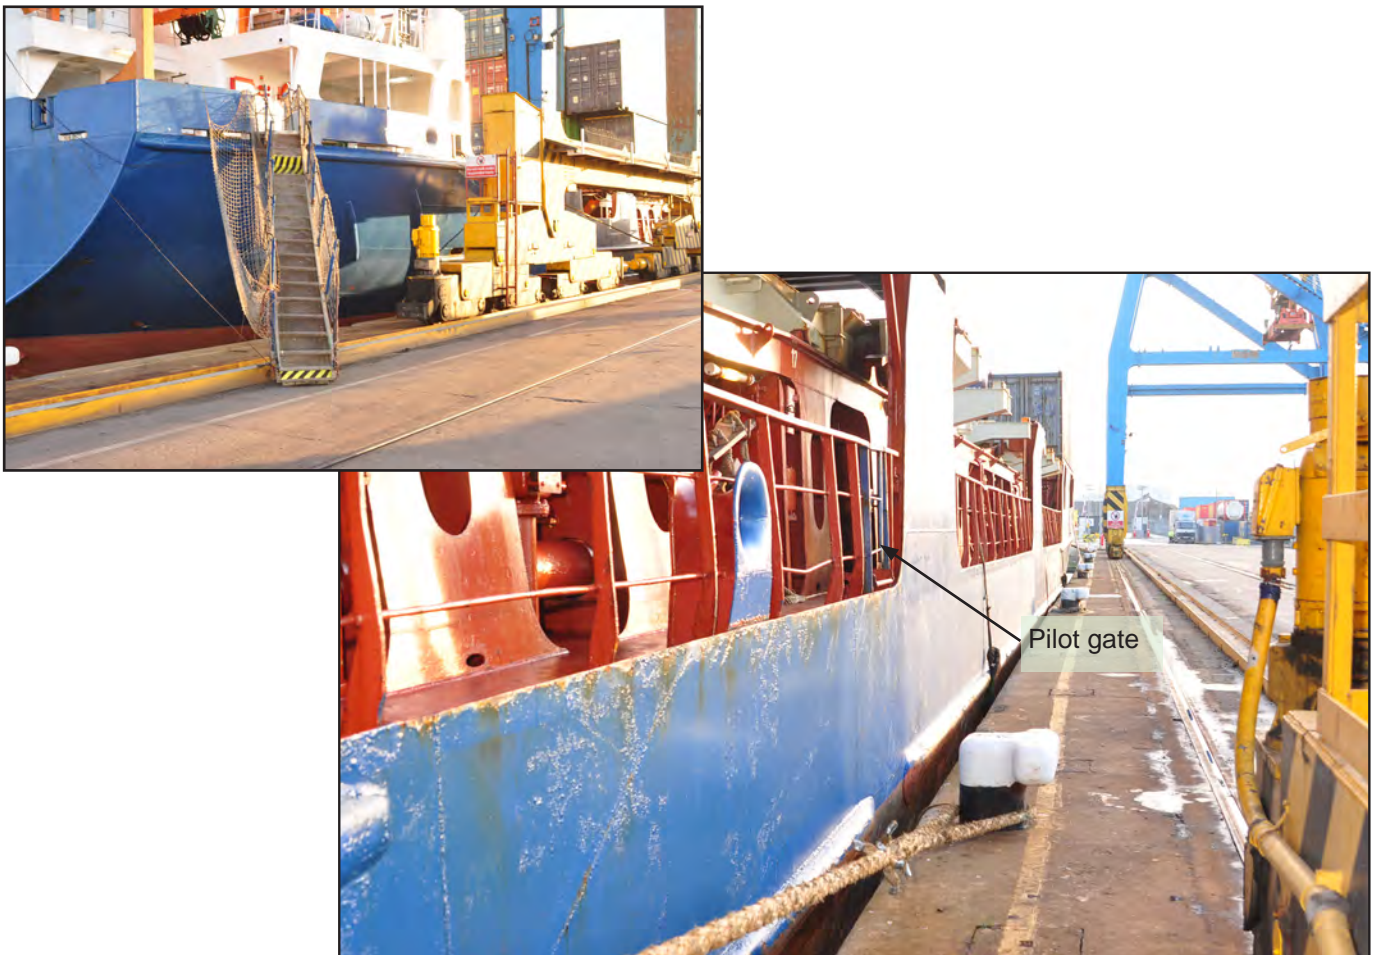
**Figure 1:** *Dette G* alongside Hull container terminal

At 2040 (UTC) on 16 January 2012, *Dette G* moored starboard side to alongside PD Ports' container terminal in the Queen Elizabeth Dock, Hull. The 3999gt vessel was close to the quay wall with only small rope fenders protecting the ship's side (**Figure 1**). A gangway was rigged from the vessel's aft deck to provide a means of access. It was a cold, clear and still night.

*Dette G's* accommodation ladder (**Figure 1**) was properly secured and was fitted with a safety net. The ladder was rigged to meet the requirements of The Merchant Shipping (Means of Access) Regulations 1988 and the Code of Safe Working Practices for Merchant Seamen (CoSWP), which apply to all merchant vessels in UK ports. The pilot gate did not and, notwithstanding the ergonomic advantages it afforded to the crew working on deck, it should not have been used as a means of access alongside. Although PD Ports had recognised the risks associated with the use of unauthorised means of access combined with vessel movement during cargo operations, the vessel's manager and crew clearly had not. The onboard risk assessment covering cargo operations was scant, and it is not surprising that a complacent attitude towards the use of the pilot gate had developed among at least some of the crew.

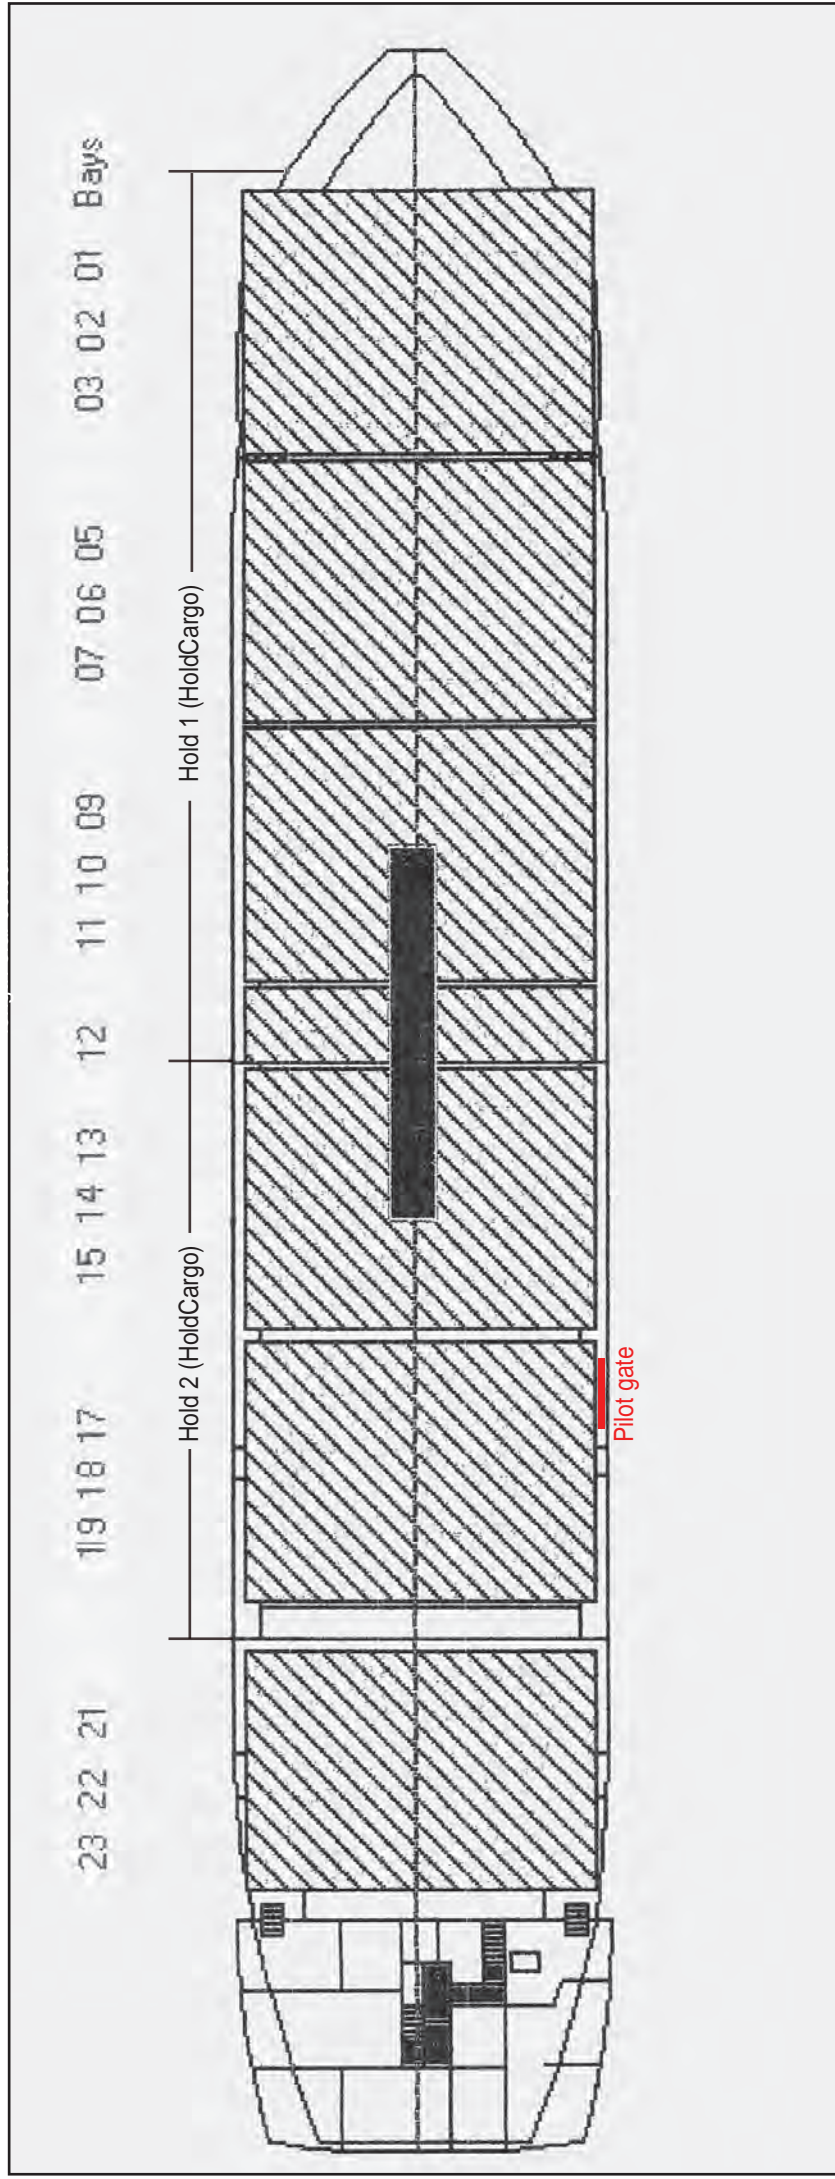
Figure 2: Hold and container bay configuration

The vessel's cargo of 171 containers was loaded in the holds, and on deck in bays 2, 6, 10, 14, 18 and 22 (**Figure 2**). The containers were stacked four tiers high in bay 22 and three tiers high in bays 6, 10, 14 and 18 with each tier containing seven containers. Bay 2 was loaded with one tier of three containers. The vessel's draught was 6.3m aft and 5.7m forward.

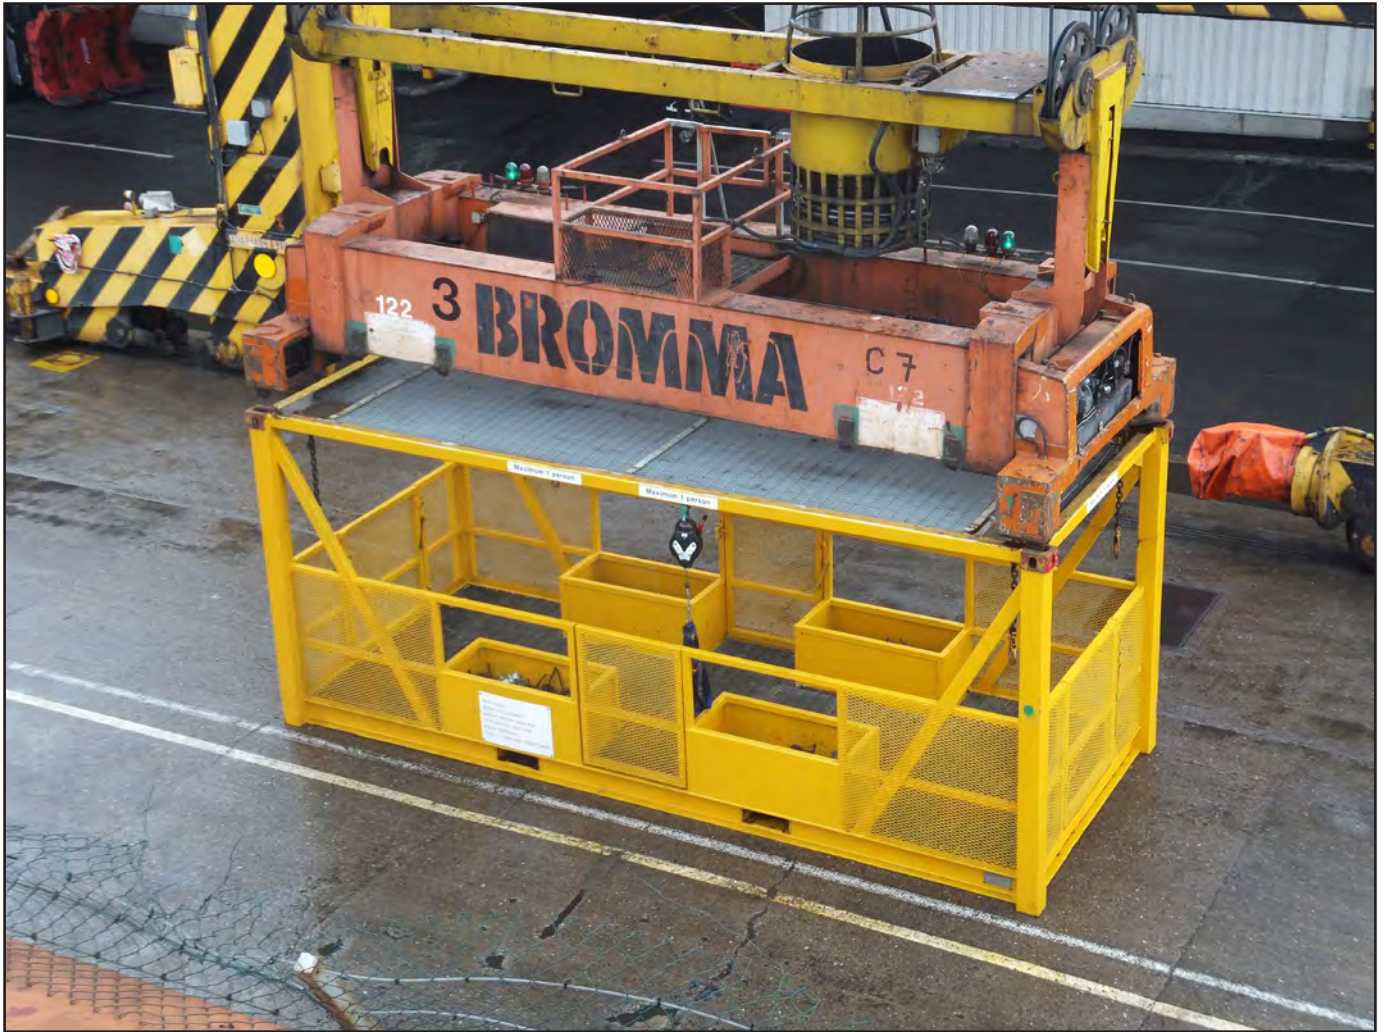
Figure 3: Man-basket

At 2115, discharge of bay 14 was commenced using one of three shore cranes that were available. Working on the deck, which was very well lit, were an AB, Anton Trofimov, and an ordinary seaman (OS). The ratings were responsible for releasing the semi-automatic twistlocks securing the containers. They also had to remove the twistlocks from the top of the container stack after each tier had been discharged. To achieve this task, the ratings were transported between the quay and the top of the container stacks in a man-basket (**Figure 3**), which was lifted by crane, and was equipped with fall arrest devices and safety harnesses.

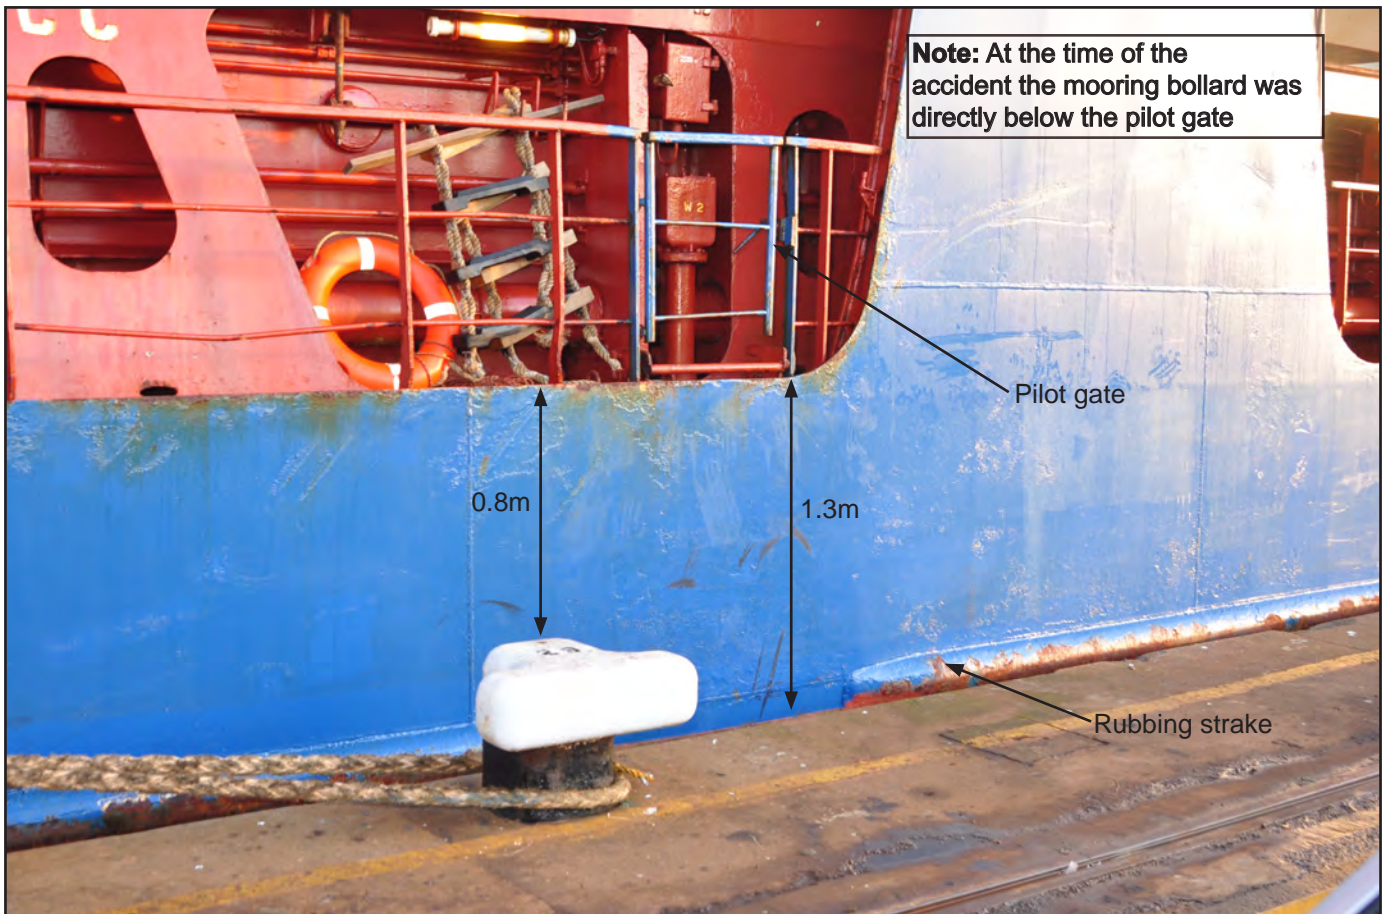
Figure 4: Pilot gate

At the time of the accident, *Dette G* was on an even keel with a mean draught of 5.35m. The vessel's main deck was 1.3m above the quay and 0.8m above the top of a quayside bollard positioned directly beneath the gate (the photograph shown in **Figure 4** was taken after the vessel had been moved). The paint on the bollard was in good condition. A break in the hull's rubbing strake was sited below the pilot gate. Although the accommodation ladder was the only authorised means of access to and from the vessel when moored alongside, the pilot gate was occasionally used by the vessel's crew.

- The 0.8m drop from the deck to the top of the bollard.
- The painted surface of the bollard below the pilot gate was likely to have been slippery, particularly in the freezing temperature.
- The vessel's movement following the discharge of the last container remaining on the upper tier of bay 6.

As Anton fell between the ship and the quay, it is clear that *Dette G*'s movement during cargo operations had caused the gap between the ship and the quay to widen to at least 50cm, particularly in the vicinity of the pilot gate where there was a break in the rubbing strake (**Figure 4**). Furthermore, the vessel's continued movement, which brought her back towards the quay, prevented Anton's immediate recovery from the water.

However, as the discharge of the cargo progressed and *Dette G's* freeboard increased, the use of the pilot gate as a means of access became more dangerous. Notably, the height of the deck above the bollard increased to 80cm as the containers were discharged, and the vessel would have started to rock from side to side and to oscillate towards and away from the quay as the containers were lifted.

- Issued a circular to all its vessels emphasising that crew must only use the gangway provided as a means of access on and off the vessel.
- Instructed its masters that pilot gates must remain closed other than when embarking or disembarking a pilot.
- Provided additional working lifejackets for use by crew working on deck.
- Advised its masters to conduct further training in man overboard.
