## Manoverboard during cargo operations **DETTE G**

**Queen Elizabeth Dock, Hull  
16 January 2012**

### SUMMARY

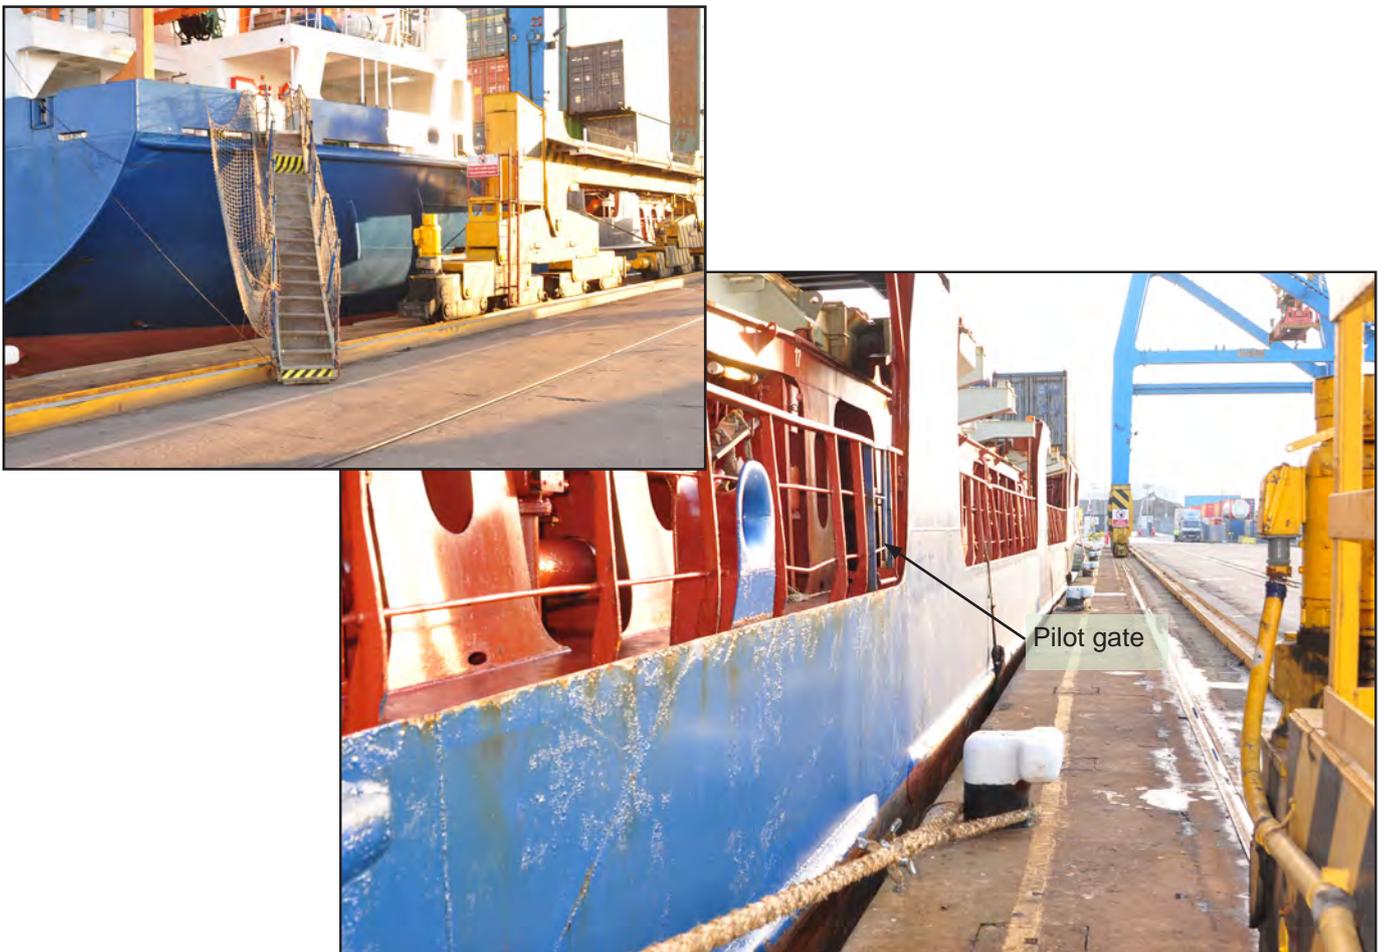
At 2040 (UTC) on 16 January 2012, *Dette G* moored starboard side to alongside PD Ports' container terminal in the Queen Elizabeth Dock, Hull. The 3999gt vessel was close to the quay wall with only small rope fenders protecting the ship's side (**Figure 1**). A gangway was rigged from the vessel's aft deck to provide a means of access. It was a cold, clear and still night.

**Figure 1:** *Dette G* alongside Hull container terminal

*Dette G's* accommodation ladder (**Figure 1**) was properly secured and was fitted with a safety net. The ladder was rigged to meet the requirements of The Merchant Shipping (Means of Access) Regulations 1988 and the Code of Safe Working Practices for Merchant Seamen (CoSWP), which apply to all merchant vessels in UK ports. The pilot gate did not and, notwithstanding the ergonomic advantages it afforded to the crew working on deck, it should not have been used as a means of access alongside. Although PD Ports had recognised the risks associated with the use of unauthorised means of access combined with vessel movement during cargo operations, the vessel's manager and crew clearly had not. The onboard risk assessment covering cargo operations was scant, and it is not surprising that a complacent attitude towards the use of the pilot gate had developed among at least some of the crew.

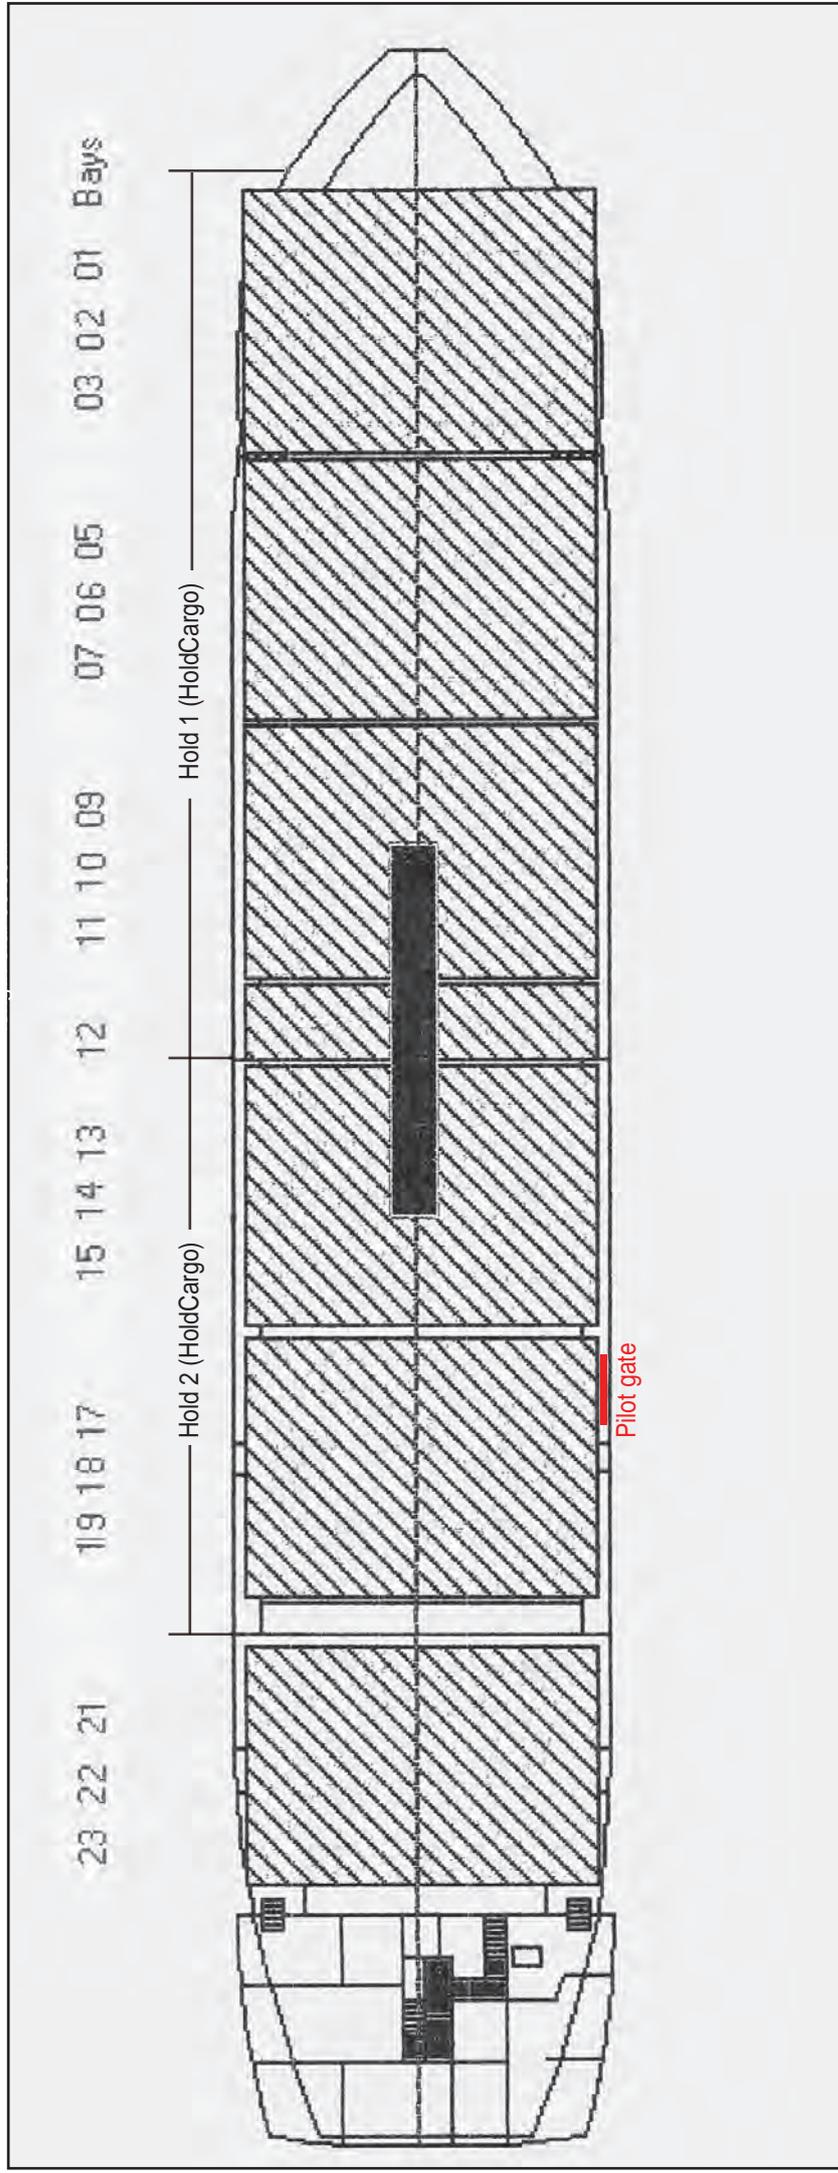
The vessel's cargo of 171 containers was loaded in the holds, and on deck in bays 2, 6, 10, 14, 18 and 22 (**Figure 2**). The containers were stacked four tiers high in bay 22 and three tiers high in bays 6, 10, 14 and 18 with each tier containing seven containers. Bay 2 was loaded with one tier of three containers. The vessel's draught was 6.3m aft and 5.7m forward.

Figure 2: Hold and container bay configuration

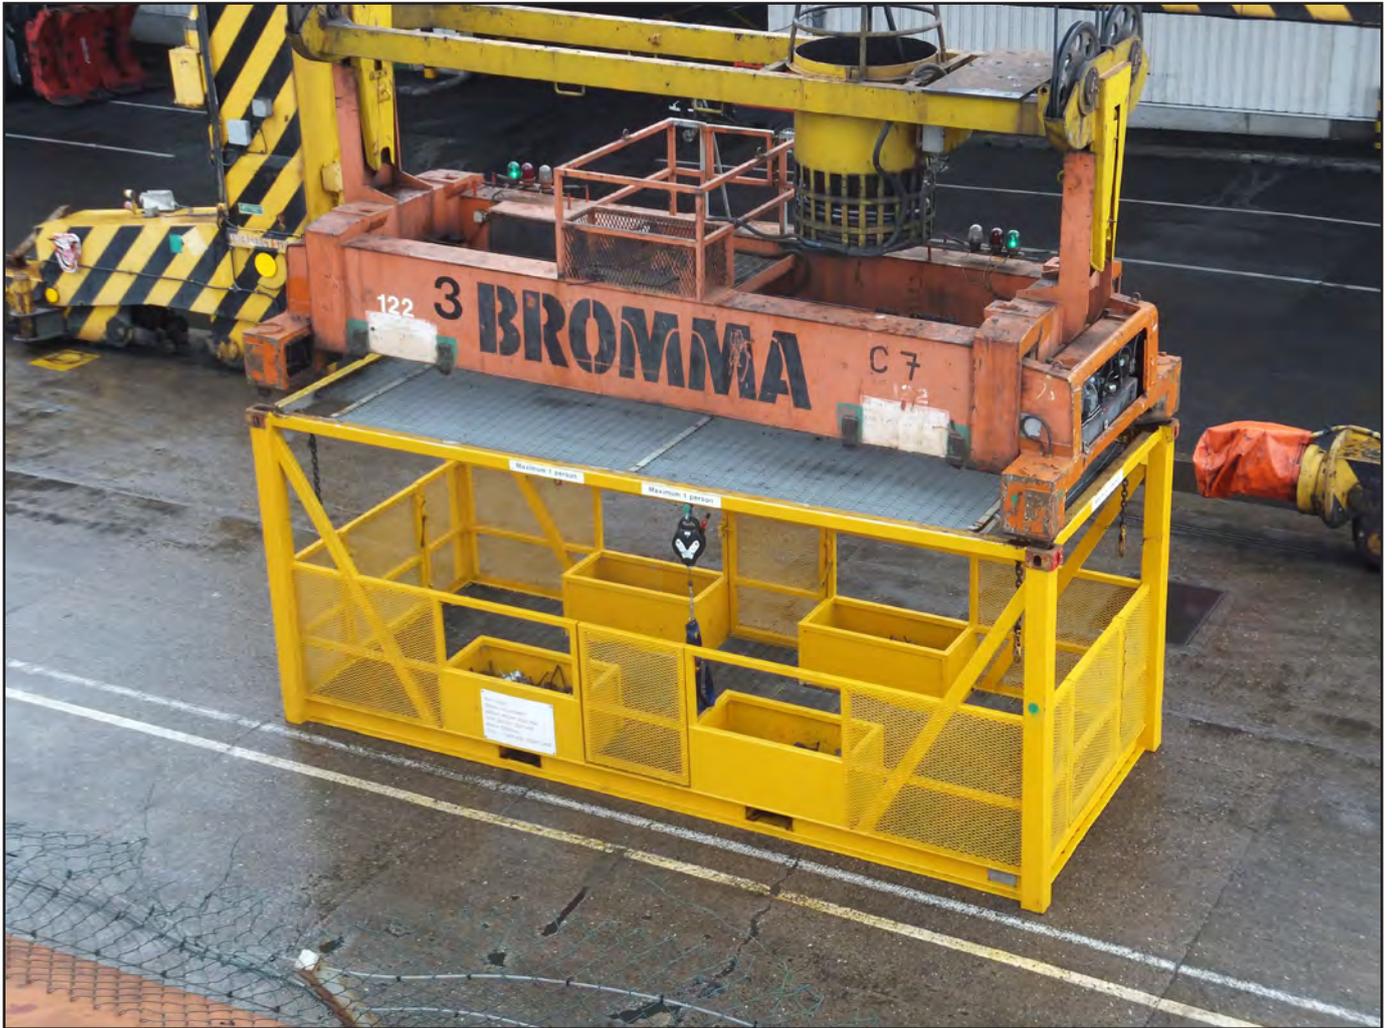
At 2115, discharge of bay 14 was commenced using one of three shore cranes that were available. Working on the deck, which was very well lit, were an AB, Anton Trofimov, and an ordinary seaman (OS). The ratings were responsible for releasing the semi-automatic twistlocks securing the containers. They also had to remove the twistlocks from the top of the container stack after each tier had been discharged. To achieve this task, the ratings were transported between the quay and the top of the container stacks in a man-basket (**Figure 3**), which was lifted by crane, and was equipped with fall arrest devices and safety harnesses.

Figure 3: Man-basket

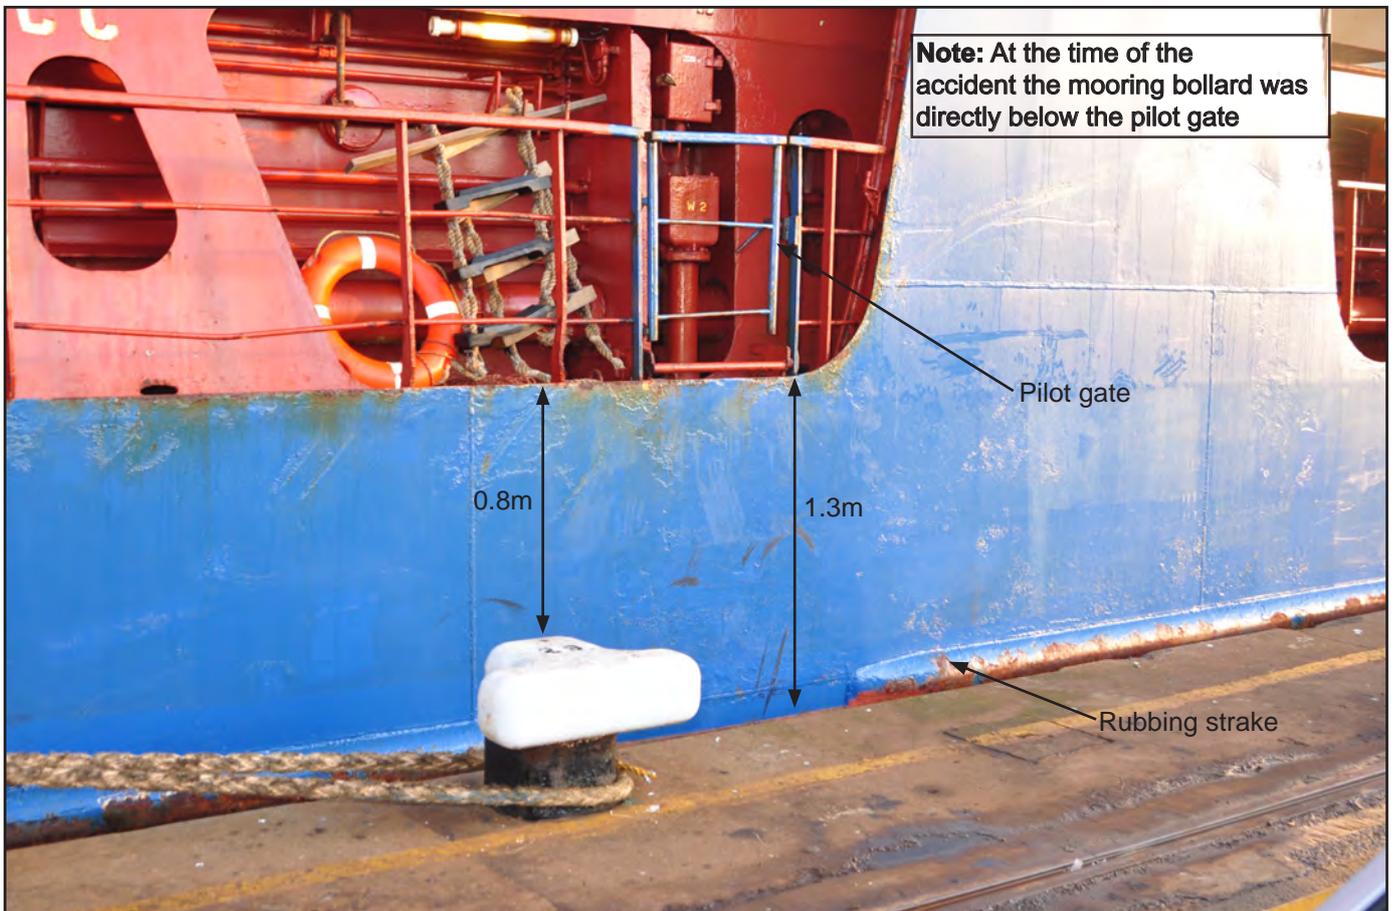
At the time of the accident, *Dette G* was on an even keel with a mean draught of 5.35m. The vessel's main deck was 1.3m above the quay and 0.8m above the top of a quayside bollard positioned directly beneath the gate (the photograph shown in **Figure 4** was taken after the vessel had been moved). The paint on the bollard was in good condition. A break in the hull's rubbing strake was sited below the pilot gate. Although the accommodation ladder was the only authorised means of access to and from the vessel when moored alongside, the pilot gate was occasionally used by the vessel's crew.

Figure 4: Pilot gate

- The 0.8m drop from the deck to the top of the bollard.
- The painted surface of the bollard below the pilot gate was likely to have been slippery, particularly in the freezing temperature.
- The vessel's movement following the discharge of the last container remaining on the upper tier of bay 6.

As Anton fell between the ship and the quay, it is clear that *Dette G's* movement during cargo operations had caused the gap between the ship and the quay to widen to at least 50cm, particularly in the vicinity of the pilot gate where there was a break in the rubbing strake (**Figure 4**). Furthermore, the vessel's continued movement, which brought her back towards the quay, prevented Anton's immediate recovery from the water.

However, as the discharge of the cargo progressed and *Dette G's* freeboard increased, the use of the pilot gate as a means of access became more dangerous. Notably, the height of the deck above the bollard increased to 80cm as the containers were discharged, and the vessel would have started to rock from side to side and to oscillate towards and away from the quay as the containers were lifted.

- Issued a circular to all its vessels emphasising that crew must only use the gangway provided as a means of access on and off the vessel.
- Instructed its masters that pilot gates must remain closed other than when embarking or disembarking a pilot.
- Provided additional working lifejackets for use by crew working on deck.
- Advised its masters to conduct further training in man overboard.
