Report on the investigation of the collision between

ACX Hibiscus

Hyundai Discovery

at 0756 local time on 11 December 2011

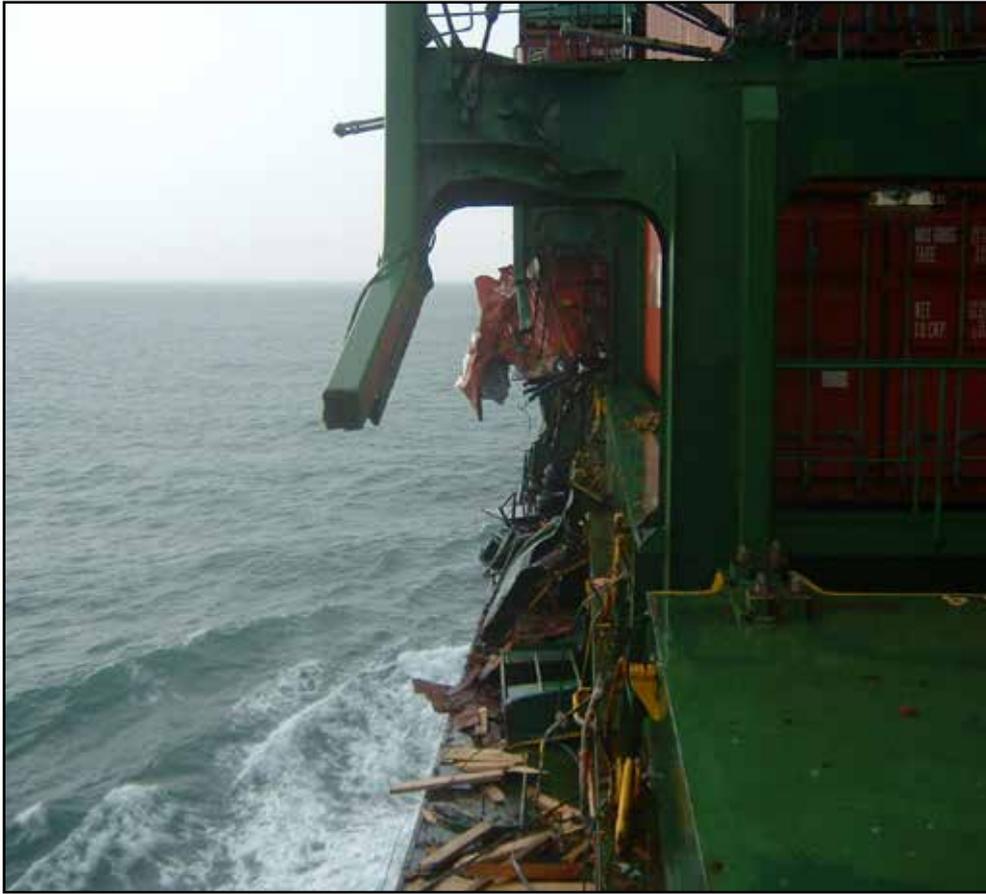
Figure 9: Environmental condition shortly after the collision

A picture taken soon after the collision shows the typical conditions at the time (**Figure 9**).

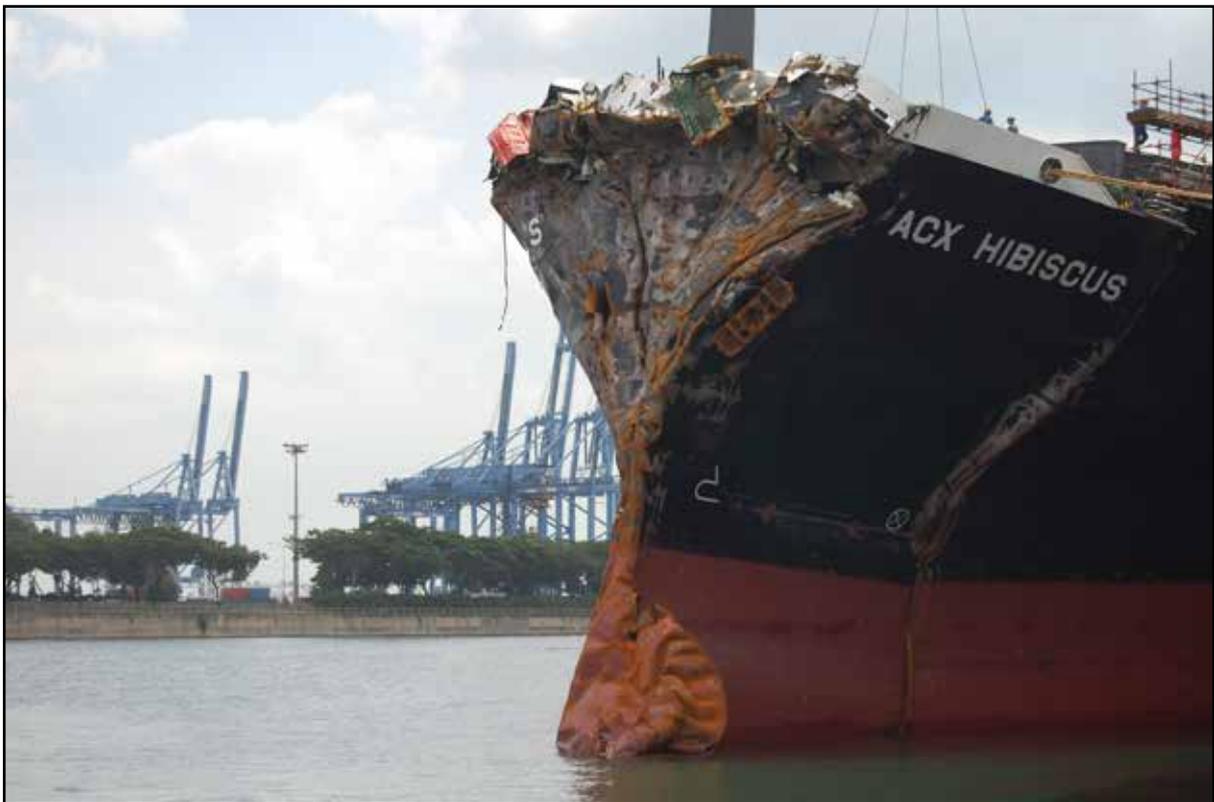
Figure 10: Damage to *ACX Hibiscus*'s bow

ACX Hibiscus sustained significant damage to its bow section (**Figure 10**). The forward mooring deck, chain locker, fore peak tank and bow thrust room were very heavily damaged. Both anchors were unusable. The collision bulkhead was breached and damage extended into the forward hold.

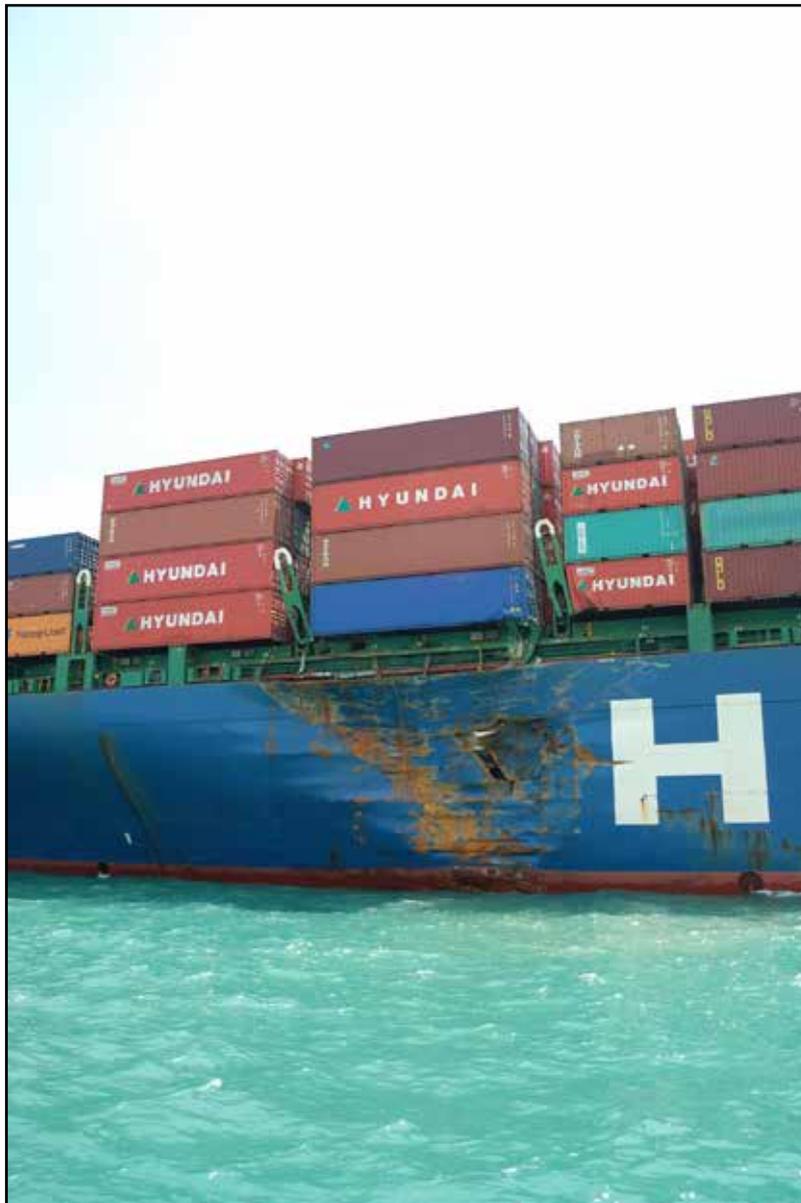
Figure 11: Damage to *Hyundai Discovery*'s port side No. 2 water ballast tank

Hyundai Discovery's hull was holed in No.2 water ballast wing tank, both above and below the waterline (**Figure 11**). No.2 hold port bulkhead was indented but remained watertight. Five, 40-foot long containers were lost overboard and several other 20 and 40-foot long containers and their securing arrangements were damaged. The port side of the vessel was indented along the length of the hull from No. 2 hold, aft to the accommodation where the port accommodation ladder and surrounding structure was heavily deformed (**Figure 12**).
