**Marine Weather Legal Report  
Vessel: MV SWANLAND**

MV *Swanland* Review of Structural History, Survey and Repair Records following the Structural Failure and Foundering on 27th November 2011, Braemar report, dated 31 May 2013

### REVIEW OF STRUCTURAL HISTORY, SURVEY AND REPAIR RECORDS FOLLOWING THE STRUCTURAL FAILURE & FOUNDING ON 27<sup>th</sup> NOVEMBER 2011

**Report No.: 312835.1R v3.5**  
**31<sup>st</sup> May 2013**

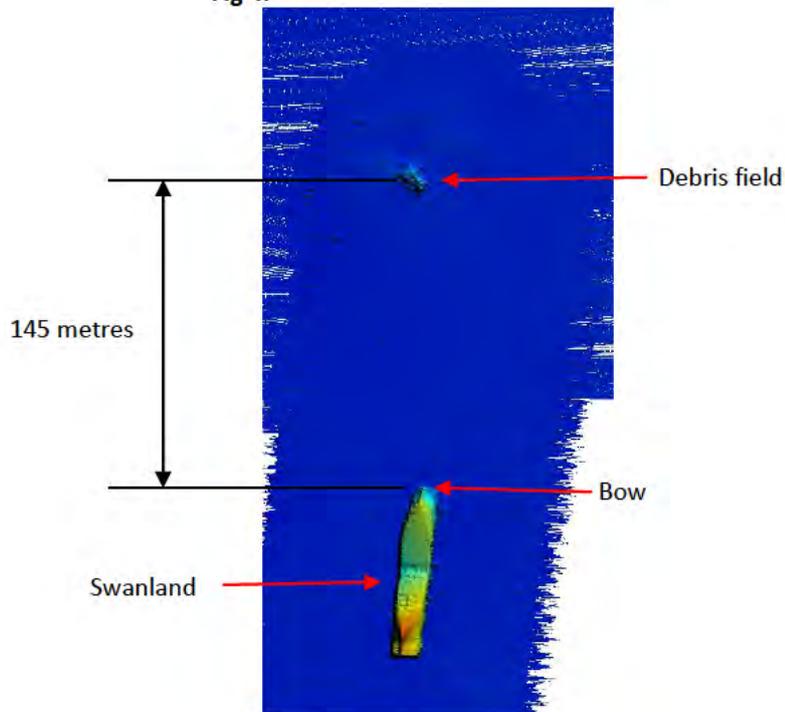
Fig 4. North

6. Debris field North of the Swanland - [Target North of the Swanland](#)  
**Co ordinates – Eastings 360012.8    Northings 5859951.7**  
This area of interest was found to be approximately 145 metres North of the Bow section. Debris field is illustrated in figure 4 above on page 5

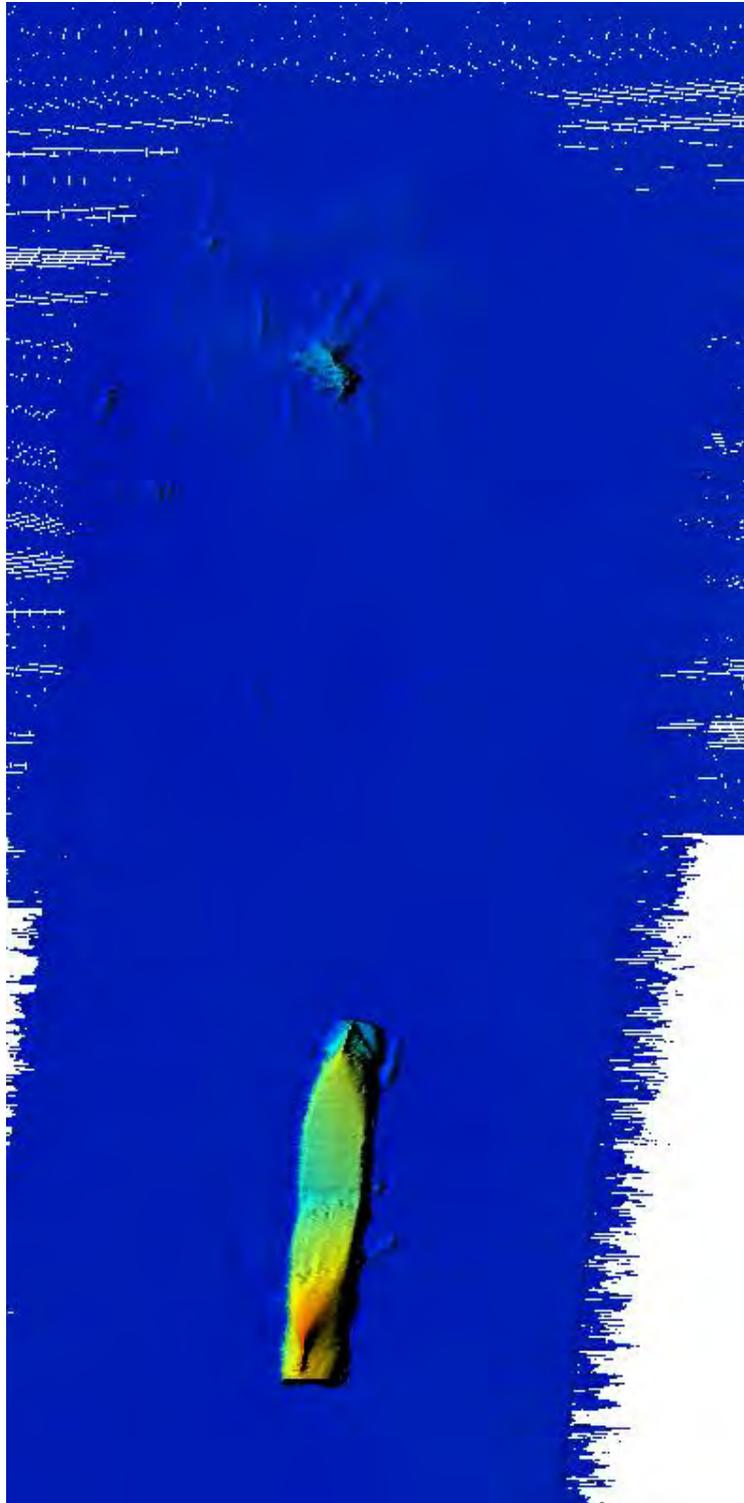
Figure 3 Swanland\_2D\_0.4m\_boundary

The image in Fig. 3 is displayed at a lower resolution of 0.4m, however a 0.2m deliverable is provided. It shows the location of the Swanland in relation to debris to its North. The debris was hypothesised to be a pile of the Swanland's cargo, limestone, covering a partially exposed hatch cover.

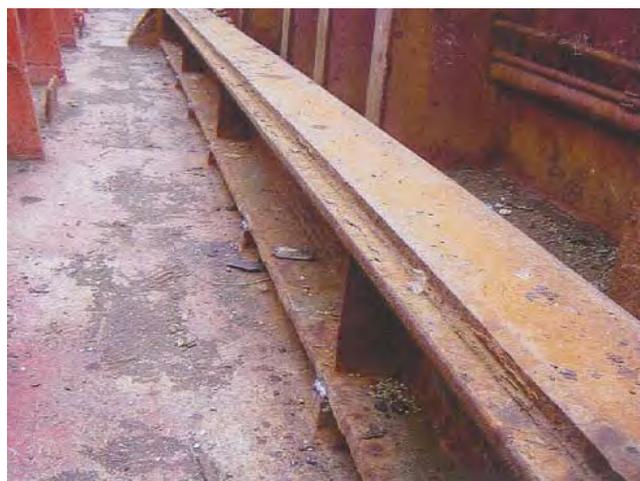
Figure 7 - Excavator Carriage Rail

5.1.12. In 2003, with the addition of the conveyor and hopper system to enable self-discharge, a moveable carriage was added to the main deck on which an excavator was situated. The carriage was moveable up and down the length of the hold on a rail located either side of the Port and Starboard longitudinal hatch coaming, approximately 300mm outboard of the coaming and slightly raised off the deck plate (see Figure 7 below). The date of the photograph in Figure 7 is not known, but the build up of scale and loose material can clearly be seen underneath the rail and in between the hatch coaming stays. As such areas become blocked or clogged, they can create water traps and over time, areas of localised corrosion. It is also notable that the welds joining the rail to the supports on the main deck are new, suggesting that the rail has torn away from the deck supports at some point, or that the previous welds had failed.

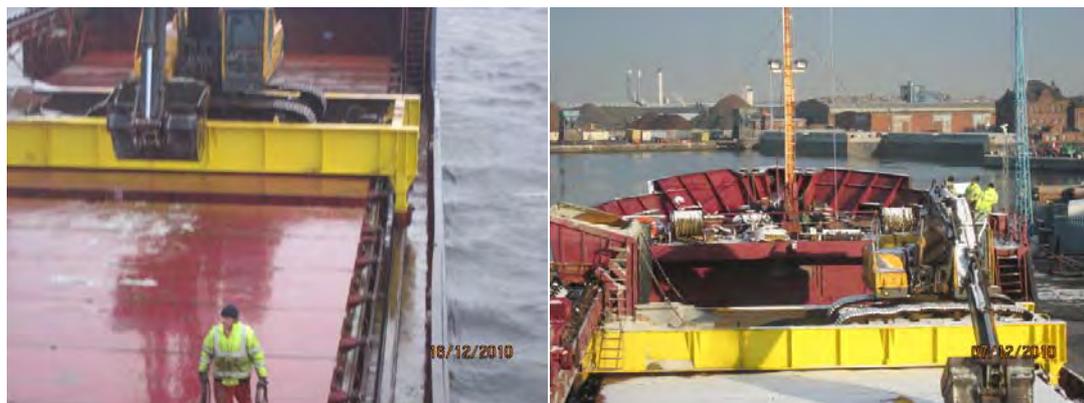
*Figure 9 – Operating Conditions during Period of Carrying Salt.*

- 5.3.7. Figure 9 below shows two photographs showing the conditions at the time with rain and snow and residual cargo on the vessel’s deck structure. It is likely that similar residual cargo and moisture existed in the hold enabling a period of potentially accelerated corrosion of the vessel’s structure.

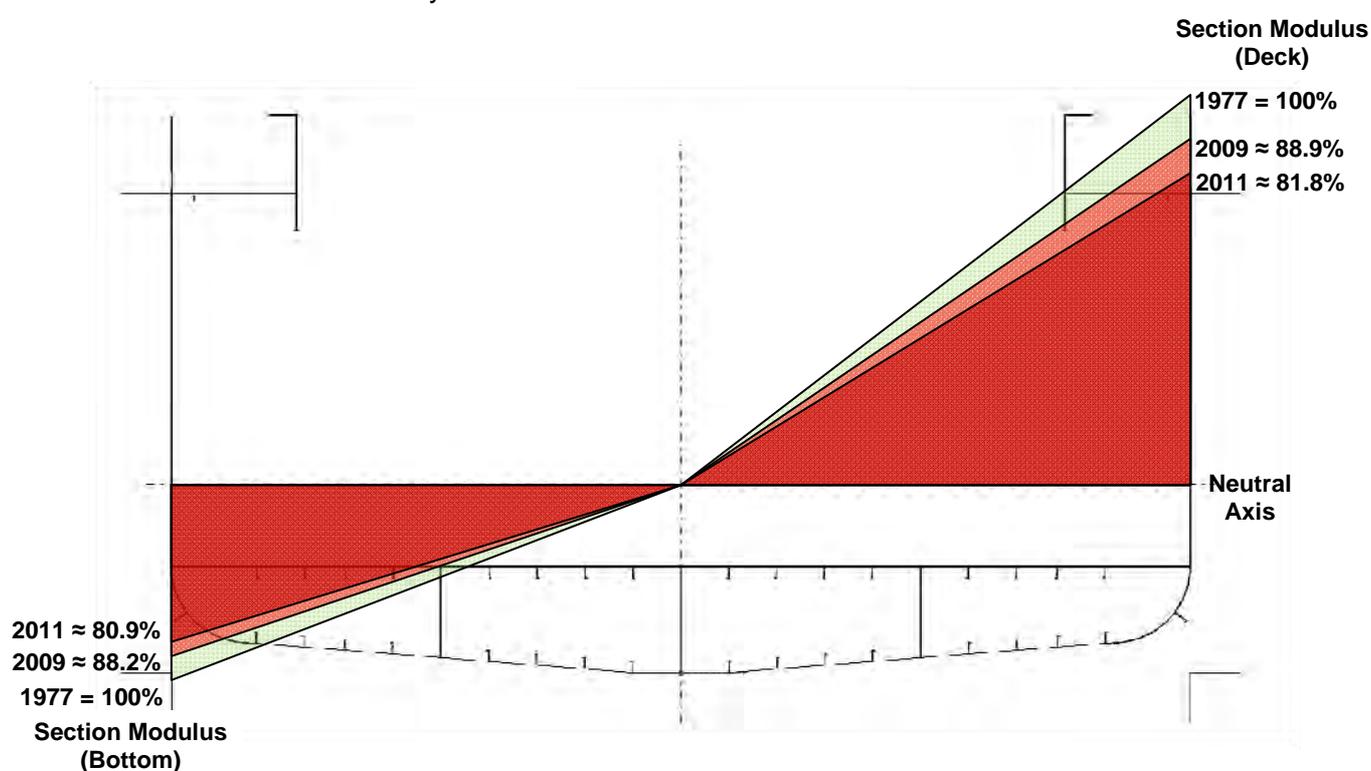
Figure 10 – Calculated Midship Section Modulus at Build, 2009 (post-repair) and at Time of Loss (frame 58)

An examination of the vessel's structural condition following the 2009 INSB survey was carried out as part of this investigation. Taking the Ultrasonic Thickness Measurements (UTM) report and applying standard Classification Society corrosion rates for the different structural elements plus cargo specific corrosion rates (in particular for the extended period of voyages carrying rock salt in wet conditions), estimates have been made of the midship (frame 58) Section Modulus of MV SWANLAND at the time of the sinking. This showed that significant parts of the vessel's structure would potentially have been sufficiently corroded to cause an overall reduction in Section Modulus of approximately 18% by November 2011.

5.3.21. Figure 10 below presents a schematic comparison of the Midships Section Modulus (Frame 58) at the time of build, in 2009 (post dry-dock) and at the time of the incident. The Section Modulus has been calculated based on the scantlings from the ‘as-built’ approved drawings and is assumed to be 100% at the time of build. From this, diminution of relevant plates and stiffeners is applied to determine an approximate section modulus value after the 2009 dry-docking<sup>12</sup> and an estimation of the value at the time of the accident (November 2011). The November 2011 section modulus value is determined using the 2009 UTM data and extrapolating this forward using Classification Society corrosion allowances for general corrosion (Ref. 4) and cargo specific data where it can be applied with reasonable certainty (Ref. 6). With regard to cargo specific corrosion, this was only applied for the periods carrying salt cargoes, where we can make reasonable assumptions on the conditions in which it was carried. No allowance was made for grooving or pitting corrosion from any other sources.

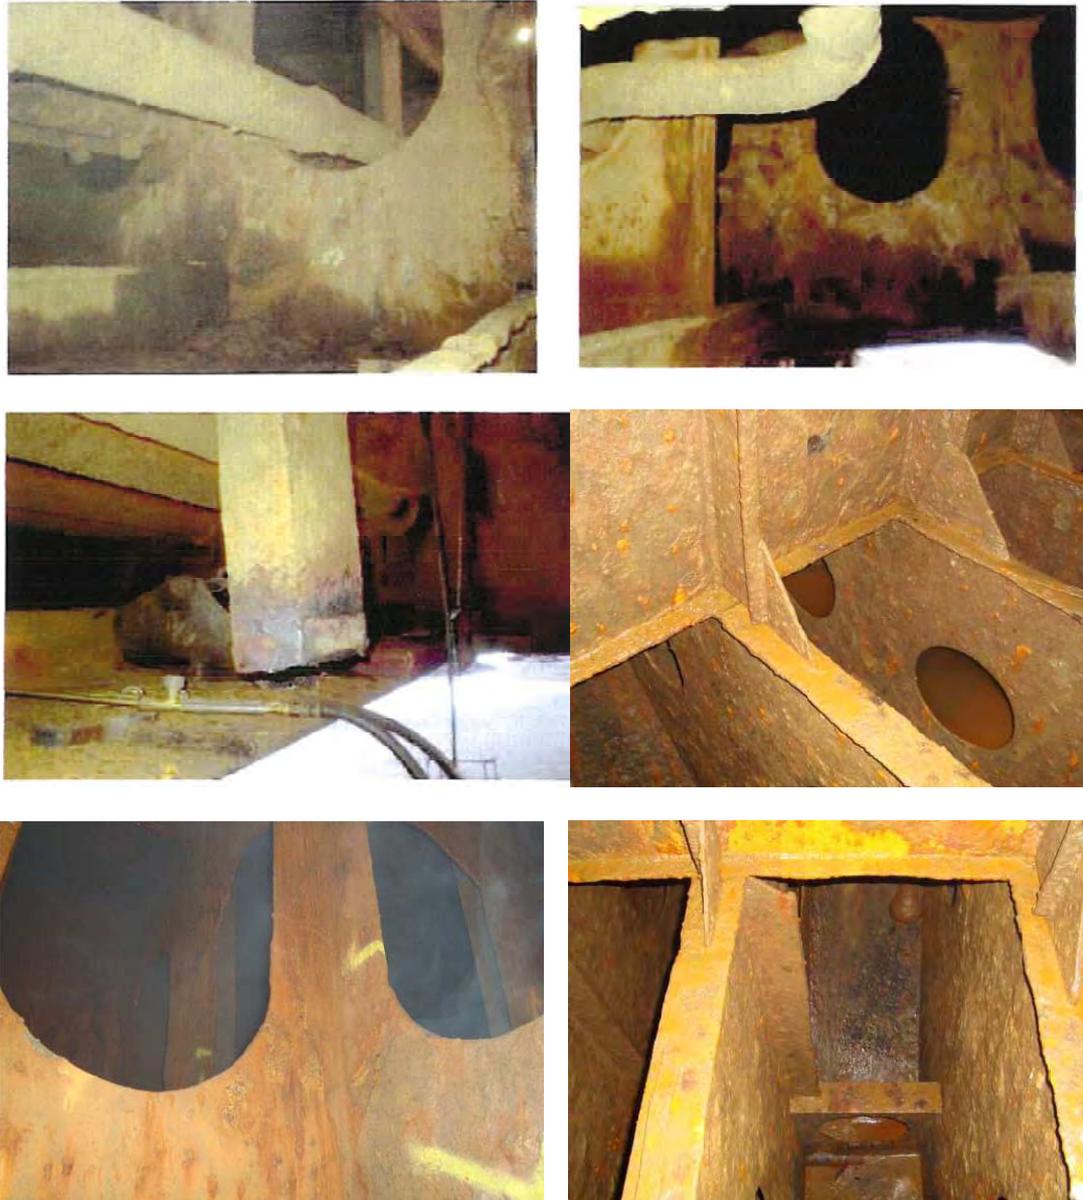
*Figure 11 – Various Photos of Double Bottom Tanks Showing Heavy Corrosion and Wastage (2009, exact locations unknown)*

<sup>16</sup> It is believed that these photographs are of the condition pre-repair, although it should be noted that no location references are provided in the Owner’s dry-dock report.

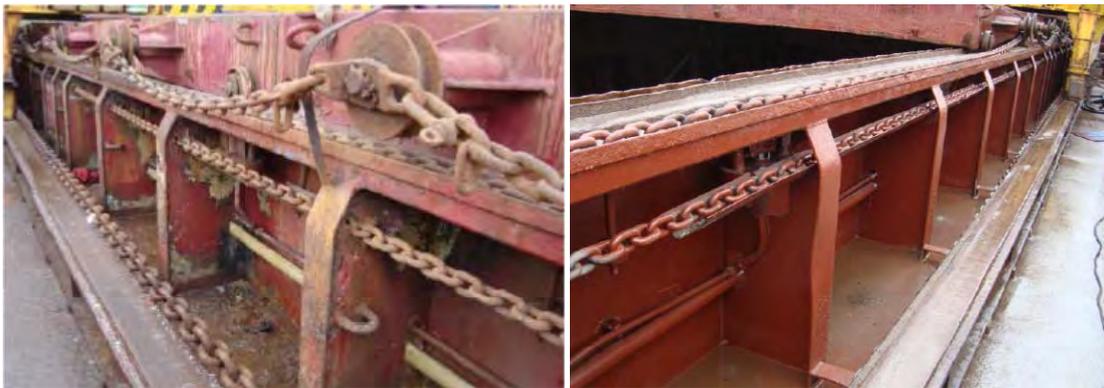
Figure 12 – Water and Dirt Trap Area between Hatch Coaming Stays

- 7.2.4. The addition of the self-discharging conveyor system in 2003 did not in itself provide any detrimental effect to the structural capacity of the vessel. On the contrary, it required the scantlings of the transverse frames to be increased and thus it likely had an overall beneficial effect in structural strength terms. However, the installation of the rails on either side of the hatch coamings created a water ‘trap’ between the stays and hence an area where corrosion would have been able to develop and propagate unless a diligent approach to cleaning and maintenance was applied. See Figure 12 below which demonstrates the problem of water and dirt trapped between the stays.
