FV *MOYUNA*

Grounding at the entrance to Ardglass Harbour, Northern Ireland 21 November 2011

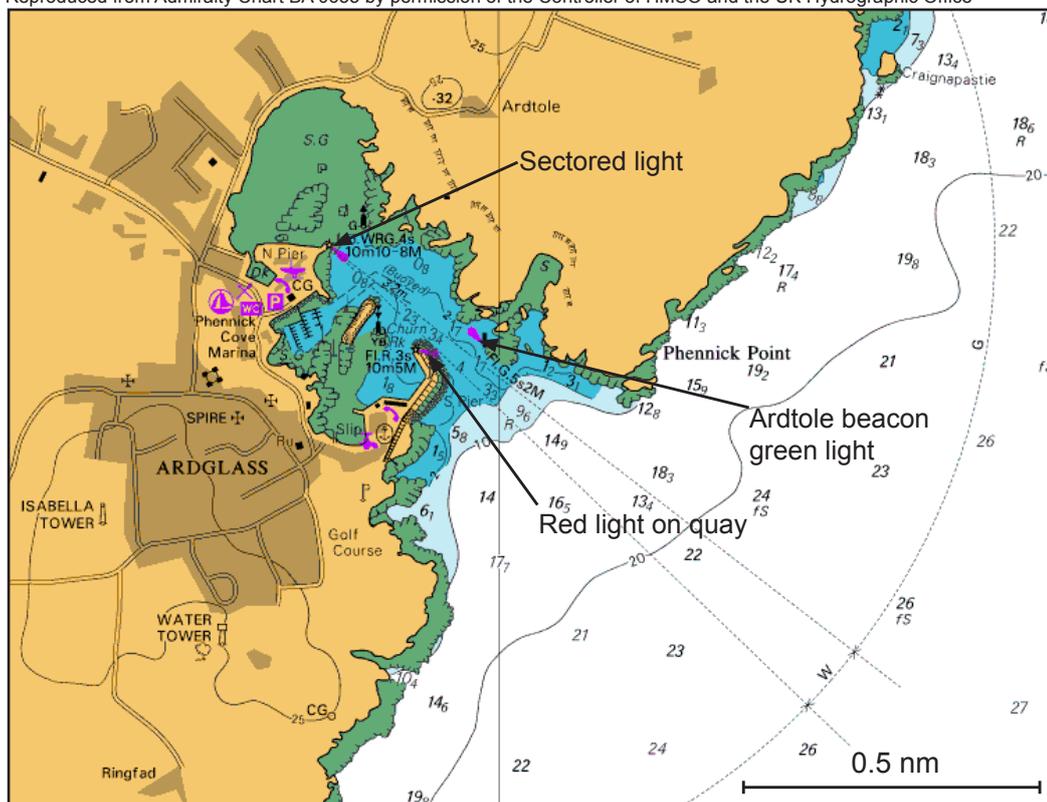
Figure 3: Chart showing Ardglass and approaches

The skipper steered *Moyuna* towards the quay (Figure 3), which was brightly lit, while also attempting to follow a previous track which was displayed on one of the plotters. The radar was operational but was not used. At one stage, the skipper believed the vessel was heading too close to the quay, so he made a small alteration to starboard and at the same time reduced speed.

At the time of the accident, Ardglass had six AtoN, three of which were equipped with lights (**Figure 3**). These comprised the sectored light, the quay red light and the Ardtole beacon green light.

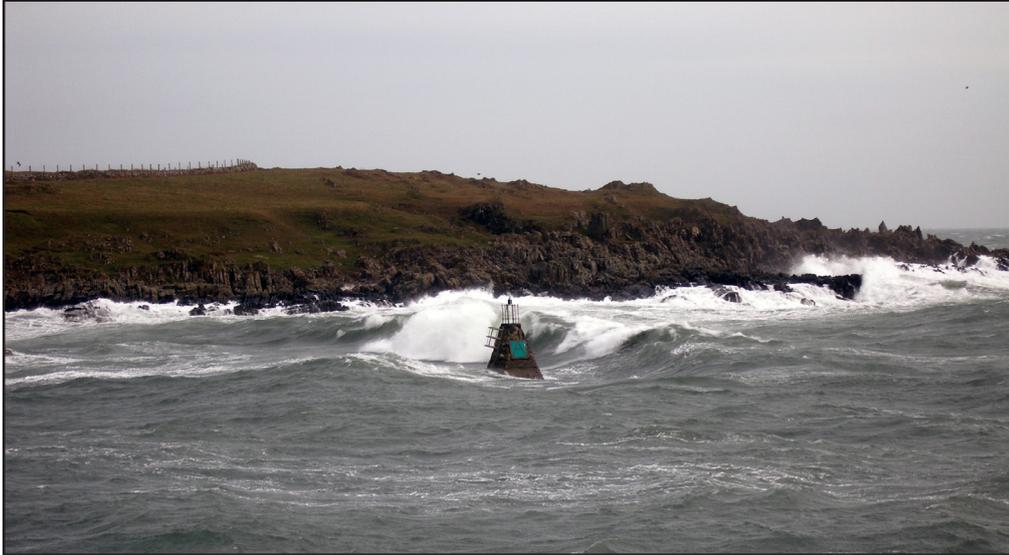
Figure 4: Ardtole beacon

The Ardtole beacon was not formally recorded by the Commissioners of Irish Lights as having a light until 2008. The light was reported as 'washed away' on 5 October 2010 and reinstated on 11 February 2011. Given the intermittent operation of the light, the harbourmaster routinely checked the harbour navigation lights every evening.

The Ardtole beacon (**Figure 4**) had been in position for over 100 years, but attempts to equip it with a light had only started after the quay was extended in 1992. There was concern that vessels leaving the port in darkness were heading too far north and grounding on the reef on which the Ardtole beacon was located. The first light quickly became inoperative due to the adverse environmental conditions and, over the years, alternative arrangements were equally unsuccessful.

NIFHA is responsible for ensuring the AtoN in Ardglass are effective and reliable. The exposed position of the Ardtule beacon (**Figure 4**) has made it difficult to mount a light, and to inspect and maintain it. Indeed, in November 2011 adverse weather conditions prevented the light's annual inspection from being conducted. Consequently, when the light became inoperative, it often took some time before it was repaired.

In view of the confined nature of the entrance to Ardglass Harbour, it is vital that the AtoN provide a safe means for entry and departure. Given the unreliable nature of the Ardtole beacon light and, as evidenced by previous groundings, the over-reliance by some harbour users on its operation, a review of the suitability and effectiveness of the AtoN provided in Ardglass Harbour, as intended by NIFHA, would be appropriate.

Since the accident, NIFHA has applied for a statutory sanction to remove the Ardtole beacon light and intends to complete a scheduled review of the AtoN in Ardglass before the end of July 2012.

- 2012/126 In conjunction with the Commissioners of Irish Lights, complete its intended review of navigational aids in Ardglass Harbour, to ensure they are:
- Effective and reliable.
 - Well-publicised to local harbour users.

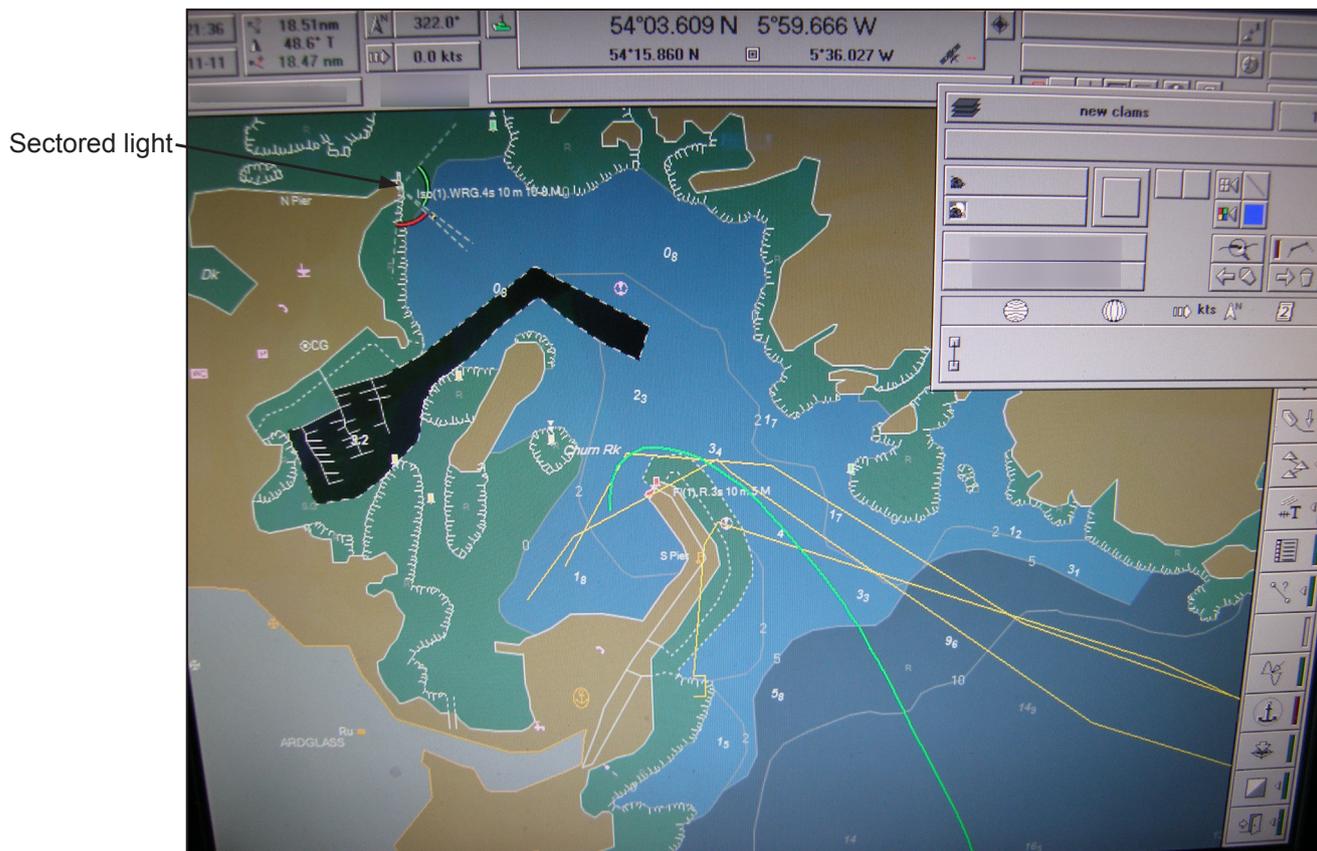
Figure 5: Chart plotter display

Electronic navigation systems are not a replacement for proper passage planning and monitoring. MGN 313 (F) highlights that over-reliance on track plotters has often led to fishing vessels running aground, and that previously recorded tracks should be used with great caution. Systems can store numerous tracks, but users must be aware of the limitations of their systems and know the origin of a particular track. There were several historical tracks on *Moyuna's* track plotter, some of which appeared to pass through the quay at Ardglass (**Figure 5**).

The Ardglass sectored light was not very clearly marked on the chart plotter (**Figure 5**). If it had been displayed in a way that more closely resembled the way it is shown on the navigational chart, it is possible the skipper would have recognised it and used the light when approaching the harbour.
