Serious injury to a chief officer **CAMERON**

Crosby Channel, Liverpool

21 November 2011

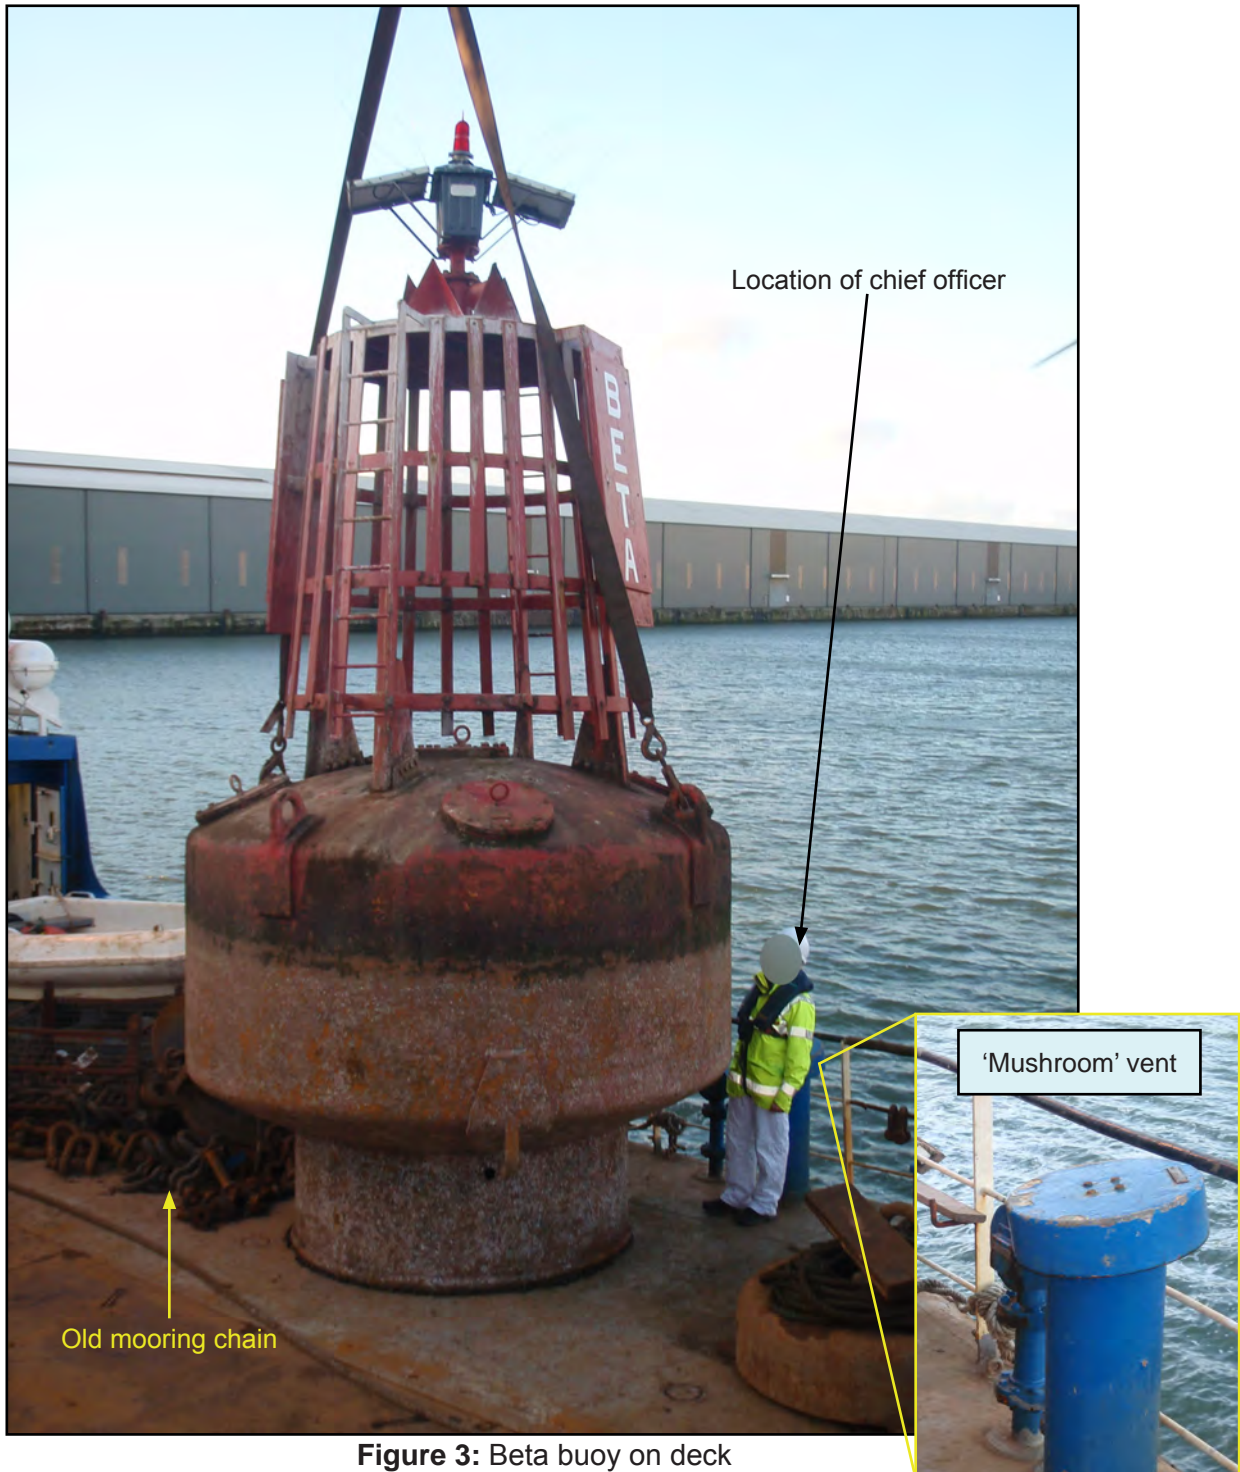
Figure 3: Beta buoy on deck
