Serious injury to a chief officer **CAMERON**

Crosby Channel, Liverpool

21 November 2011

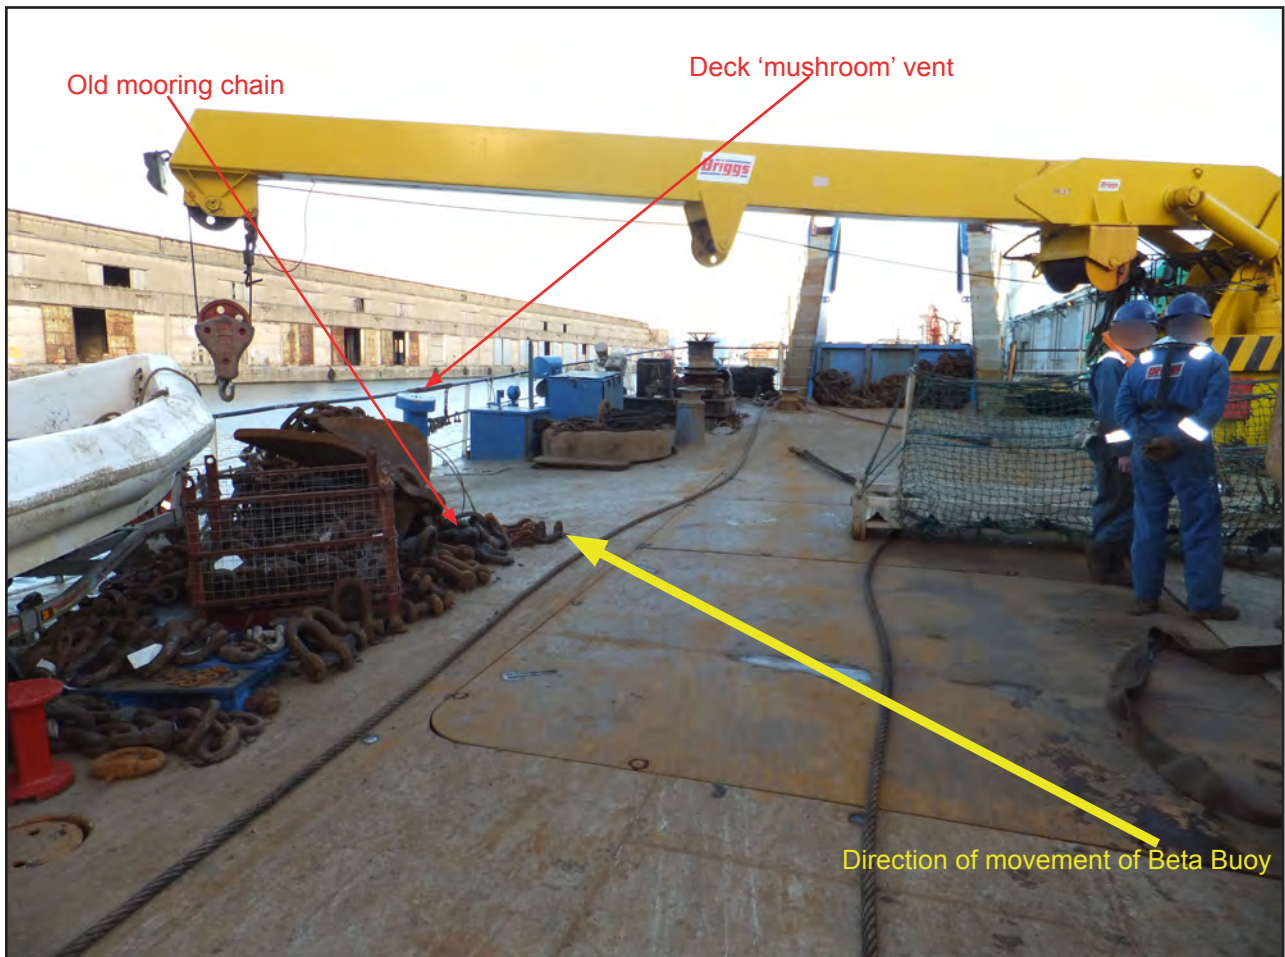
Figure 2: Working deck - Looking forward

By 1145, the replacement of the Beta buoy had been completed and the chief engineer left the deck and went to the bridge via the engine room. The crew remaining on deck recovered *Cameron's* anchor and then began to tidy the working area in readiness for the next buoy recovery operation. As part of this process it was necessary to move the recently recovered Beta buoy, which weighed 6t, from aft of the crane on the vessel's starboard side, to an area between a pile of mooring chain and a 'mushroom' air vent close to the guardrail on the vessel's port side (**Figure 2**).

The chief officer's injuries were sustained when he was crushed against the 'mushroom' air vent by the navigation buoy. The chief officer was standing very close to the buoy and the vent when the crane operator moved the buoy towards him. The crane operator warned the other deck crew that he was going to move the buoy further forward, and was not aware that the chief officer was standing between the buoy and the vent. However, the chief officer either did not hear or did not understand the implications of the crane operator's warning that he was about to move the buoy further forward. As

soon as the buoy started to move, the chief officer had insufficient space in which to attempt to move clear.

In this case, the chief officer was crushed between the buoy and the mushroom vent as he placed a wooden bearer on the deck, just as the crane operator moved the buoy further forward. It is clear that had the operation been properly considered and planned, the wooden bearers could have been pre-positioned, therefore negating the need for any of the crew to be close to the buoy as it was manoeuvred into position.

All deck crane operations must be in control of the Officer on deck. No movement of loads should be done unless the officer or the crane operator has a clear line of sight of the area where the load is to be placed.

2012/121 Introduce measures to improve the safety of deck operations conducted on board its vessels, by ensuring that:

- All tasks are appropriately planned and briefed
- Supervising officers and ratings maintain an objective overview of the work being undertaken
- Risks associated with lifting operations are identified, assessed, and have appropriate control measures in place, and
- All crew are familiar with, and adhere to, applicable regulations and guidance.
