Serious injury to a chief officer **CAMERON**

Crosby Channel, Liverpool

21 November 2011

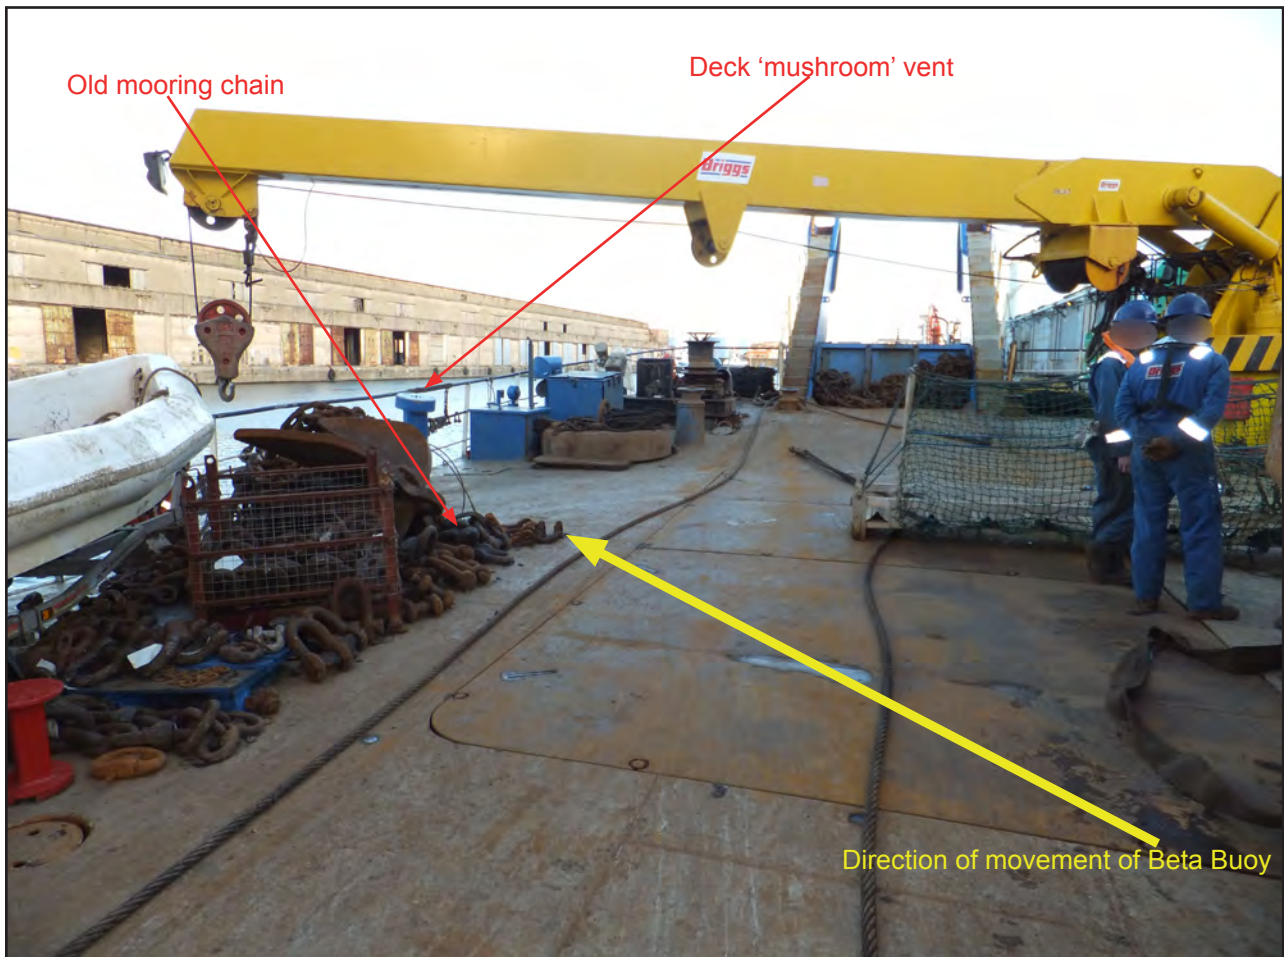
Figure 2: Working deck - Looking forward

By 1145, the replacement of the Beta buoy had been completed and the chief engineer left the deck and went to the bridge via the engine room. The crew remaining on deck recovered Cameron's anchor and then began to tidy the working area in readiness for the next buoy recovery operation. As part of this process it was necessary to move the recently recovered Beta buoy, which weighed 6t, from aft of the crane on the vessel's starboard side, to an area between a pile of mooring chain and a 'mushroom' air vent close to the guardrail on the vessel's port side (Figure 2).

The chief officer's injuries were sustained when he was crushed against the 'mushroom' air vent by the navigation buoy. The chief officer was standing very close to the buoy and the vent when the crane operator moved the buoy towards him. The crane operator warned the other deck crew that he was going to move the buoy further forward, and was not aware that the chief officer was standing between the buoy and the vent. However, the chief officer either did not hear or did not understand the implications of the crane operator's warning that he was about to move the buoy further forward. As

In this case, the chief officer was crushed between the buoy and the mushroom vent as he placed a wooden bearer on the deck, just as the crane operator moved the buoy further forward. It is clear that had the operation been properly considered and planned, the wooden bearers could have been pre-positioned, therefore negating the need for any of the crew to be close to the buoy as it was manoeuvred into position.
