MV SCOT PIONEER

Fatal injury to a crewman during cargo operations

Belview Port, Waterford

27 October 2011

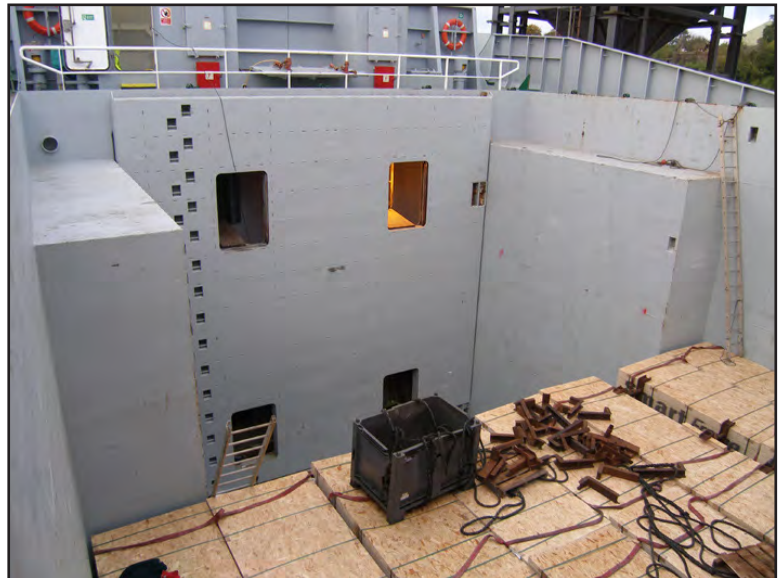
Figure 1: Forward portable bulkhead

The forward portable bulkhead had four openings (**Figure 1**) which were 0.95m wide and 1.35m high and could be sealed with wooden shuttering if required. Access to and from the bottom of the cargo hold from the forecastle deck was via an access trunk that contained two vertical ladders, separated by a landing (**Figure 2**). At cargo deck level was an opening that led from the access trunk to the 1.22m void space between the hold's forward bulkhead and the forward portable bulkhead. The hold was then accessed through either of the lower openings in the portable bulkhead. There was a similar opening in the access trunk at the level of the landing between the two vertical ladders.

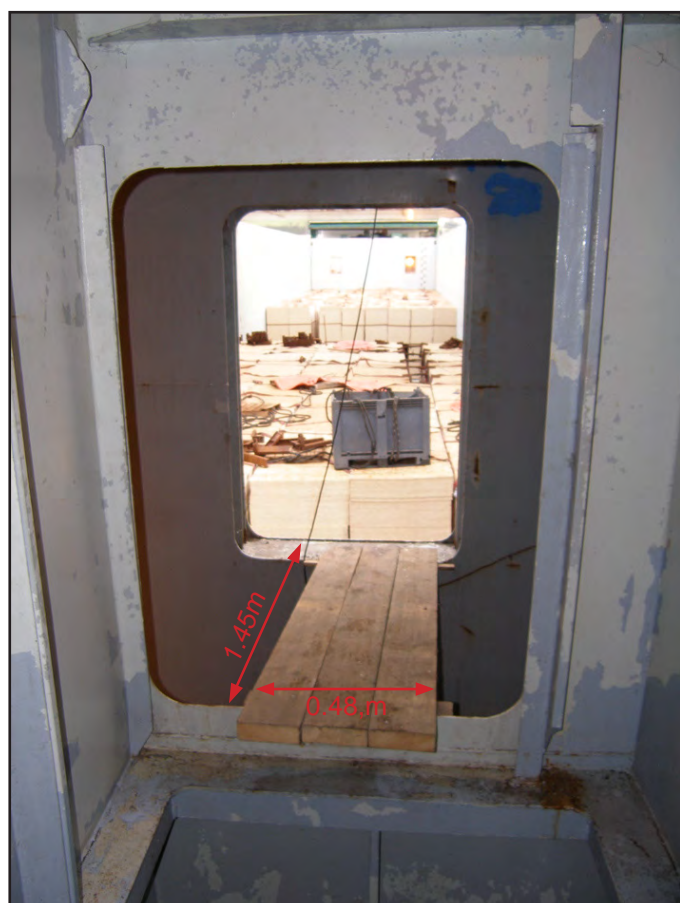
Figure 3: Wooden bridge access to hold

To enable access to the cargo hold when the lower bulkhead openings were obstructed by cargo, a wooden footbridge had been constructed that spanned the gap between the opening by the landing of the access trunk and the upper opening on the port side of the portable bulkhead (**Figure 3**). The footbridge was 5.2m above the bottom of the hold and was made of three planks of wood joined by timber cross-braces at each end, that also retained it in position. A similar bridge provided access between the upper opening on the starboard side of the portable bulkhead and a store recessed in the forward bulkhead in which one of the cargo hold floodlights was mounted (**Figure 4**).

- The narrow wooden footbridge between the forward portable bulkhead and the access trunk was not fitted with guard rails or toe boards
- The openings at either end of the footbridge were not high enough to allow the crew to pass through without stooping
- To access or leave the footbridge at the forward end required the crew to step over the opening at the top of a vertical ladder
- The aft end of the footbridge was 1.37m above the packaged cargo below.
- The void space between the bulkheads was not well lit, particularly when the hatch covers were closed.

The use of the footbridge as a means of access to and from the cargo hold was therefore unsafe and did not meet the criteria for the safe movement of personnel or the standards for hold access detailed in the Code of Safe Working Practices (CoSWP) for Merchant Seamen.

Although the upper openings in the forward portable bulkhead were designed to ventilate the cargo hold, it is clear that the openings were used by the ship's crews as a means of access soon after the vessel entered service in 2006. The wooden footbridges were in place when the vessel changed ownership in 2008, and their basic construction (**Figure 3**) indicates that they were possibly manufactured on board.

- Removed both the wooden footbridges and the forward portable bulkhead from *Scot Pioneer*.
- Modified the access arrangements to the hold, including the fitting of guards or closures on openings as necessary.
