MV SCOT PIONEER

Fatal injury to a crewman during cargo operations

Belview Port, Waterford

27 October 2011

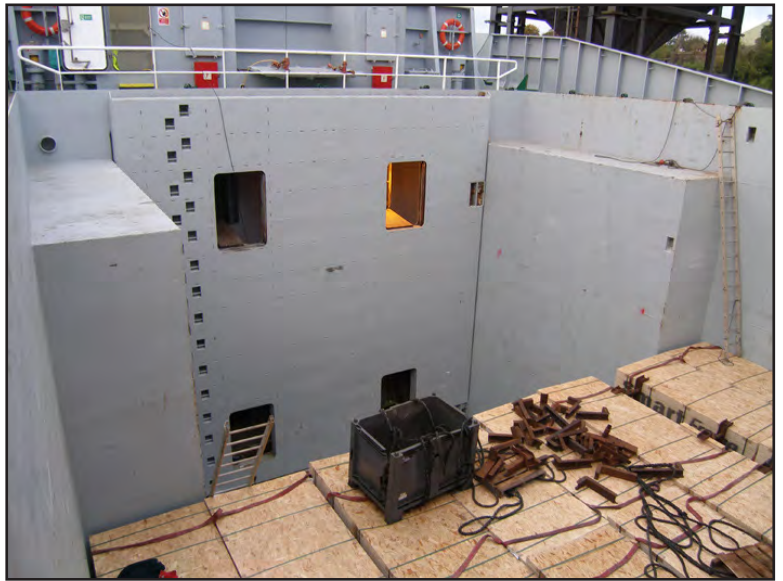
Figure 1: Forward portable bulkhead

The forward portable bulkhead had four openings (**Figure 1**) which were 0.95m wide and 1.35m high and could be sealed with wooden shuttering if required. Access to and from the bottom of the cargo hold from the forecastle deck was via an access trunk that contained two vertical ladders, separated by a landing (**Figure 2**). At cargo deck level was an opening that led from the access trunk to the 1.22m void space between the hold's forward bulkhead and the forward portable bulkhead. The hold was then accessed through either of the lower openings in the portable bulkhead. There was a similar opening in the access trunk at the level of the landing between the two vertical ladders.

The upper openings in the portable bulkhead were provided by the shipbuilder solely to assist with the ventilation of the hold, not to facilitate access. The wooden footbridges had not been provided by the shipbuilder but were on board when Scott Pioneer changed ownership in 2008. The use of the bridge to access the hold was infrequent, being only possible when a part-cargo was loaded.

- Removed both the wooden footbridges and the forward portable bulkhead from *Scot Pioneer*.
- Modified the access arrangements to the hold, including the fitting of guards or closures on openings as necessary.

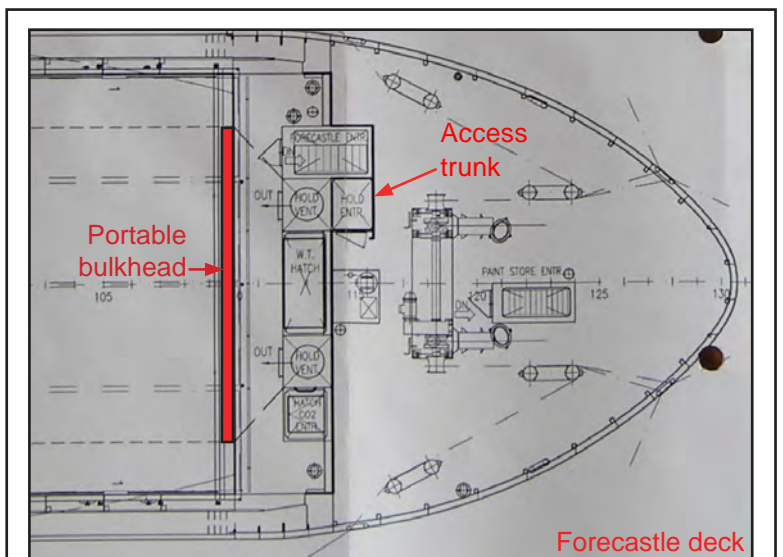
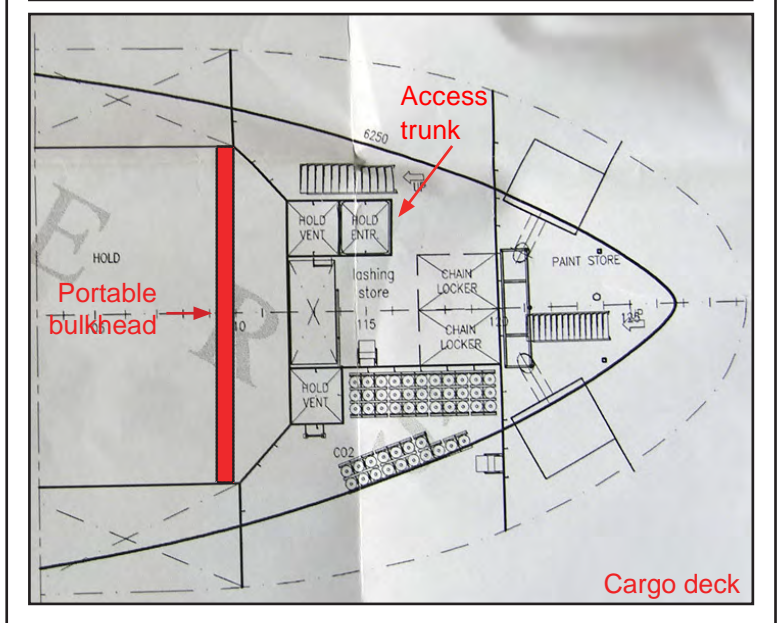
Figure 2: Positions of portable bulkheads

Scot Pioneer's single hold had a capacity of 4929m³ and was equipped with three portable bulkheads to facilitate the simultaneous carriage of different cargoes. When not in use, two of the portable bulkheads were stowed at the aft end of the hold. The third portable bulkhead was stowed in the forward part of the hold and was rarely used (Figures 1 and 2). Narrowing of the hold prevented the forward portable bulkhead from stowing flush with the forward bulkhead, and when in its stowed position there was a 1.22m void between the forward portable bulkhead and the end of the hold. The portable bulkheads were fitted with recessed vertical ladders on
